Enclosed is a final report prepared by Jeffrey Santrock of General Motors Corporation, entitled, "Evaluation of Motor Vehicle Fire Initiation and Propagation Part 4: Propagation of an Underbody Gasoline Pool Fire in a 1996 Passenger Van."

**Evaluation of Motor Vehicle Fire Initiation and Propagation
Part 4: Propagation of an Underbody Gasoline Pool Fire in a 1996
Passenger Van**

Jeffrey Santrock
General Motors Corporation

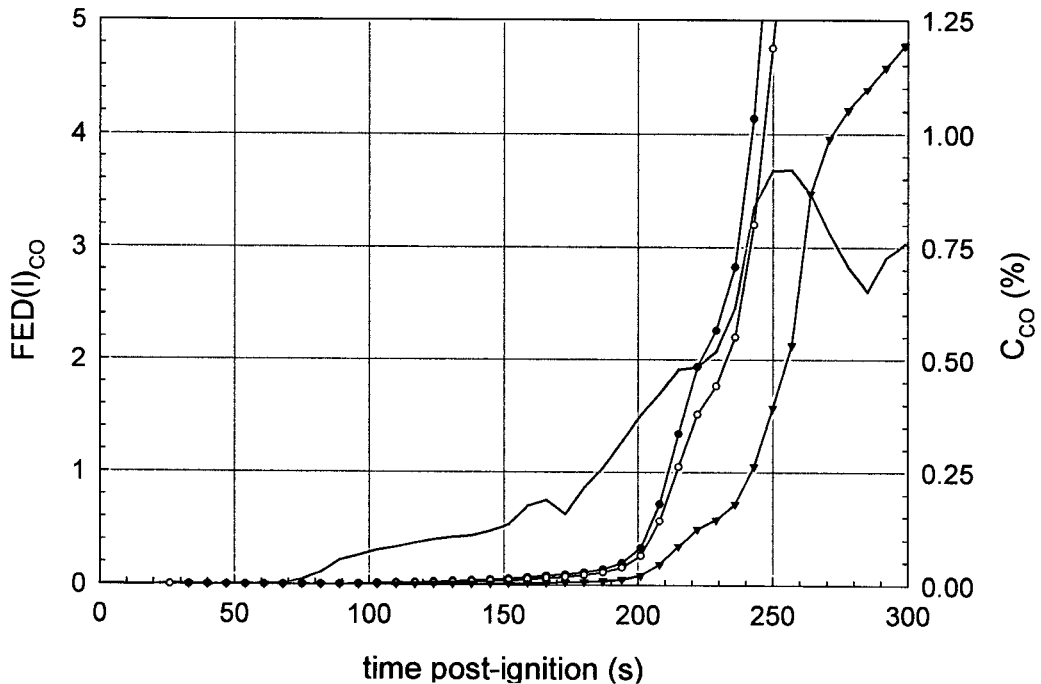
Figures 63 through 66 show plots of the estimated $FED(I)_{CO_2}$, $FED(I)_{CO}$, $FED(I)_{HCN}$, and $FED(I)_{TOTAL}$ computed using the FAA Combined Hazard Survival Model and Purser's model for assessment of the toxicity of combustion products. Both models predicted values of $FED(I)_{CO_2} > 1$ starting at approximately 240 seconds post-ignition, and exceeded a value of $FED(I)_{CO_2} \approx 5$ at about 260 seconds post-ignition (Fig. 63). The FAA Combined Hazard Survival Model and Purser's model yielded different estimates of $FED(I)_{CO}$ (Fig. 64). In Purser's model, the equation for computation of $FED(I)_{CO}$ includes a term for respiratory minute volume. Values of 8.5 and 25 L/min, representing rest or light activity, respectively [11], were used to calculate $FED(I)_{CO}$. Purser's model yielded estimates of $FED(I)_{CO} > 1$ starting at approximately 245 seconds post-ignition with a respiratory minute volume of 8.5 L/min and $FED(I)_{CO} > 1$ starting at approximately 210 seconds post-ignition with a respiratory minute volume of 25 L/min. The FAA Combined Survival Hazard Model yielded estimates of $FED(I)_{CO} > 1$ starting at approximately 215 seconds post-ignition. Both yielded estimated $FED(I)_{HCN} > 1$ starting between 200 and 210 seconds post-ignition, and $FED(I)_{HCN} \approx 5$ by 220 seconds post-ignition (Fig. 65).

Figure 64. Fire Test F961116. Plots of estimates of $FED(I)_{CO}$ versus time post-ignition computed using the FAA Combined Hazard Survival Model (—○—), the Purser model with a respiratory minute volume of 8.5 L/min (—▼—), and the Purser model with a respiratory minute volume of 25 L/min (—●—). A plot of C_{CO} (—) is included for reference.

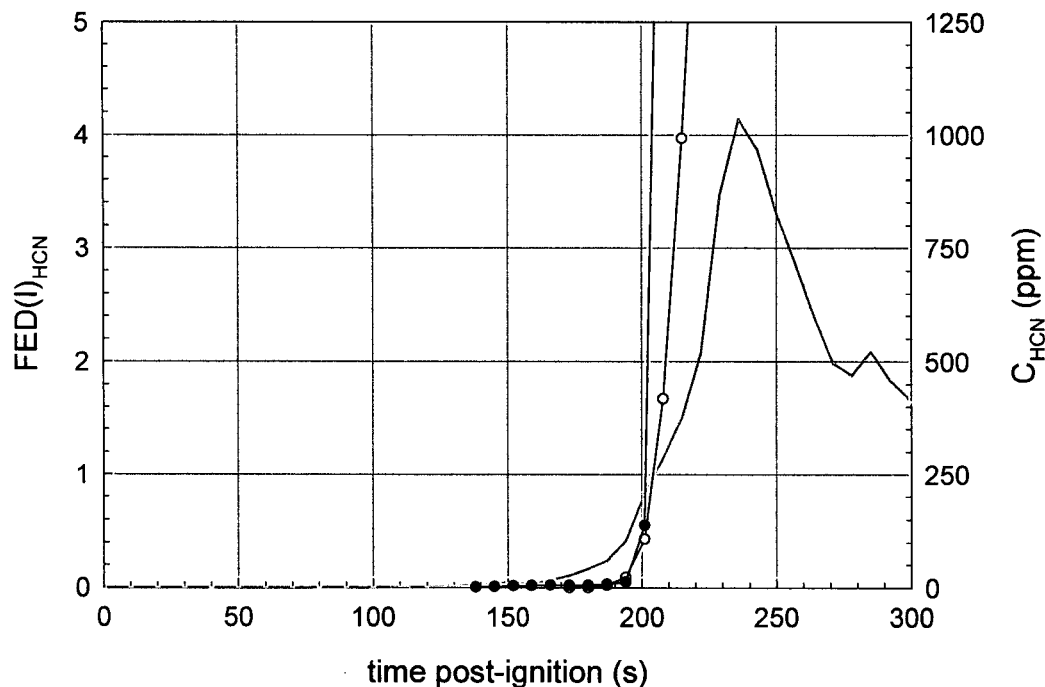
Figure 65. Fire Test F961116. Plots of estimates of $FED(I)_{HCN}$ versus time post-ignition computed using the FAA Combined Hazard Survival Model (\circ) and Purser's model for assessment of the toxicity of combustion products (\bullet). A plot of C_{HCN} (—) is included for reference.

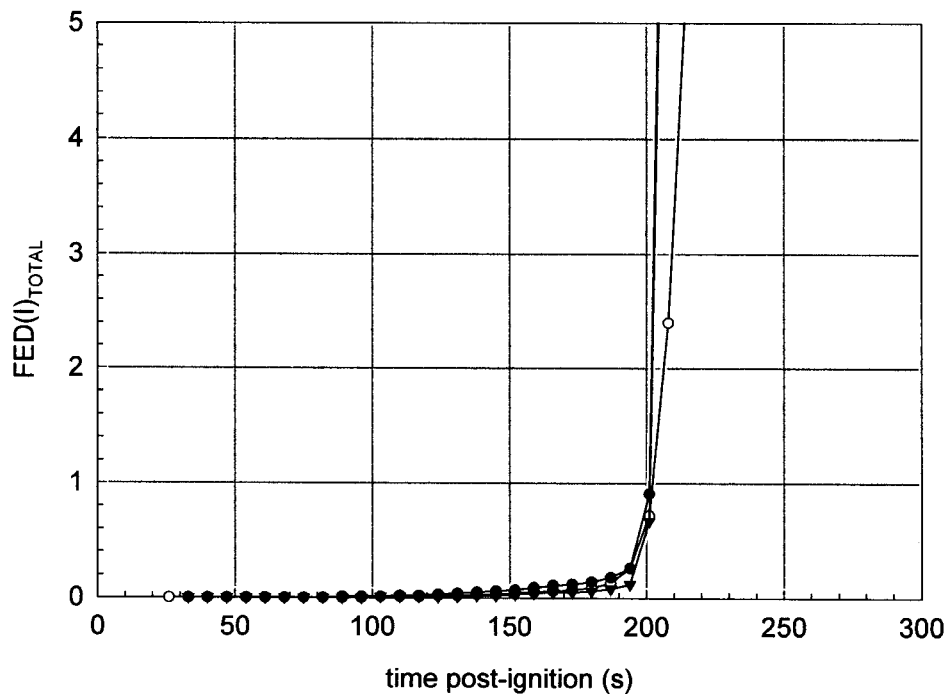
Figure 66 shows estimates of $FED(I)_{TOTAL}$ versus time post-ignition computed using the FAA Combined Hazard Survival Model and Purser's model for assessment of the toxicity of combustion products. The FAA Model indicated that hydrogen cyanide, carbon monoxide, and carbon dioxide accounted for 70, 23, and 12%, respectively, of $FED(I)_{TOTAL}$. Purser's model indicated hydrogen cyanide accounted for between 91 and 96% of $FED(I)_{TOTAL}$, carbon monoxide accounted for between 2 and 7% of $FED(I)_{TOTAL}$, and carbon dioxide accounted for less than 2% of $FED(I)_{TOTAL}$.

Figure 66. Fire Test F961116. Plots of $FED(I)_{TOTAL}$ versus time post-ignition: FAA Combined Hazard Survival Model (\circ); Purser's model with $RMV = 8.5$ L/min (\blacktriangledown); and Purser's model with $RMV = 25$ L/min (\bullet).

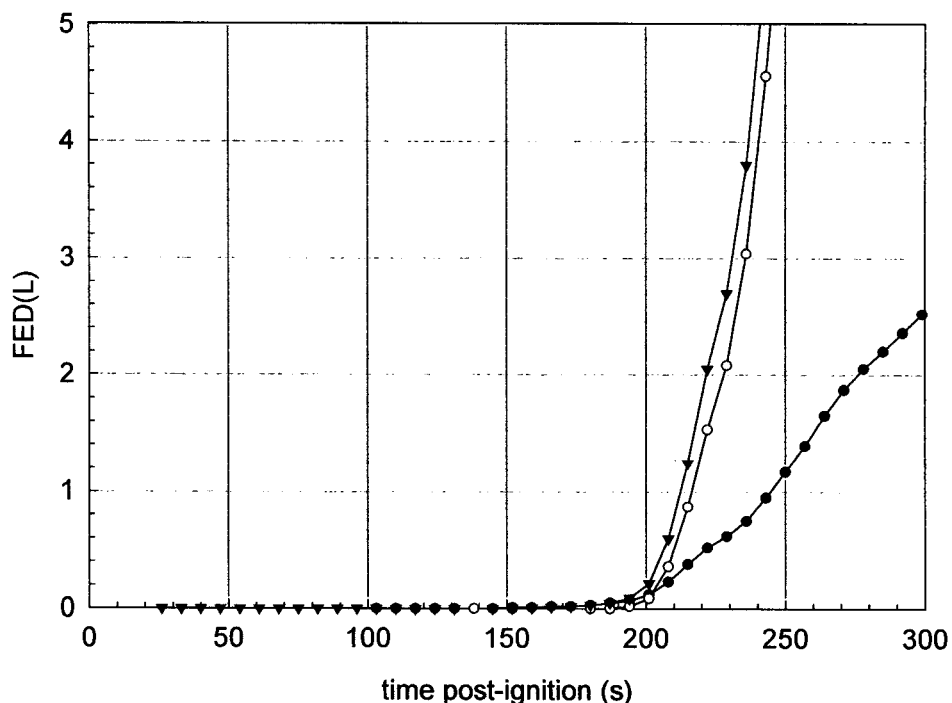
Figure 67 shows plots of $FED(L)_{CO}$, $FED(L)_{HCN}$, and $FED(L)_{TOTAL}$ computed using the FAA Combined Survival Hazard Model.

Figure 67. Fire Test F961116. Plots of $FED(L)_{CO}$ (—●—), $FED(L)_{HCN}$ (—○—), and $FED(L)_{TOTAL}$ (—▼—) versus time post-ignition computed using the FAA Combined Hazard Survival Model.

The estimate of $FED(L)_{HCN}$ increased sharply between 180 and 240 seconds post-ignition, exceeding a value of 1 at approximately 200 seconds post-ignition. In contrast, the estimate of $FED(L)_{CO}$, started to increase gradually at the same time, exceeding a value of 1 at approximately 245 seconds post-ignition. And $FED(L)_{TOTAL}$, which is the sum of $FED(L)_{CO}$ and $FED(L)_{HCN}$, also increased sharply between 180 and 240 seconds post-ignition, exceeding a value of 1 at approximately 205 seconds post-ignition, where $FED(L)_{HCN}$ accounted for 70% and $FED(L)_{CO}$ accounted for 30% of $FED(L)_{TOTAL}$. These estimates suggest that the concentrations of combustion gases may have exceeded lethal levels in the front of the passenger compartment after approximately 205 seconds post-ignition.

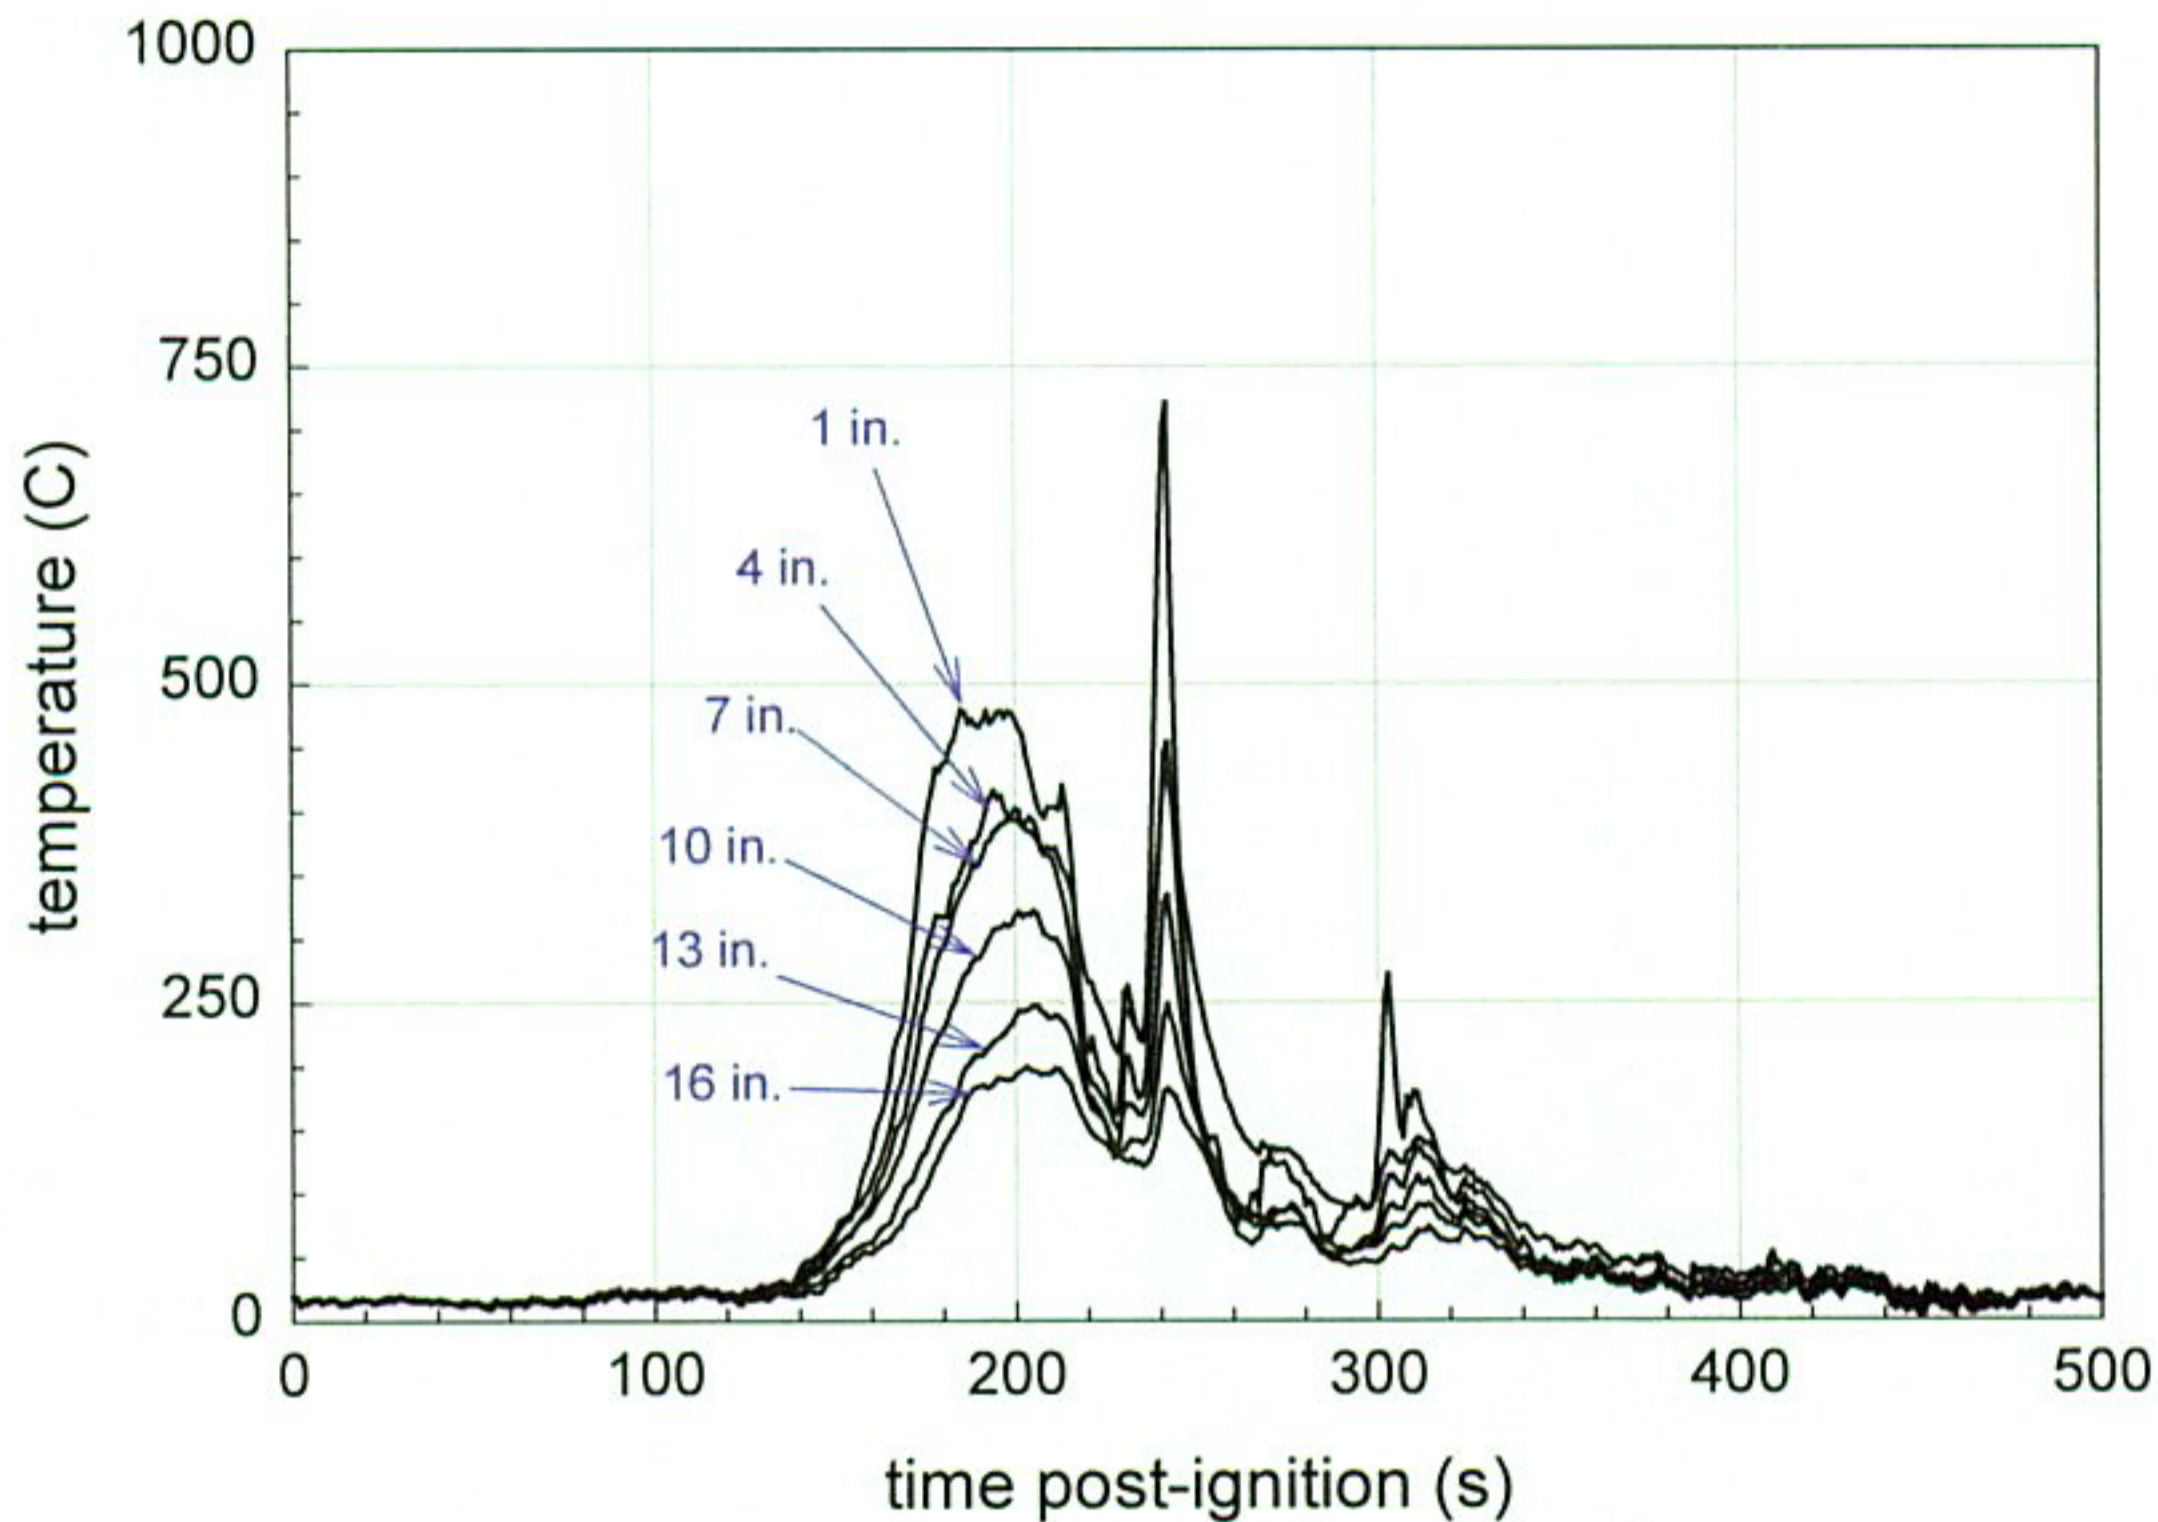
Figure 68 shows plots of the air temperature measured at 1, 4, 7, 10, 13, and 16 inches below the lower surface of the headlining panel versus time post-exposure. These plots show that the average air temperature in the front of the passenger compartment was in the range of 453°C (1

inch below the headlining panel) to 182°C (16 inch below the headlining panel) between 180 and 210 seconds post-ignition.

Figure 68. Fire Test F961116. Plots of air temperature at 1, 4, 7, 10, 13, and 16 inches below the lower surface of the headlining panel versus time post-ignition.

As the data in Figure 68 shows, the temperature of the air inhaled by an occupant in the front of the test vehicle at this time would have depended on the height of the occupant's head. It is impossible to estimate the potential for burn injury to the respiratory tract caused by inhalation of hot air from this air temperature data alone. Water and particulate produced by the fire increase the heat capacity of the air. The concentrations of these species in the inhaled air have been shown to affect both the severity and depth of burn injury in the respiratory system. Neither the water- nor the particulate-concentrations of air in the passenger compartment were measured in this test. Purser states that a robust quantitative relationship between the temperature, water-content, and particulate-content of inhaled air and subsequent burn injury to respiratory airways has not been established [11]. A few controlled animal studies indicate that inhalation of steam at 100°C caused burns to the larynx and trachea similar to those produced by inhalation of dry air at 350°C or flames at 500°C [see references in 11]. In these controlled animal studies, death was not immediate, but resulted from obstructive edema in the burned airways a few to twenty-four hours after the exposure. As neither water nor particulate were measured in the air sampled from the passenger compartment during this test, the potential for burn injury to the respiratory airways

from inhalation of hot gas cannot be determined accurately from the air temperature data shown in Figure 68.
