Re: **Settlement Agreement**
Section B. Fire Safety Research

On August 31, 2001, GM submitted a final report for Project B.3 (Fire Initiation and Propagation Tests), entitled, "Evaluation of Motor Vehicle Fire Initiation and Propagation/Part 6: Propagation of an Underbody Gasoline Pole Fire in a 1997 Rear Wheel Drive Passenger Car." This letter supplements that report.

This report describes a vehicle fire propagation test conducted pursuant to the GM/DOT Settlement Agreement. This fire test was conducted on September 30, 1997. The test vehicle was a crash-tested 1997 Chevrolet Camaro. In the crash test, the test vehicle was stationary and struck in the rear by a moving barrier. No leaks were detected in the fuel system of the test vehicle during the crash test or the subsequent roll test performed after the crash test. No fire was observed during the crash test, nor was there evidence of fire present in the test vehicle after the crash test. To create a gasoline pool under the test vehicle for the fire test, a gasoline delivery system consisting of a gasoline reservoir, compressed nitrogen reservoir, a pressure regulator, and a flow regulator was used to deliver liquid gasoline u

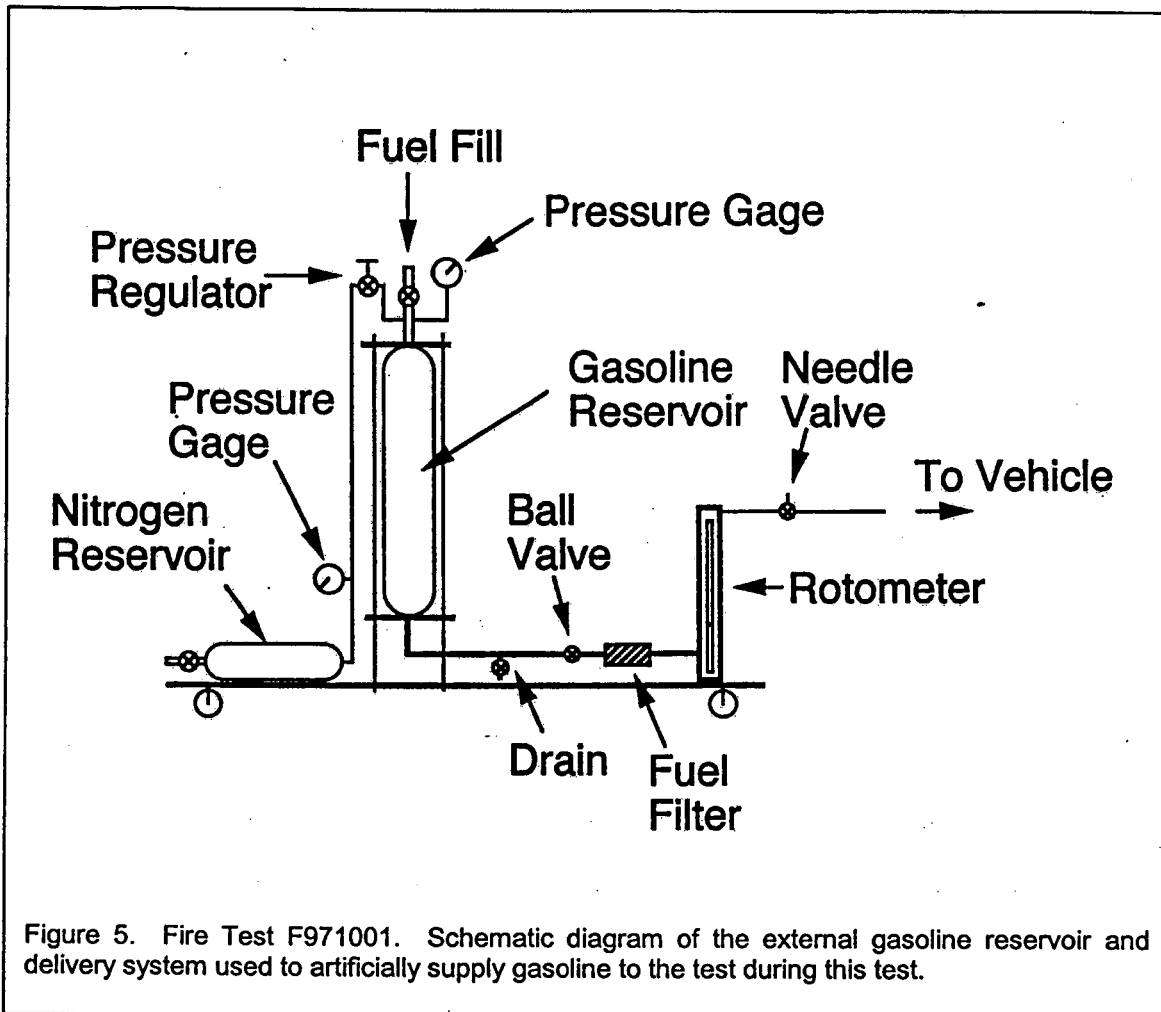
A technical error was recently identified on page 8, second paragraph, of the B.3 final report. Specifically, one of the units of measurement referenced on that page was incorrect. The report states, "The needle valve was adjusted to give a flow rate of approximately 500 cm³/s, measured before the test by collecting the gasoline effluent in a graduated container for a specified period of time." The actual flow rate was approximately 500 cm³/min.

Figure 5. Fire Test F971001. Schematic diagram of the external gasoline reservoir and delivery system used to artificially supply gasoline to the test during this test.

The outlet of the tube was located at the lower left edge of the fuel tank, below the area where the fuel filler tube enters the fuel tank. The outlet of the tube was fitted with a flow restrictor (i.d. = 0.125") to reduce vaporization of gasoline by maintaining some back-pressure in the delivery tube.

Gasoline (4 L) was added to a steel fluid reservoir (4 L). The gas reservoir was filled with dry nitrogen gas. The pressure regulator was adjusted to maintain a head pressure of 275 kPa (25.0 psi) in the fluid reservoir. Before the test, the delivery tube was purged with gasoline before the start of the test to eliminate air. The needle valve was adjusted to give a flow rate of approximately 500 cm³/min, measured before the test by collecting the gasoline effluent in a graduated container for a specified period of time.

Enclosed is a corrected replacement page for your records. I apologize for any confusion this error may have caused.

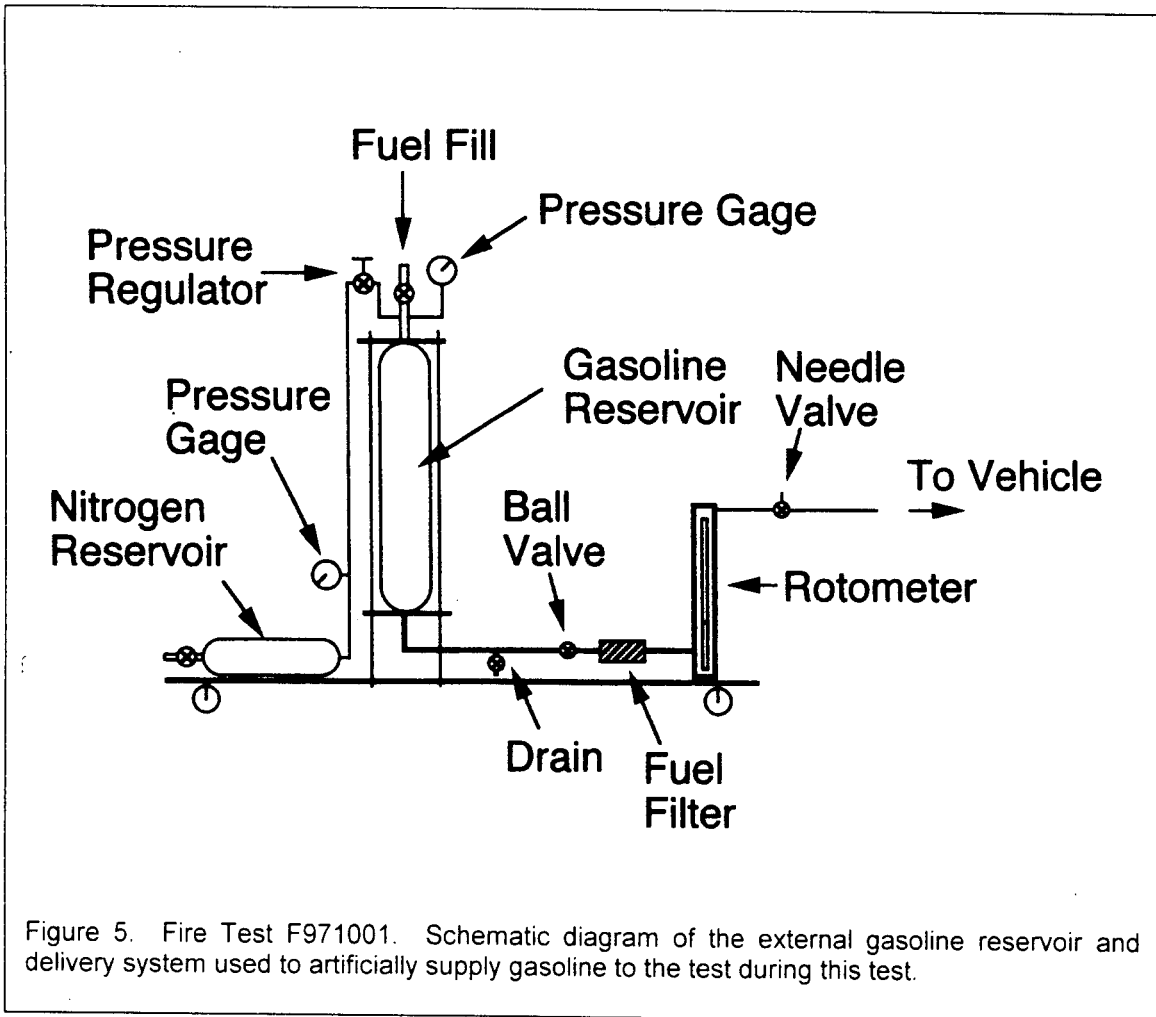
Gasoline was delivered from a pressurized external reservoir at a constant flow rate during this test. Technical personnel from the Building and Fire Research Laboratory of the National Institutes of Standards and Technologies designed, built, and operated the gasoline delivery system used in this test. Figure 5 shows a schematic diagram of the gasoline delivery system used in this test. This system consisted of two stainless steel cylinders. One cylinder functioned as a fluid reservoir and had a capacity of 4 L, while the other cylinder functioned as a pressurized gas reservoir. A pressure regulator in the line connecting the gas reservoir to the fluid reservoir controlled the head pressure in the fluid reservoir. The outlet line of the fluid reservoir contained a ball valve that was used to turn on and off the flow of gasoline during the test, a rotometer to indicate the flow of gasoline during the test, and a needle valve to control the flow of gasoline.

Figure 5. Fire Test F971001. Schematic diagram of the external gasoline reservoir and delivery system used to artificially supply gasoline to the test during this test.

The outlet of the tube was located at the lower left edge of the fuel tank, below the area where the fuel filler tube enters the fuel tank. The outlet of the tube was fitted with a flow restrictor (i.d. = 0.125") to reduce vaporization of gasoline by maintaining some back-pressure in the delivery tube.

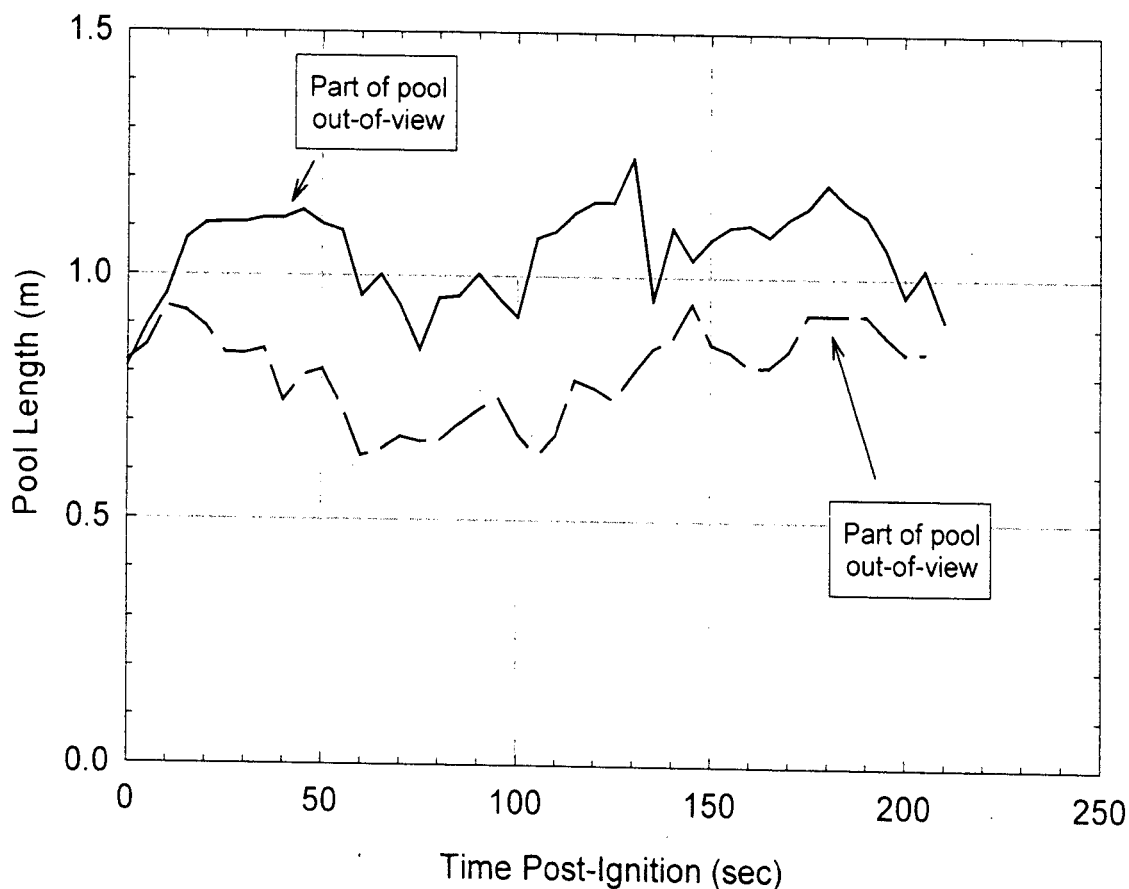
The flow rate of gasoline was maintained at approximately 515 cm³/min throughout the test. After ignition, the length of the burning gasoline pool was estimated from the videotapes from Cameras 5 and 8. Figure 11 shows plots of the estimated length of the gasoline pool at five-second intervals from the time of ignition to approximately 210 seconds post-ignition. The uncertainty in the estimated pool size was ± 5 cm.

Figure 11. Fire Test F971001. Estimates of the length of the gasoline pool under the test vehicle obtained by analysis of the videotapes from Cameras 5 (—) and 8 (— —).

nearly head-on (perpendicular to its long axis). Camera 8 viewed the gasoline pool at approximately a 45° angle to its long axis. The difference in the two estimates of gasoline pool length shown in Figure 11 were the result of the different view-angles of Cameras 5 and 8. These estimates indicate that the gasoline pool was between 60 and 120 cm long, with an average length of between 90 and 100 cm (Fig. 11). The pool was estimated to have been less 12 cm wide. It was not possible to estimate the lateral extension of flames along the underbody of the test vehicle accurately from the videos from Cameras 5 and 8 because the low clearance under the test vehicle did not allow good views of the underbody of the test vehicle.

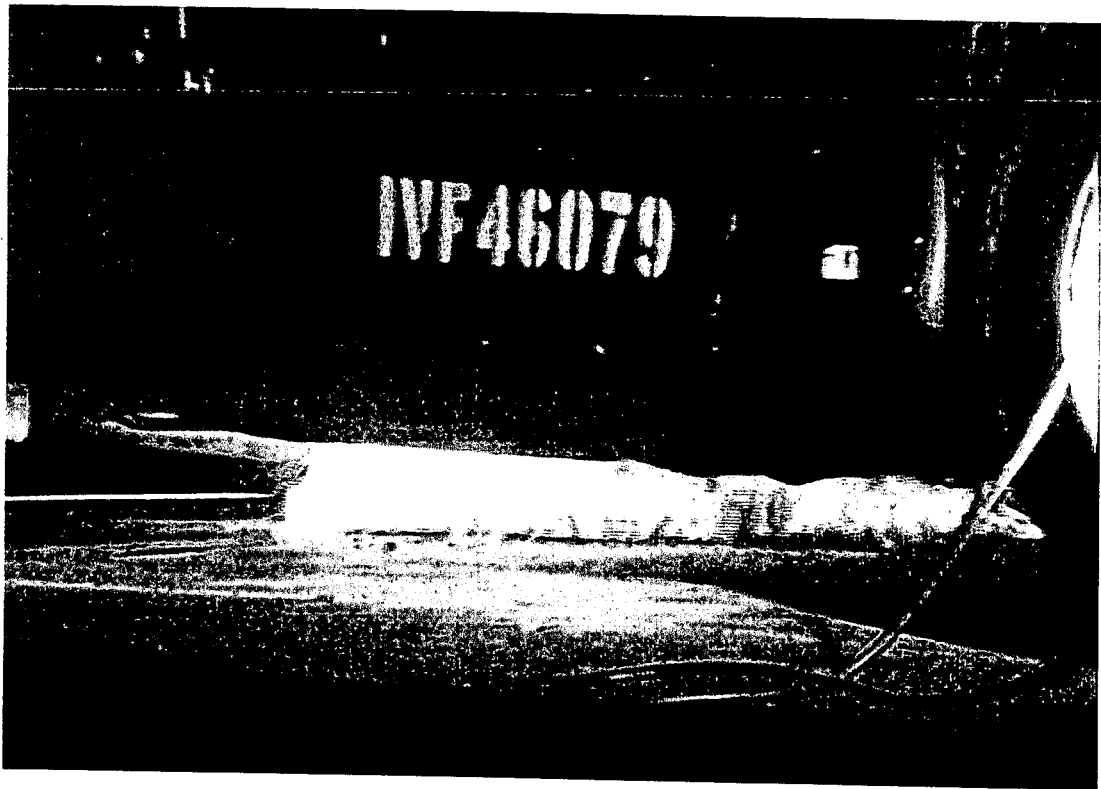
Figure 17. Fire Test F971001. Video stills from Camera 5 (upper) and Camera 8 (lower) at 150 seconds post-ignition of the burning gasoline pool under the test vehicle.

spread forward along the fuel lines to the in-line fuel filter⁵, also located under the rear left seat, which separated from its mounting bracket and fell onto the surface of the fluid containment pan by 150 seconds post-ignition (upper video still, Fig. 17).

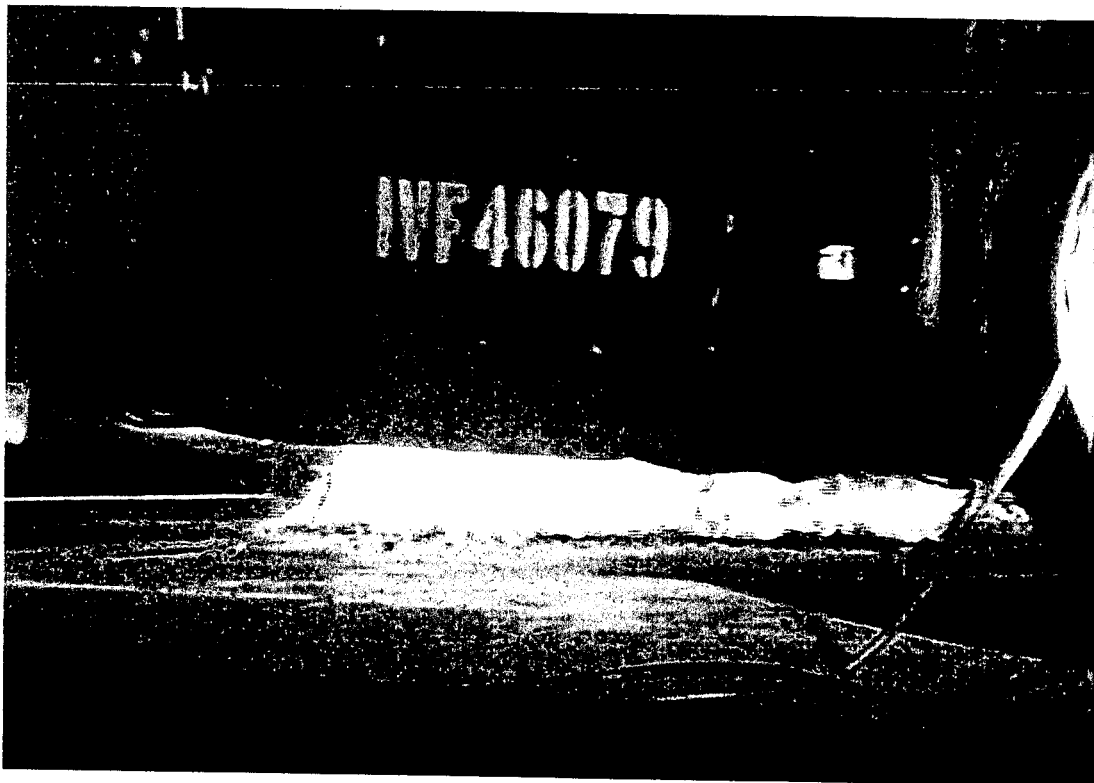
Figure 18. Fire Test F971001. Video stills from Camera 5 (upper) and Camera 8 (lower) at 175 seconds post-ignition of the burning gasoline pool under the test vehicle.

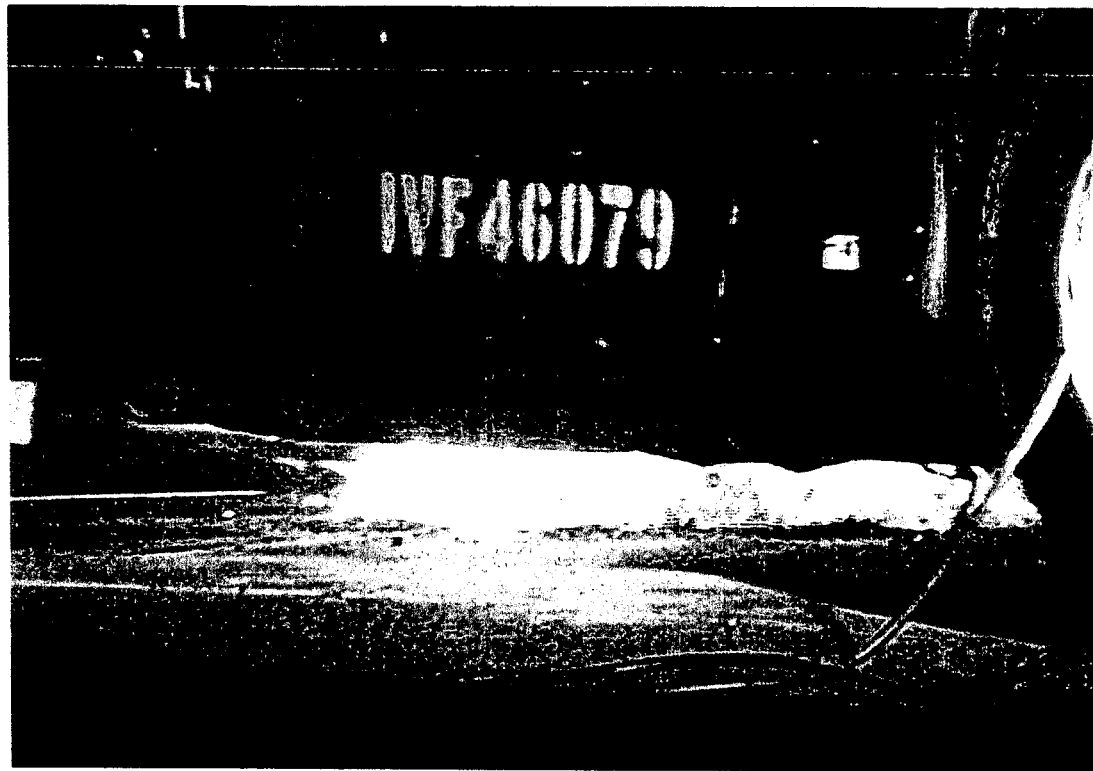
Figure 19. Fire Test F971001. Video stills from Camera 5 (upper) and Camera 8 (lower) at 200 seconds post-ignition of the burning gasoline pool under the test vehicle.

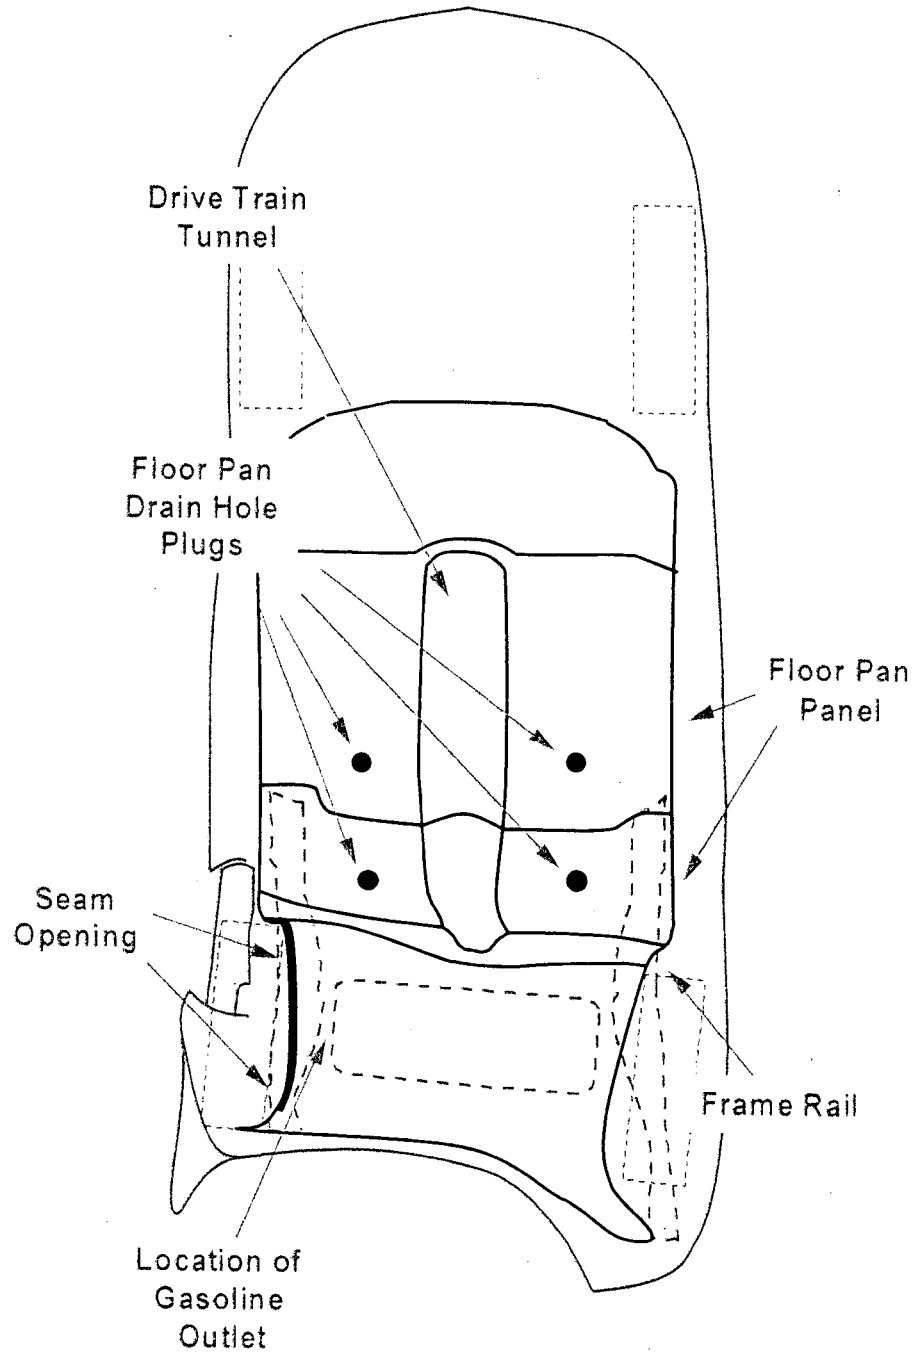
Isothermal contour plots of temperatures below the test vehicle were estimated from data recorded from thermocouples located below the floor pan panel.² Figure 20 shows some of the structures forming the underbody of the test vehicle after the crash test. The approximate locations of the floor panel drain hole plugs, and outlines of the body, tires, fuel tank, and rear compartment floor pan rails (frame rails) are also shown in this diagram. Thermocouples were placed in pairs on the floor panel and the section of the rear compartment front panel around the rear left wheelhouse. One thermocouple of each pair was adhered to the upper surface of the metal with thermally conducting ceramic cement. The other thermocouple in each pair was positioned approximately 1 cm below the metal panel. The number of thermocouples on the rear compartment front panel and rear compartment rear panel was not sufficient to allow accurate estimation of isothermal contours under the section of the test vehicle rearward of the rear seat backs. For this reason, only isothermal contours under the floor panel are shown.

Figure 20. Fire Test F971001. View from above the test vehicle showing the floor panel, rear compartment front panel, and rear compartment rear panel.

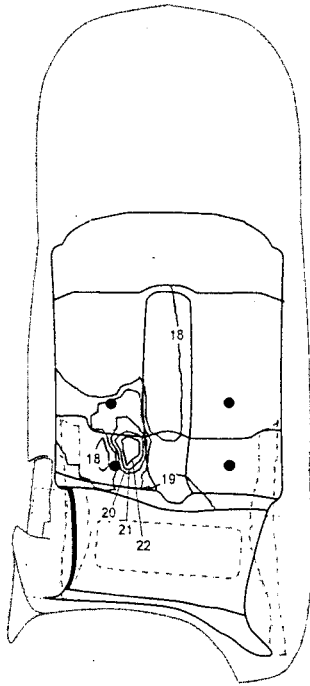
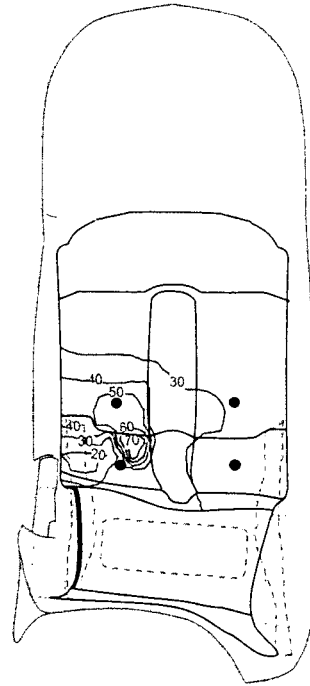
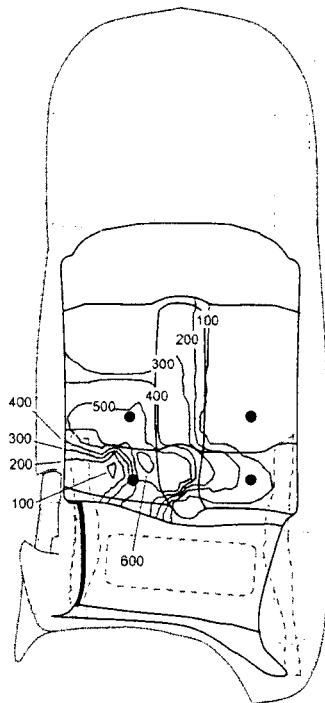
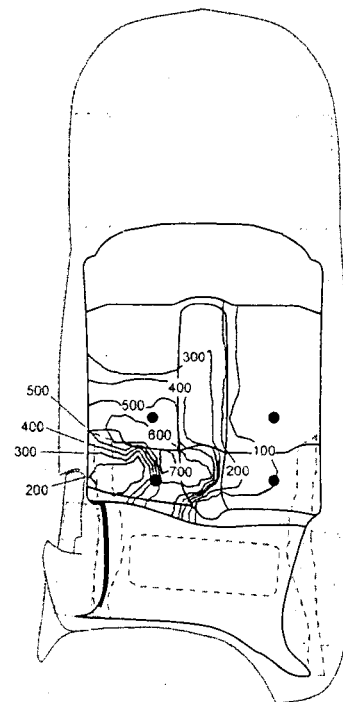
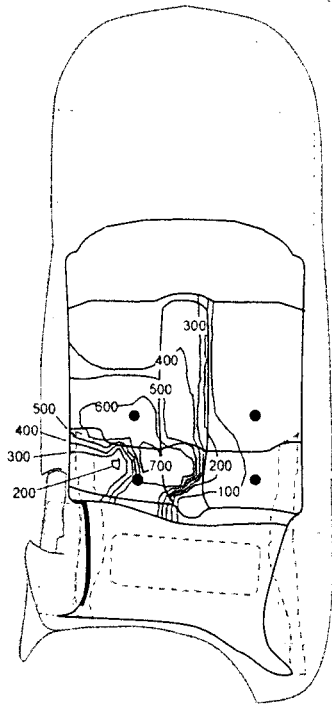
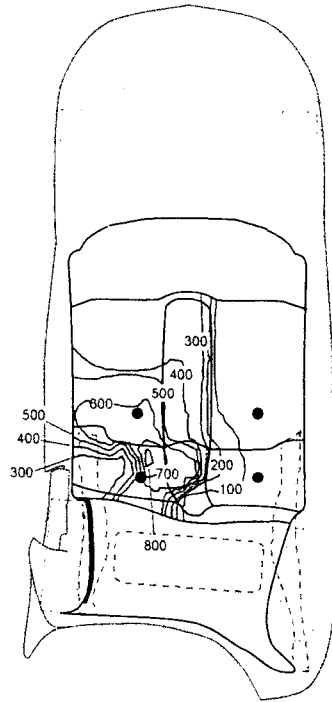
The distribution of flames under the test vehicle³ was indicated by isothermal contours with $t \geq 600^\circ\text{C}$ (Fig. 21). These plots indicate that heated gases started to spread forward along the left side of the floor panel at about the time of ignition. The natural buoyancy of the hot gases in the fire plume caused the flames to move upward toward the highest points in the floor panel, which appeared to be a pocket under the rear left seat created as the floor panel buckled during the crash test. The left rocker panel and left rear compartment floor panel rail (frame rail) appeared to limit lateral extension of flames to the edge of the left side of the floor panel. Heated gases and flames appeared to accumulate in the rear section of the drive train tunnel, but not to have spread

Figure 21. Fire Test F971001. Isothermal contour plots showing estimated temperatures below the floor panel at -10, 0, 25, 50, 75, 100, 125, 150, 175, and 200 seconds post-ignition.

Thermocouples located below the floor panel under the inboard half of the rear left seat cushion recorded temperatures exceeding 600°C at approximately 25 seconds post-ignition (Fig. 21), indicating that flames were below this section of the floor panel at this time. By 50 seconds post-ignition, the isothermal contour plots indicate that the area of the floor panel exposed to flames increased to include an adjacent section of the drive train tunnel and a section just forward of the rear left seat cushion (Fig. 21). The distribution of flames on the floor panel inferred from the isothermal contour plots could not be confirmed by the direct observation of flames contacting specific areas of the underbody (Fig.'s 12 through 19).

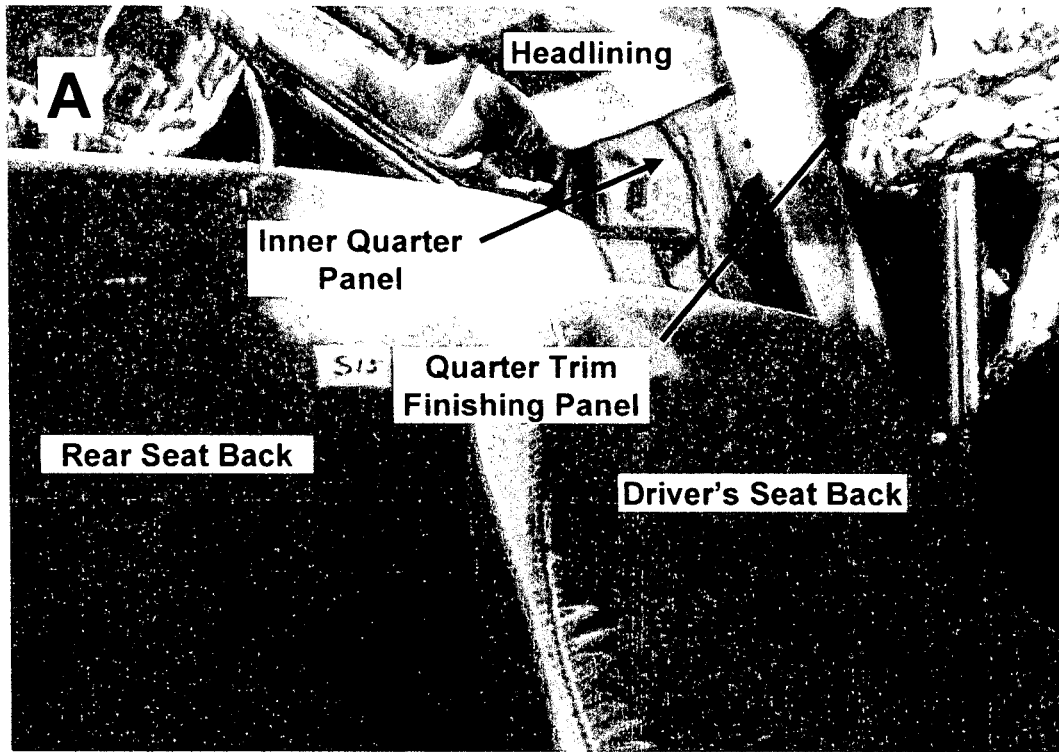
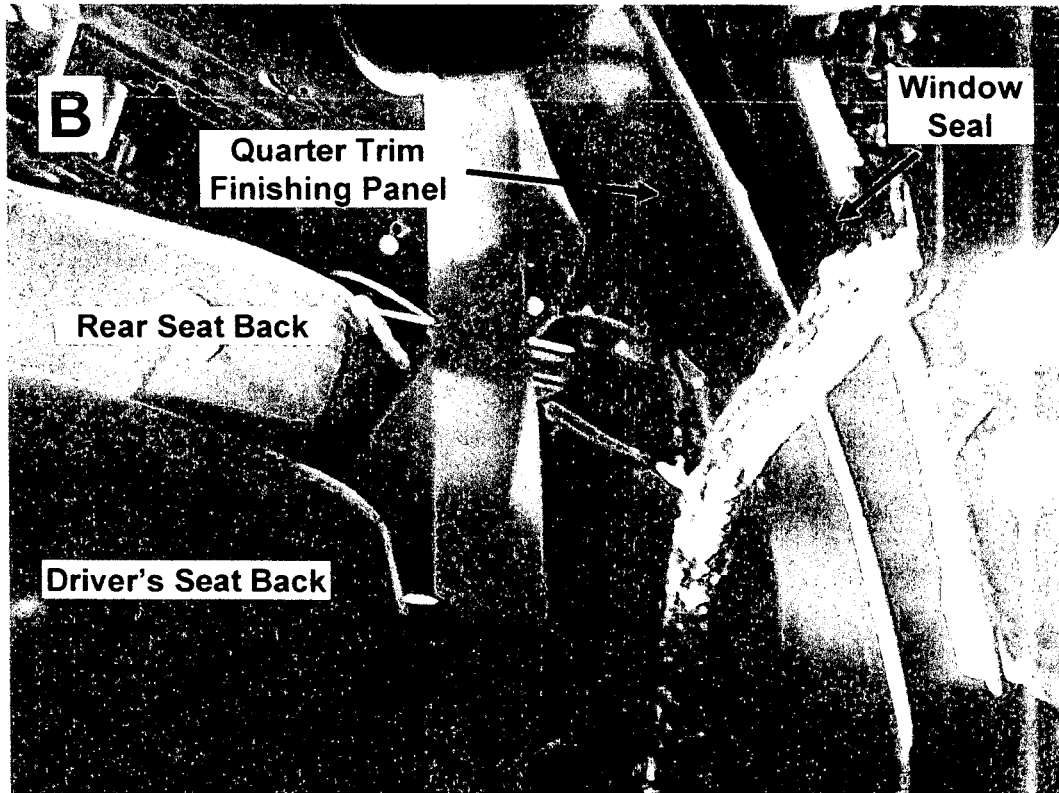
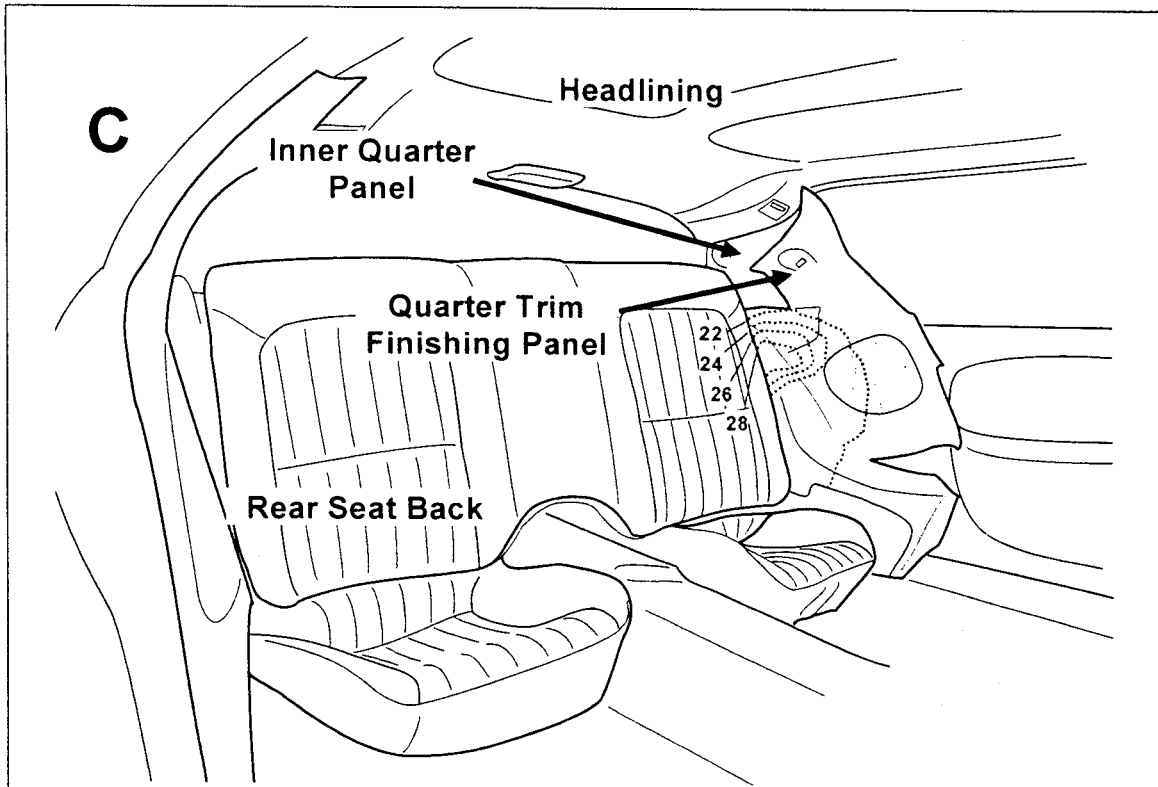
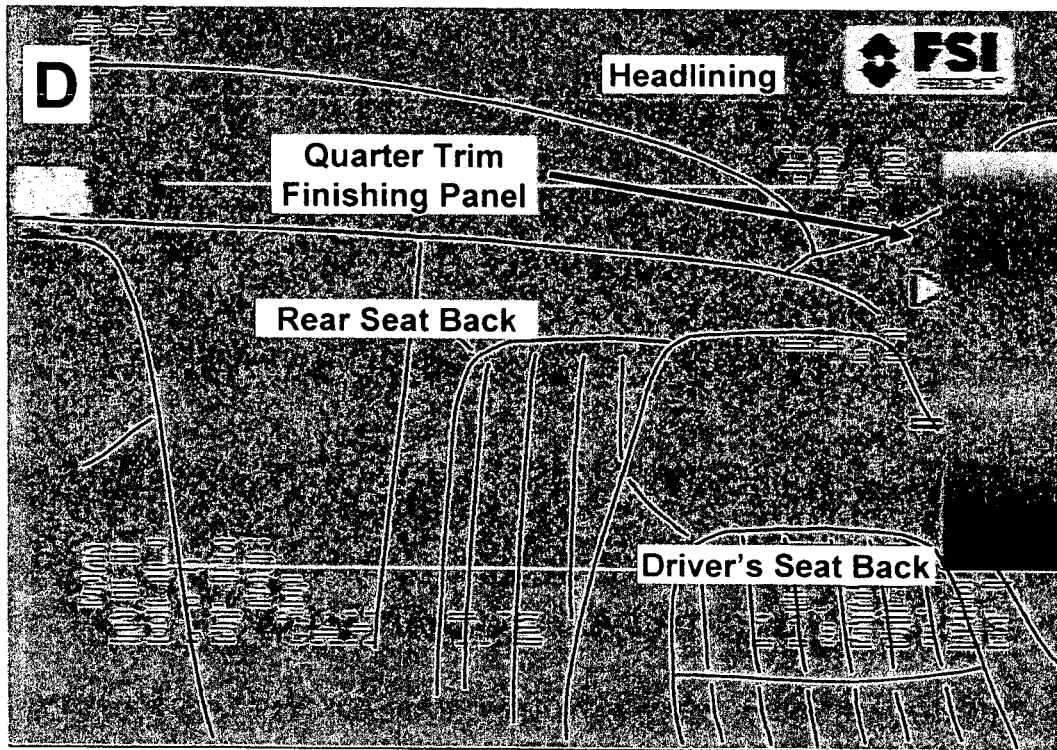
The video stills, isothermal contour plot, and Infrared thermogram in Figure 24 show the interior of the test vehicle at the time of ignition (0 seconds post-ignition). Some of the interior components are labeled for reference. Figure 25 shows the video stills, isothermal contour plot, and Infrared thermogram at 15 seconds post-ignition. Flames were visible at the top of the left quarter trim finishing panel (A, Fig. 25) and behind the test vehicle through the rear compartment opening (B, Fig. 25). The isothermal contour plot (C, Fig. 25) indicates that the fire plume had not contacted the roof of the test vehicle at this time as the temperatures along the headlining panel were between 100 and 250°C, with the hottest area just above the rear of the drivers door. The infrared thermogram shows that the temperature in the left rear of the test vehicle was > 174°C (the upper limit the range IR6 was set to at that time). This is 25 to 100°C than the temperatures shown in the isothermal contour plots, and was attributed to hot gases and airborne particulate in this space, which also emitted infrared radiation detected by IR6.

Figure 24. Fire Test F971001. Video stills from Cameras 6 (A) and 7 (B) showing the rear left corner of the test vehicle at the time of ignition (0 seconds post-ignition).

Figure 24, continued. Fire Test F971001. Estimated isothermal contour plot (C) and Infrared thermogram (lower) from IR6 (D) showing temperatures in the rear left corner of the test vehicle at the time of ignition (0 seconds post-ignition).

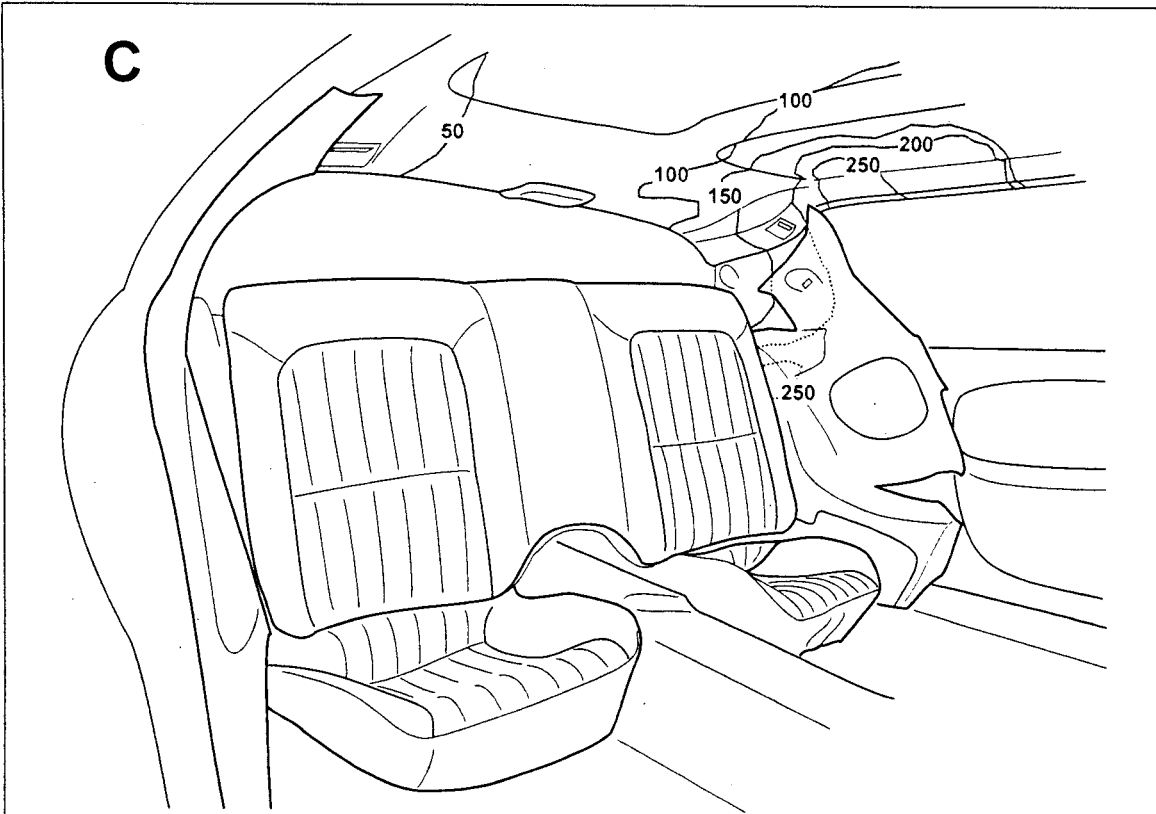
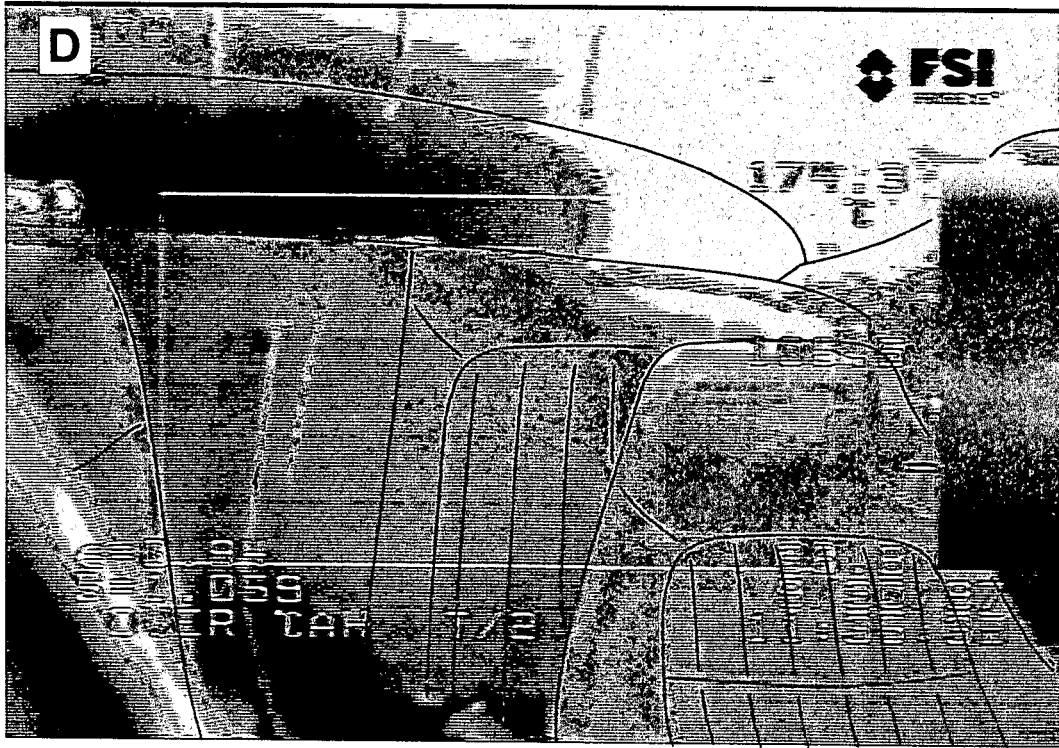
Figure 25. Fire Test F971001. Video stills from Cameras 6 (A) and 7 (B) showing the rear left corner of the test vehicle at 15 seconds post-ignition.

Figure 25, continued. Fire Test F971001. Estimated isothermal contour plot (C) and Infrared thermogram from IR6 (D) showing temperatures in the rear left corner of the test vehicle at 15 seconds post-ignition.

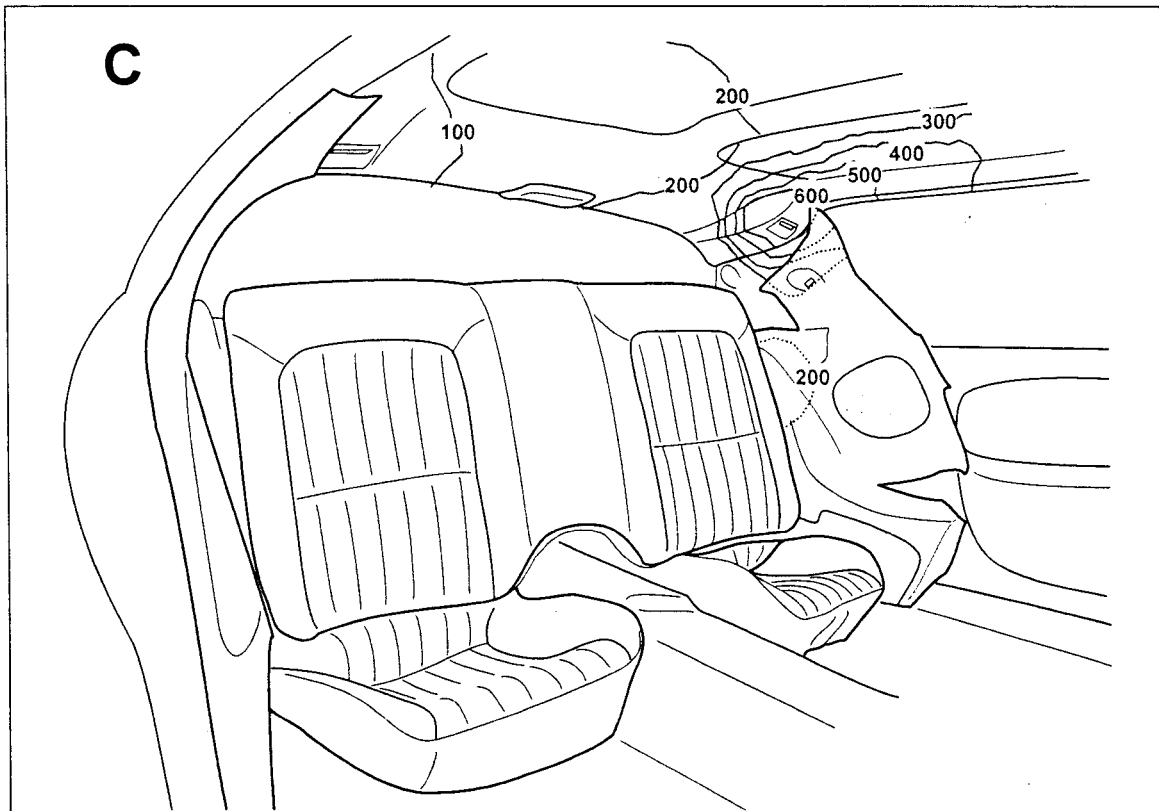
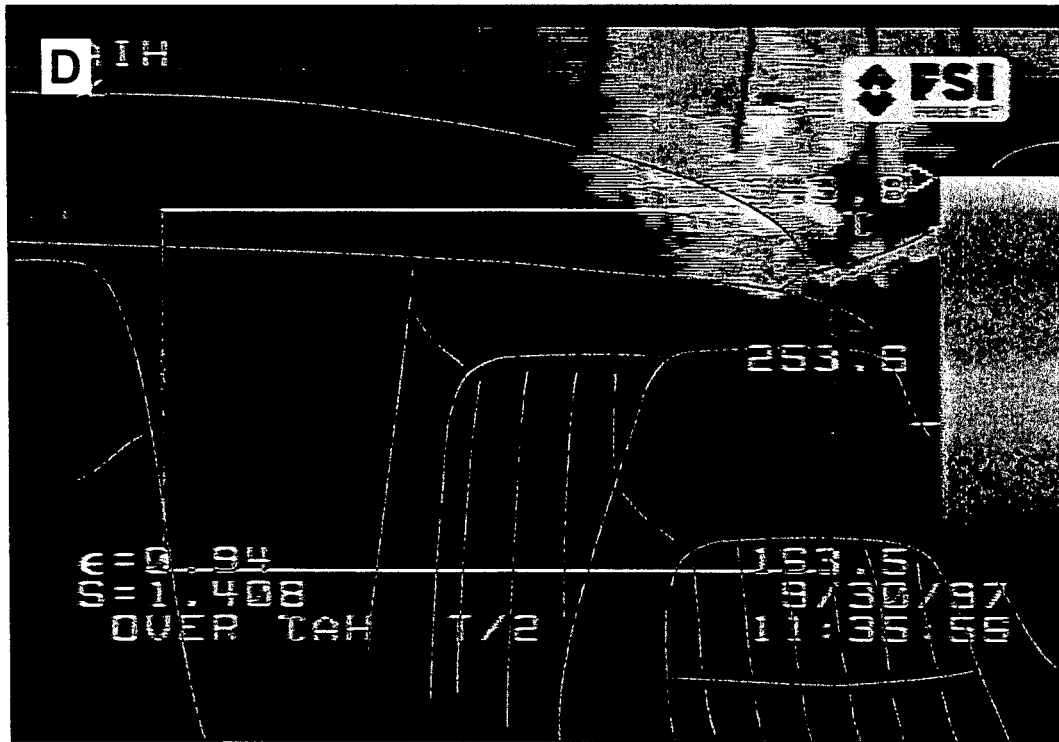
The fire plume had reached the headlining by 30 seconds post-ignition (A and B, Fig. 26). The temperature along an area of the headlining panel just above the upper edge of the left quarter trim finishing panel was > 600°C (C, Fig. 26).

Figure 26. Fire Test F971001. Video stills from Cameras 6 (A) and 7 (B) showing the rear left corner of the test vehicle at 30 seconds post-ignition.

Figure 26, continued. Fire Test F971001. Estimated isothermal contour plot (C) and Infrared thermogram from IR6 (D) showing temperatures in the rear left corner of the test vehicle at 30 seconds post-ignition.

The infrared thermogram from IR6 at this time (D, Fig. 26) shows temperatures in this area were greater than 444°C (the upper temperature limit of IR6 at that time). By 45 seconds post-ignition, the fire plume had disappeared (A and B, Fig. 27). Temperatures along the headlining panel and behind the quarter trim panel less than 300 °C at this time (C and D, Fig. 27).

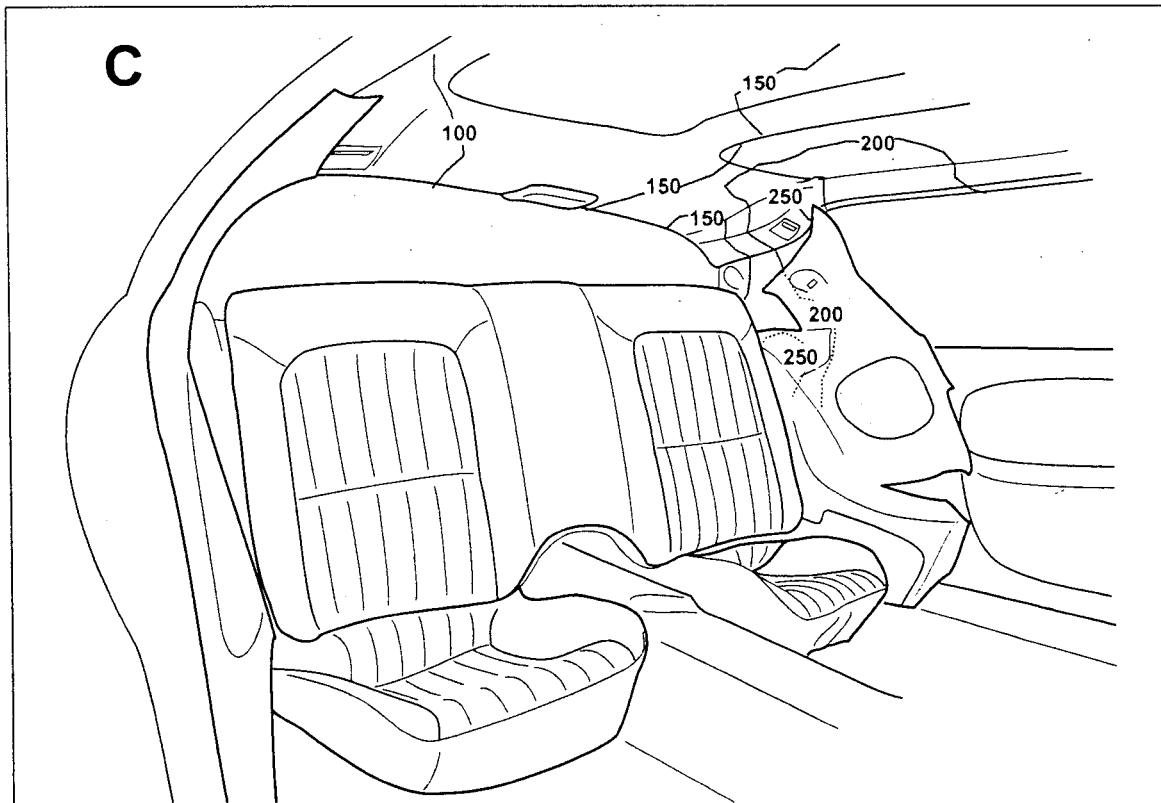
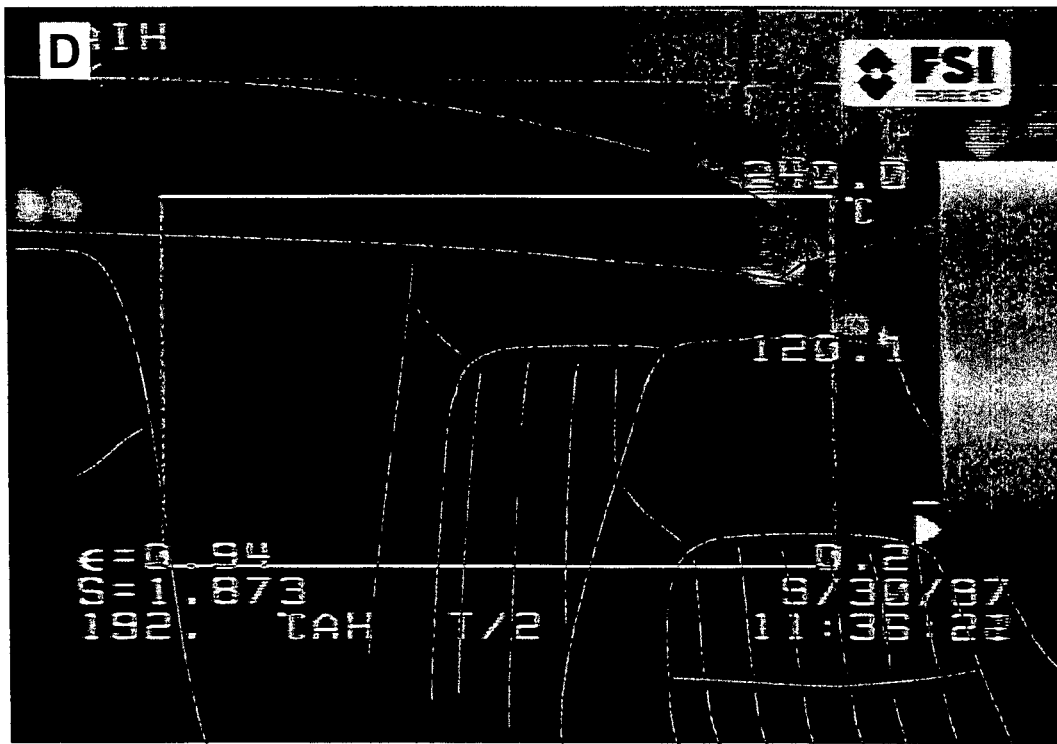
Figure 27. Fire Test F971001. Video stills from Cameras 6 (A) and 7 (B) showing the rear left corner of the test vehicle at 45 seconds post-ignition.

Figure 27, continued. Fire Test F971001. Estimated isothermal contour plot (C) and Infrared thermogram from IR6 (D) showing temperatures in the rear left corner of the test vehicle at 45 seconds post-ignition.
