Re: **Settlement Agreement**
Section B. Fire Safety Research

On August 31, 2001, GM submitted a final report for Project B.3 (Fire Initiation and Propagation Tests), entitled, "Evaluation of Motor Vehicle Fire Initiation and Propagation/Part 6: Propagation of an Underbody Gasoline Pole Fire in a 1997 Rear Wheel Drive Passenger Car." This letter supplements that report.

This report describes a vehicle fire propagation test conducted pursuant to the GM/DOT Settlement Agreement. This fire test was conducted on September 30, 1997. The test vehicle was a crash-tested 1997 Chevrolet Camaro. In the crash test, the test vehicle was stationary and struck in the rear by a moving barrier. No leaks were detected in the fuel system of the test vehicle during the crash test or the subsequent roll test performed after the crash test. No fire was observed during the crash test, nor was there evidence of fire present in the test vehicle after the crash test. To create a gasoline pool under the test vehicle for the fire test, a gasoline delivery system consisting of a gasoline reservoir, compressed nitrogen reservoir, a pressure regulator, and a flow regulator was used to deliver liquid gasoline u

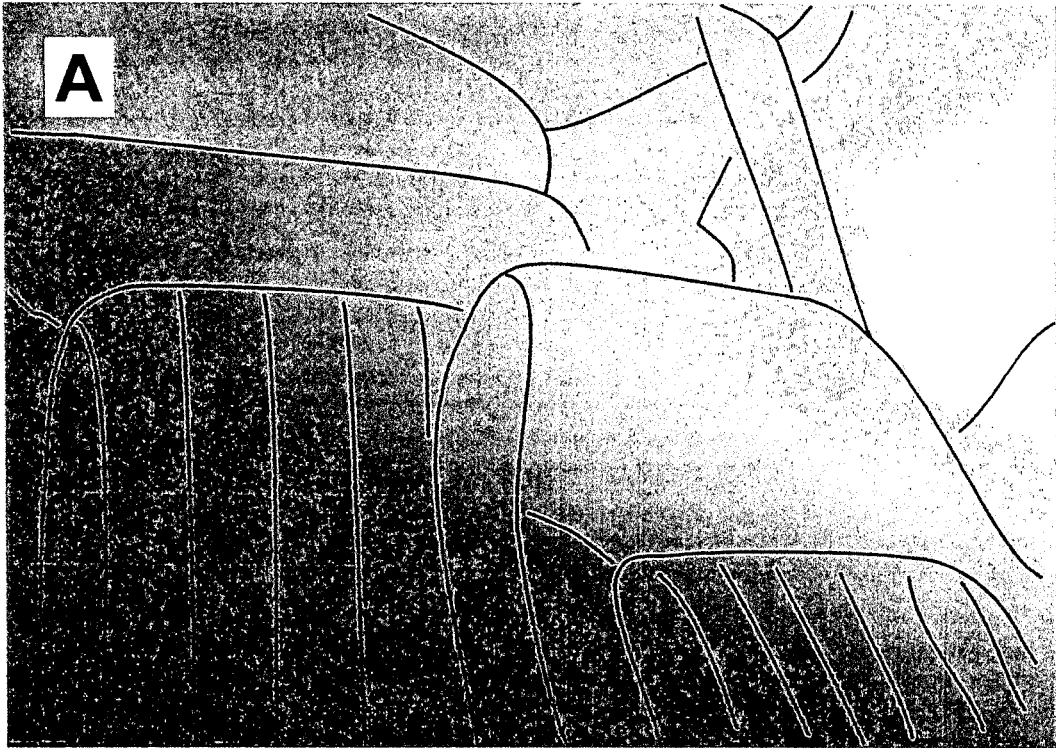
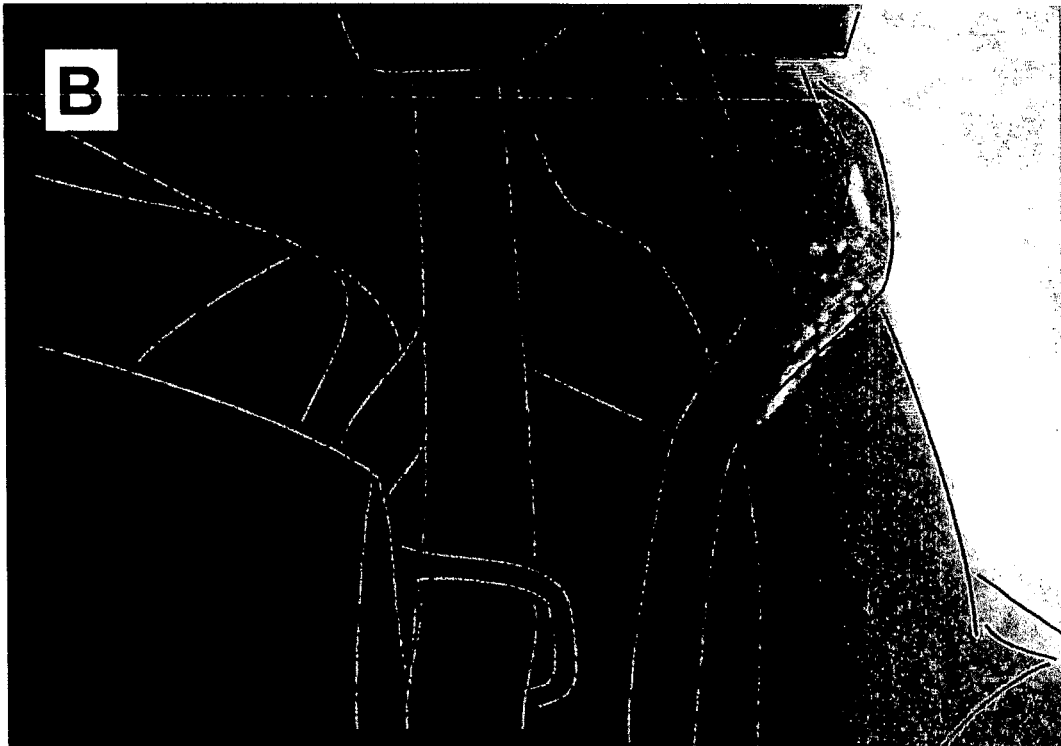
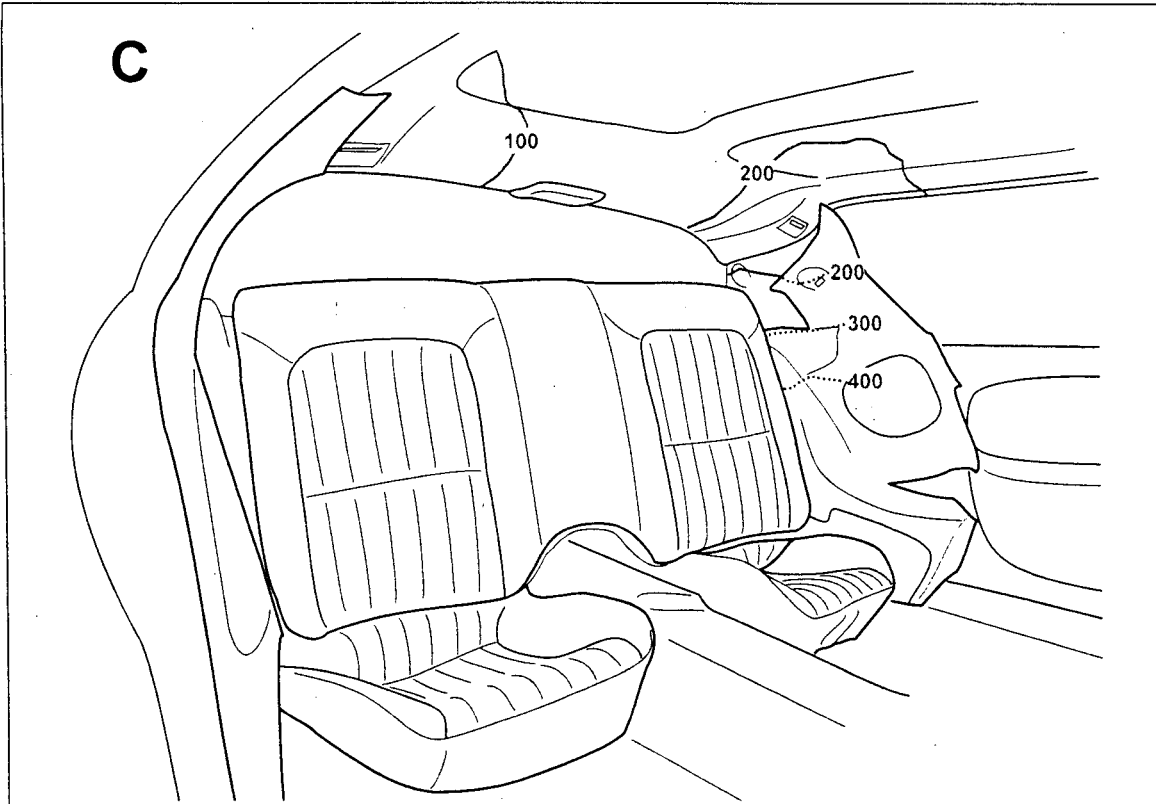
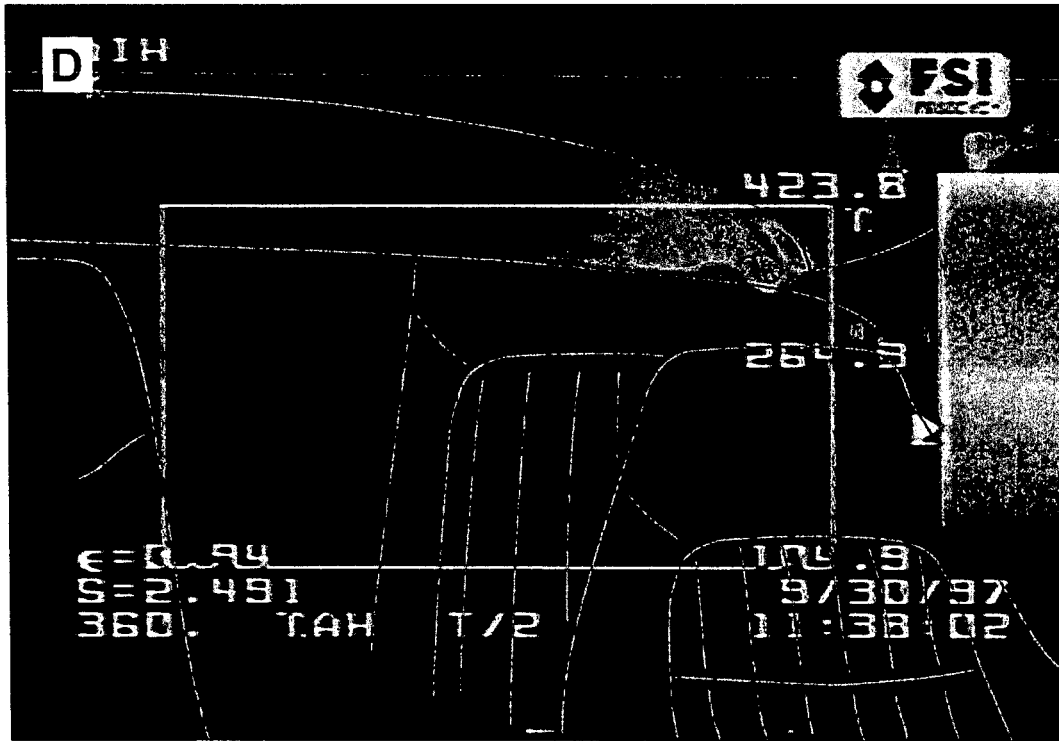
Flames were observed in the area behind the displaced left interior quarter trim finishing panel between 160 and 170 seconds post-ignition. Figures 28 through 33 show a series of video stills from Cameras 6 and 7, estimated isothermal contour plots, and Infrared thermograms from IR6 at 160, 170, 180, 190, 200, and 210 seconds post-ignition. Comparison of the video stills in Figures 28 and 29 shows that flames became visible along the forward edge of the left interior quarter trim finishing panel between 160 and 170 seconds post-ignition (B, Fig.'s 28 and 29). Flames were not visible along its upper edge at this time (A, Fig.'s 28 and 29). The isothermal contour plots (C, Fig.'s 28 and 29) and infrared thermograms (D, Fig.'s 28 and 29) in these figures indicate that flames did not contact the headlining panel during this time. By 180 seconds post-ignition, flames were visible between the front of the left interior quarter trim finishing panel and the drivers seat back (B, Fig. 30). Temperatures along the lower surface of the of the left rear corner of the headlining panel were between 300 and 400°C at 180 seconds post-ignition (C, Fig. 30), indicating that heated gases were spreading outward below the roof of the test vehicle at this time. Flames were not visible around the upper and rear edges of the displaced interior quarter trim finishing panel at this time (A, Fig. 30). The thermocouple data indicate that flames were present along the top edge of the left interior quarter trim finishing panel between 180 and 190 seconds post-ignition (C, Fig. 31). Flames had started to spread forward and to the right along the headlining panel by 190 seconds post-ignition (Fig. 31).

Figure 28. Fire Test F971001. Video stills from Cameras 6 (A) and 7 (B) showing the rear left corner of the test vehicle at 160 seconds post-ignition.

Figure 28, continues. Fire Test F971001. Estimated isothermal contour plot (C) and Infrared thermogram from IR6 (D) showing temperatures in the rear left corner of the test vehicle at 160 seconds post-ignition.

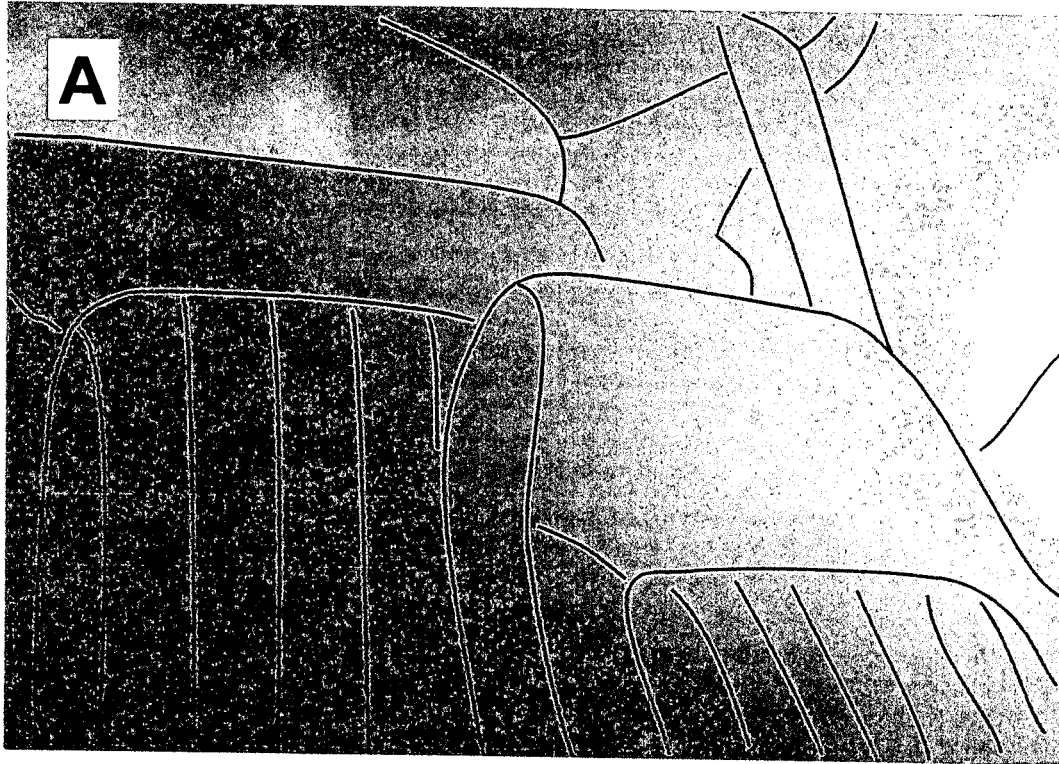
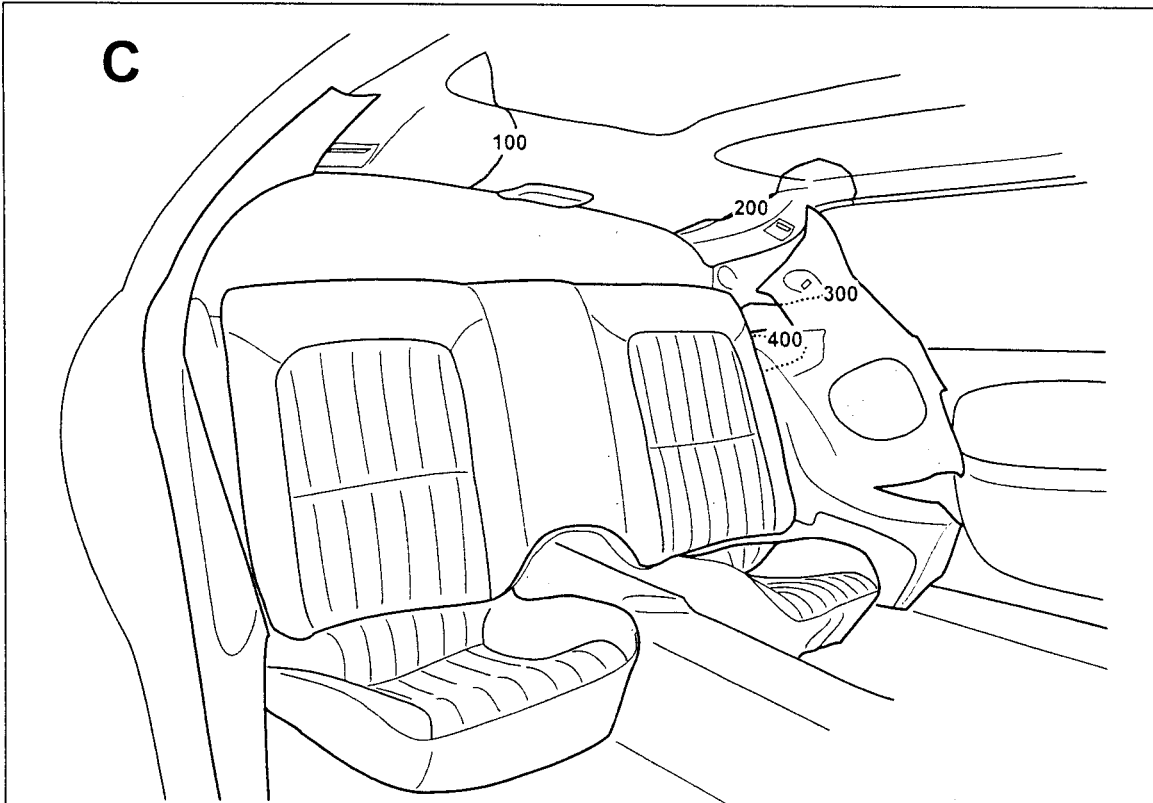
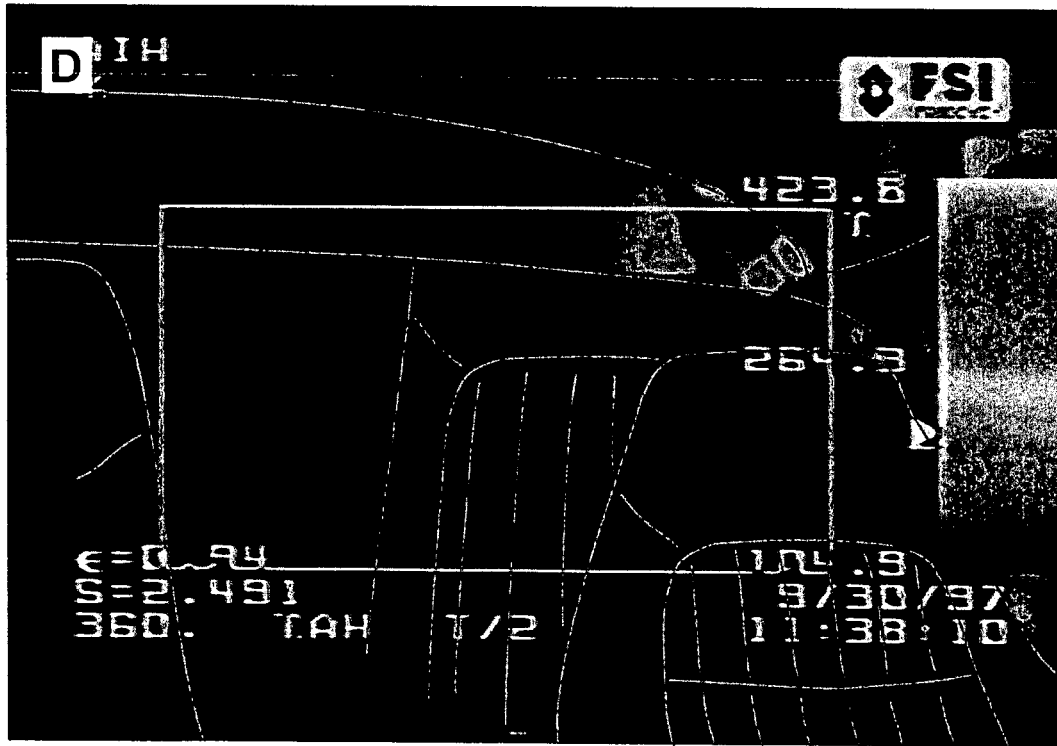
Figure 29. Fire Test F971001. Video stills from Cameras 6 (A) and 7 (B) showing the rear left corner of the test vehicle at 170 seconds post-ignition.

Figure 29, continues. Fire Test F971001. Estimated isothermal contour plot (C) and Infrared thermogram from IR6 (D) showing temperatures in the rear left corner of the test vehicle at 170 seconds post-ignition.

(B, Fig. 29). This was approximately 30 seconds before the thermocouple and heat flux transducer data indicated that flames were present in the left rear wheelhouse or in the seam opening at the front of the left rear wheelhouse. Data from thermocouples on the headlining panel indicated an area directly above the back of the driver's door where temperatures were greater than 600°C by 190 seconds post-ignition (panel C, Fig. 31), which is consistent with flame spread at the back of the driver's door. Neither thermocouples nor heat flux transducers were installed on the driver's door or the interior quarter trim panel in this area. Thus, the recorded thermocouple and heat flux transducer/radiometer data could not be used either to confirm flame-spread at the back of the door or to determine the timing of flame-spread along this pathway.

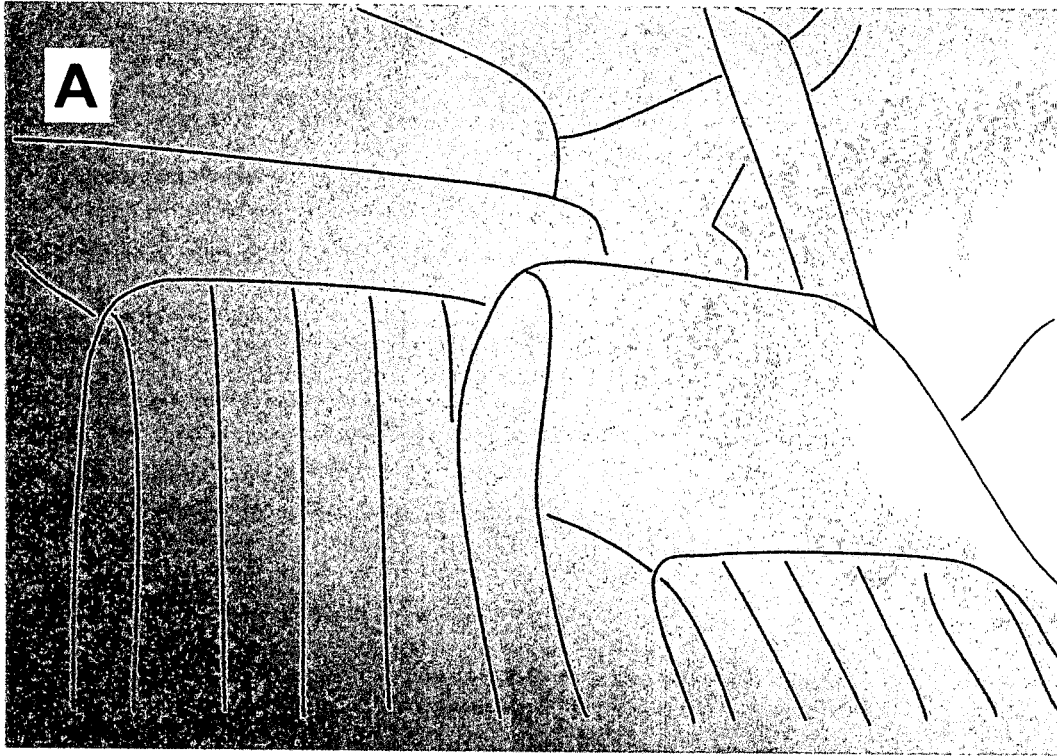
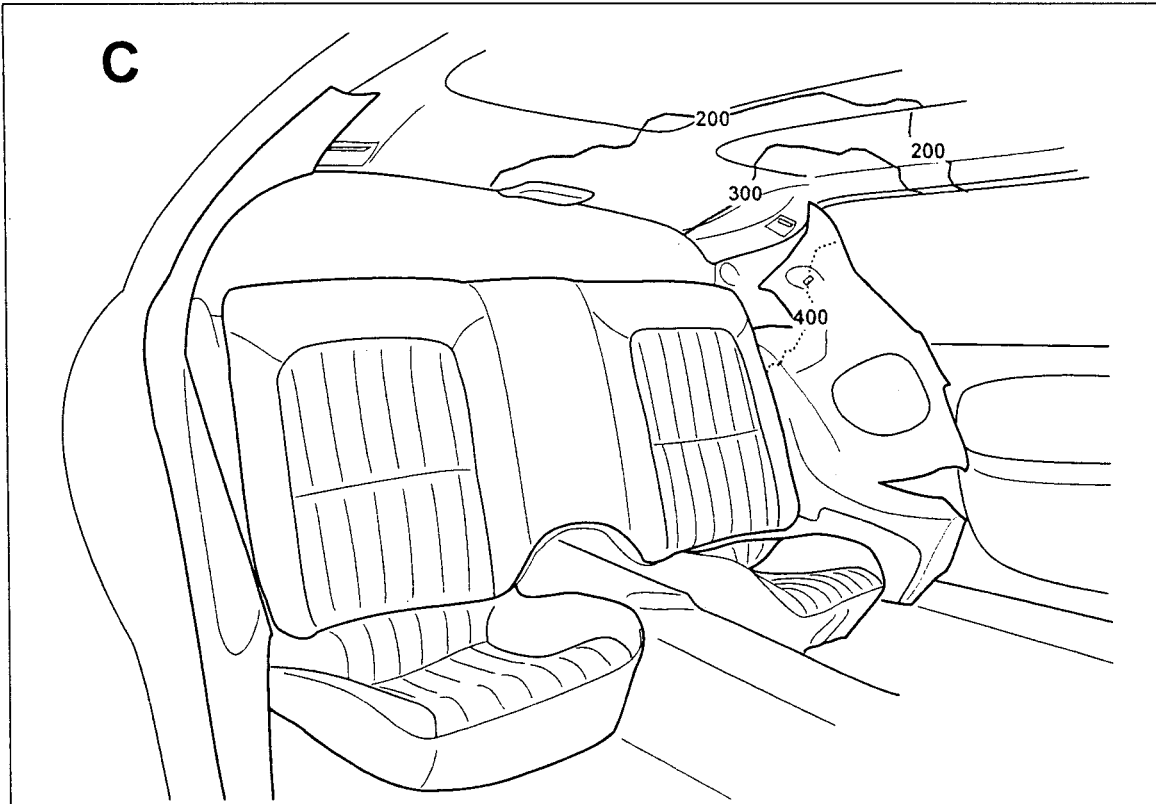
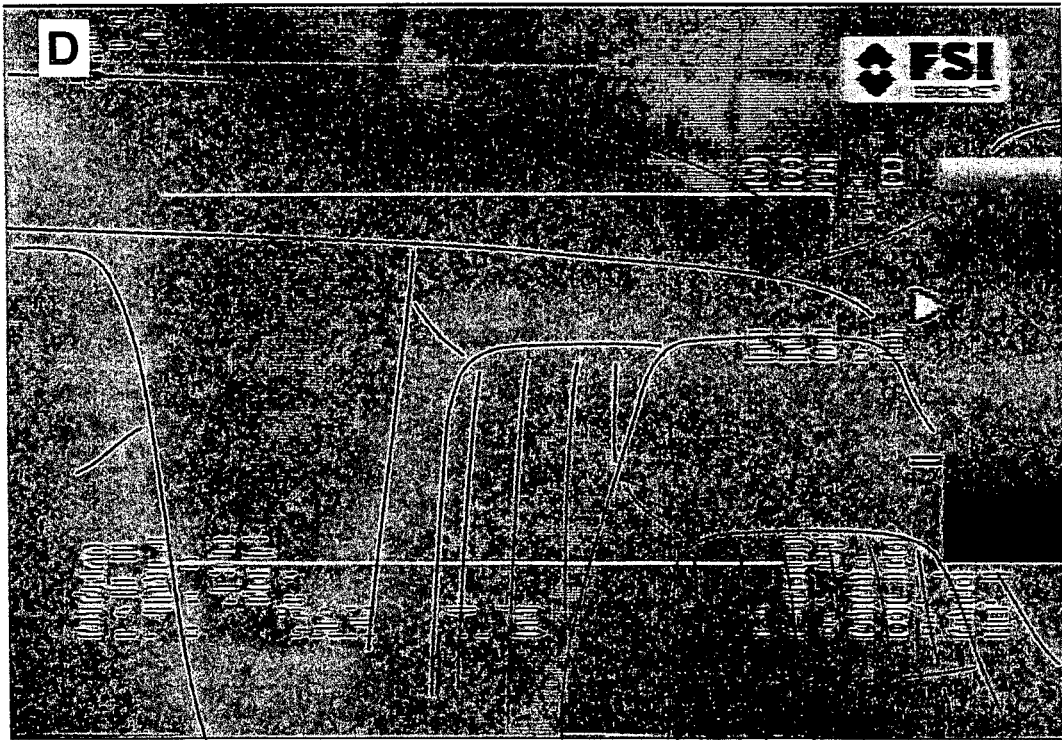
Figure 30. Fire Test F971001. Video stills from Cameras 6 (A) and 7 (B) showing the rear left corner of the test vehicle at 180 seconds post-ignition.

Figure 30, continued. Fire Test F971001. Estimated isothermal contour plot (C) and Infrared thermogram (lower) from IR6 (D) showing temperatures in the rear left corner of the test vehicle at 180 seconds post-ignition.

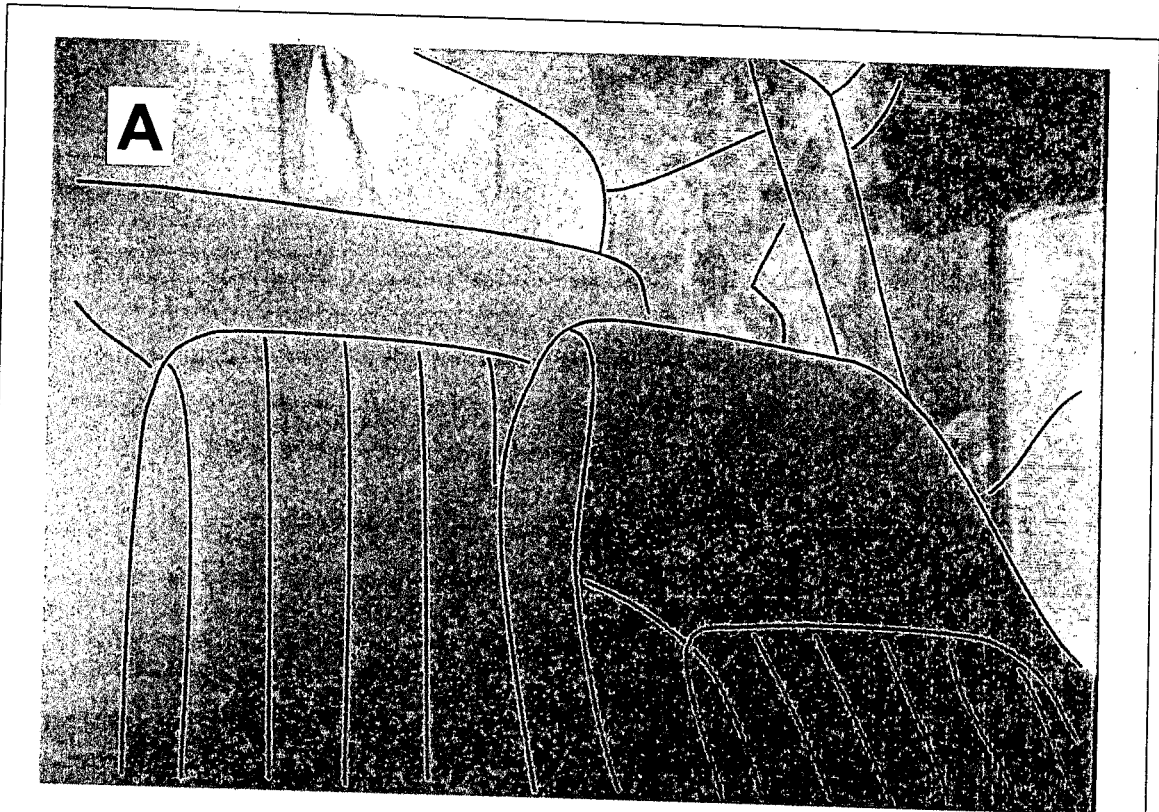
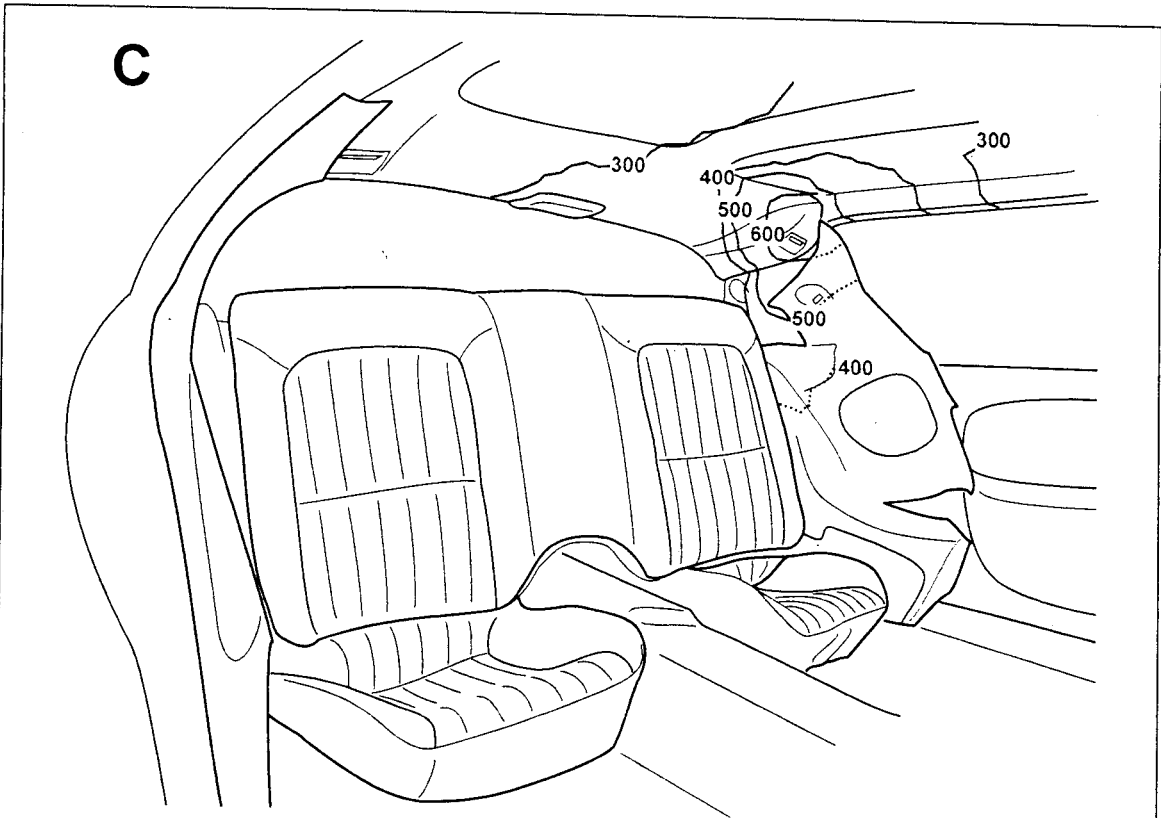
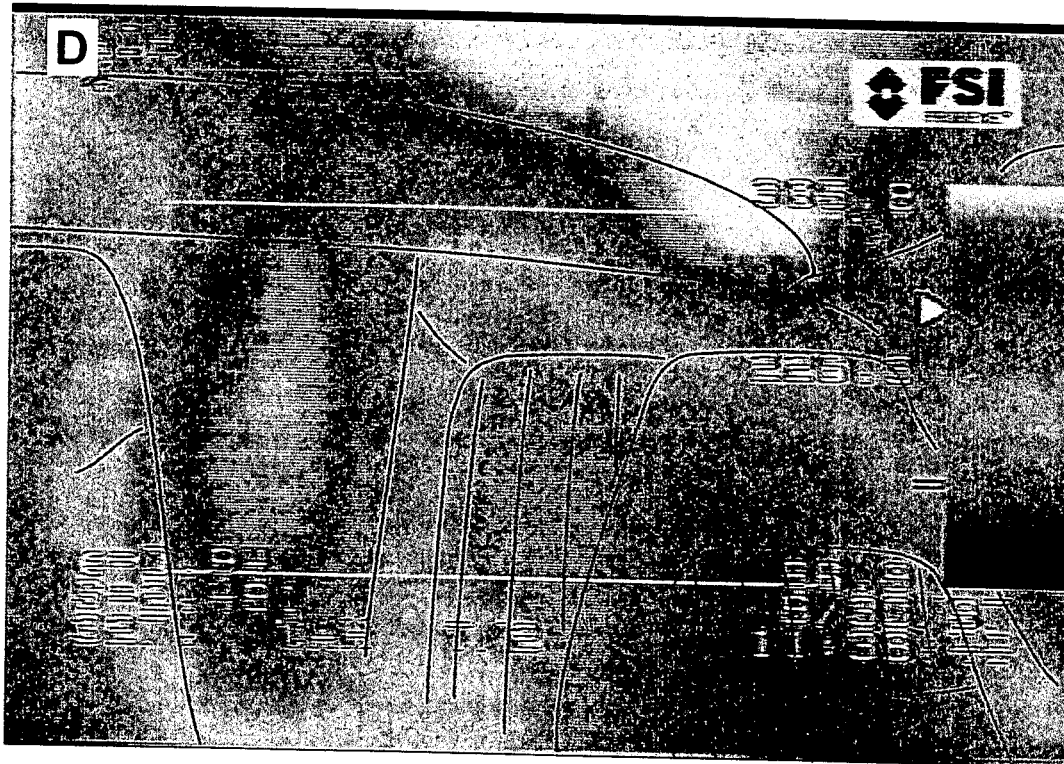
Figure 31. Fire Test F971001. Video stills from Cameras 6 (A) and 7 (B) showing the rear left corner of the test vehicle at 190 seconds post-ignition.

Figure 31, continued. Fire Test F971001. Estimated isothermal contour plot (C) and Infrared thermogram from IR6 (D) showing temperatures in the rear left corner of the test vehicle at 190 seconds post-ignition.

thermocouples on the upper section of the interior quarter trim finishing panel indicate that it was exposed to flames starting at about 190 seconds post-ignition (C, Fig. 31). The video record shows flames attached to the upper section of the interior quarter trim finishing panel by 210 seconds post-ignition, when it was observed sagging downward. The quarter inner rear trim finishing panel on the package shelf behind the rear seat back (and under the fallen piece of interior quarter trim finishing panel) was not burned (Fig. 37).

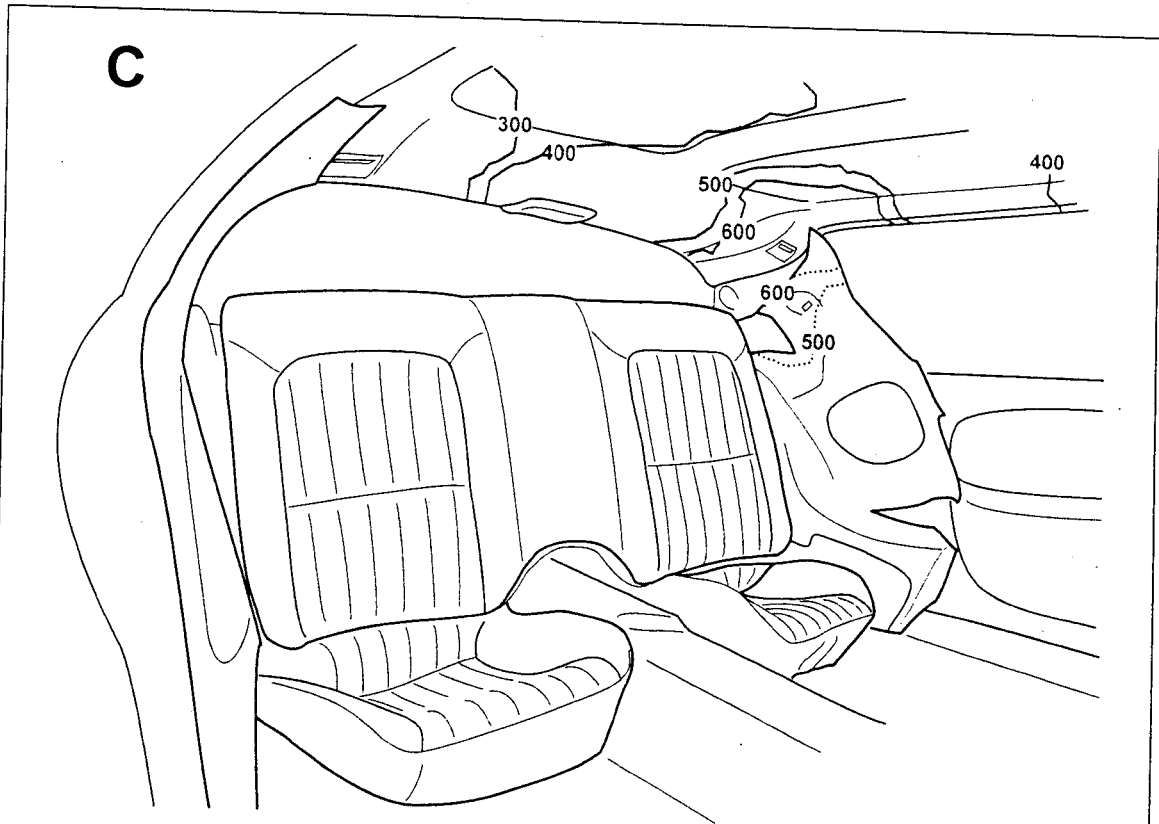
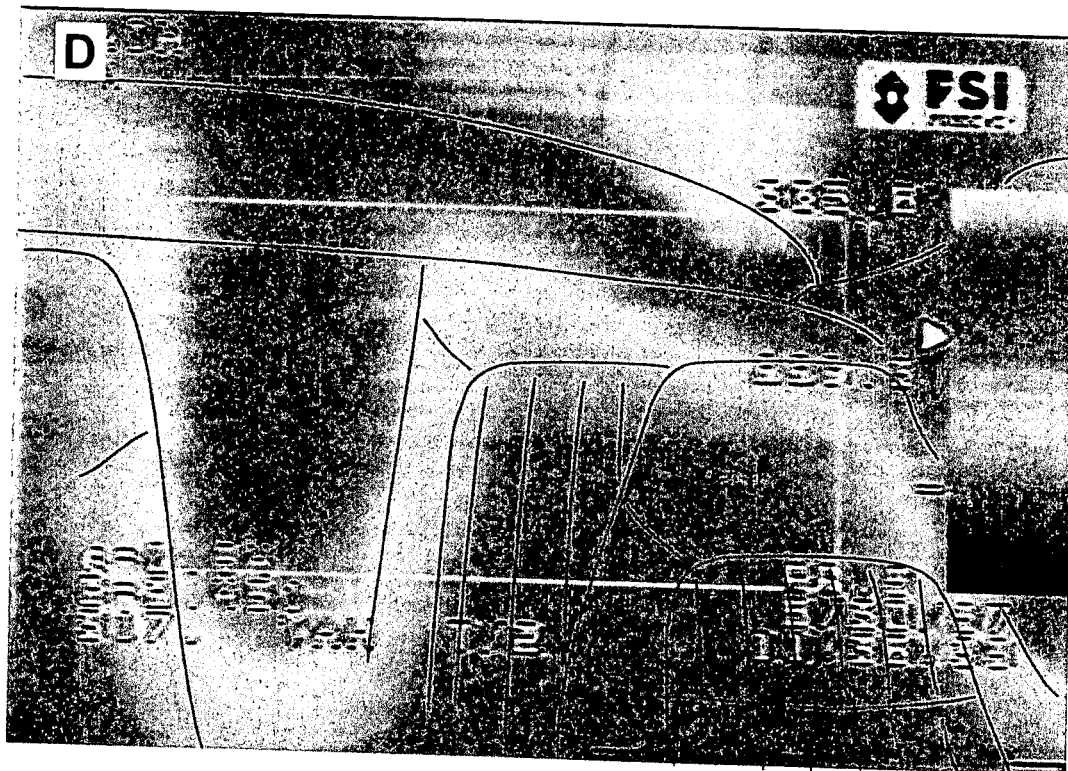
The time of ignition, the rate of flame spread, or the area of the on the left interior quarter trim finishing panel that had burned could not be determined precisely from the data acquired during this test. For example, the video stills from Camera 6 at 200 and 210 post-ignition, and from Camera 7 and 200 seconds post-ignition show flames in front of much of the left rear quarter of the test vehicle (Fig.'s 32 and 33), suggesting that the entire trim panel had ignited. The accompanying isothermal contour plots calculated using data recorded from thermocouples located on the inner and outer surfaces of the trim panel show temperatures less than 500°C between 190 and 200 seconds post-ignition (see **APPENDIX C**), suggesting that the trim panel had not ignited at this time. One possible explanation for this apparent discrepancy is that this area of the trim finishing panel had not ignited at this time and flames observed in the video stills from Cameras 6 and 7 at 200 and 210 seconds post-ignition were from burning objects below the fields of view of these cameras. Another possible explanation is that the thermoplastic trim panel

Figure 32. Fire Test F971001. Video stills from Cameras 6 (A) and 7 (B) showing the rear left corner of the test vehicle at 200 seconds post-ignition.

Figure 32, continued. Fire Test F971001. Estimated isothermal contour plot (C) and Infrared thermogram from IR6 (D) showing temperatures in the rear left corner of the test vehicle at 200 seconds post-ignition.

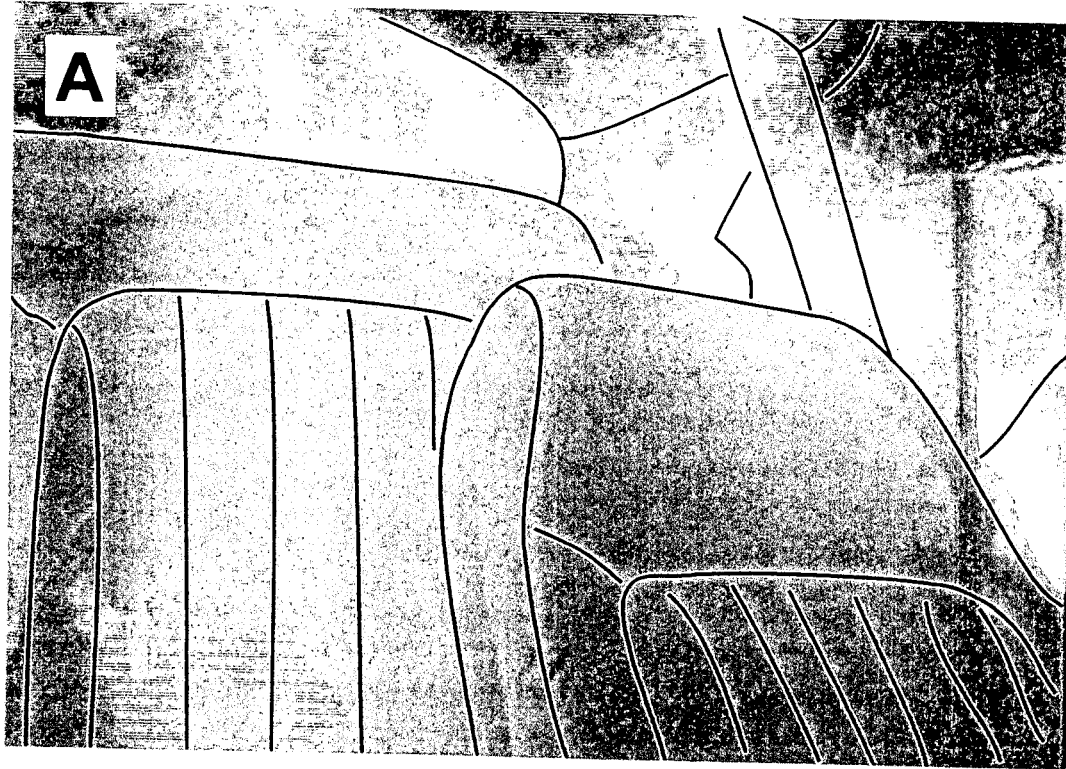
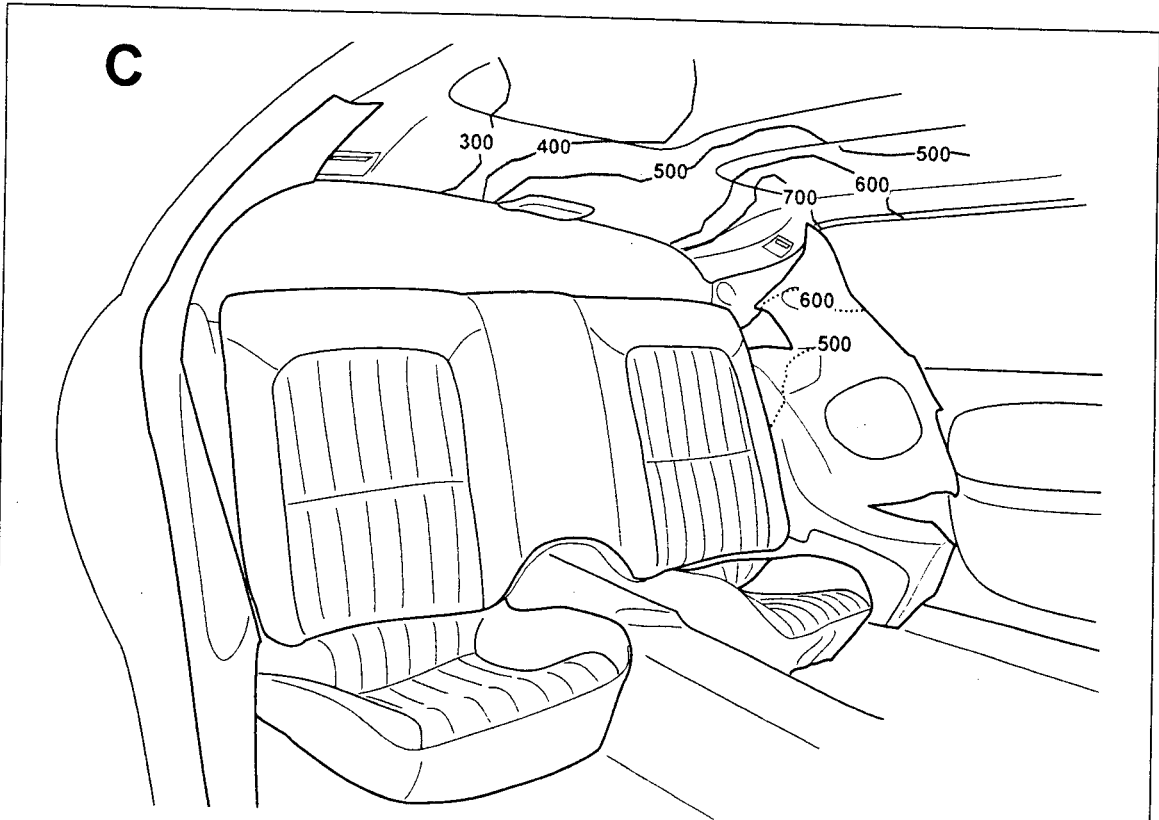
Figure 33. Fire Test F971001. Video stills from Cameras 6 (A) and 7 (B) showing the rear left corner of the test vehicle at 210 seconds post-ignition.

Figure 33, continued. Fire Test F971001. Estimated isothermal contour plot (C) and Infrared thermogram from IR6 (D) showing temperatures in the rear left corner of the test vehicle at 210seconds post-ignition.

test. This photograph shows that the headlining panel was burned and charred in areas where the estimated temperature at 210 seconds post-ignition was greater than 500°C (C, Fig. 33). The left side of the driver's seat back was burned, as was the left side and top of the rear seat back (Fig. 36). The section of the interior trim panel on the driver's door that was behind the displaced interior quarter trim finishing panel was burned. The interior quarter trim finishing panel was not visible in this photograph.

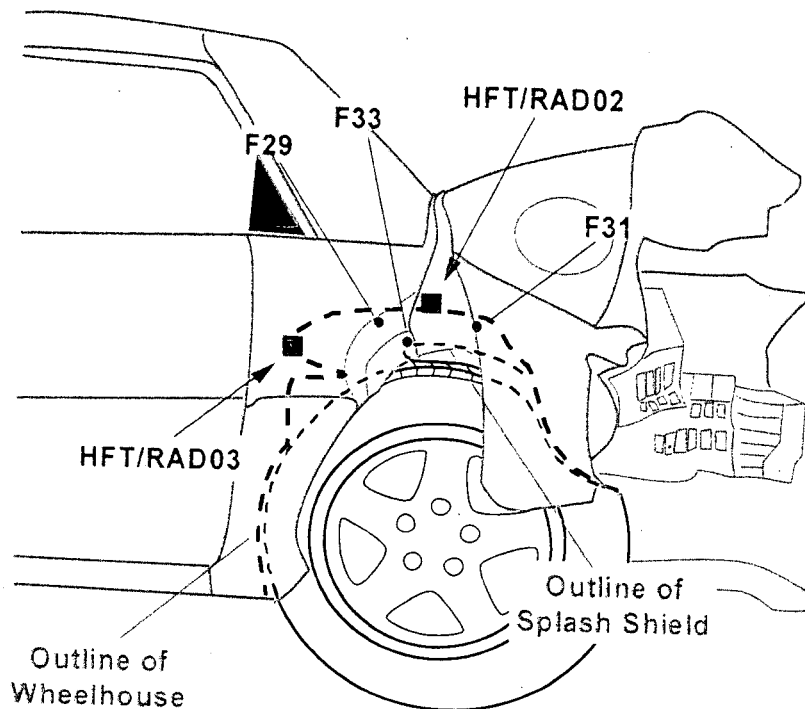
Two thermocouples were installed in the wheelhouse just below the inner wheelhouse panel and above the left rear tire (Fig. 34). One thermocouple also was on the filler splash shield, which was folded on top of the tire. One heat flux transducer was installed in the top of the inner wheelhouse panel facing downward, and one heat flux transducer was installed in a seam opening at the front of the wheelhouse and facing rearward.

Figure 34. Fire Test F971001. Left side view of the test vehicle. Thermocouples F29 and F31 were located inside the wheelhouse approximately 1 cm below the wheelhouse inner panel (see also Fig. C1). Thermocouple F33 was located inside the wheelhouse on the filler splash shield (see also Fig. C1). HFT/RAD02 was located in the left rear wheelhouse inner panel and facing downward (see also Fig. E1). HFT/RAD03 was located in a seam opening at the front of the left rear wheelhouse and facing rearward (see also Fig. E1).

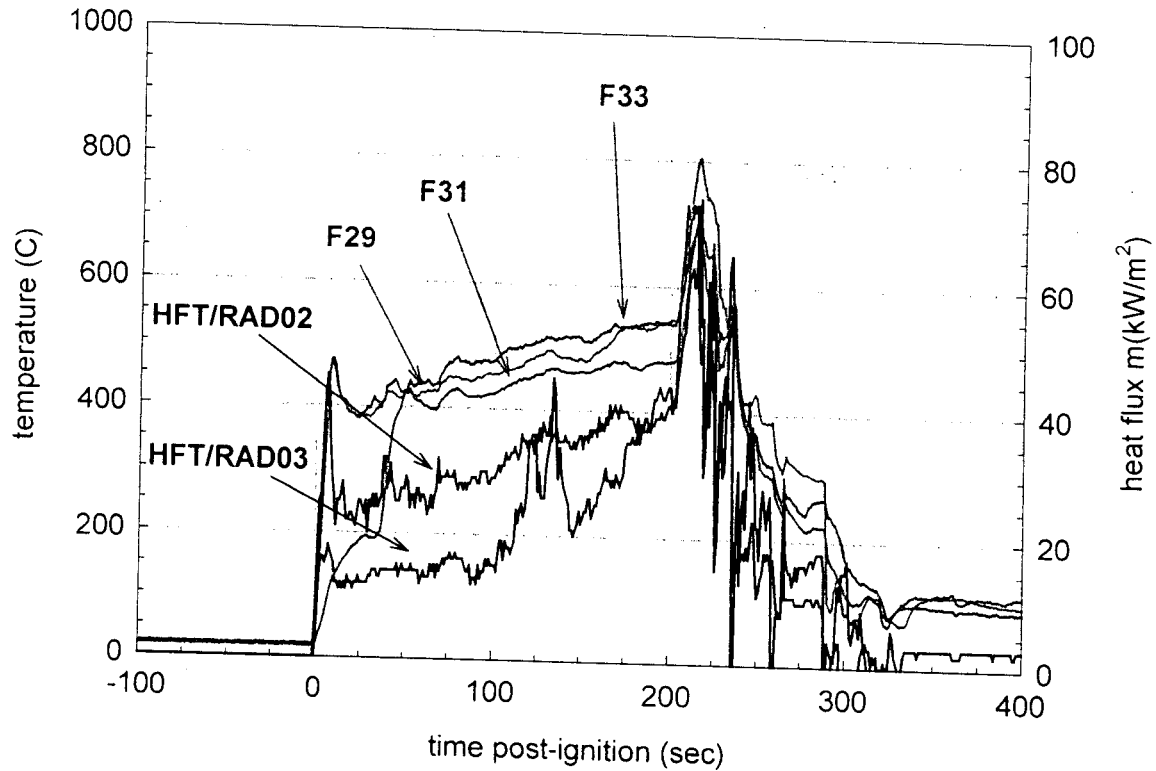
Figure 35. Fire Test F971001. Plots of data recorded from Thermocouples F29, F31, and F33, and Heat Flux Transducers HFT/RAD02 and HFT/RAD03.

The temperature data recorded from Thermocouples F29 and F31 before 200 seconds post-ignition were less than 600°C (Fig. 35), indicating that neither of these thermocouples were exposed directly to flames during this time (see footnote 4). The increase in temperature from 500 – 550°C to 650 – 700°C recorded from these thermocouples between 200 and 215 seconds post-ignition indicates that flames entered the top of the wheelhouse at this time. The simultaneous increase in the temperatures recorded from Thermocouple F33 from greater than 550°C to approximately 700°C suggests that flames were contacting the splash shield between 200 and 215 seconds post-ignition (Fig. 35).

The total heat flux data recorded from HFT/RAD02 and HFT/RAD03 followed similar trends to the temperatures recorded from Thermocouples F29 and F31 (Fig. 35). The heat fluxes recorded

from both transducers were $< 45 \text{ kW/m}^2$ for the first 200 seconds post-ignition. The heat fluxes recorded from both transducers increased from $40 - 45 \text{ kW/m}^2$ to greater than 60 kW/m^2 between 200 and 215 seconds post-ignition. And except for two transient peaks, the heat flux recorded from HFT/RAD03 was less than the heat flux recorded from HFT/RAD02 before 200 seconds post-ignition. As with the temperature data recorded from Thermocouples F29 and F31, the heat flux data recorded from HFT/RAD02 indicated that flames entered the part of the left rear wheelhouse between 200 and 215 seconds post-ignition (Fig. 35). The heat flux data recorded from HFT/RAD03 indicates that flames entered the passenger compartment through the seam opening at the front of the left rear wheelhouse between 200 and 215 seconds post-ignition (Fig. 35).

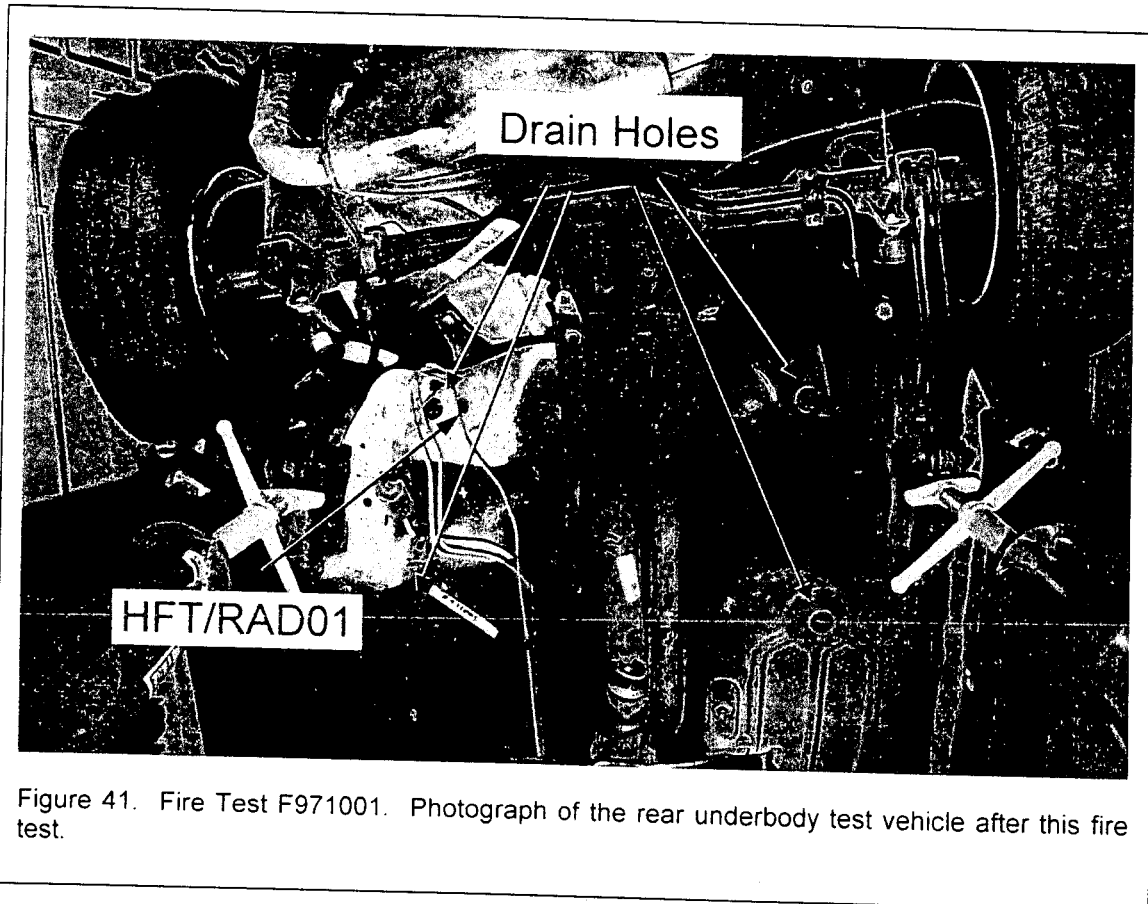
The video from Camera 4 showed that flames were visible in front of the middle of the rear seat back between 185 and approximately 210 seconds post-ignition (Fig. 40). Physical inspection of the underbody of the test vehicle after this test revealed that flames had burned-through a drain hole plug in the front floor pan panel (Fig. 41). Three other drain hole plugs in the front floor pan

panel of the test vehicle were in place after this test. Paint had burned away from an area at the rear of the left side of the front floor pan panel (Fig. 41). This area corresponded roughly to the area where the estimated temperatures below the floor pan were greater than about 600°C at the end of this test (Fig. 21). The lower surface of the floor pan panel in this area contained charred paint and exposed metal with a red or white oxide layer (Fig. 41).

Figure 41. Fire Test F971001. Photograph of the rear underbody test vehicle after this fire test.

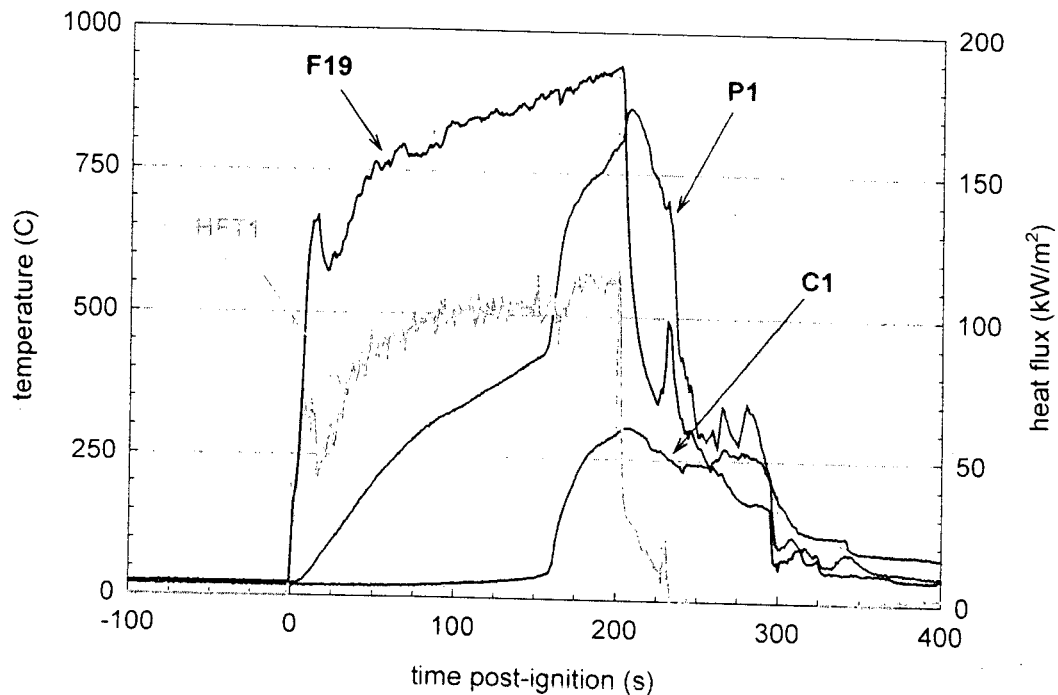
The temperature and heat flux data acquired during this test indicate that the section of the floor pan around the drain hole under the left rear seat was exposed to flames from about 15 seconds post-ignition until the end of the test (Fig. 42). The temperature data recorded from Thermocouple F19, located below the floor pan panel adjacent to the drain hole plug under the left rear seat cushion, increased from ambient temperature before ignition to 670°C at 16 seconds post-ignition (Fig. 42). After decreasing to 570°C at 22 seconds post-ignition, the temperature recorded from Thermocouple F19 increased steadily to a maximum temperature of 940°C at 202 seconds post-ignition. The heat flux to this area of the floor pan followed a trend similar to the temperature data recorded from Thermocouple F19 (Fig 42). The heat flux to the floor pan increased from 0 kW/m² before ignition to 69 kW/m² at 13 seconds post-ignition, decreased to 44 kW/m² at 18 seconds post-ignition, and reached a maximum of 116 kW/m² at 202 seconds post-

ignition (Fig. 42). The estimated isothermal contour plots in Figure 21 indicate that the fire plume extended forward onto the foot well in front of the left rear seat and to the right into the rear section of the transmission tunnel.

Figure 42. Fire Test F971001. Plots of temperatures recorded from Thermocouples F19, P1, and C1, and the Heat flux recorded from Heat Flux Transducer HFT1. Thermocouple F19 was located above the center of this floor pan drain hole adjacent to this drain hole. Thermocouple P1 was located above the center of this floor pan drain hole plug. Thermocouple C1 was located above the section of carpet over this drain hole plug. Heat Flux Transducer HFT1 was located in the floor pan adjacent to this drain hole (HFT1).

Temperature data recorded from Thermocouple P1 indicates that the left rear floor pan drain hole plug burned through between 155 and 170 seconds post-ignition, when recorded temperature increased from approximately 430 to 680°C (Fig. 42). Heated gases and flames that entered the drain hole appeared to have followed channels between the floor pan and carpet that were created when the floor pan deformed during the crash test. The pattern of char and soot deposits on the carpet (upper photograph, Fig. 43) and on the interior surfaces of the floor pan (lower photograph, Fig. 43) indicate that flames entered the drain hole under the left rear seat cushion. Flames then spread between the carpet and floor pan to the right and upward along the vertical section of the pan behind the rear seat back. These areas of the carpet were covering an upward sloping section of the drive train tunnel (upper photograph, Fig. 43). A section of the carpet directly above the drain hole plug was not burned or charred (upper photograph, Fig. 43).

Temperature data recorded from Thermocouple C1, located on the upper surface of the carpet just above the drain hole plug, reached a maximum of 306°C at 208 seconds post-ignition (Fig. 42). This temperature data also indicated that flames did not burn through the section of carpet directly above the drain hole.
