Re: **Settlement Agreement**
Section B. Fire Safety Research

On August 31, 2001, GM submitted a final report for Project B.3 (Fire Initiation and Propagation Tests), entitled, "Evaluation of Motor Vehicle Fire Initiation and Propagation/Part 6: Propagation of an Underbody Gasoline Pole Fire in a 1997 Rear Wheel Drive Passenger Car." This letter supplements that report.

This report describes a vehicle fire propagation test conducted pursuant to the GM/DOT Settlement Agreement. This fire test was conducted on September 30, 1997. The test vehicle was a crash-tested 1997 Chevrolet Camaro. In the crash test, the test vehicle was stationary and struck in the rear by a moving barrier. No leaks were detected in the fuel system of the test vehicle during the crash test or the subsequent roll test performed after the crash test. No fire was observed during the crash test, nor was there evidence of fire present in the test vehicle after the crash test. To create a gasoline pool under the test vehicle for the fire test, a gasoline delivery system consisting of a gasoline reservoir, compressed nitrogen reservoir, a pressure regulator, and a flow regulator was used to deliver liquid gasoline u

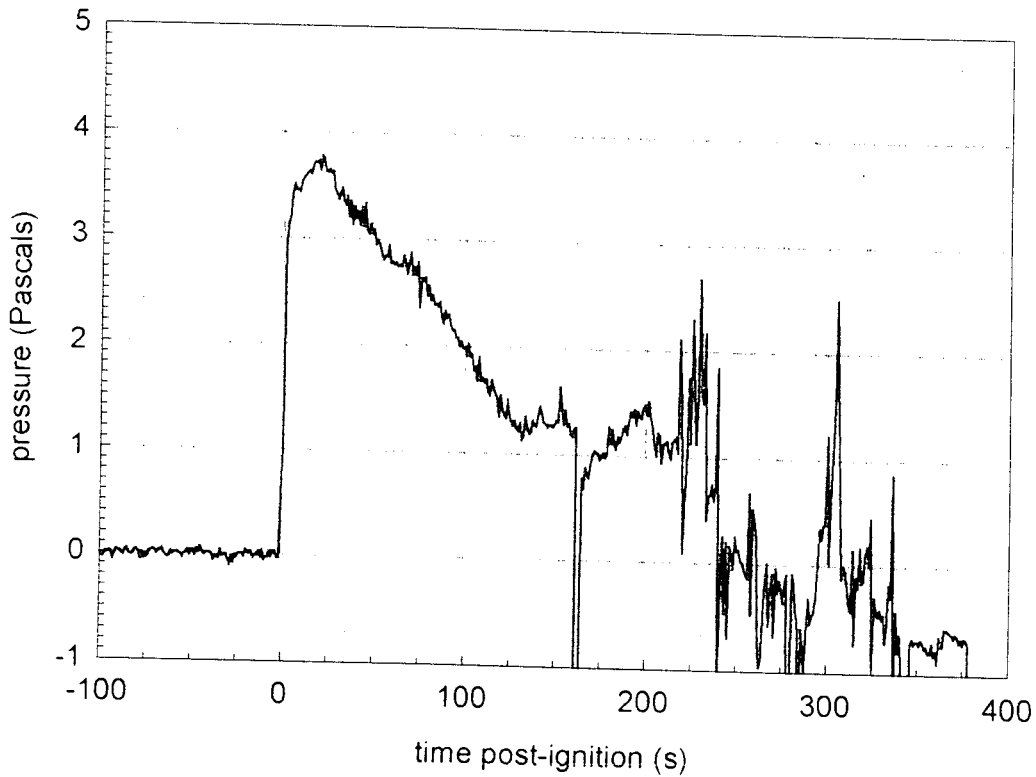
The pressure difference across the rear of the floor pan panel was estimated from the pressure data recorded from pressure gauges P3 and P7 (Fig. 46). Pressure Tap P3 was located above the carpet in the foot-well in front of the left rear passenger's seat. Pressure Tap P7 was located directly above the burning gasoline pool on the lower surface of the middle floor pan panel where it forms the package shelf behind the rear seat. The plot of the pressure difference shown in Figure 46 indicates that the pressure along the lower surface of the rear of the floor pan panel was greater than the pressure along the upper surface of the floor pan panel from the time of ignition until approximately 240 seconds post-ignition. After ignition of the gasoline, the flames below the test vehicle created an area of high pressure relative to atmosphere along the lower surface of the floor pan. Airflow into the fire plume caused air to be drawn out of the test vehicle through the rear opening, resulting in low pressure relative to atmosphere along the upper surface of the floor pan. Accumulation of buoyant heated gases in the pocket formed by the middle floor pan panel and the rear wheel houses would have caused the pressure to have been higher than where hot gases could flow unobstructed from under the test vehicle, such as below

the rear seat cushions. Thus, the pressure curve shown in Figure 46 is an upper bound for the pressure difference across the floor pan under the left rear seat cushion.

Figure 46. Fire Test F971001. Plot of the difference in pressures measured by Pressure Taps P7 and P3. P3 was located in the foot well in front of the left rear seat. P7 was located below the lower surface of the middle floor pan panel where it forms the package shelf behind the rear seat.

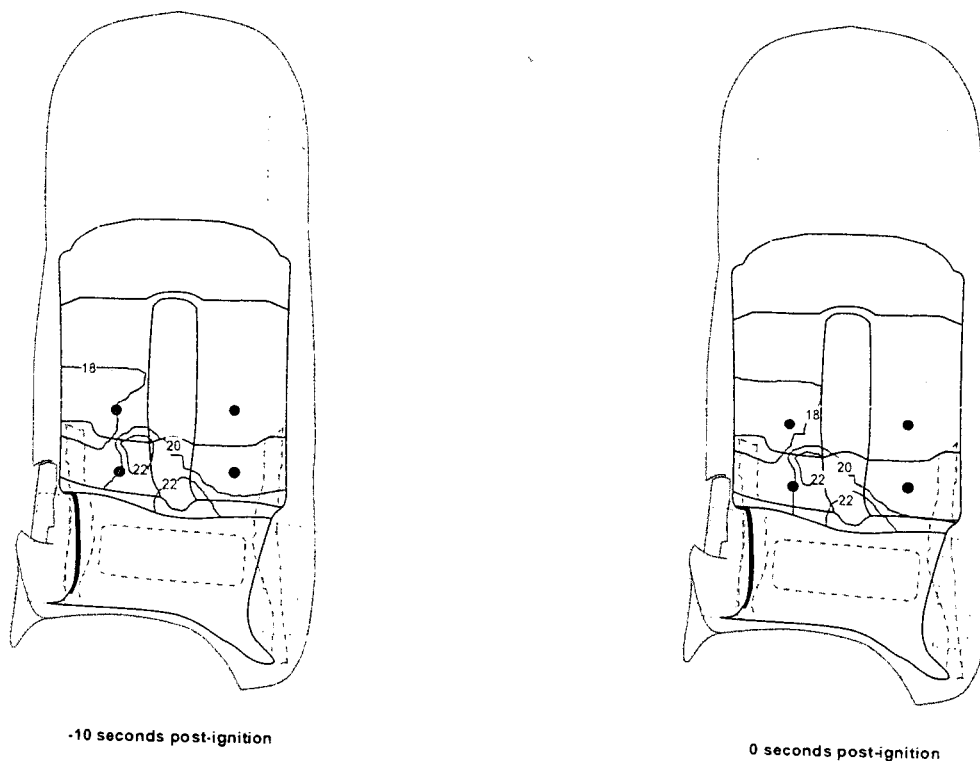
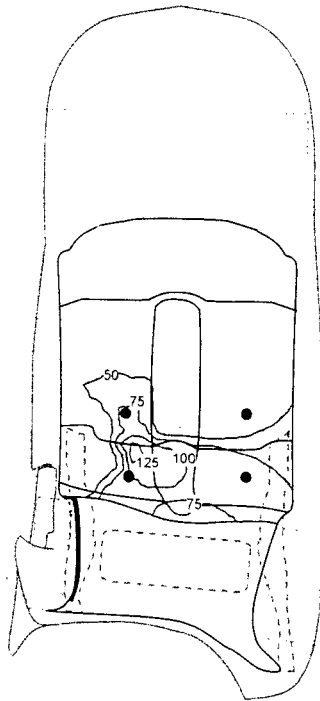
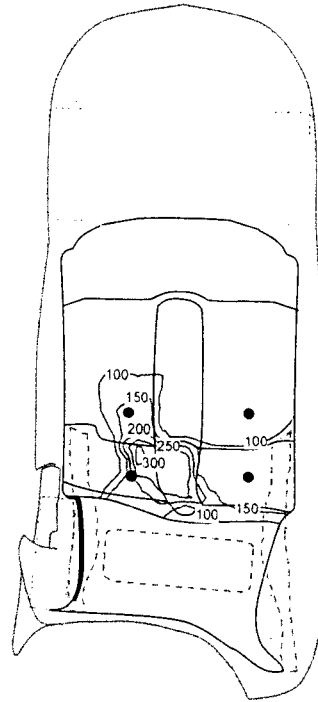
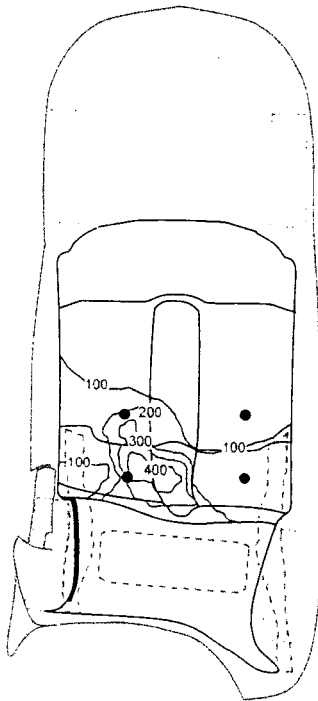
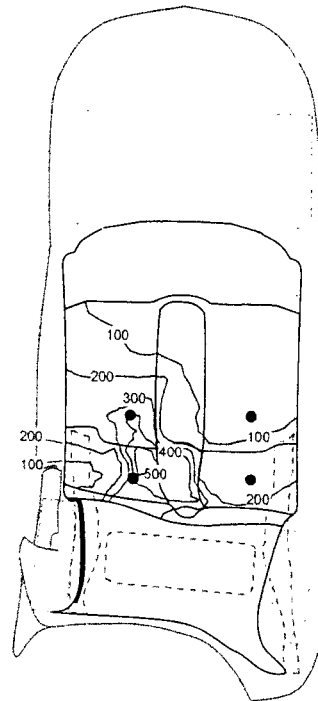
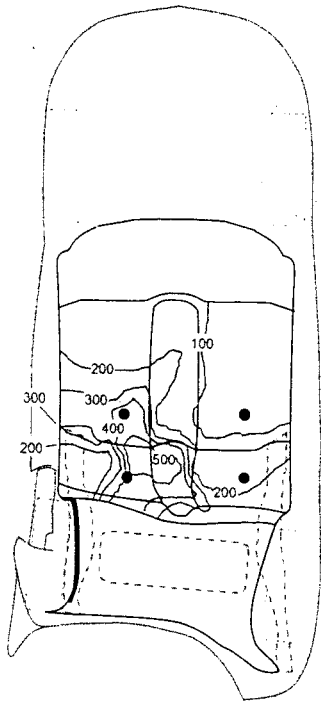
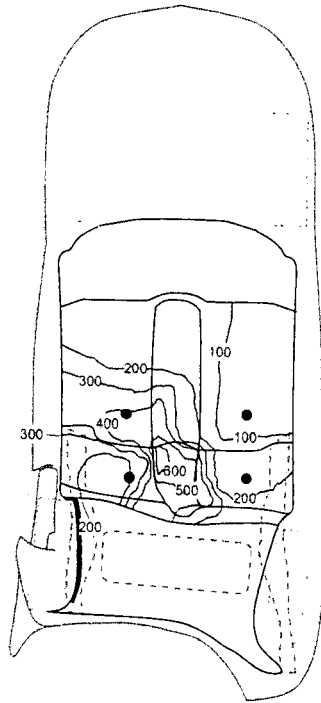
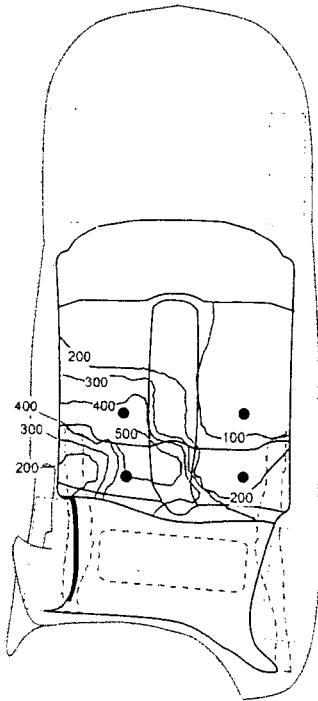
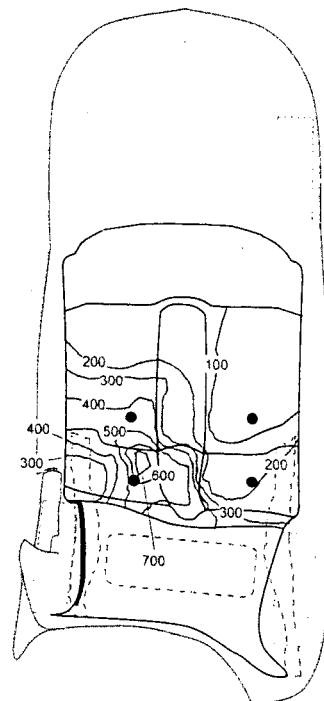
Estimated isothermal contour plots of floor pan temperatures¹⁰ indicate that the floor pan under these areas of the carpet reached temperatures greater than 500°C by 200 seconds post-ignition (Fig. 48). Heat transfer from the floor pan to the carpet pad and carpet appeared to have caused these materials to undergo thermal decomposition. Airflow into the space between carpet and floor pan was restricted and probably insufficient for well-ventilated combustion of the pyrolysate produced by thermal decomposition of the materials in the carpet pad and carpet. These incomplete combustion products formed the residue of soot particles and an oily liquid film observed on the front and middle floor pan panels after this test (lower photograph, Fig. 43) and carpet pad (Fig. 47).

Figure 48. Fire Test F971001. Isothermal contour plots showing estimated temperatures below the floor panel at -10, 0, 25, 50, 75, 100, 125, 150, 175, and 200 seconds post-ignition.

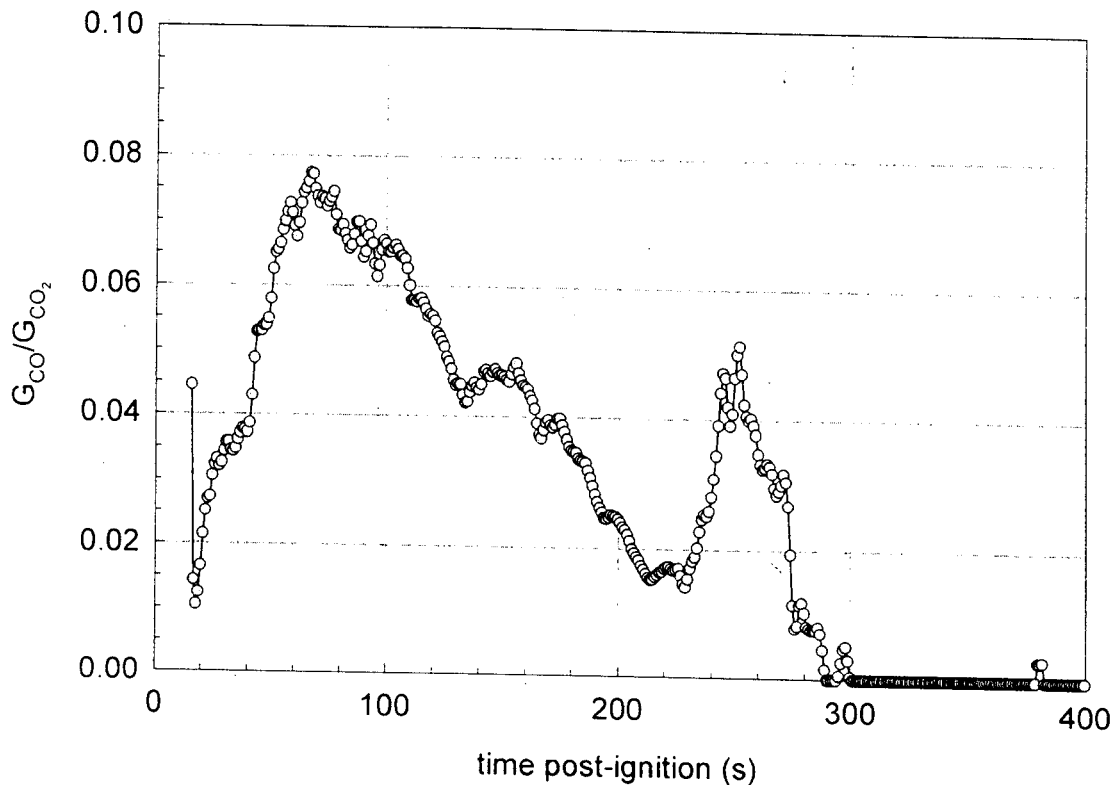
Analysis of the data from the Fire Products Collector suggests that initially, the production of carbon monoxide relative to carbon dioxide was greater than expected for well-ventilated combustion of gasoline and of materials similar to those used in the test vehicle. Figure 49 shows a plot of $[G_{\text{CO}}]/[G_{\text{CO}_2}]$ versus time post-ignition, where G_{CO} and G_{CO_2} are the carbon monoxide- and carbon dioxide-release rates measured using the Fire Products Collector (APPENDIX G).

Figure 49. Fire Test F971001. Plot of $[G_{\text{CO}}]/[G_{\text{CO}_2}]$ versus time post-ignition determined from the carbon monoxide- and carbon dioxide-release rates measured by the Fire Products Collector.

Values of $[G_{CO}]/[G_{CO_2}]$ could not be calculated for the first 17 seconds post-ignition because the concentration of carbon dioxide in the air entering the Fire Products Collector was less than the lower limit of detection of the measurement equipment (Fig. 49).¹³ The value of $[G_{CO}]/[G_{CO_2}]$ increased from about 0.01 to almost 0.08 between 17 and 65 seconds post-ignition, indicating that the overall combustion efficiency of the fire decreased during this time. Gasoline was the predominant fuel for the fire during at this time. One possible explanation for the increasing values of $[G_{CO}]/[G_{CO_2}]$ is that airflow into the restricted space below the test vehicle was insufficient for stoichiometric combustion of the hydrocarbons vaporizing from the gasoline pool. Immediately after ignition, radiation from the burning gasoline vapor transferred heat back to the surface of the gasoline pool, increasing the vaporization rate of hydrocarbons from the liquid gasoline. Oxygen in the air flowing into the space under the vehicle would have been consumed at an increasing rate as the rate of vaporization of the gasoline increased, and the efficiency of combustion would have decreased as the fuel-to-air ratio became greater than stoichiometric.

After about 60 seconds post-ignition, the value of $[G_{CO}]/[G_{CO_2}]$ decreased (Fig. 49), approaching the ranges expected for well-ventilated combustion (Table 1) by the end of this test. The heat release rate measured with the Fire Products Collector at the test facility increased exponentially from about 250 to 1200 kW during this time (Plot G1). The flow rate of gasoline from the outlet of the gasoline delivery system remained constant throughout this test and heat release rate from the burning gasoline appeared to have reached a steady-state at this time. The increase in heat release rate measured by the Fire Products Collector starting at about 60 seconds indicated that other combustible materials had started to ignite at this time. One consequence of flame-spread to these other materials was that a significant portion of the growing fire plume extended out from the restricted space below the test vehicle. This may have allowed higher buoyant flow and greater air entrainment into the flames extending away from the vehicle, resulting in an increase in the overall combustion efficiency after 60 seconds post-ignition. A correlation between heat

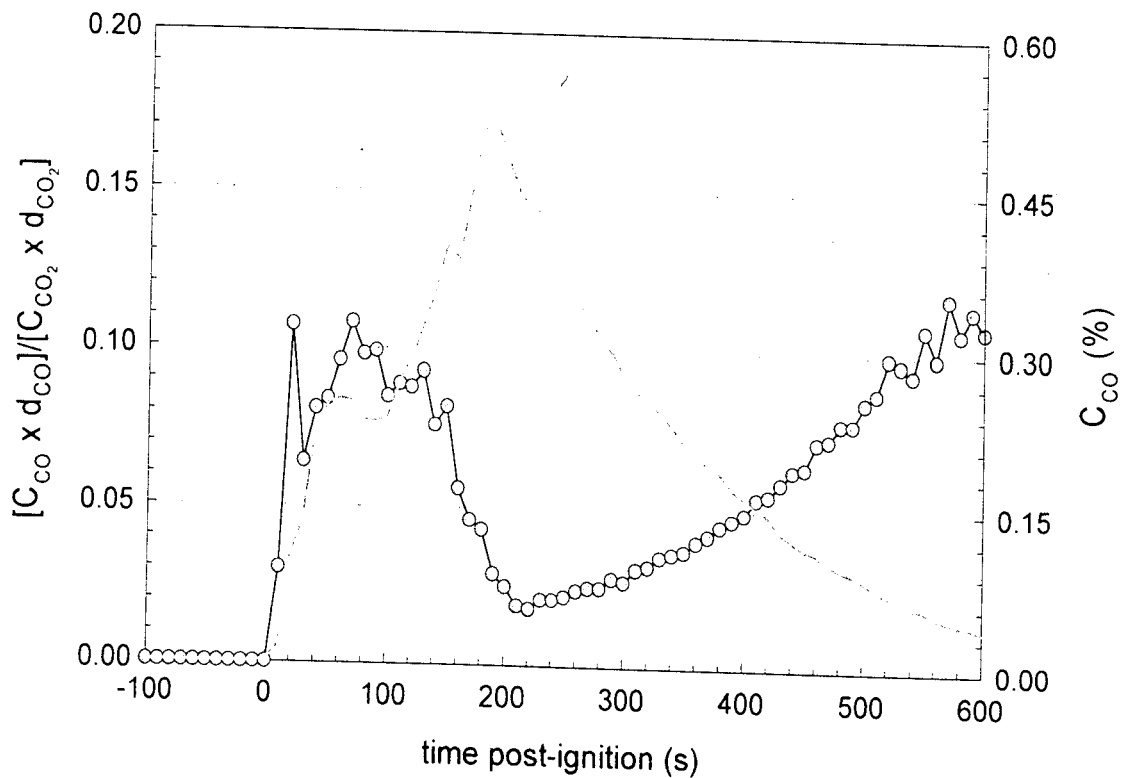
Figure 50. Fire Test F971001. Plots of $[C_{CO} \times d_{CO}]/[C_{CO_2} \times d_{CO_2}]$ (\circ , left axis) and the concentration of carbon monoxide (—, right axis) in the passenger compartment.

The values of $[C_{CO} \times d_{CO}] / [C_{CO_2} \times d_{CO_2}]$ and $[C_{HC} \times d_{HC}] / [C_{CO_2} \times d_{CO_2}]$ varied within narrow ranges around 0.090 and 0.080, respectively, from 20 seconds after ignition until 150 seconds post-ignition. These plots do not reflect combustion conditions inside the test vehicle during this time because combustible materials in the passenger compartment had not ignited (**SECTION 5**). There were two potential sources of gases in the passenger compartment at this time: combustion gases from the burning gasoline entering the test vehicle through the seam openings around the left rear wheelhouse and gases produced by pyrolysis of materials in contact with heated metal surfaces such as the floor pan. As discussed above, the Fire Products Collector data indicates that the burning gasoline, which was under the test vehicle, was under-ventilated. The relative concentrations of carbon dioxide, carbon monoxide, partially oxidized, and

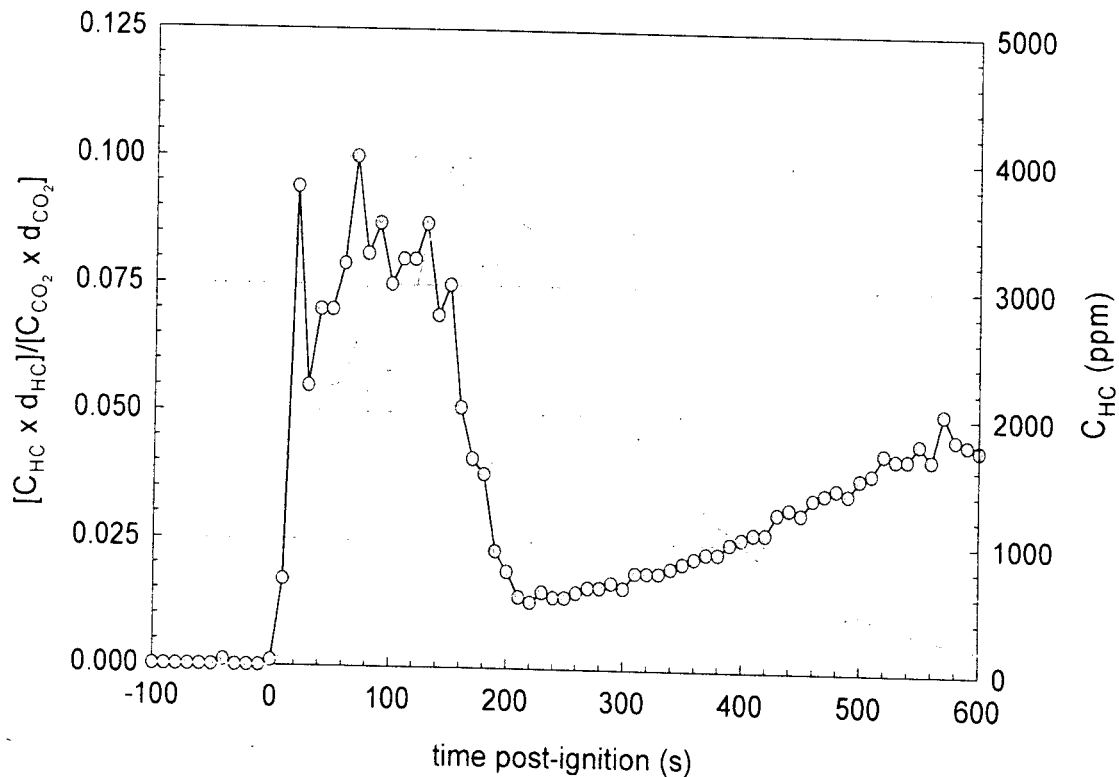
Figure 51. Fire Test F971001. Plots of $[C_{HC} \times d_{HC}] / [C_{CO_2} \times d_{CO_2}]$ (\circ , left axis) and the concentration of total hydrocarbons (—, right axis) in the passenger compartment.
