Re: **Settlement Agreement**
Section B. Fire Safety Research

This final report relates to Project B.3 (Fire Initiation and Propagation Tests).

Evaluation of Motor Vehicle Fire Initiation and Propagation
Part 11: Crash Tests on a Front-Wheel Drive Passenger Vehicle

Jack L. Jensen, Jeffrey Santrock
General Motors Corporation

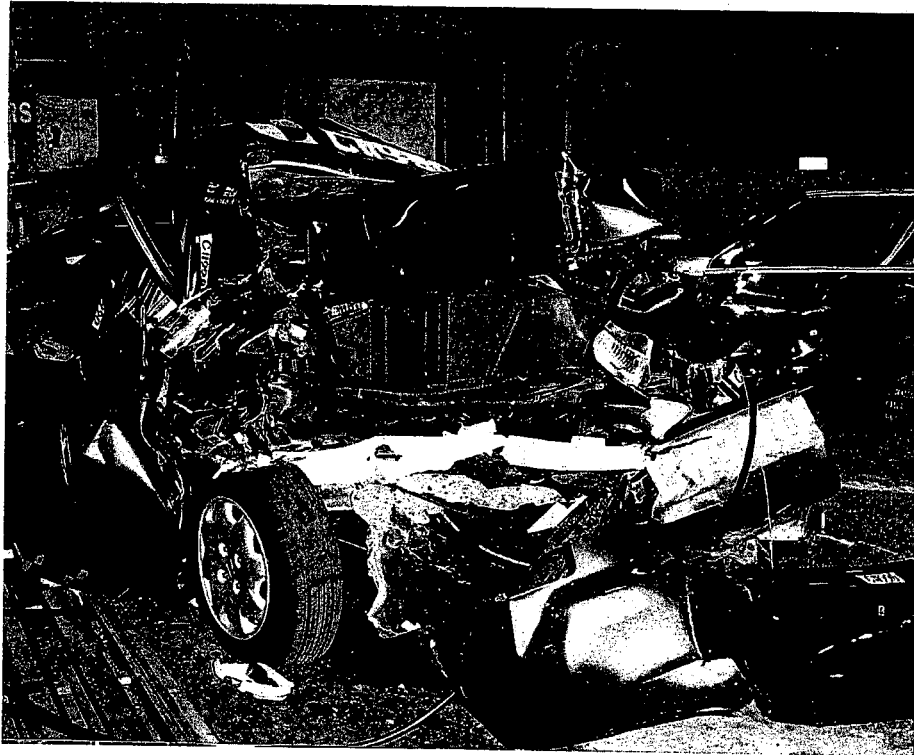
Figure 5
Post-Test Photograph of Test C11990, Left-Rear View

Post-test photographs of the vehicle are shown in Figure 5 and Figure 6.

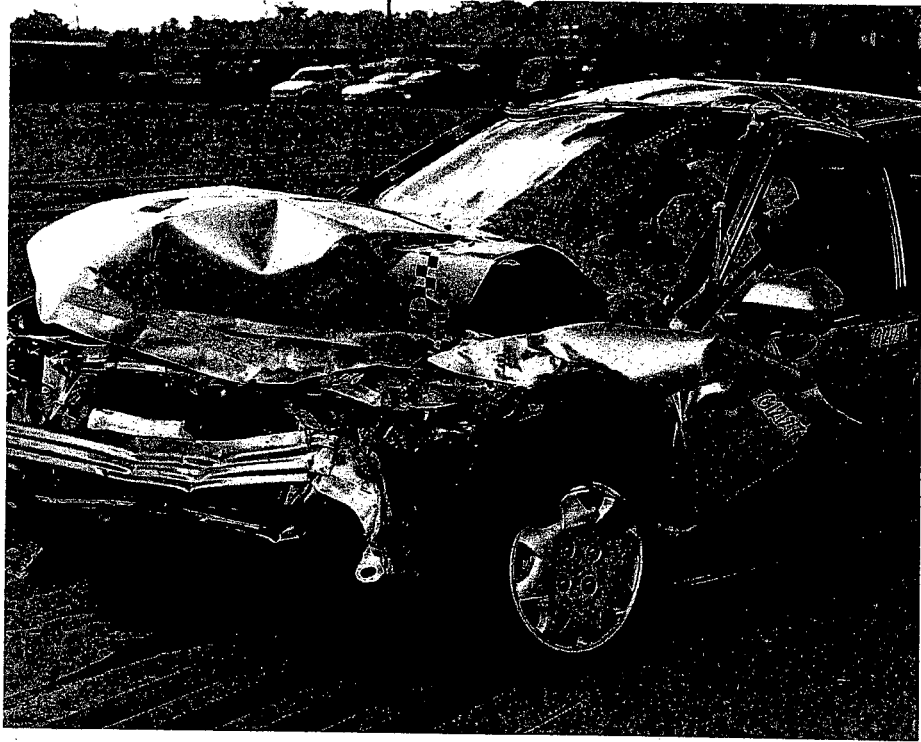
Figure 16
Post-Test Photograph of Test C12127, Front Left View

Post-test photographs of the vehicle are shown in Figure 16 and Figure 17.

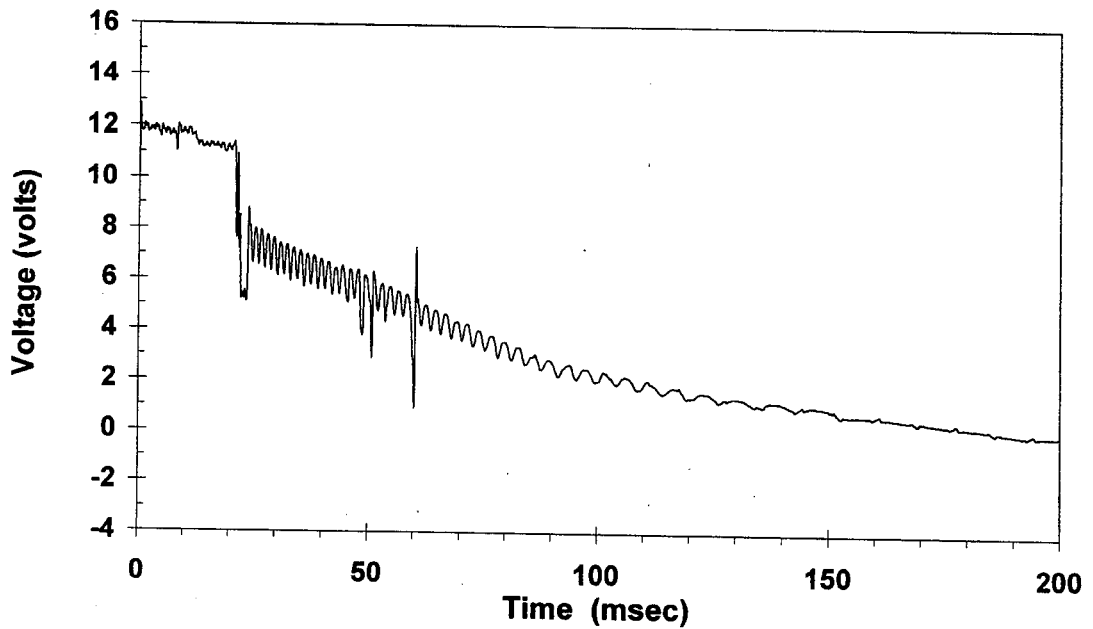
Figure 26
Fuel Pump Voltage
Test C12127

The ignition feed voltage, battery voltage and starter voltage all indicated intermittent drops from the nominal 13 volts throughout the impact. These voltages are shown in Figure 25 (plot 79), plot 80 and plot 81 respectively. The first drop in system voltage however, occurred at 20 msec coinciding with the loss in current to the fuel pump. Consistent with other frontal tests in this series, the fuel pump shut down at the first drop, albeit partial drop, in system voltage. The fuel pump voltage decayed from 12 volts to near zero from about 20 msec to 200 msec as shown in Figure 26 and Plot 83 (Appendix D), due to the loss of supplied voltage at 20 msec. Bench-tests on fuel pumps for other vehicles in this project [2] also indicated a gradual decay in voltage (lasting 40-150 msec) when current flow was stopped to the motor. This is likely

due to the windings of the motor producing a voltage drop as the motor stops. The decay shown in Figure 26 is consistent with the observations from other tests.

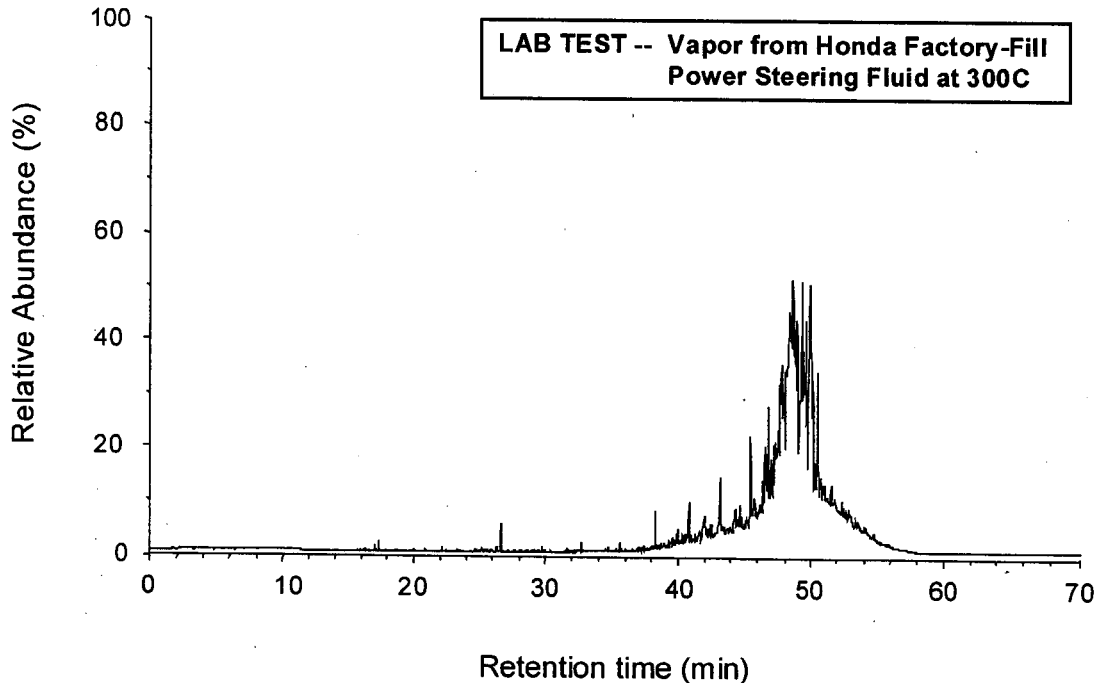
Additional fluid headspace vapors were analyzed to identify the sources of the vapors sampled during the crash test. In a series of laboratory tests, Honda factory-fill engine coolant, Honda factory-fill brake fluid, and Honda factory-fill power steering fluid were heated to approximately 300°C. The vapors above these heated fluids were sampled for a GC/MS analysis (Appendix E, Figures EE6 through EE8.) The vapor above liquid gasoline at room temperature was also sampled for GC/MS analysis (Figure EE9). The vapor above the engine coolant heated to 300°C was predominantly ethylene glycol (Figure EE8). The vapor above the brake fluid was a mixture of poly (ethylene glycol) ethers (Figure EE6). The vapor above the power steering fluid heated to 300°C was a mixture of aliphatic hydrocarbons in the range of C12 to C26. The GC/MS chromatogram from the heated power steering fluid is shown in Appendix E, Figure EE7 and recreated here as Figure 29. The vapor above liquid gasoline at room temperature was a mixture of aliphatic and aromatic hydrocarbons in the range of C5 to C10 (Figure EE9). The distribution of aliphatic hydrocarbons from locations 3 and 4 was the same as the distribution of aliphatic hydrocarbons vaporizing from the Honda factory-fill power steering fluid heated to 300°C in the laboratory experiment. Thus, the source of the Hydrocarbon vapors measured during the crash test was power steering fluid.

Figure 29
Chromatogram of vapor from Honda factory-fill power steering fluid heated to 300°C in a laboratory test

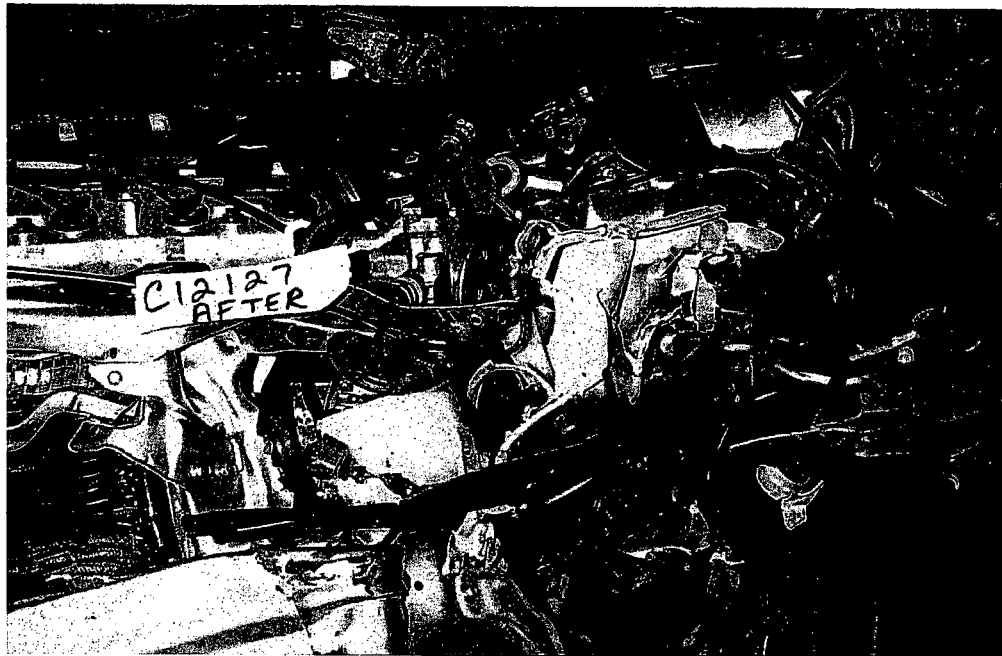
Figure 32

Results of the GC/MS analyses indicate that hydrocarbons produced by vaporizing power steering fluid on a heated surface were present around the exhaust manifold of the test vehicle during this crash test, suggesting that power steering fluid was involved in this fire. (See Section 3.2.4.) The power steering fluid reservoir was located in the left front quadrant of the engine compartment of the test vehicle. Components in this area were displaced rearward and to the right, along the approximate trajectory of the moving barrier (Figure 32). The power steering fluid reservoir was crushed against the alternator. The top of the power steering fluid reservoir was disconnected from the body of the reservoir, and power steering fluid had been expelled from the reservoir when it was crushed. These observations suggest that the flames in the front of the engine compartment at 44 milliseconds resulted from power steering fluid that had vaporized and ignited by contact with the exhaust manifold and ignited.

Photograph of the left side of the engine compartment in the test vehicle after test #C12127.

An oily liquid was observed pooled in the web-pockets of the exhaust manifold, and an oily residue was observed on a number of components in and around the engine compartment of the test vehicle after this test. A sample of the liquid in the exhaust manifold web-pocket was obtained for GC/MS analysis using a clean glass pipette. Samples of the oily residue on a number of components were obtained using either clean glass fiber filters or clean cotton swabs. The areas sampled included: the collector on the exhaust manifold, the exhaust manifold heat shield (2 samples), the valve cover on the engine, the subframe left strut mounting, the lens from the left head light assembly, and the reflector in the left head lamp assembly. The residue was extracted from the glass filter or cotton swabs into a mixture of analytical grade solvents (1:1 hexane-tetrahydrofuran). In cases where there did not appear to be sufficient residue to obtain an amount of the residue adequate for GC/MS analysis, a few drops of the extracting solvent mixture were applied to the glass filter or cotton swab to dissolve the residue and wick it into the fibers. Figures EE10 through EE17 in Appendix E show results from the GC/MS analysis of the residue samples from the test vehicle after this test. Figure EE10 from Appendix E is recreated here as Figure 34. These analyses indicated that the oily residue in the engine compartment of the test vehicle was a mixture of aliphatic hydrocarbons in the range to C₁₅ to C₃₀. In addition, each of the chromatograms in Figures EE10 through EE17 contained three distinct peaks, centered at approximately C₁₇, C₂₀, and C₂₆.

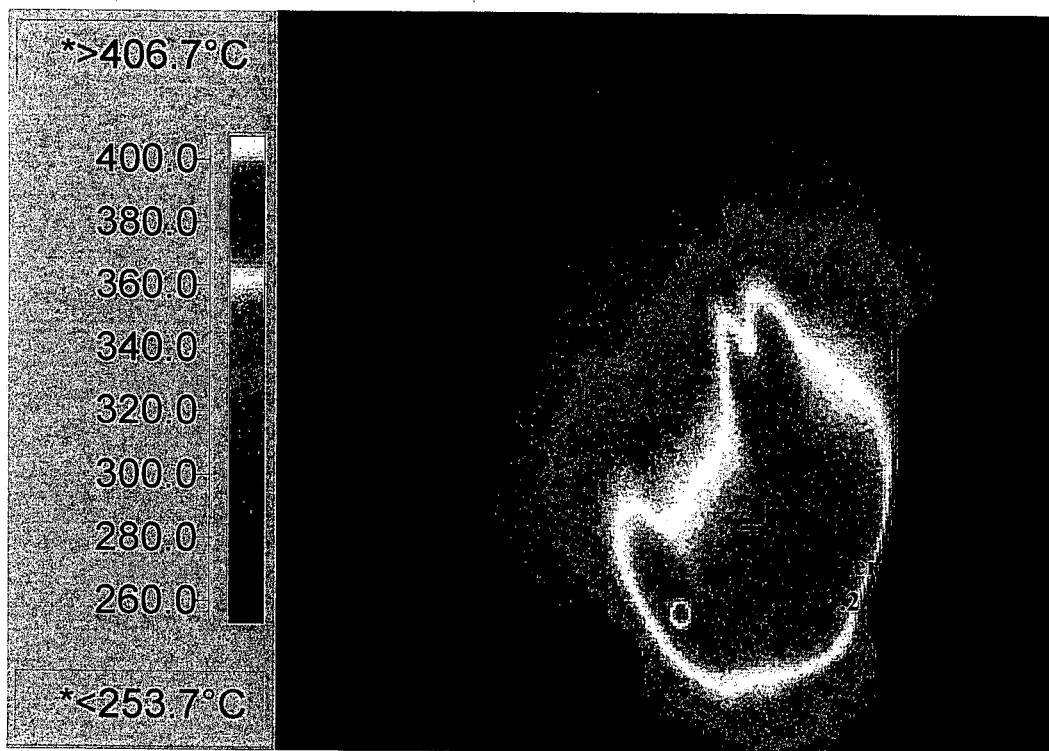
Exhaust manifold surface temperatures in the exemplary vehicle during these tests were similar to exhaust manifold surface temperatures in the test vehicle in C12127. An infrared thermogram of the exhaust manifold indicates that the temperature of the front surface of the exhaust manifold collector before the test was conducted was approximately 375 – 380°C (Figure 33). This compares to a temperature of 239°C (corrected for the emissivity of the iron manifold) that was measured by inserting single wavelength infrared thermometer through one of the holes in the exhaust manifold heat shield at the end of the engine warm-up period in C12127 (See Section 3.1.3). The holes in the exhaust manifold heat shield were above the runners in the exhaust manifold. The infrared thermogram in Figure 33 indicated that the temperatures of the surfaces of the exhaust manifold runners were between 250 and 300°C.

Infrared thermogram of the exhaust manifold in the vehicle used for the laboratory tests immediately after the heat shield was removed

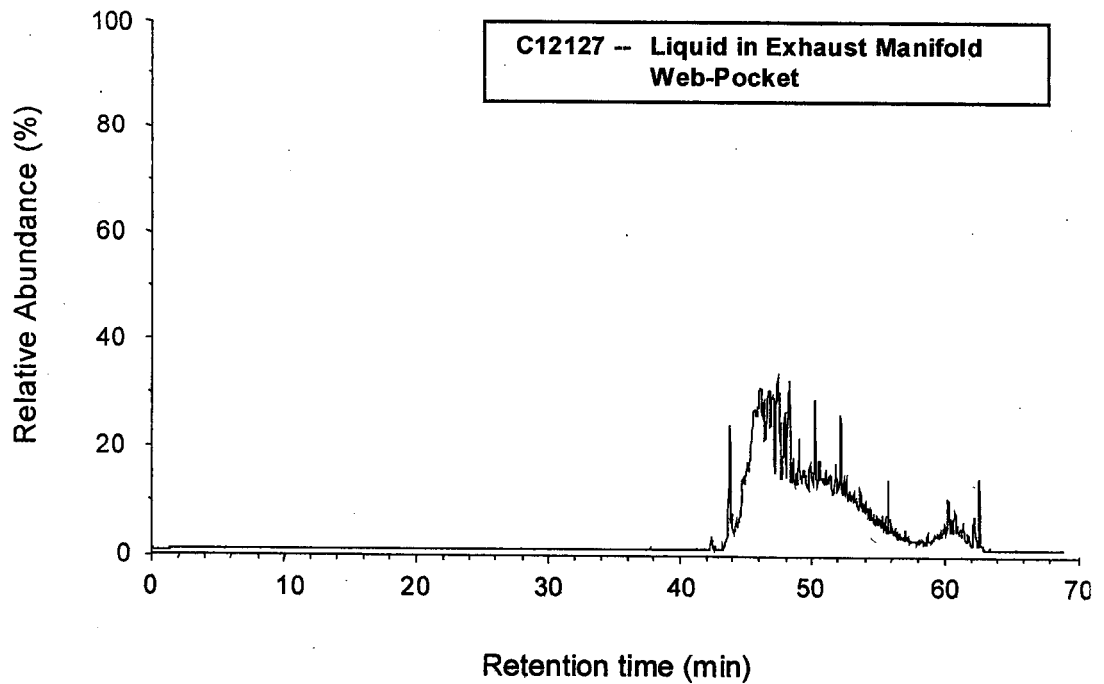
Samples of liquid residue remaining in the exhaust manifold web-pockets after these tests were retained for GC/MS analysis. Figures EE18 through EE20 in Appendix E show results of the GC/MS analyses of the remaining liquid residue. Each of these samples was a mixture of aliphatic hydrocarbons in the range of range of C₁₅ to C₃₀ with distinct peaks at approximately C₁₇, C₂₀, and C₂₆. The distribution of hydrocarbons in the oily residue sampled from the engine compartment of the test vehicle after this crash test (Figure 34 and Appendix E, Figures EE10 through EE17) matched the distribution of hydrocarbons in the residue from power steering fluid on the exhaust manifold of the exemplar vehicle (Appendix E, Figures EE18 through EE20). Figure EE18, a chromatogram from the residue from the exemplary vehicle is recreated here as Figure 35 for comparison to Figure 34, a chromatogram from the residue of the crash tested vehicle.

Figure 34
 Chromatogram of liquid residue pooled in the left exhaust manifold web-pocket from crash tested vehicle Test C12127

These results suggest that power steering fluid was the fuel and the exhaust manifold was the ignition source for the fire observed in the engine compartment of the test vehicle during this crash test. The GC/MS analyses of the oily residue in the engine compartment (Figures EE10 to EE17) confirm that power steering fluid was expelled from the power steering fluid reservoir, and sprayed onto components in the upper part of the engine compartment. Hydrocarbon vapor from power steering fluid was detected in gas samples collected from above and below the exhaust manifold heat shield (Figures EE3 and EE4 in Appendix E, and Figure 28). Of the fluids in the test vehicle released during this crash test, only power steering fluid ignited when poured onto the exhaust manifold of the exemplar vehicle when it was operated under conditions similar to the test vehicle at the time of this crash test (Table 2). As no other flammable vapors were detected in the gas samples from the test vehicle, the flames observed in the upper part of the engine compartment appear to have been burning power steering fluid aerosol/vapor.

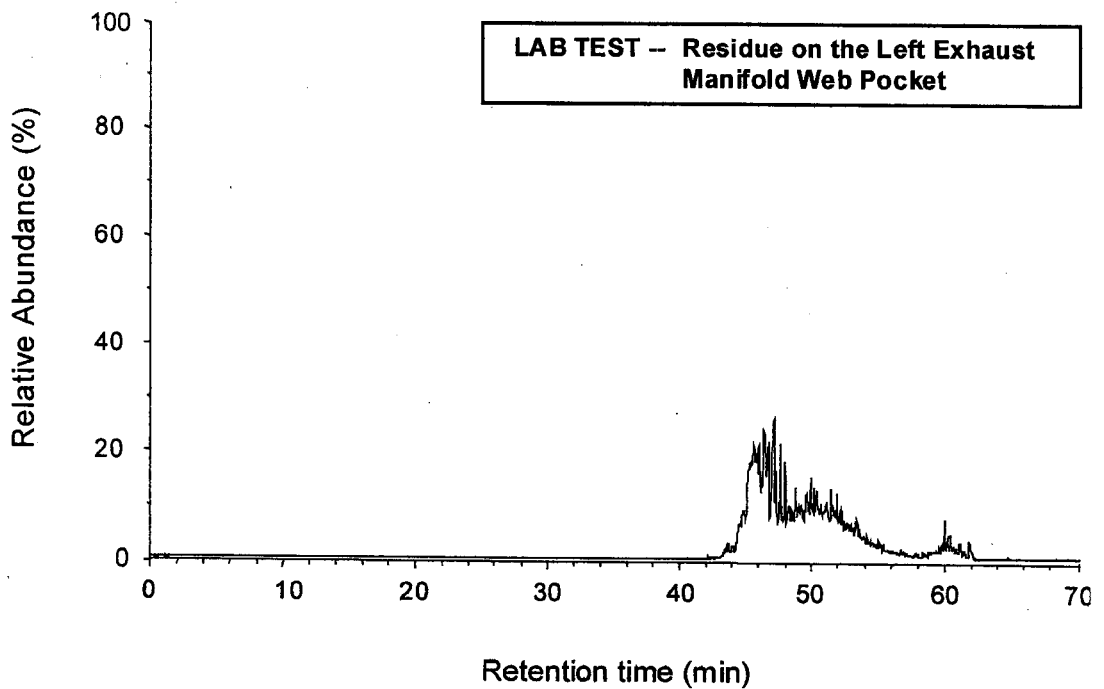
Figure 35
 Chromatogram of the liquid residue from Honda power steering fluid in left exhaust manifold web-pocket of the exemplar vehicle

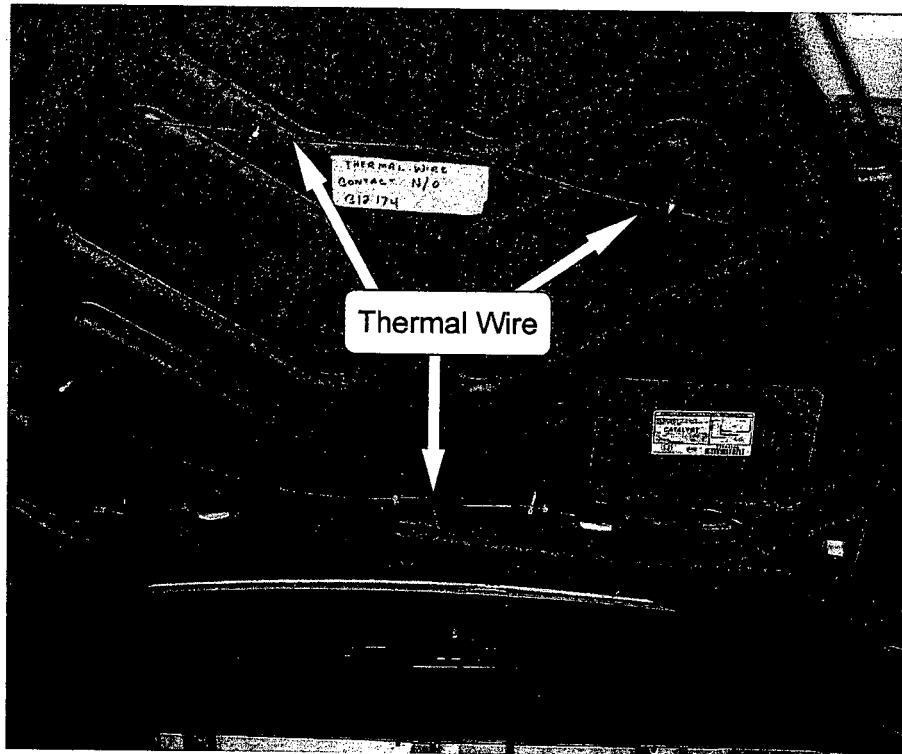
Figure 40
Thermal Wire Fire Detector
Test C12174

Both the experimental thermal wire and optical sensor fire detectors (as described in Section 3.1.12) were evaluated on test C12174. The mounting locations for the optical sensors were the same as for test C12127. The underhood mounting location of the thermal wire was similar to but slightly more rearward than the location for test C12127, as shown in Figure 40.

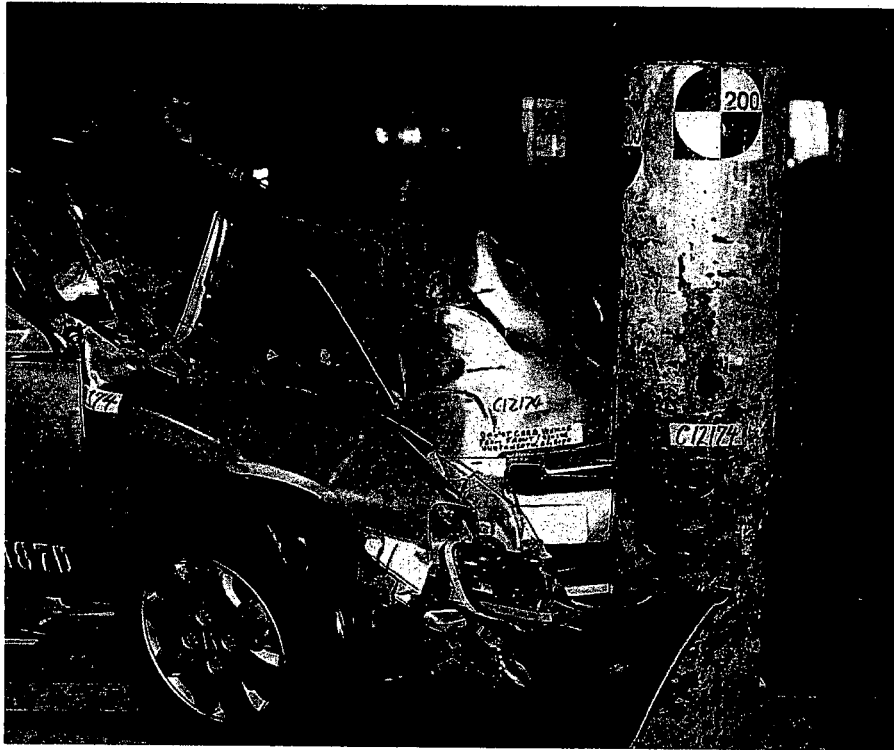
Figure 41
Post-Test Photograph of Test C12174, Front-Right View

Post-test photographs of the vehicle are shown in Figure 41 and Figure 42.

The following fluid leaks were identified during the post-test inspection:

- Engine coolant: radiator crushed, coolant lost
- Battery electrolyte: housing cracked, electrolyte lost
- Brake fluid reservoir knocked off of master cylinder, brake fluid lost

There were no leaks found in the transmission fluid system, fuel lines, engine oil system, washer solvent reservoir, or power steering system.

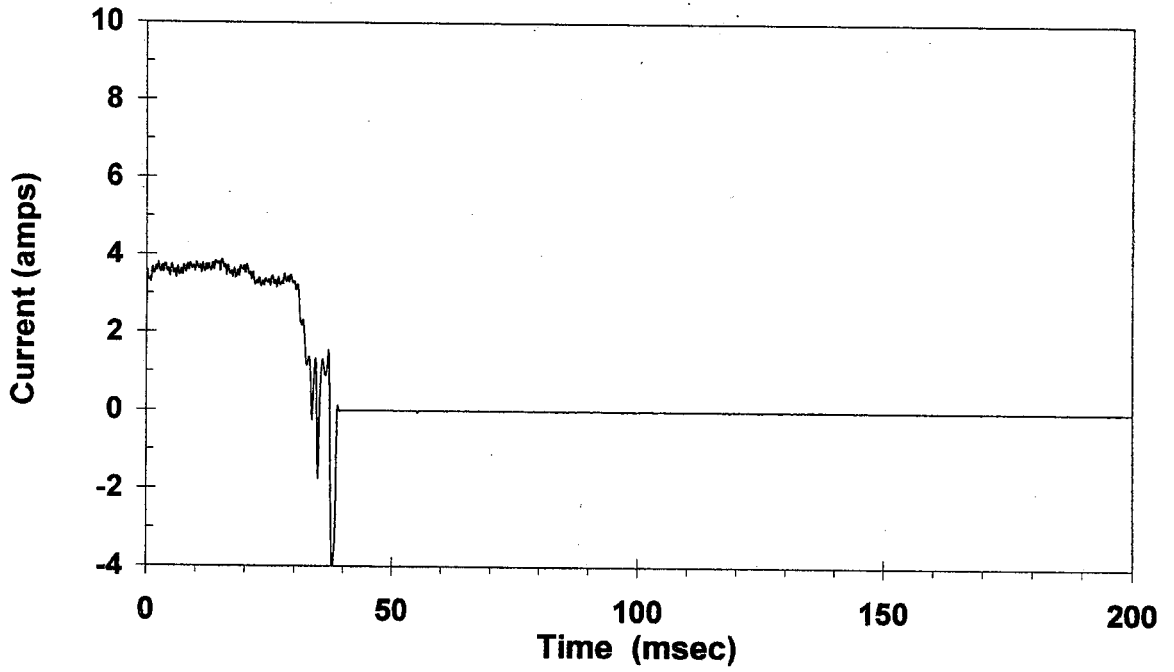
Figure 47
 Fuel Pump Current
 Test C12174

Figure 47 and Plot 97 in Appendix F show the fuel pump current draw during the impact. Similar to test C12127, the fuel pump was drawing about 4 amps at impact. The current began to drop at 30 msec and stopped flowing by about 35 msec. The fuel pump was likely stopped due to the drop in main vehicle voltage, as shown by the battery voltage in Figure 48 and Plot 81. The battery voltage dropped from 13 volts to 11 volts at 30 msec and indicated intermittent and partial drops in voltage throughout the impact. The starter cable voltage (Plot 82) and ignition voltage (Plot 85) indicated nearly identical time histories as the battery voltage, indicating that all circuits on the vehicle were likely limited to voltages indicated in Figure 48.

1. There were no fires observed during or after this crash test.
2. The electric fuel pump began stopping at 30 msec after impact due to a temporary drop in the main vehicle system voltage.

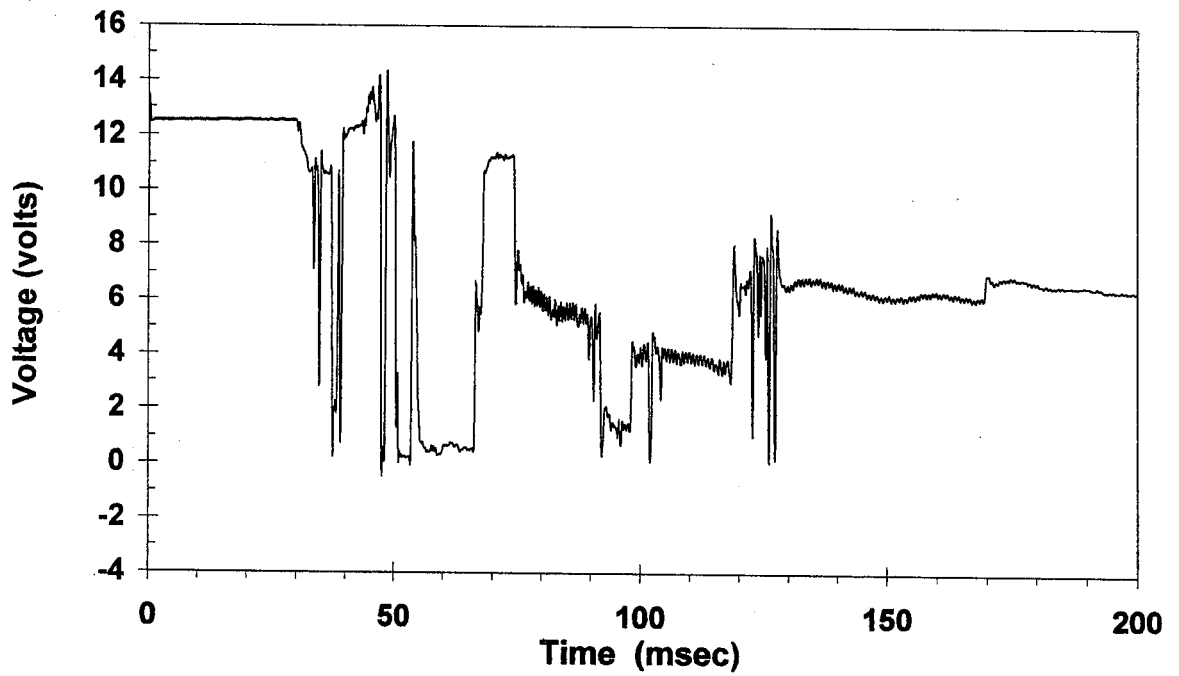
Figure 48
 Battery Voltage
 Test C12174

The battery voltage, starter cable voltage, and ignition voltage (Figure 48, Plot 81, Plot 82 and Plot 85), all exhibited temporary and sometimes partial drops in system voltage during the impact as described in Section 4.2.1. Temporary voltage drops during the crush were observed in test C12127 as well as other frontal crash tests for this project. [2],[3],[4]. A significant increase in current was observed on two monitored channels: the radiator fan (Plot 102 and Figure 51) and the A/C clutch (Plot 98). The rise in

current occurred from about 30 to 40 msec coinciding with the drop in voltage as shown in Figure 48. Thus, this voltage drop from 30 – 40 msec was likely due to a short to ground affecting both the radiator fan and A/C clutch current flow. An increase in current flow was also measured on the battery cable (Plot 96), which would be expected as the battery cable supplies the other two circuits. The current transducer on the battery cable was a larger transducer capable of measuring more current (500 amps) than the transducers used on individual circuits. Thus, this measurement did not overload its full scale range from 30 to 40 msec and indicated a current flow of about 300 amps. The causes of the other voltage drops after 40 msec (Figure 48) were not positively identified, and could possibly be due to the physical crushing of the battery.

11. Brake fluid, engine coolant, and battery electrolyte all leaked during the test. No other engine compartment fluids were released.
12. The main system voltage indicated temporary and partial drops in system voltage beginning at 30 msec and lasting throughout the impact. At least one short was identified which caused one of the drops due to additional loading on the battery. The other drops in system voltage were likely due to unidentified shorts to ground or internal damage to the battery as it was crushed.

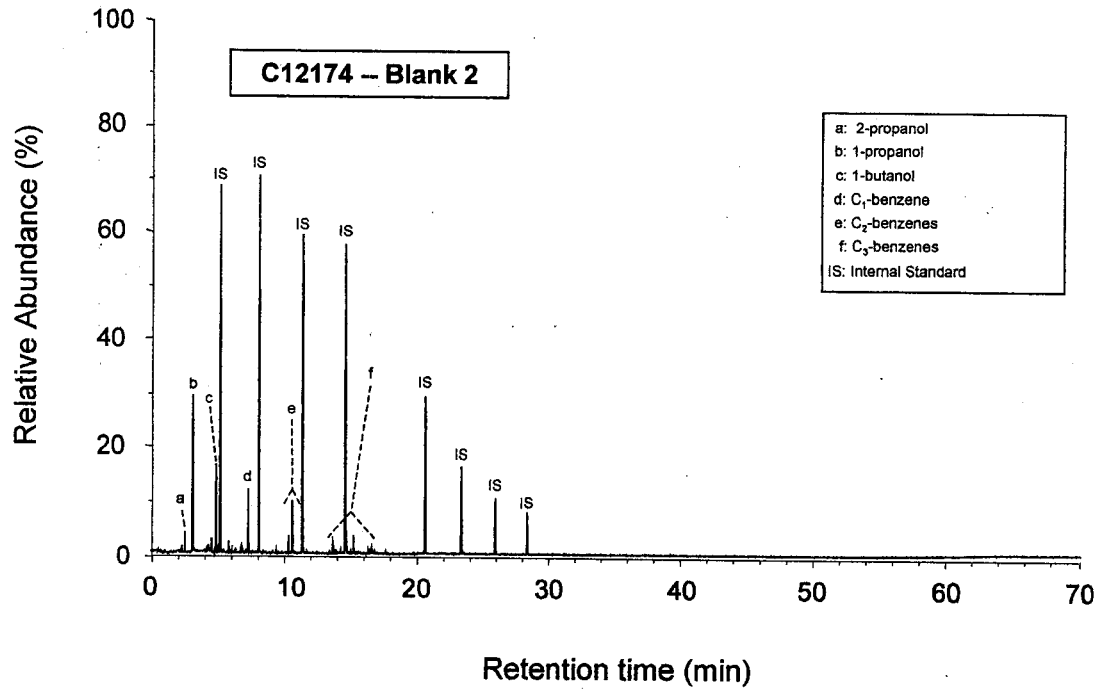
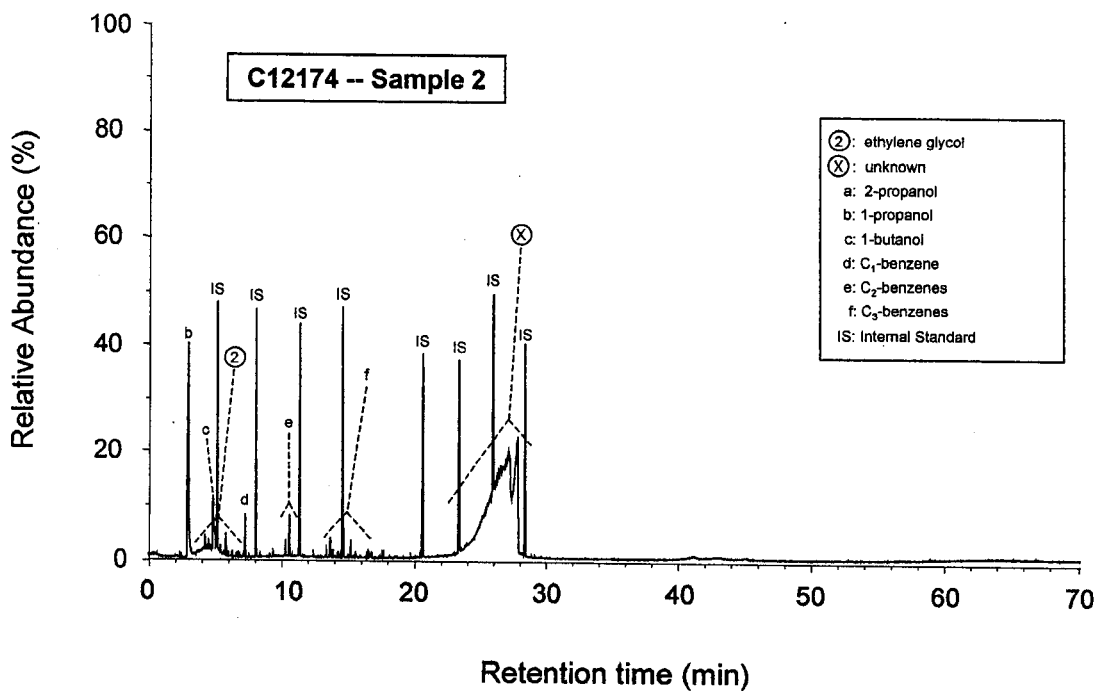
Figure 50
 GC/MS analysis of hydrocarbon vapor sample from near the right fuel rail (location #2) during Crash Test C12174. The top panel is the chromatogram of background sample and the bottom panel is the chromatogram of the post-crash sample.

The GC/MS analysis was completed on the vapors collected from all 5 locations [1]; the results are shown in Appendix G Figures GG1 through GG5. The GC/MS analysis of samples collected from locations #3 and #4 did not indicate the presence of a vapor unique to those locations. Thus, it is possible the high concentration measurements from locations #3 and #4 (Figures G3 and G4) are suspect measurements. These types of tin oxide sensors no longer function properly when doused with liquids, which may have happened during the crash. The results of the GC/MS analysis for location #2, however, did identify the presence of vaporized engine coolant and is recreated here as Figure 50. Ethylene glycol (coolant) is shown as a peak number 2 in Figure 50.
