**Evaluation of Motor Vehicle Fire Initiation and Propagation
Part 9: Propagation of a Rear-Underbody Gasoline Pool Fire in a
1998 Sport Utility Vehicle**

Jeffrey Santrock
General Motors Corporation

ABSTRACT

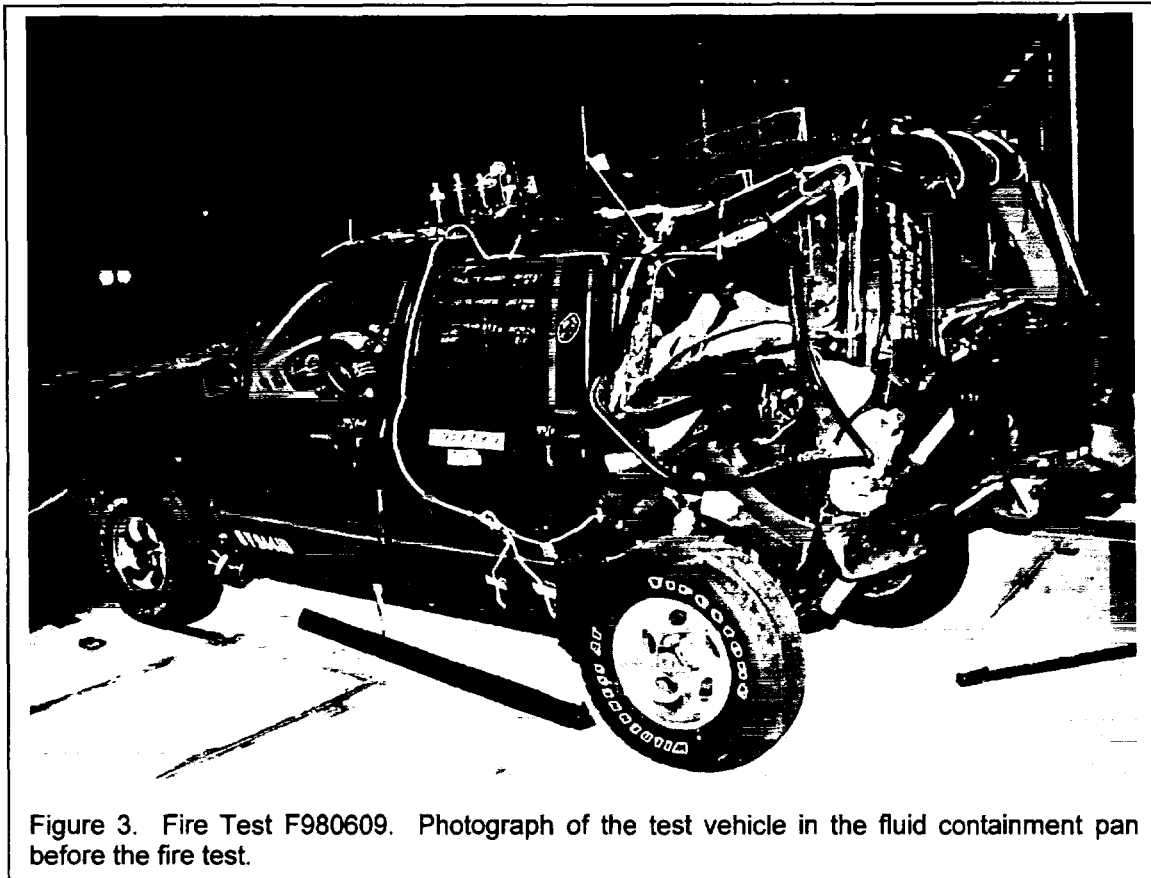
Figure 3. Fire Test F980609. Photograph of the test vehicle in the fluid containment pan before the fire test.

The test vehicle was placed in the center of the pan (Fig. 3). All doors were closed, and the door window glasses were raised to their fully closed position in each door. The left and right quarter window glasses and the rear lift gate glass, which were broken in the crash test, were not replaced for the fire test.

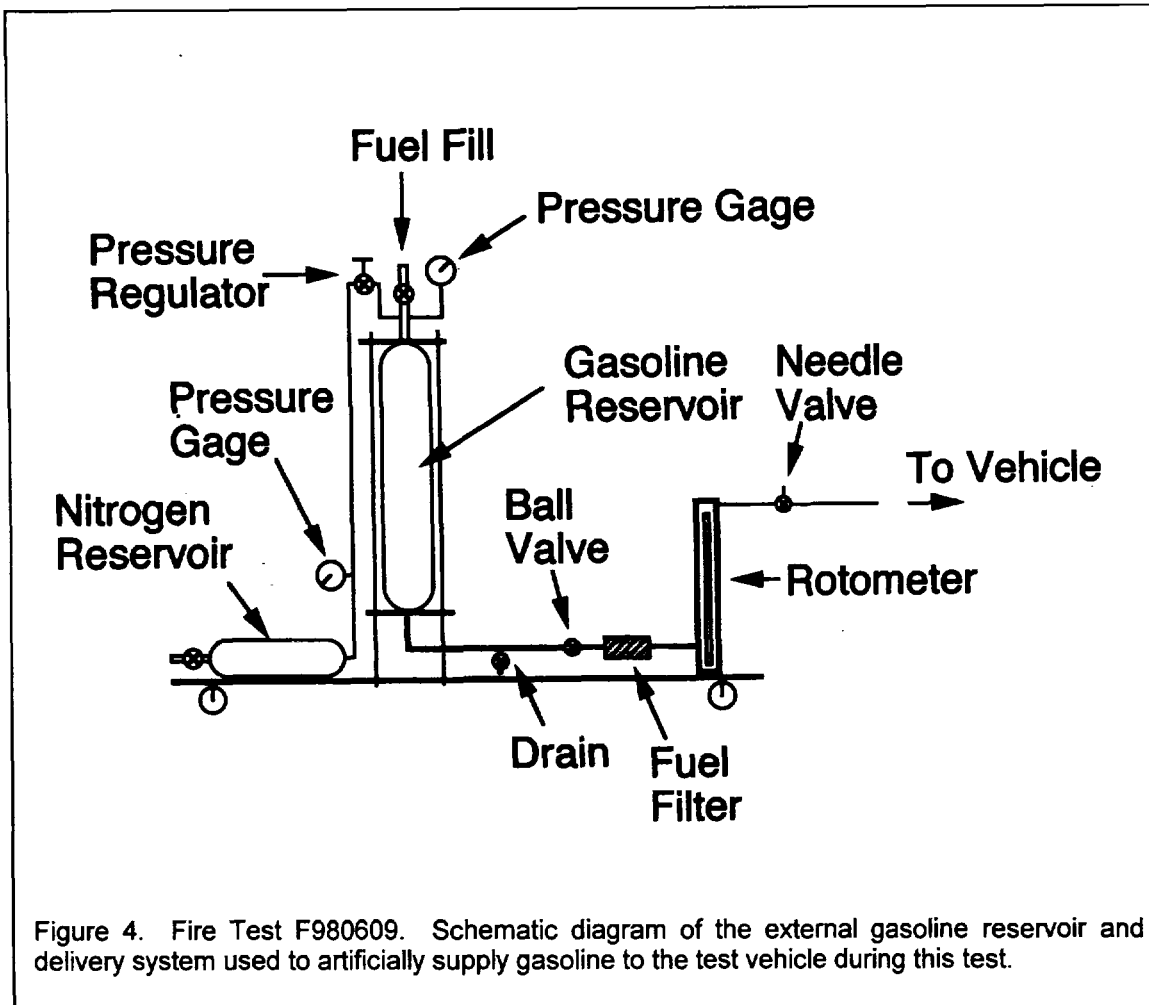
Figure 4. Fire Test F980609. Schematic diagram of the external gasoline reservoir and delivery system used to artificially supply gasoline to the test vehicle during this test.

used in this test. This system consisted of two stainless steel cylinders. One cylinder functioned as a fluid reservoir and had a capacity of 4 L, while the other cylinder functioned as a gas reservoir and had a capacity of 2 L. A pressure regulator in the line connecting the gas reservoir to the fluid reservoir controlled the head pressure in the fluid reservoir. The outlet line of the fluid reservoir contained a ball valve that was used to turn on and off the flow of gasoline during the test, a rotometer to indicate the flow of gasoline during the test, and a needle valve to control the flow of gasoline.

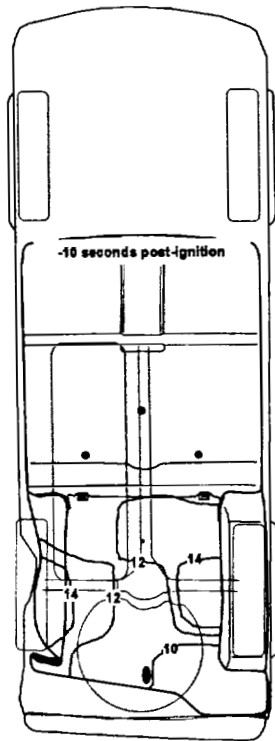
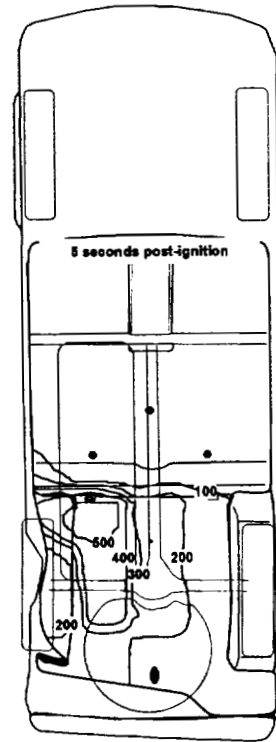
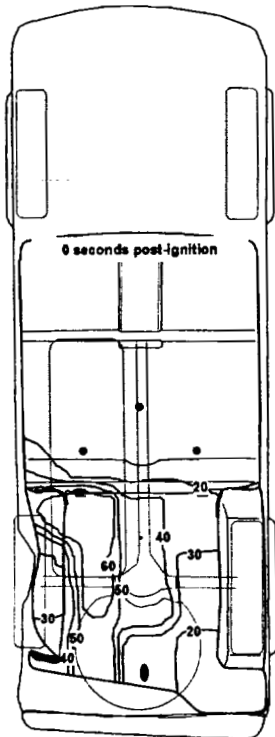
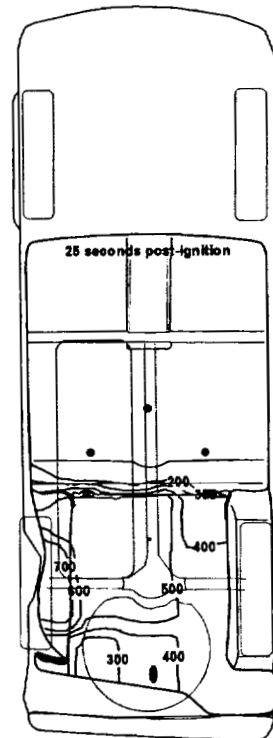
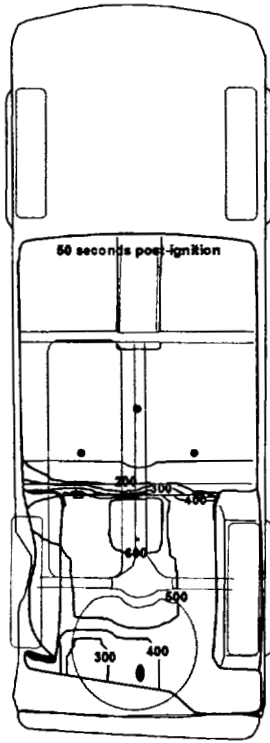
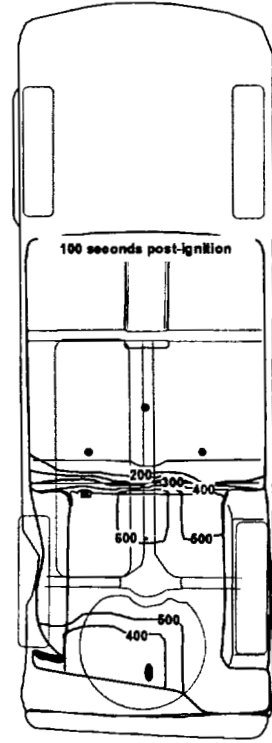
⁴ Isothermal contours of the temperature below the rear compartment floor panel were estimated from the temperature data recorded from Thermocouples F5, F7, F9, F12, F14, F16, F18, F20, F22, F24, WW1, and WW6 using a three-dimensional interpolation algorithm available in SigmaPlot for Windows Version 4.00 [6]. This algorithm used an inverse distance method to interpolate temperature values for points on a uniformly spaced Cartesian grid from the $[x,y,t]$ triple data from these thermocouples. Refer to APPENDIX C for the approximate locations of these thermocouples.

⁵ As in previous reports, a value of 600°C was used in this report as the threshold to indicate the presence of flame.

Figure 25. Fire Test F980609. Isothermal contour plots showing estimated temperatures below the floor panel at -10, 0, 5, 25, 50, 75, 100, 120, 125, 150, 157, and 170 seconds post-ignition.

The estimated temperature profiles in Figure 26 indicate that heated gases and flames were not distributed along the lower surface of the rear compartment floor panel concentrically around the gasoline outlet, which was the approximate center of the gasoline pool. For example, estimated temperatures above the spare tire and exhaust system were 100 to 200°C lower than estimated temperatures above the rear of the fuel tank or in the left rear wheelhouse (Fig. 26). One possible explanation of this temperature difference is that the spare tire and exhaust system acted as physical obstacles shielding areas of the floor pan in the rear compartment from direct exposure to heated gases and flames. These and other underbody components also may have restricted airflow into the space just below the floor panel reducing ventilation and resulting in insufficient oxygen for combustion, which may explain the decrease in estimated temperatures below the floor pan between 125 and 150 seconds post-ignition.

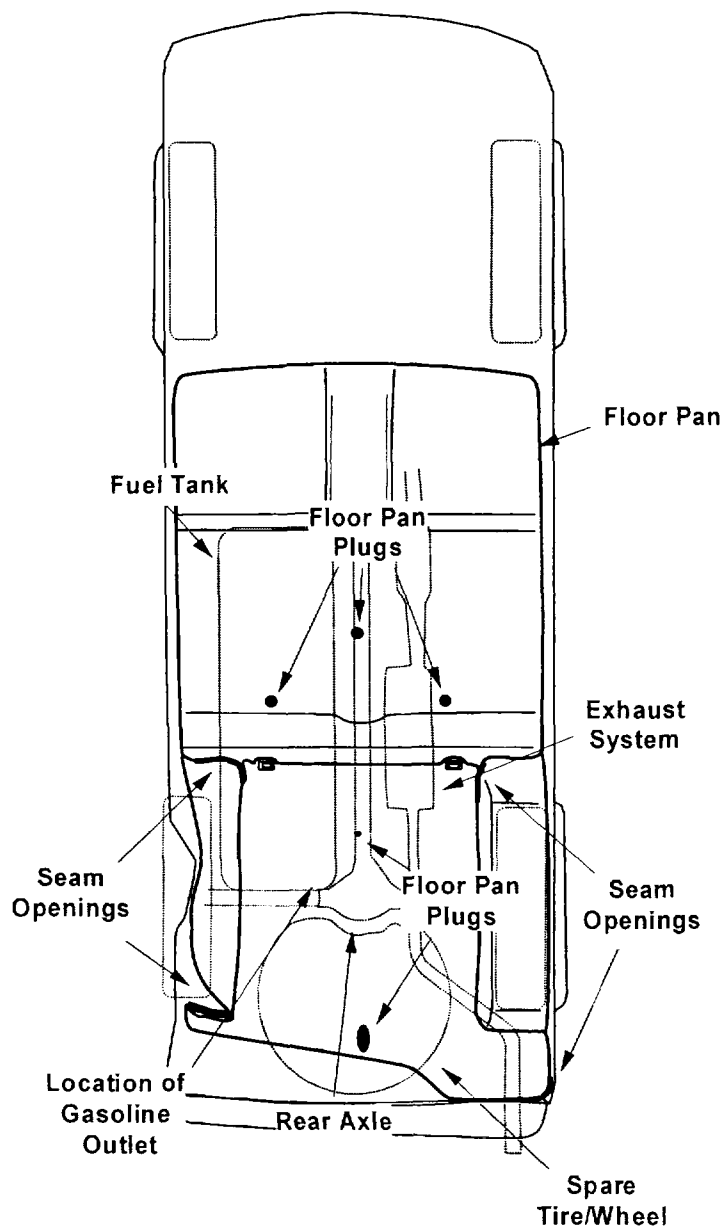
Components such as the fuel tank, spare tire, and exhaust system heat shields appear to have affected the distribution of heated gases and flames in the area just below the lower surface of the rear compartment floor panel. Figure 26 is a diagram of the test vehicle showing the approximate locations of crash-induced seam openings, floor pan plugs, fuel tank, the spare tire/wheel, rear axle and rear tires/wheels, and the exhaust system components.

Figure 26. Fire Test F980609. Top view of the floor pan in the test showing the floor pan and the approximate locations of crash-induced seam openings, floor pan plugs, fuel tank, the spare tire/wheel, rear axle and rear tires/wheels, exhaust system components, and the gasoline outlet installed on the test vehicle for this test.

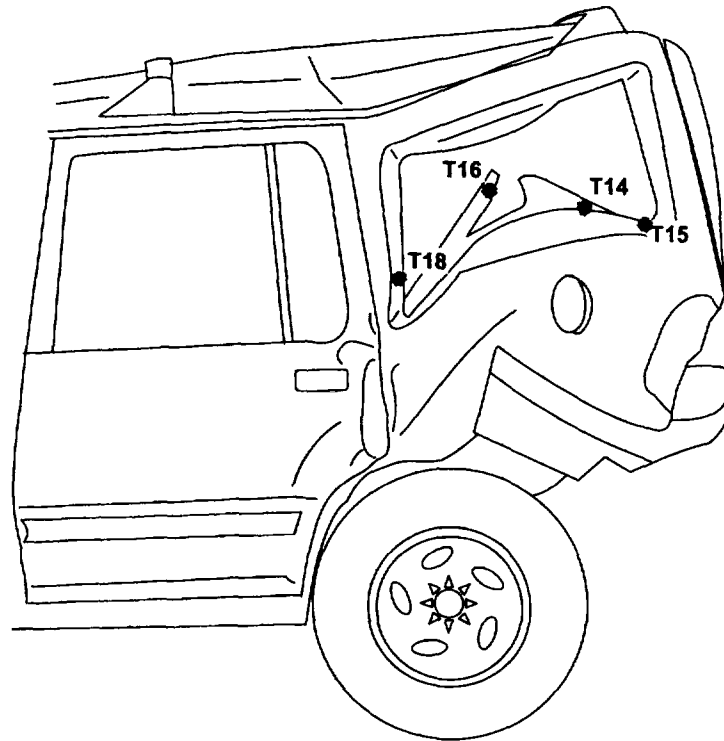
Figure 36. Fire Test F980609. Approximate locations of Thermocouples T14, T15, T16, and T18 on the left quarter trim panel.

Thermocouples T14 and T15 were located along the edge of the left quarter trim panel adjacent to the lower edge of the quarter glass opening (Fig. 36). Thermocouple T16 was located on a section of the quarter trim panel that broke during the crash test and extended outward into the quarter glass opening. Thermocouple T18 was located on a section of the quarter trim panel covering the C-pillar. Thermocouples T20, T21, and T22 were located on the section of the left quarter trim panel along the header to the left quarter glass opening (Fig. 36).

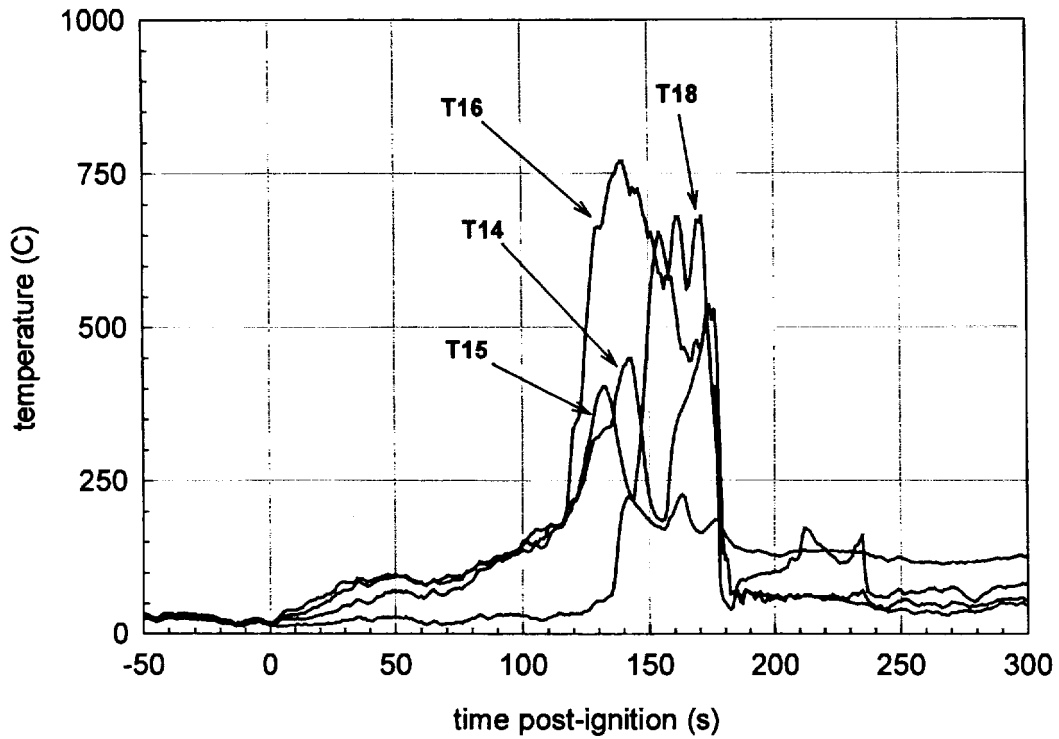
Plots of data recorded from thermocouples located on the left quarter trim panel around the quarter glass opening are shown in Figures 37 and 38. Temperatures recorded from Thermocouple T16 increased from $< 200^{\circ}\text{C}$ at 110 seconds post-ignition to $> 650^{\circ}\text{C}$ at 130 seconds post-ignition (Fig. 37).

Figure 37. Fire Test F980609. Plots of data recorded from Thermocouples T14, T15, T16, and T18.

Temperatures recorded from Thermocouple T18 increased from approximately 50°C at 130 seconds post-ignition to approximately 650°C at 155 seconds post-ignition (Fig. 37). Temperatures recorded from Thermocouples T14 and T15 were <450°C throughout this test (Fig. 37). Temperatures recorded from Thermocouples T21 and T22 increased monotonically from the time of ignition and exceeded 600°C between 160 and 170 seconds post-ignition (Fig. 38). Temperatures recorded from Thermocouple T20 were < 150°C throughout this test (Fig. 38).

These data indicate that the section of the broken left quarter trim panel that extended outward through the quarter glass opening ignited between 100 and 130 seconds post-ignition. A section of the left quarter trim panel along the C-pillar at the lower edge of the quarter glass opening ignited between 130 and 155 seconds post-ignition. The timing of ignition of the left quarter trim panel in these areas preceded the first evidence of flames entering the rear compartment through a seam opening in the wheelhouse (Fig. 35). These areas of the left quarter trim panel appeared to have been exposed through the left quarter glass opening to a fire plume emerging from the left rear wheelhouse starting at about 100 seconds post-ignition. Video Stills from Cameras 1 and 2 at 100 seconds post ignition show a fire plume emerging from the left rear wheelhouse and extending upward along the outer quarter panel and outboard of the left quarter glass opening (Fig 39). Review of these videos showed flames entering the left quarter glass opening and contacting left quarter trim panel. The thermocouple data indicates that a section of the left quarter trim panel along the header at the rear of the quarter glass opening ignited between 160 and 170 seconds post-ignition, which is coincident with the timing of flame-spread through the seam opening in the wheelhouse (Fig. 35). Sections of the left quarter trim panel along the rear portion of the lower edge of the quarter glass opening and the header at the front of the quarter glass opening did not ignite during this test.

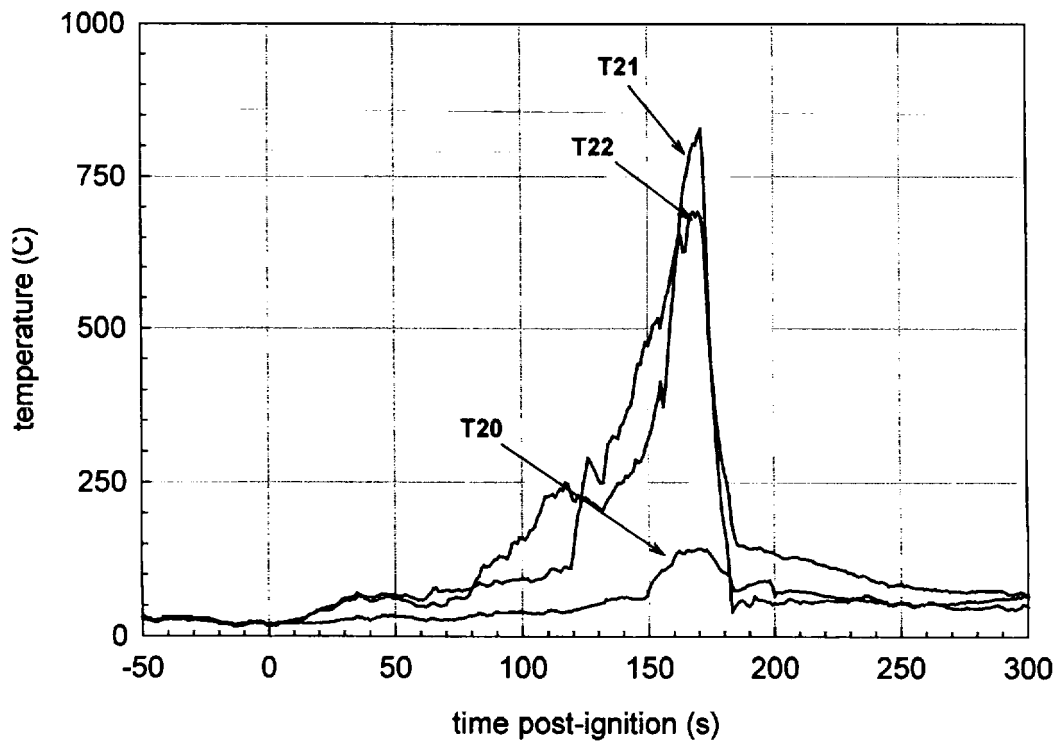
Figure 38. Fire Test F980609. Plots of data recorded from Thermocouples T20, T21, and T22.

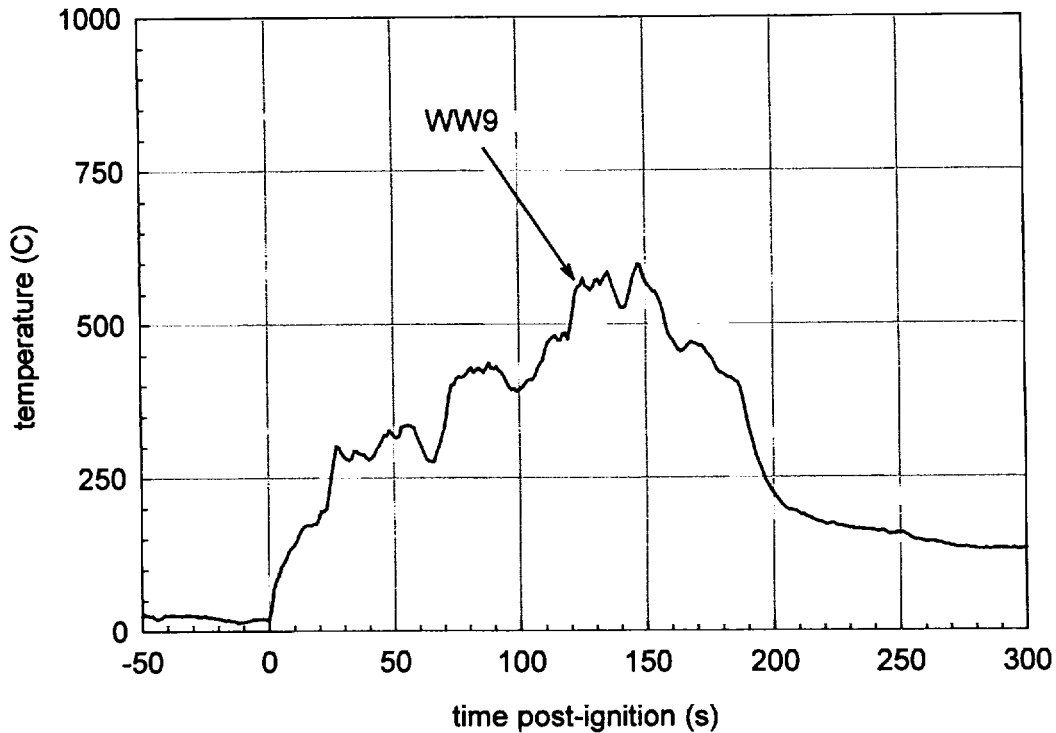
Figure 41. Fire Test F980609. Plot of data recorded from Thermocouple WW9.

Temperatures recorded from Thermocouple WW9 increased from an ambient temperature of approximately 20°C at the time of ignition to a maximum of 597°C at 147 seconds post-ignition, and decreased to 225°C at 200 seconds post-ignition (Fig. 38). This temperature data indicates that heated gases started to flow into this seam opening during the first few seconds after ignition, and continued to flow into this seam opening until this test was ended and the fire was extinguished.

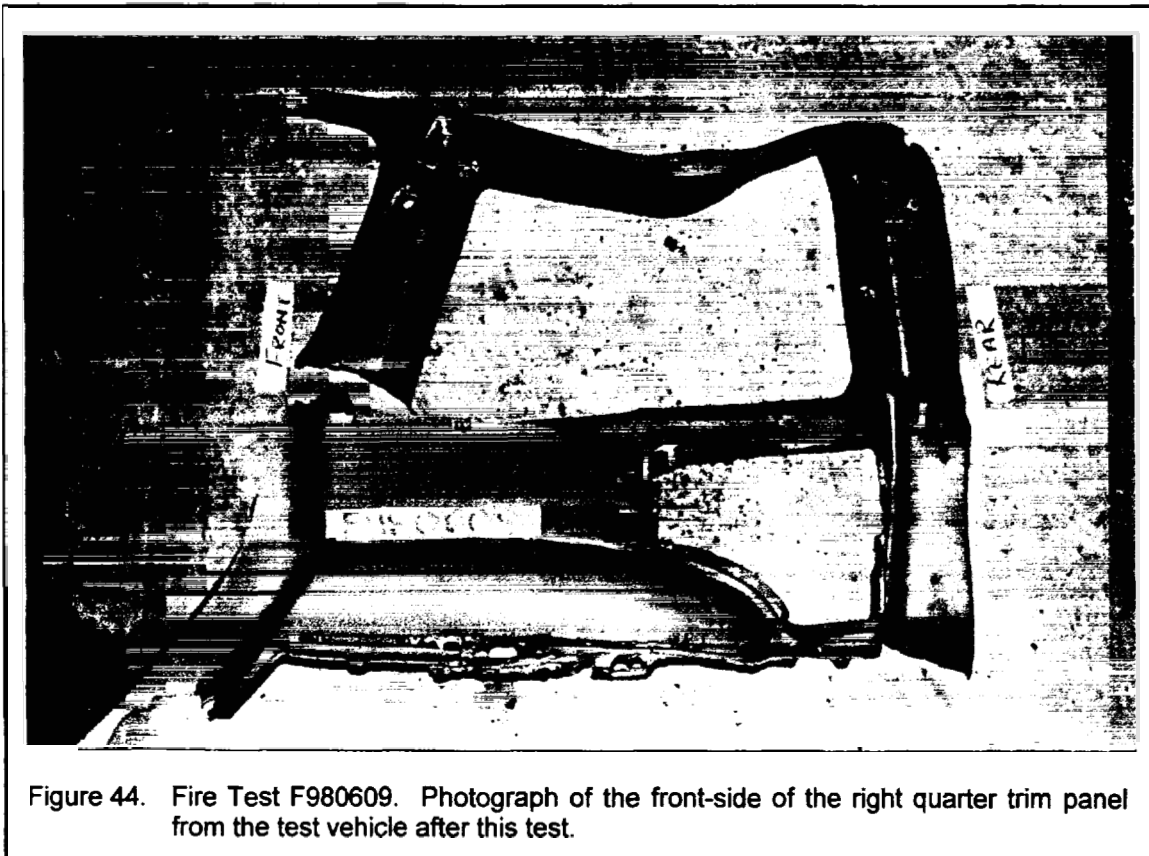
the right quarter trim panel contained deposits of soot on the sections covering of the C- and D-pillars and the header and sill of the glass opening (Fig. 44). There was no evidence of burning or charring on the outer surfaces of the trim panel, indicating that flames did burn through the right quarter trim panel during this test. Although the video and thermocouple data acquired during this test indicate that flames spread into the space behind the right quarter trim panel through a seam opening between the rear compartment floor panel and right quarter panel, this does not appear to account for the fire plume visible in the lower right glass opening in the liftgate at the end of this test.

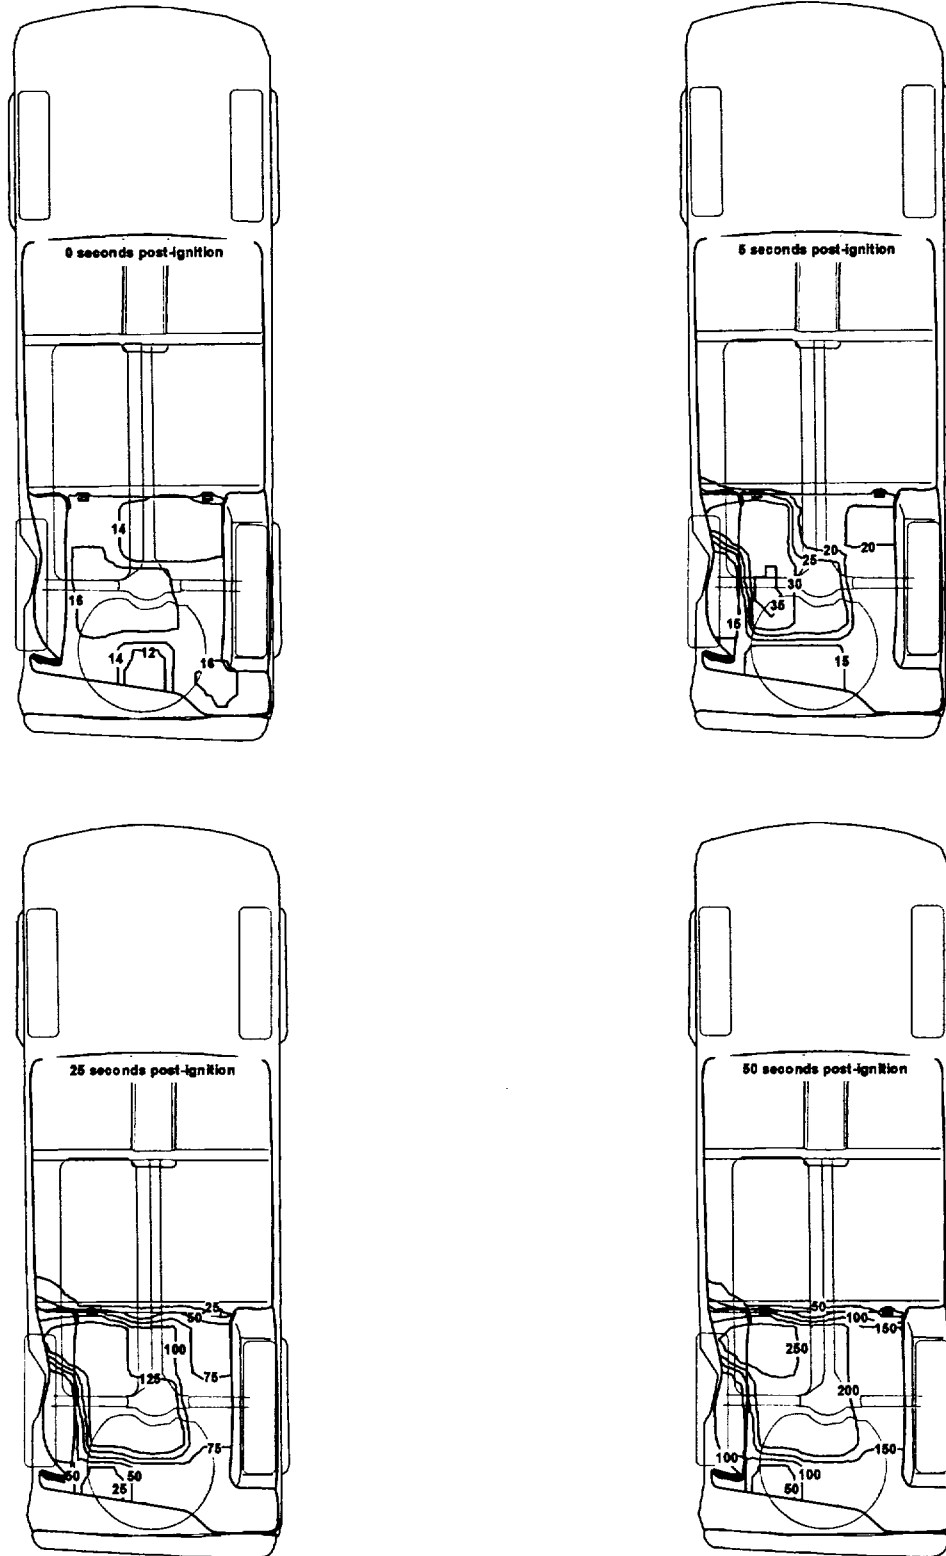
Figure 47 shows a series of diagrams of the test vehicle with the isothermal contours of the estimated floor panel temperature at 0, 5, 25, 50, 75, 100, 120, 125, 150, 170, and 175 seconds post-ignition.¹¹ This analysis indicated that the temperature of the floor panel started to increase by 5 seconds post-ignition (Fig. 47). The temperature of the rear compartment floor panel was not uniform either before ignition or during this test. Estimated temperatures were highest in an area extending from the "kick-up" at the front of the rear compartment to a line intersecting the center of the spare tire toward the rear of the rear compartment, and from the rear left wheelhouse to a line parallel to and right of the longitudinal center-line of the test vehicle (Fig. 46). This area corresponded approximately to the area where estimated temperatures were greatest below the rear compartment floor panel (Fig.25). The maximum estimated floor panel temperature was >500 °C at 175 seconds post-ignition (Fig. 47).

Figure 47. Fire Test F980609. Diagrams showing isothermal contour plots of estimated temperature of the rear compartment floor panel at 0, 5, 25, 50, 75, 100, 125, 150, 170 and 175 seconds post-ignition.

The charred area of the carpet pad was over the section of the floor panel with estimated temperatures $>400^{\circ}\text{C}$ (Fig. 47).

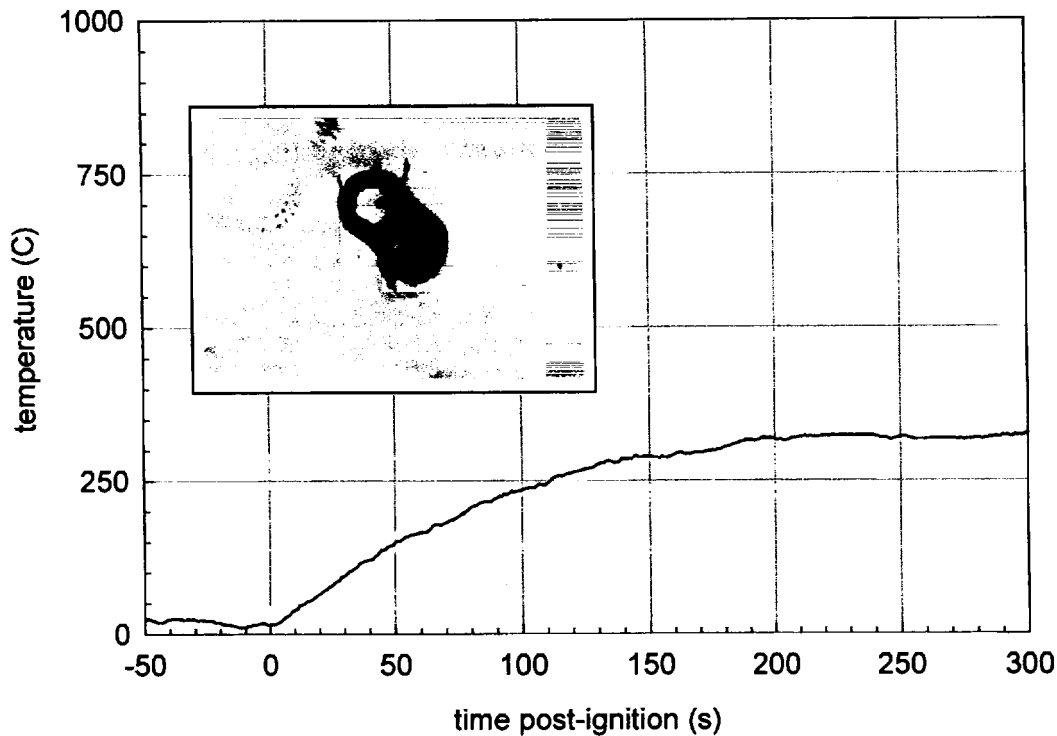
Figure 49. Fire Test F989698. Plot of data recorded from Thermocouple FP1. The insert is a photograph of the drain hole plug from the rear section of the rear compartment floor panel. Thermocouple FP1 was located on a section of the drain hole plug that did not burn through during this test.

It was not possible to determine if the two holes in this area and soot deposits on the carpet backing along the front of the rear compartment were caused by heated gases and flames flowing through the drain hole in the front section of the rear compartment floor panel and the clearance hole drilled in the floor panel for the heat flux transducer or by contact with the heated floor panel. The thermocouple on the drain plug in the rear section of the rear compartment floor panel was on a section of the plug that did not burn through during this test. Thus, the temperature data plotted in Figure 49 are a measure of the temperature of the upper surface of this plug, and cannot be used to determine if heated gases and flames flowed through the drain hole in the rear section of the floor panel during this test. The areas where the carpet pad (Fig. 48) in the rear compartment were burned and charred, and where the floor carpet was burned and contained deposits of soot (Fig. 50) coincided with the area where the estimated temperature of the floor panel was greater than 400°C (Fig. 47). The plug in the drain hole in the front section of the floor panel had burned through during this test. Without thermocouple data, it was not possible to determine if heated gases or flames flowed through this drain hole during test.

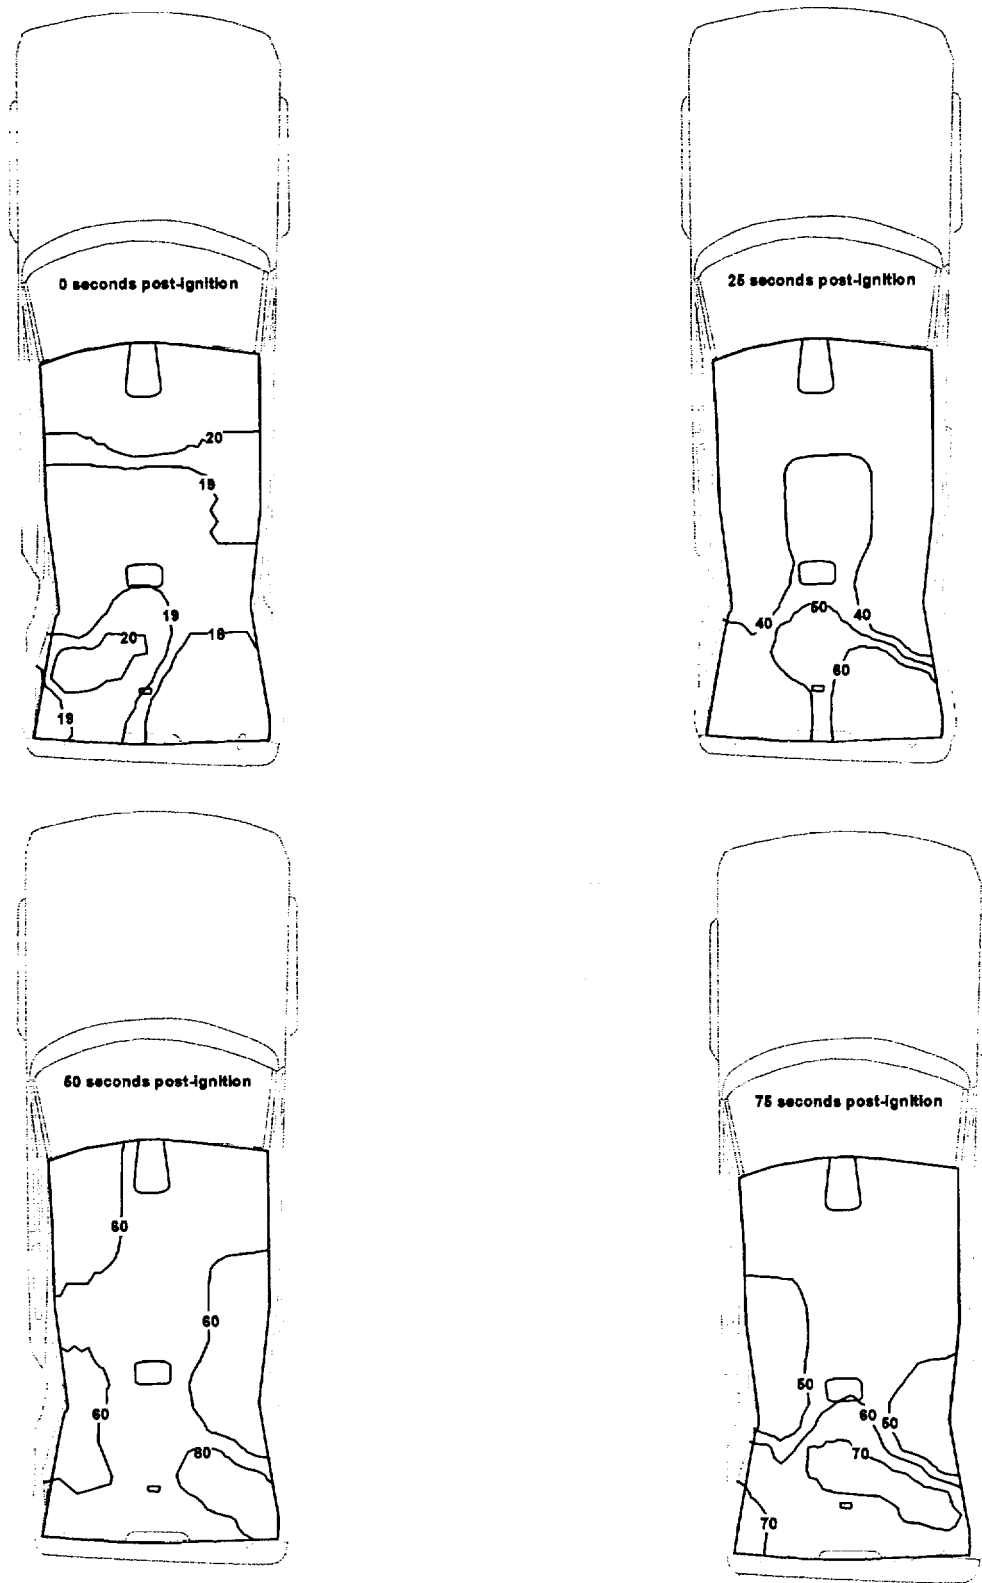
Flames were first observed in the space above the left rear wheel house starting at about 125 seconds post-ignition (Fig. 29) – about the time the spare tire blew out. Estimated temperatures along the roof trim panel above this area were $>250^{\circ}\text{C}$ by 125 seconds post-ignition (Fig. 51). The estimated isothermal contour plots indicate that flames first contacted the roof trim panel in the rear left corner of the rear compartment between 150 and 157 seconds post-ignition (Fig. 51). This is consistent with the apparent height of the fire plume visible in the video stills and the apparent temperatures in the infrared thermograms in Figures 30 and 31. The estimated isothermal contour plots indicate that flames spread along the roof trim panel to the right side of the rear compartment and forward to above the rear seats between 157 and 170 seconds post-ignition (Fig. 51).

Figure 51. Fire Test F980609. Diagrams showing isothermal contour plots of estimated temperature of the rear compartment floor panel at 0, 5, 25, 50, 75, 100, 125, 150, 170, and 175 seconds post-ignition.

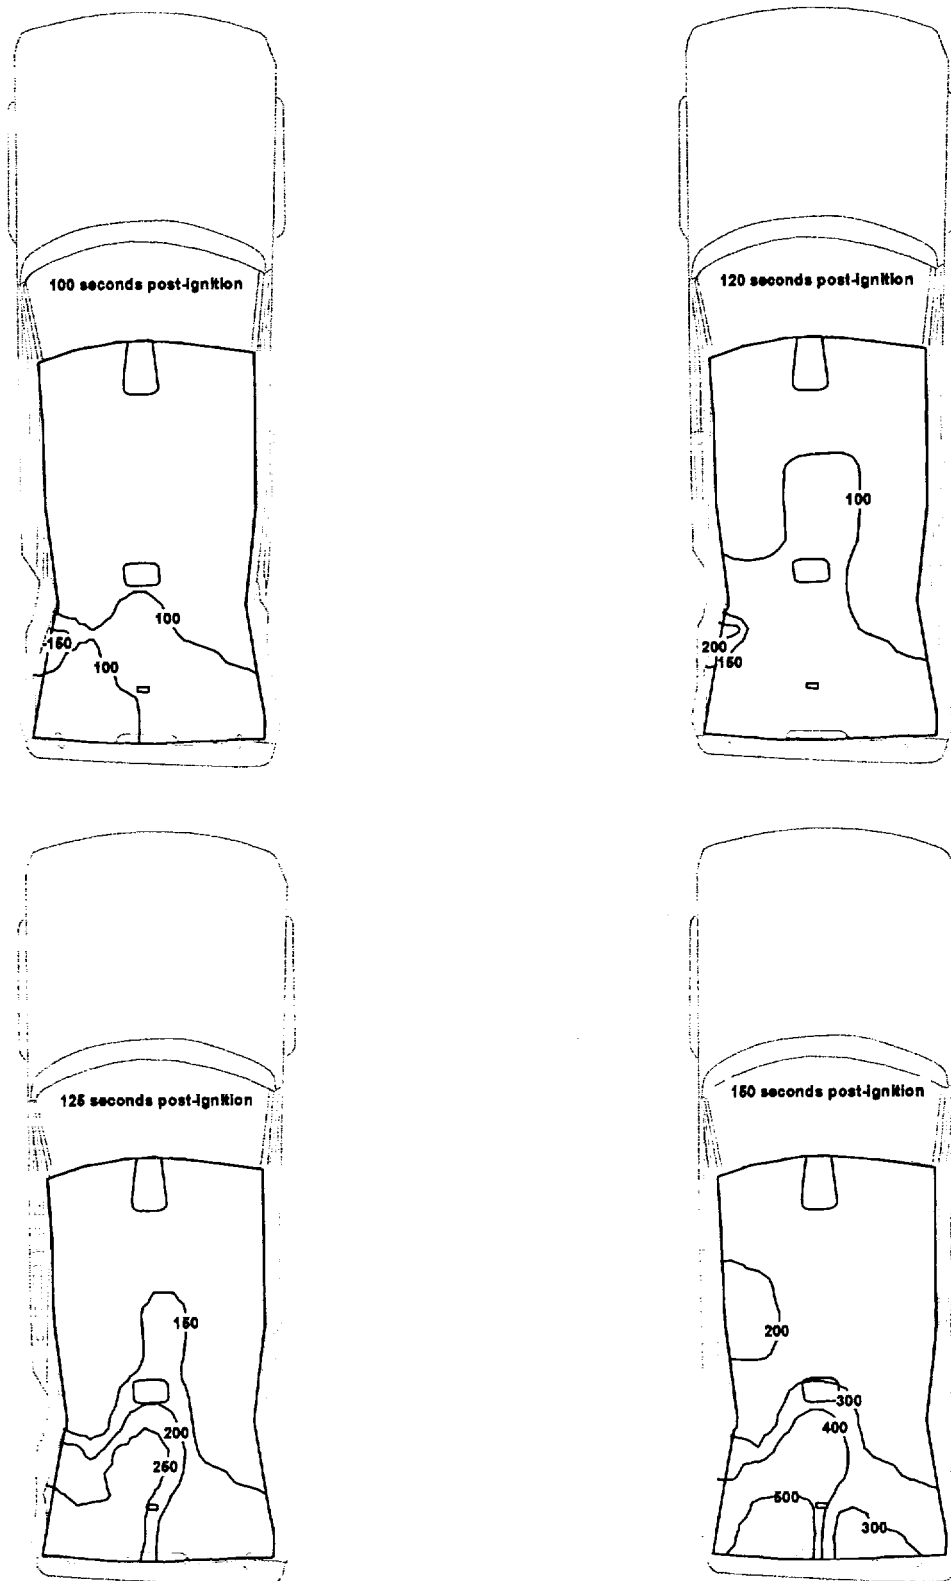
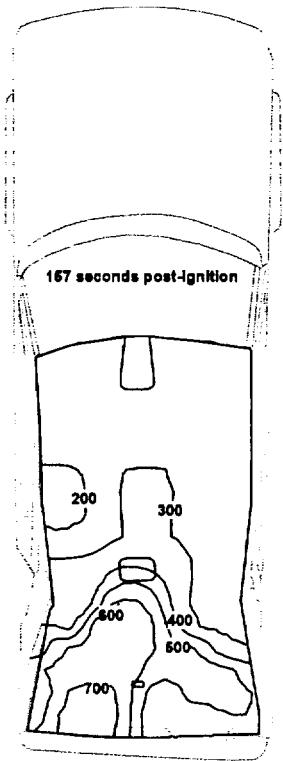
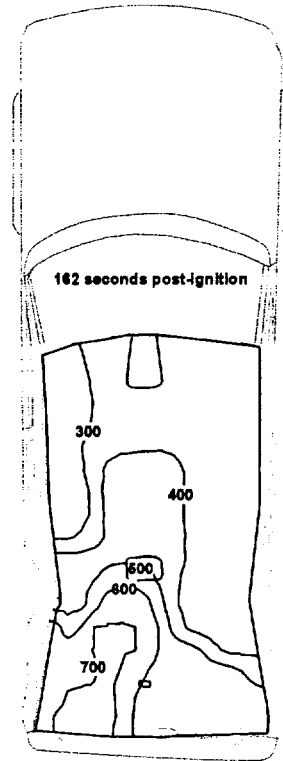
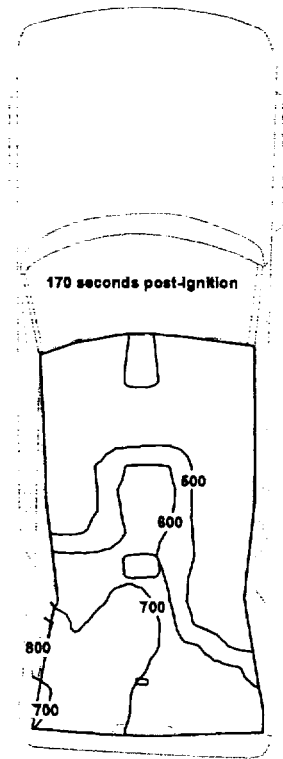
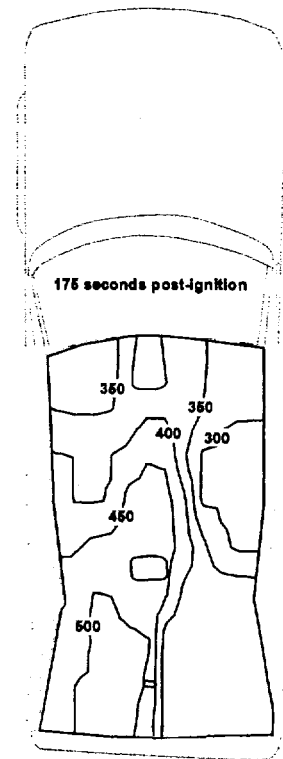
The pattern of thermal damage observed on the roof trim panel after this test was consistent with extent of flame-spread inferred from the estimated isothermal contour plots. The fabric covering on the lower surface of the roof trim panel was burned and charred (Fig. 52) in areas where the maximum estimated temperature was greater than about 500°C (Fig. 51). The extent of charring appeared to correlate with the estimated temperature. For example, areas where the $t_{\text{estimated}} > 700^{\circ}\text{C}$ were more extensively charred than areas where $500^{\circ}\text{C} < t_{\text{estimated}} < 600^{\circ}\text{C}$.

Figure 51, continued. Fire Test F980609. Diagrams showing isothermal contour plots of estimated temperature of the rear compartment floor panel at 0, 5, 25, 50, 75, 100, 125, 150, 170, and 175 seconds post-ignition.

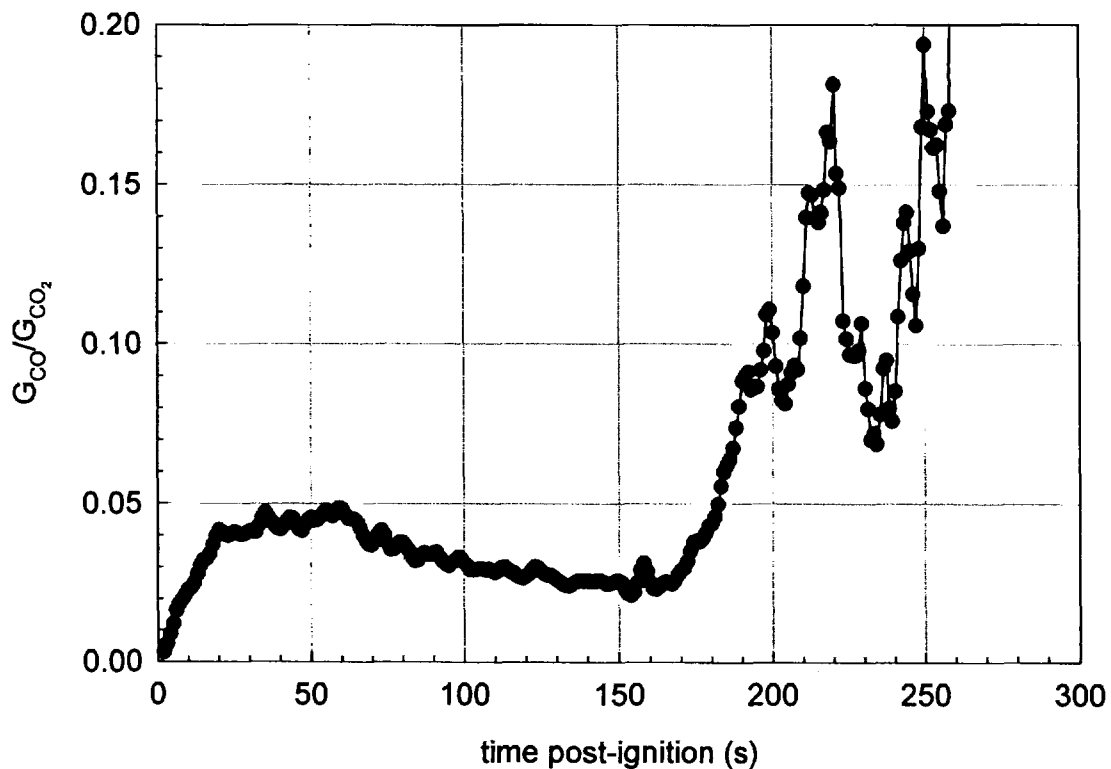
Analysis of the data from the Fire Products Collector suggested that production of carbon monoxide relative to carbon dioxide was greater than expected for well-ventilated combustion of gasoline and of materials similar to those used in the test vehicle. Figure 53 shows a plot of $[G_{\text{CO}}]/[G_{\text{CO}_2}]$ versus time post-ignition, where G_{CO} and G_{CO_2} are the carbon monoxide- and carbon dioxide-release rates measured using the Fire Products Collector (APPENDIX G).

Figure 53. Fire Test F980609. Plot of $[G_{\text{CO}}]/[G_{\text{CO}_2}]$ versus time post-ignition determined from the carbon monoxide- and carbon dioxide-release rate data from the Fire Products Collector.

The value of $[G_{CO}]/[G_{CO_2}]$ started to increase at the time of ignition, asymptotically approached 0.05 at 60 seconds post-ignition (Fig. 53). One possible explanation for the behavior of $[G_{CO}]/[G_{CO_2}]$ observed during the first 60 seconds of this test is that airflow into the restricted space below the test vehicle was insufficient for stoichiometric combustion as the vaporization rate of gasoline from the liquid pool increased. Gasoline was the only fuel burning at ignition, and the predominant fuel for the fire during at this time. Values of $[G_{CO}]/[G_{CO_2}] \leq 0.014$, observed for the first few seconds after ignition (Fig. 53), indicate that the fire was well-ventilated. As radiation from the burning gasoline vapor heated the surface of the gasoline pool, the vaporization rate of hydrocarbons from the liquid gasoline increased, which resulted in an increasing heat release rate (APPENDIX G, Plot G1). Oxygen in the air flowing into the space under the vehicle would have been consumed at an increasing rate. If the airflow into the space under the test vehicle was not sufficient to accommodate this increasing oxygen consumption by the fire, then the efficiency of combustion would have decreased as observed in Figure 53.

At about 60 seconds post-ignition, the value of $[G_{CO}]/[G_{CO_2}]$ started to decrease, approaching a value of 0.02 between 165 and 170 seconds post-ignition – the time the test was ended and fire suppression began (Fig. 53). The heat release rate measured with the Fire Products Collector at the test facility increased from 0 to 450 – 500 kW from the time of ignition through about 30 seconds post-ignition, and remained approximately constant between 30 and 60 seconds post-ignition (APPENDIX G, Plot G1). The flow rate of gasoline from the outlet of the gasoline delivery system remained constant throughout this test and heat release rate from the burning gasoline appeared to have reached a steady-state at this time. The increase in heat release rate measured by the Fire Products Collector starting at about 60 seconds indicated that other combustible materials such as the tires started to ignite at this time. One consequence of flame-spread to these other materials was that a significant portion of the growing fire plume extended out from the restricted space below the test vehicle. This may have allowed higher buoyant flow and greater air entrainment into the flames extending away from the vehicle, resulting in an increase in the overall combustion efficiency after 60 seconds post-ignition. A correlation between heat output and ventilation has been demonstrated in laboratory experiments during combustion for a number of solid materials similar to the materials used in the test vehicle [7].

The value of $[G_{CO}]/[G_{CO_2}]$ started to increase when fire suppression began between 170 and 175 seconds post-ignition, indicating that the overall combustion efficiency decreased as the flames were extinguished. Although flames were visibly suppressed relatively quickly, many materials in the test vehicle continued to produce smoke. Continued thermal decomposition of these materials after the flames were visibly extinguished would have increased the production of partially oxidized and unoxidized gases relative to carbon dioxide, resulting in increasing values of $[G_{CO}]/[G_{CO_2}]$.

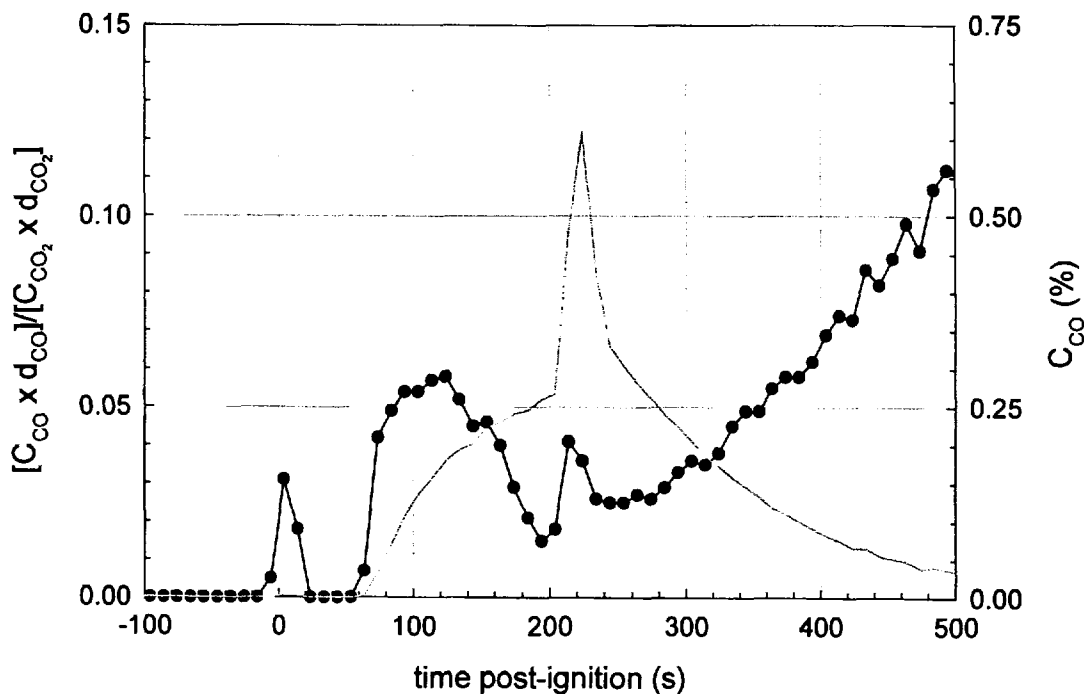
A similar analysis was performed using gas concentration data from the passenger compartment (APPENDIX H). This data was used to calculate values for $[C_{CO} \times d_{CO}]/[C_{CO_2} \times d_{CO_2}]$ and $[C_{HC} \times d_{HC}]/[C_{CO_2} \times d_{CO_2}]$ (Fig.'s 54 and 55).

Figure 54. Fire Test F980609. Plots of $[C_{CO} \times d_{CO}]/[C_{CO_2} \times d_{CO_2}]$ (—●—, left axis) and the concentration of carbon monoxide (—, right axis) in the passenger compartment.

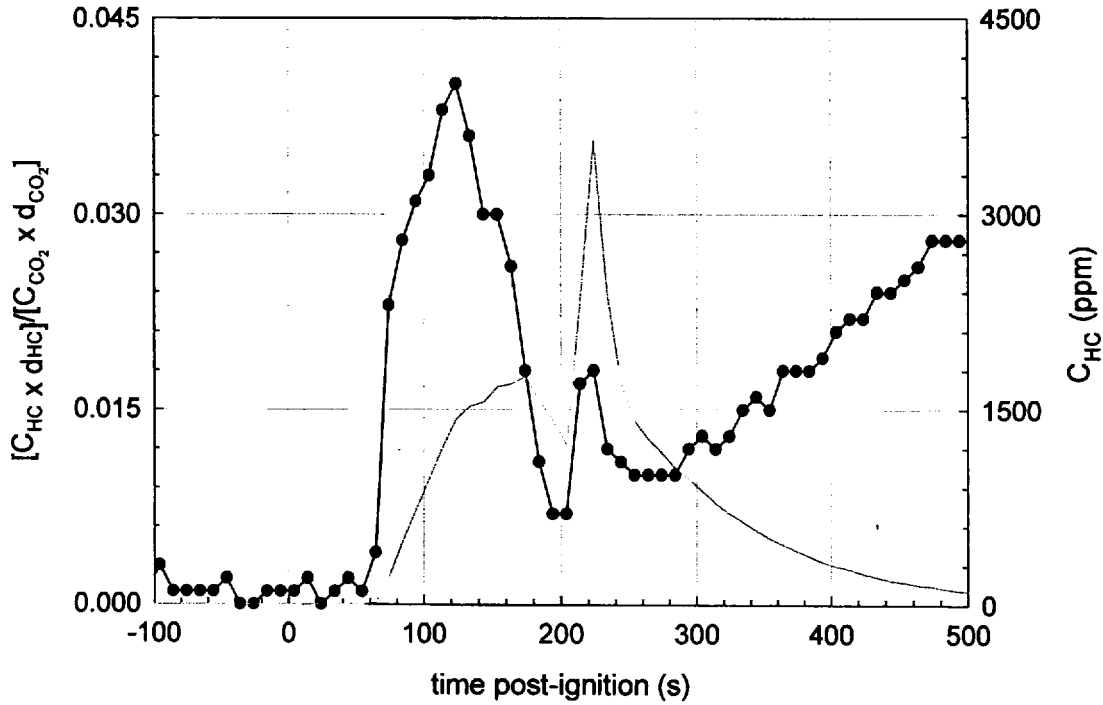
Figure 55. Fire Test F980609. Plots of $[C_{HC} \times d_{HC}]/[C_{CO_2} \times d_{CO_2}]$ (—●—, left axis) and the concentration of total hydrocarbons (—, right axis) in the passenger compartment.
