**Evaluation of Motor Vehicle Fire Initiation and Propagation
Part 9: Propagation of a Rear-Underbody Gasoline Pool Fire in a
1998 Sport Utility Vehicle**

Jeffrey Santrock
General Motors Corporation

ABSTRACT

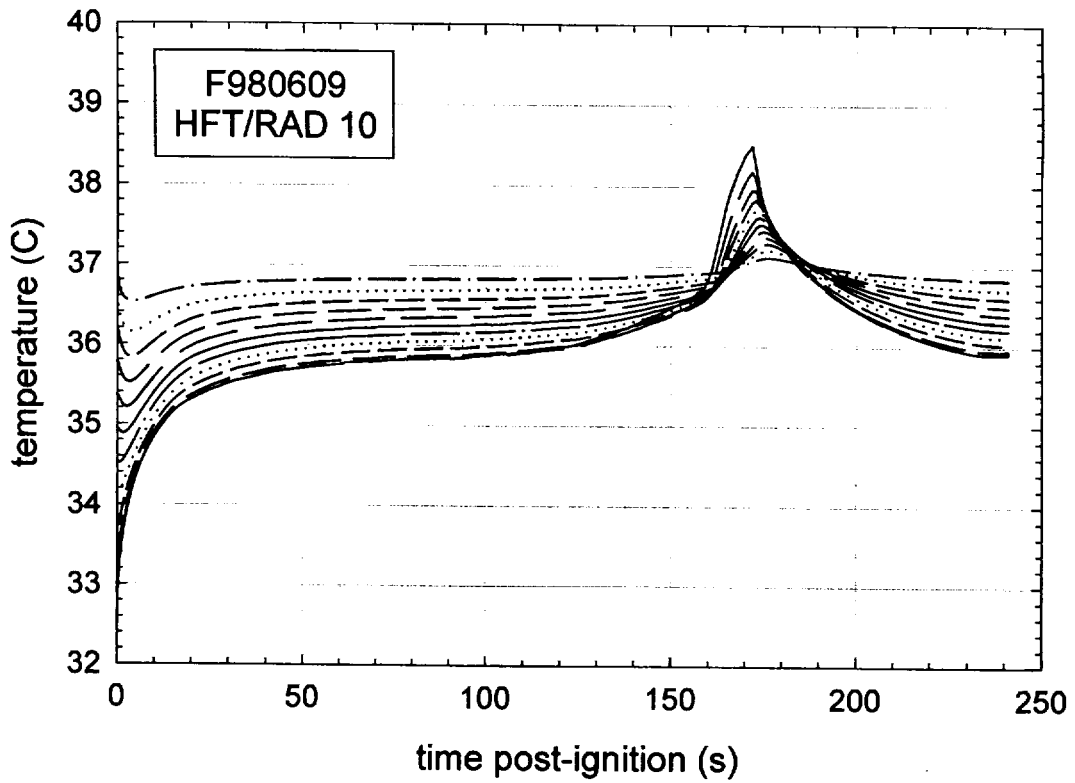
Figure 56. Fire Test F980609. Skin temperature profiles estimated from heat flux data recorded from HFT/RAD Assembly 10 (APPENDIX E, Plots E3 and E4).

The heat flux to HFT/RAD 10 increased as heated gases and flames spread forward along the head lining panel. A total heat flux of approximately 1.5 kW/m^2 and a radiative heat flux of approximately 1 kW/m^2 were recorded from HFT/RAD 10 between 165 and 170 seconds post-ignition (Appendix E, Plots E3 and E4). The estimated temperature along the headlining panel above the front passenger's seat at this time was between 400 and 500°C (Fig. 51). This heat flux data indicated that radiation from the heated gases along the headlining panel accounted for approximately $2/3$ of the heat transferred to the transducer at this time. Convection from the heated gases surrounding this transducer accounted for the remaining $1/3$ of the heat transferred to the transducer. The skin temperatures at the epidermal surface and sub-dermal interface estimated from this heat flux data were approximately 38.4 and 37.0°C , respectively, at 170 seconds post-ignition (Fig. 56).

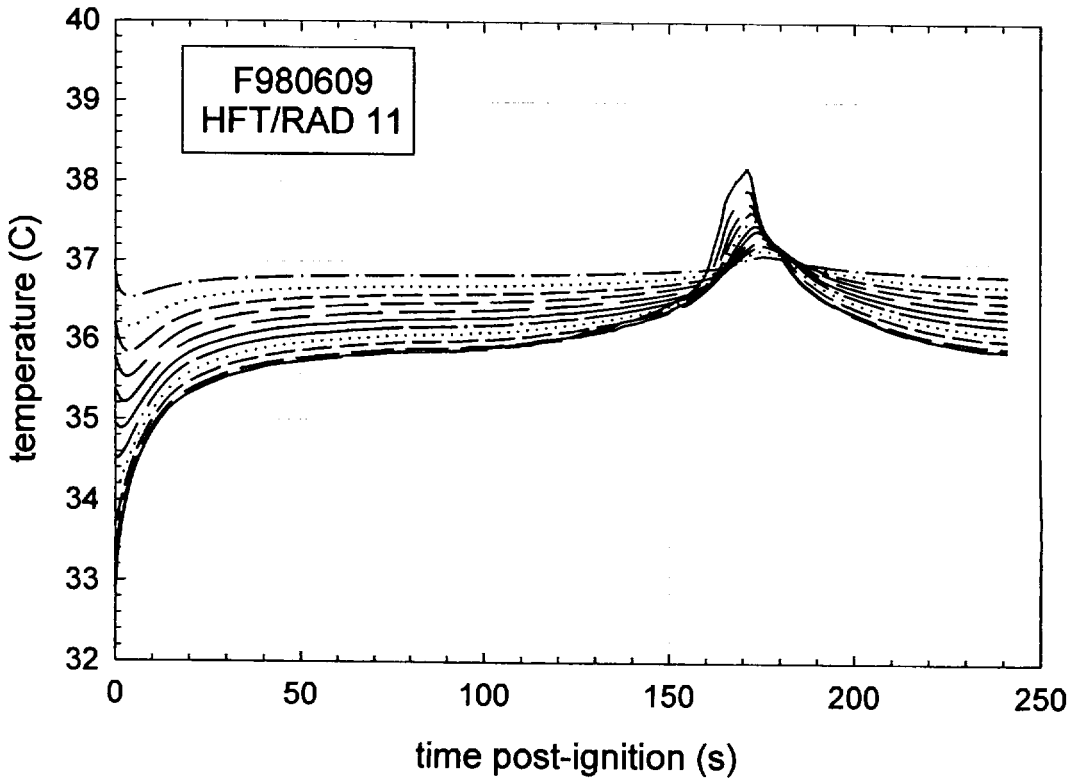
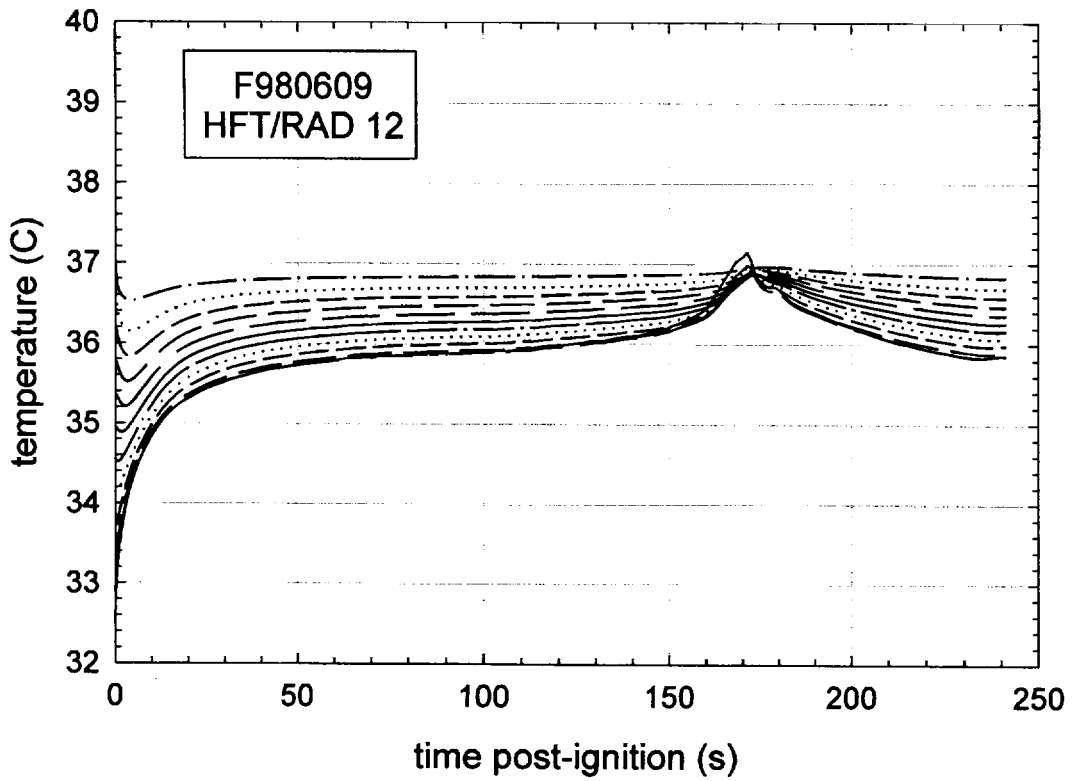
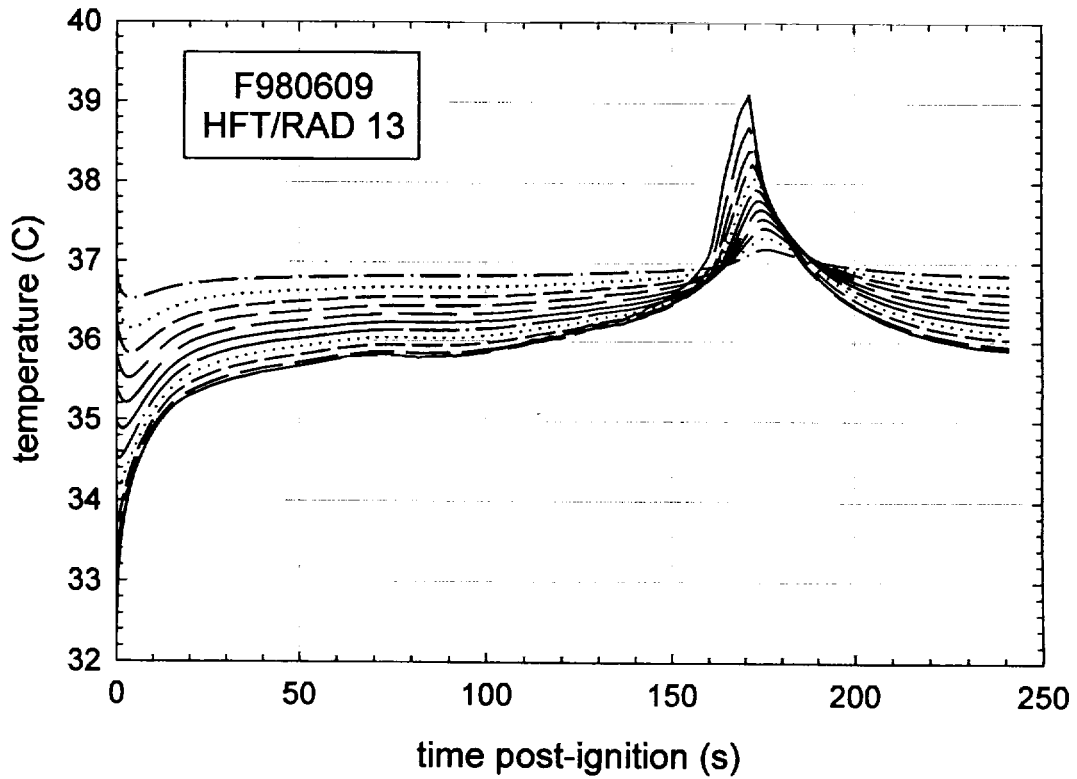
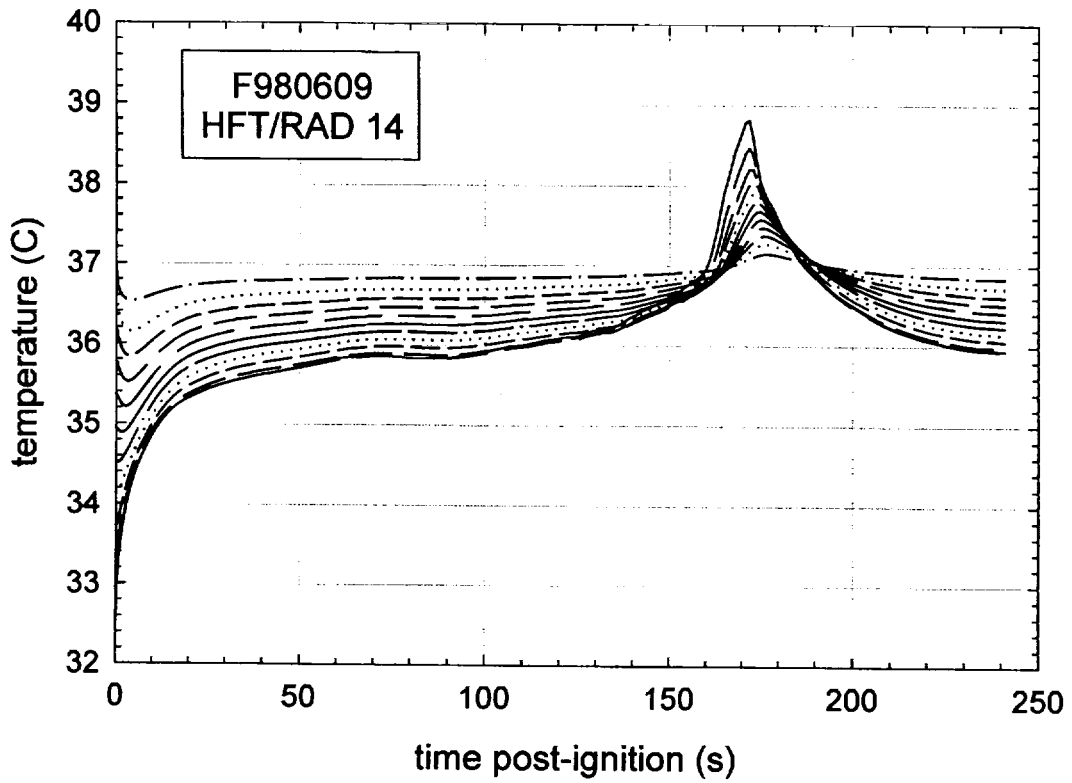
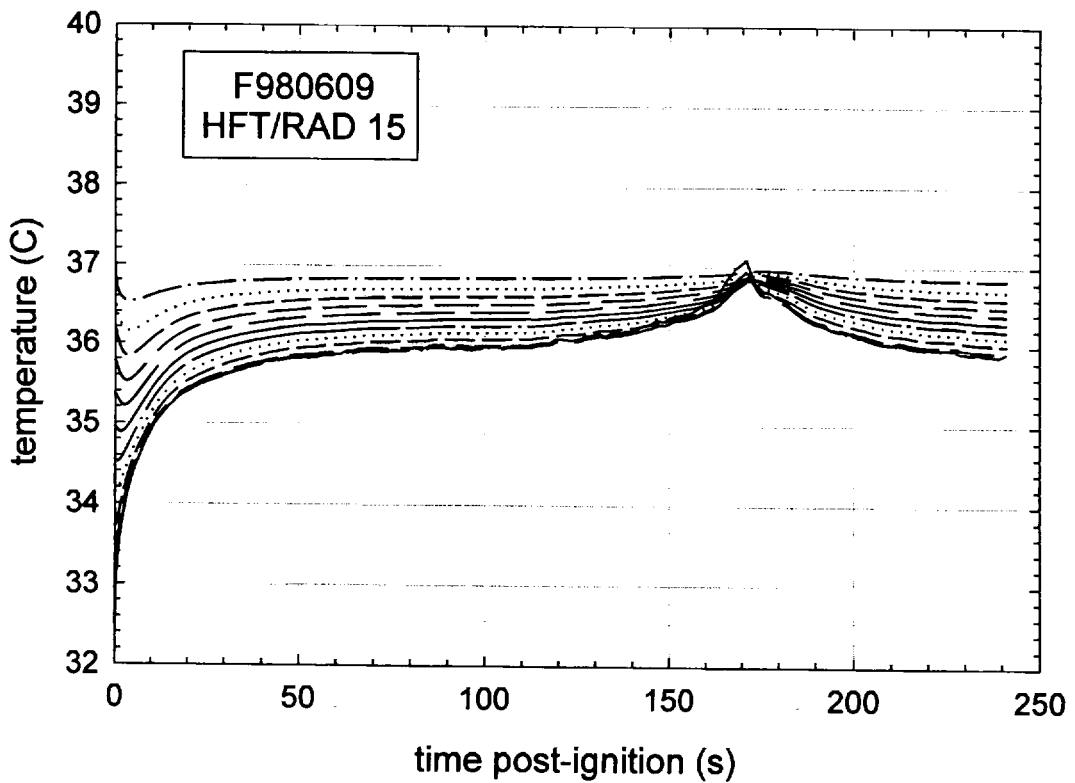
Each of the estimated skin temperature profiles in Figures 56 through 61 contain a single peak at approximately 170 seconds post-ignition. The total and radiative heat fluxes recorded from HFT/RAD 10 through HFT/RAD 15 increased as a section of the left quarter trim panel had ignited, and flames and heated gases spread forward along the lower surface of the head lining panel, and decreased as flames in the rear compartment and along the head lining panel were extinguished. HFT/RAD 10 through HFT/RAD 15 were located above the driver's and front passenger's seats in areas that were not exposed to flames during this test. These transducers

Figure 57. Fire Test F980609. Skin temperature profiles estimated from data recorded from HFT/RAD Assembly 11 (APPENDIX E, Plots E5 and E6).

Figure 58. Fire Test F980609. Skin temperature profiles estimated from data recorded from HFT/RAD Assembly 12 (APPENDIX E, Plots E7 and E8).

Figure 59. Fire Test F980609. Skin temperature profiles estimated from data recorded from HFT/RAD Assembly 13 (APPENDIX E, Plots E9 and E10).

Figure 60. Fire Test F980609. Skin temperature profiles estimated from data recorded from HFT/RAD Assembly 14 (APPENDIX E, Plots E11 and E12).

Figure 61. Fire Test F980609. Skin temperature profiles estimated from data recorded from HFT/RAD Assembly 15 (APPENDIX E, Plots E13 and E14).

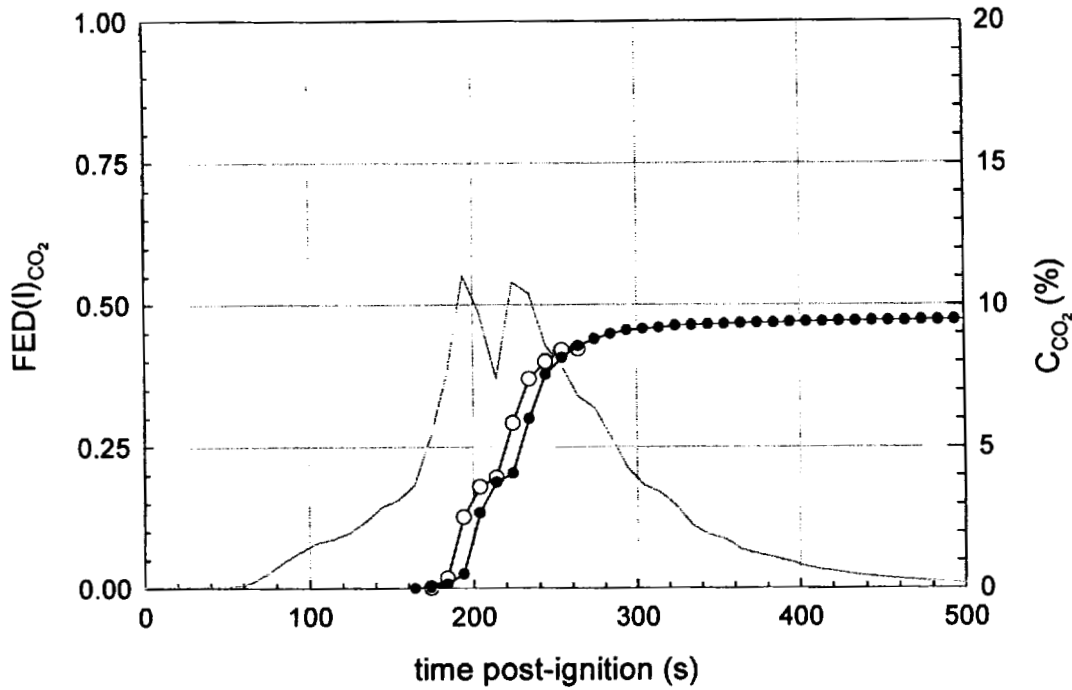
Plots of the $FED(I)_{CO_2}$ parameters estimated using the FAA Combined Hazard Model and Purser's model are shown in Figure 62. Both models yielded estimates of $FED(I)_{TOTAL} > 0$ starting at about 170 seconds post-ignition, when the concentration of carbon dioxide was about 5%. Both models yielded estimates of $FED(I)_{CO_2} < 0.5$ through 500 seconds post-ignition.

Figure 62. Fire Test F980609. Plots of $FED(I)_{CO_2}$ versus time post-ignition: FAA Combined Hazard Survival Model ($-O-$); and Purser's model ($-●-$). A plot of C_{CO_2} ($-$) is included for reference.

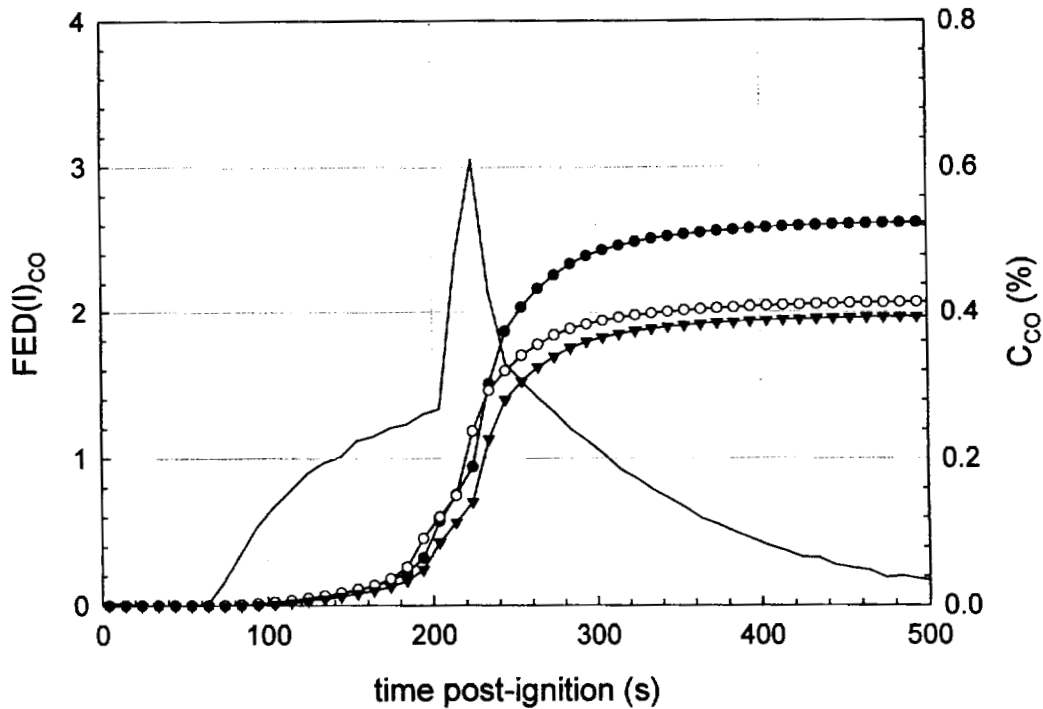
Plots of the $FED(I)_{CO}$ parameters estimated using both models are shown in Figure 63. The equations presented in the Purser model for computation of $FED(I)_{CO}$ include a term for respiratory minute volume. Minute volumes corresponding to respiration during rest (8.5 L/min) and light activity (25 L/min) were used in these calculations [9]. Purser's model also accounts for the effect of exposure to carbon dioxide on respiratory rate.

Figure 63. Fire Test F980609. Plots of estimates of $FED(I)_{CO}$ versus time post-ignition computed using the FAA Combined Hazard Survival Model ($-O-$), the Purser model with a respiratory minute volume of 8.5 L/min ($-▼-$), and the Purser model with a respiratory minute volume of 25 L/min ($-●-$). A plot of C_{CO} ($-$) is included for reference.

The FAA Combined Survival Hazard Model computes only one estimate of $FED(I)_{\infty}$, which accounts for the effect of exposure to carbon dioxide on respiratory rate [8]. These three estimates of $FED(I)_{\infty}$ became greater than zero between 70 and 80 seconds post-ignition. The estimates of $FED(I)_{\infty}$ derived using the FAA model and Purser's model with a respiratory minute volume of 25 L/min became greater than 1 between 220 and 230 seconds post-ignition, and reached values of about 2.1 and 2.6, respectively, at 500 seconds post-ignition. The estimate of $FED(I)_{\infty}$ derived using Purser's model with a respiratory minute volume of 8.5 L/min became greater than 1 between 230 and 240 seconds post-ignition, and reached a value of approximately 2.0 at 500 seconds post-ignition.

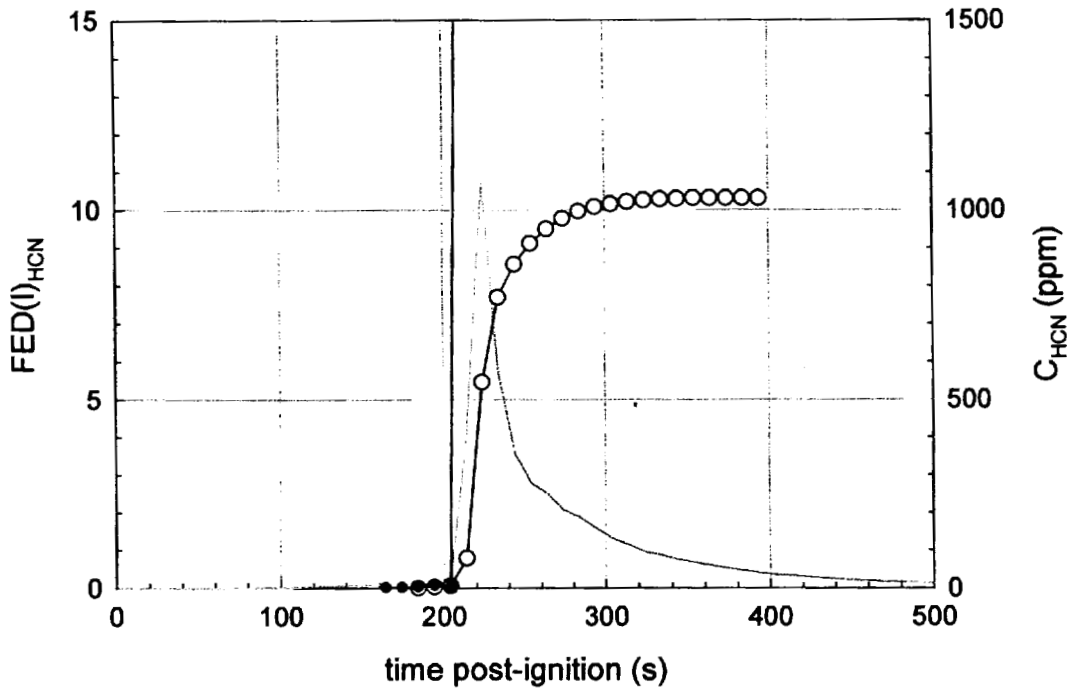
Plots of the $FED(I)_{HCN}$ parameters estimated using both models are shown in Figure 64. Both the FAA Combined Survival Hazard Model and Purser's model employ a threshold concentration to determine when to start computing $FED(I)_{HCN}$ (refer to equations 6 and 14, respectively). The estimates of $FED(I)_{HCN}$ using the FAA model started at 174 seconds post-ignition, became greater than 1 between 215 and 220 seconds post-ignition, and reached a maximum value of about 10.3 by 400 seconds post-ignition. The estimates of $FED(I)_{HCN}$ using Purser's model started at 204 seconds post-ignition, and became greater than 1 between 210 and 220 seconds post-ignition.

Figure 64. Fire Test F980609. Plots of $FED(I)_{HCN}$ versus time post-ignition: FAA Combined Hazard Survival Model (\circ); and Purser's model (\bullet). A plot of C_{HCN} (—) is included for reference.

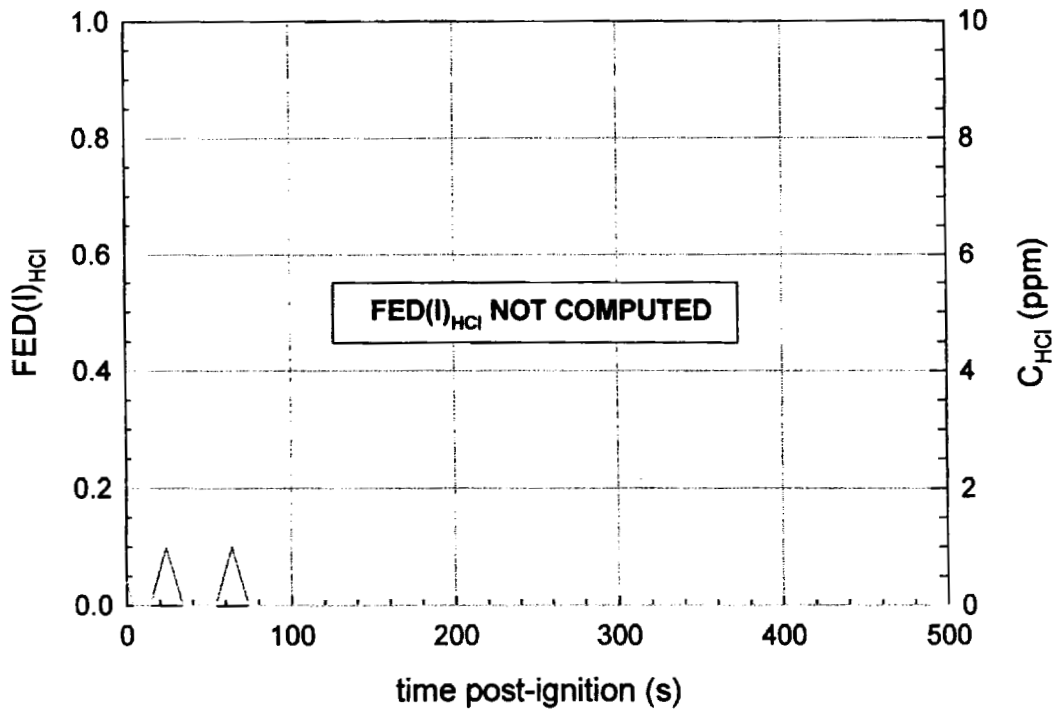
The concentration of hydrogen chloride in the passenger compartment was less than the threshold for computation of $FED(I)$ and $FED(L)$. Therefore, $FED(I)_{HCL}$ was not computed (Fig. 65).

Figure 65. Fire Test F980609. Plots of $FED(I)_{HCl}$ versus time post-ignition: FAA Combined Hazard Survival Model (\circ); and Purser's model (\bullet). A plot of C_{HCl} (—) is included for reference.

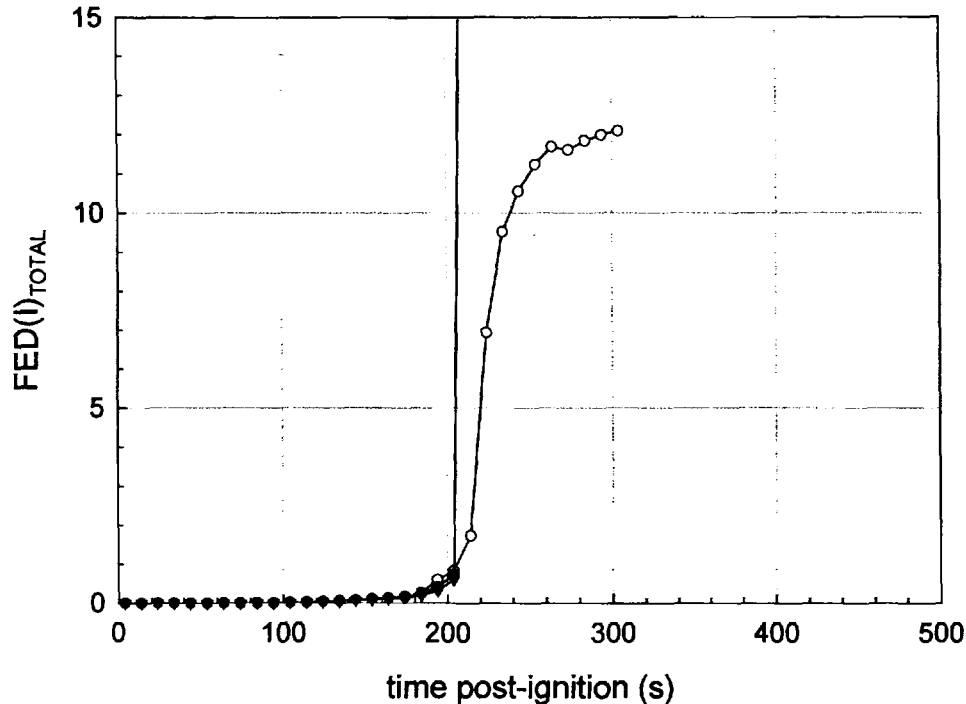
Plots of the $FED(I)_{TOTAL}$ parameters estimated using both models are shown in Figure 66. The FAA Combined Survival Hazard Model yielded $FED(I)_{TOTAL} > 1$ starting at about 210 seconds post-ignition, where $FED(I)_{CO}$ accounted for 43% of $FED(I)_{TOTAL}$, $FED(I)_{HCN}$ accounted for 46% of $FED(I)_{TOTAL}$, and $FED(I)_{CO2}$ accounted for 11% of $FED(I)_{TOTAL}$. The estimated $FED(I)_{TOTAL}$ reached a value of 12.1 at 300 seconds post-ignition.

Purser's model yielded $FED(I)_{TOTAL} > 1$ starting at about 210 seconds post-ignition using respiratory minute volumes of 8.5 L/min and 25 L/min in the calculations. With a respiratory minute volume of 8.5 L/min, $FED(I)_{CO}$ accounted for 1.5% of $FED(I)_{TOTAL}$, $FED(I)_{HCN}$ accounted for 98% of $FED(I)_{TOTAL}$ and $FED(I)_{CO2}$ accounted for 0.5% of $FED(I)_{TOTAL}$. With a respiratory minute volume of 25 L/min, $FED(I)_{CO}$ accounted for 2% of $FED(I)_{TOTAL}$, $FED(I)_{HCN}$ accounted for 97.5% of $FED(I)_{TOTAL}$ and $FED(I)_{CO2}$ accounted for 0.5% of $FED(I)_{TOTAL}$.

Figure 66. Fire Test F980609. Plots of $FED(I)_{TOTAL}$ versus time post-ignition: FAA Combined Hazard Survival Model (\circ); Purser's model with $RMV = 8.5$ L/min (\blacktriangledown); and Purser's model with $RMV = 25$ L/min (\bullet).

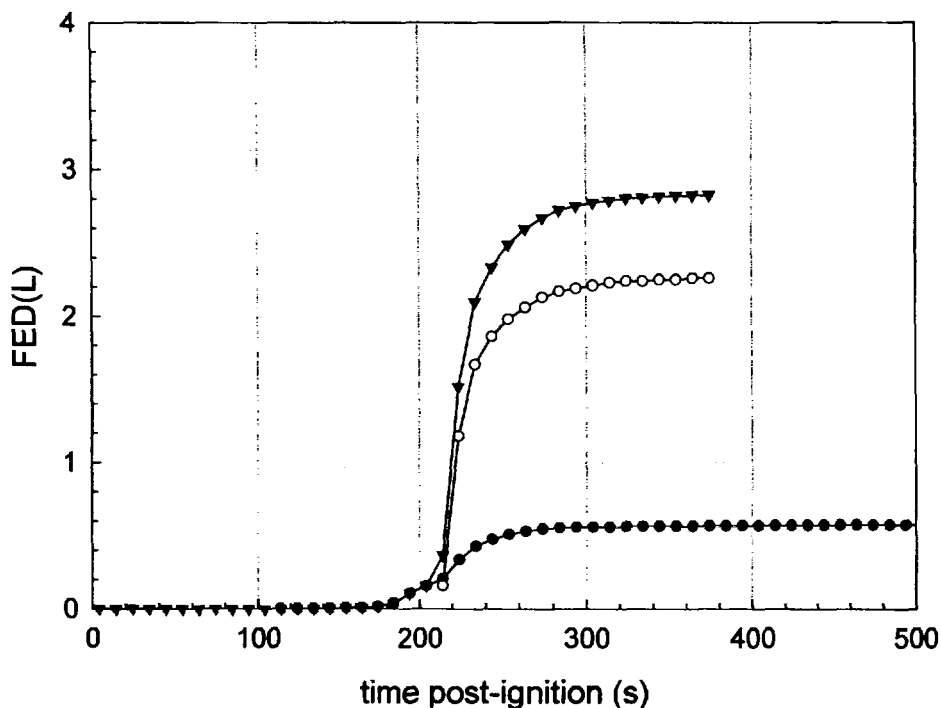
Figure 67 shows plots of $FED(L)_{CO}$, $FED(L)_{HCN}$, and $FED(L)_{TOTAL}$ computed using the FAA Combined Survival Hazard Model. These calculations yielded $FED(L)_{CO} < 1$ at all times during this test, $FED(L)_{HCN} > 1$ and $FED(L)_{TOTAL} > 1$ starting at about 220 seconds post-ignition.

Figure 67. Fire Test F980609. Plots of $FED(L)_{CO}$ (—●—), $FED(L)_{HCN}$ (—○—), and $FED(L)_{TOTAL}$ (—▲—) versus time post-ignition computed using the FAA Combined Hazard Survival Model Fire.

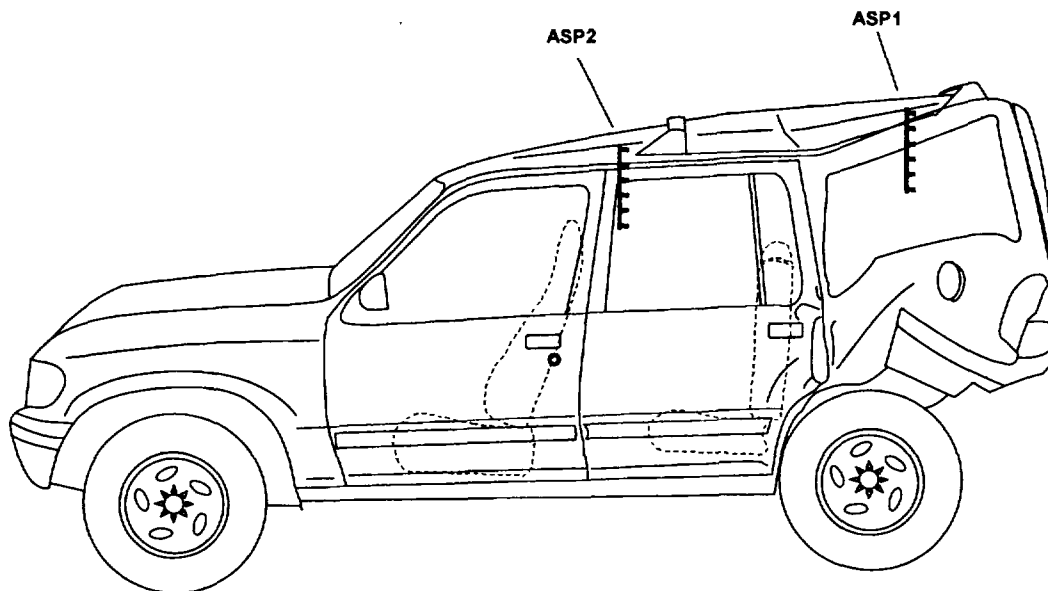
Figure D2. Fire Test F980609. Side view of the test vehicle showing the approximate location of the aspirated thermocouple probe assembly in the passenger compartment.

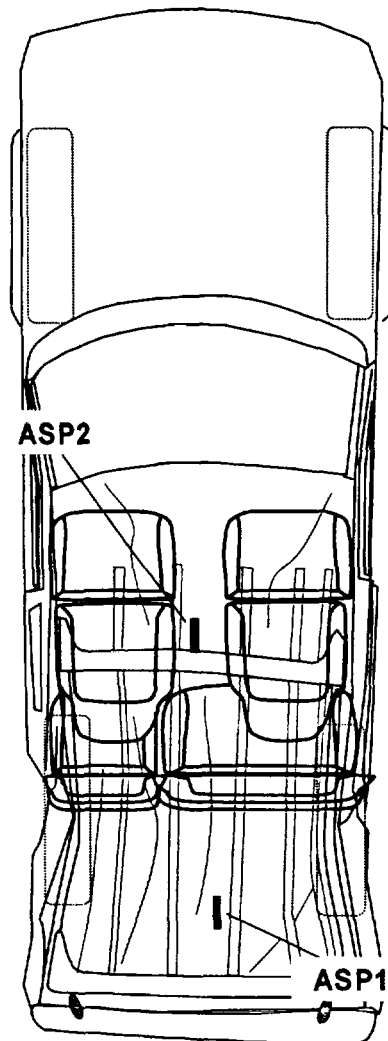
Electromagnetic interference of unknown origin could not be eliminated from the signals from the aspirated thermocouples. This interference rendered the temperature data from these thermocouples invalid. This electronic noise also feed-back through the grounds of the non-aspirated thermocouples installed in the test vehicle, thus rendering temperature data from the non-aspirated thermocouples invalid. The interference in the signals from the non-aspirated thermocouples was eliminated when the aspirated thermocouples were disconnected from the data system. This test was conducted with the aspirated thermocouples disconnected from the data system. Thus, no data was recorded from the aspirated thermocouples.

Figure D3. Fire Test F980609. Top view of the test vehicle showing the approximate location of the aspirated thermocouple probe assembly in the passenger compartment.

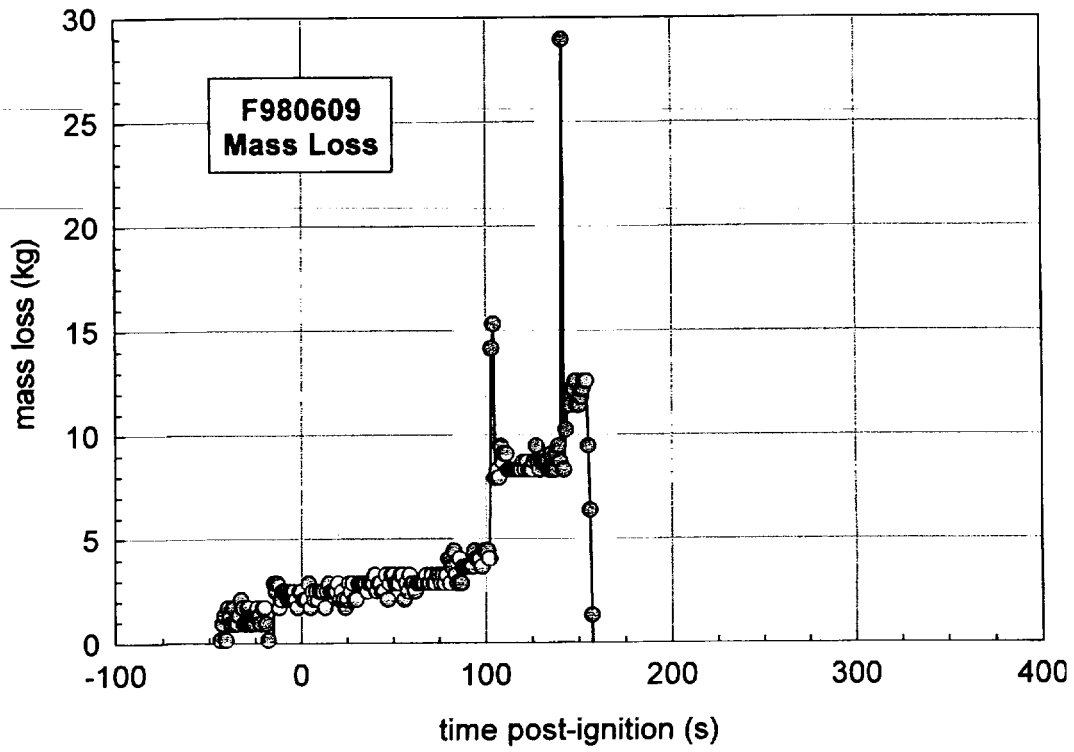
Plot G5. Fire Test F980609. Mass Loss from the test vehicle during the fire test. The mass data was not valid after 170 seconds post-ignition because test personnel stepped onto the fluid containment pan to move video equipment.

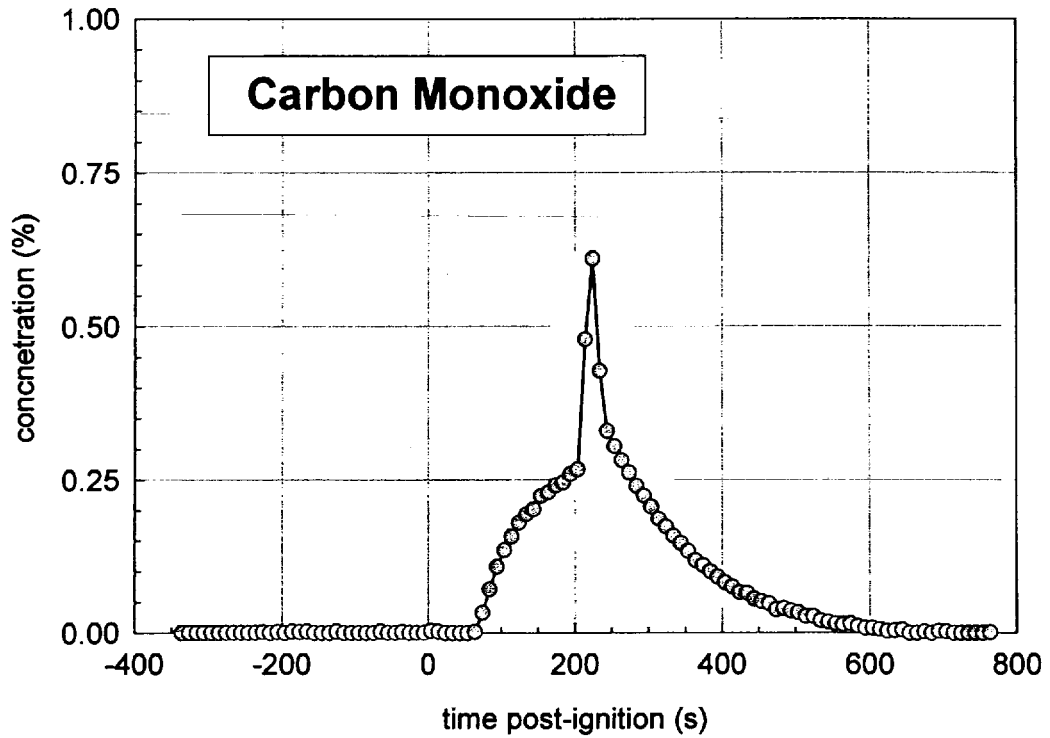
Carbon dioxide, carbon monoxide, methane, ethylene, and acetylene started to accumulate in the passenger compartment between 50 and 75 seconds post-ignition (Plots H1 through H5). The Infrared spectra acquired during this test also contained a broad absorbance band between 2800 and 3200 cm⁻¹, indicating the presence of a mixture of aliphatic hydrocarbons in the air samples from the passenger compartment. The intensity of this absorbance band generally followed the same time-course as that of methane (Plot H3), ethylene (Plot H4), and acetylene (Plot H5). This broad band appeared to contain absorbances from ethane, propane, and butane. However, all of the gaseous species contributing to this absorbance band could not be identified or accurately quantified.

Plot H1. Fire Test F980609. Concentration of carbon monoxide (CO) in the passenger compartment determined by FTIR analysis.

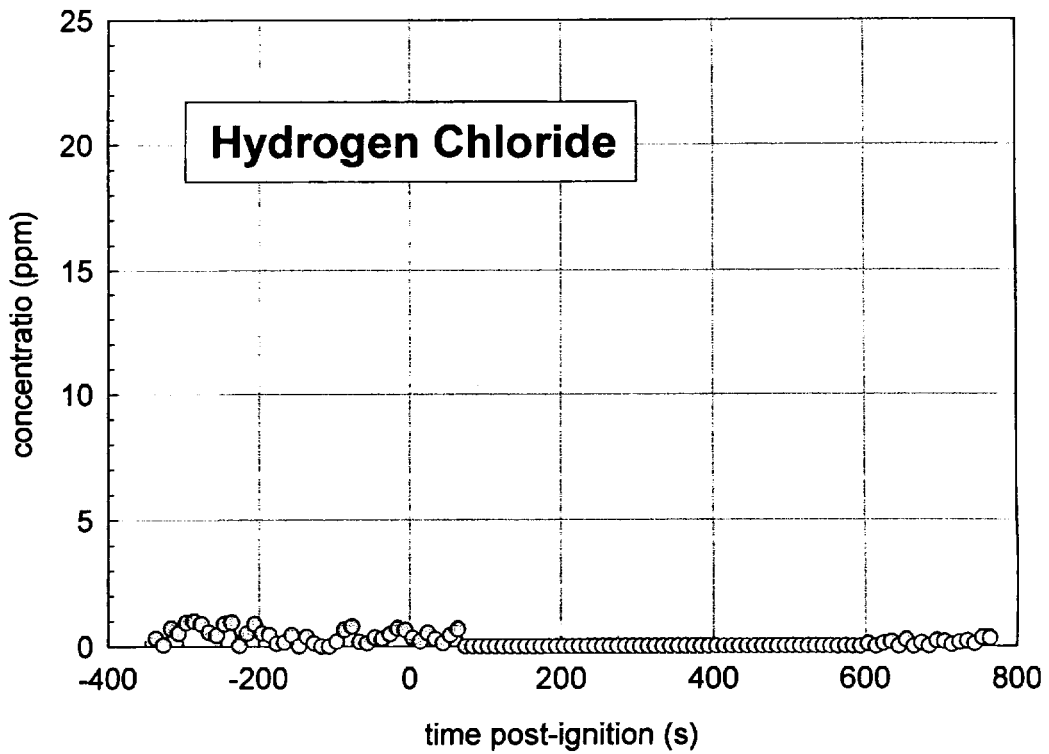
Hydrogen cyanide (Plot H7) and nitric oxide (Plot H8) started to accumulate in the passenger compartment between 50 and 100 seconds post-ignition. Hydrogen chloride (HCl) was not detected during this test (Plot H6).

Plot H6. Fire Test F980609. Concentration of hydrogen chloride (HCl) in the passenger compartment determined by FTIR analysis.

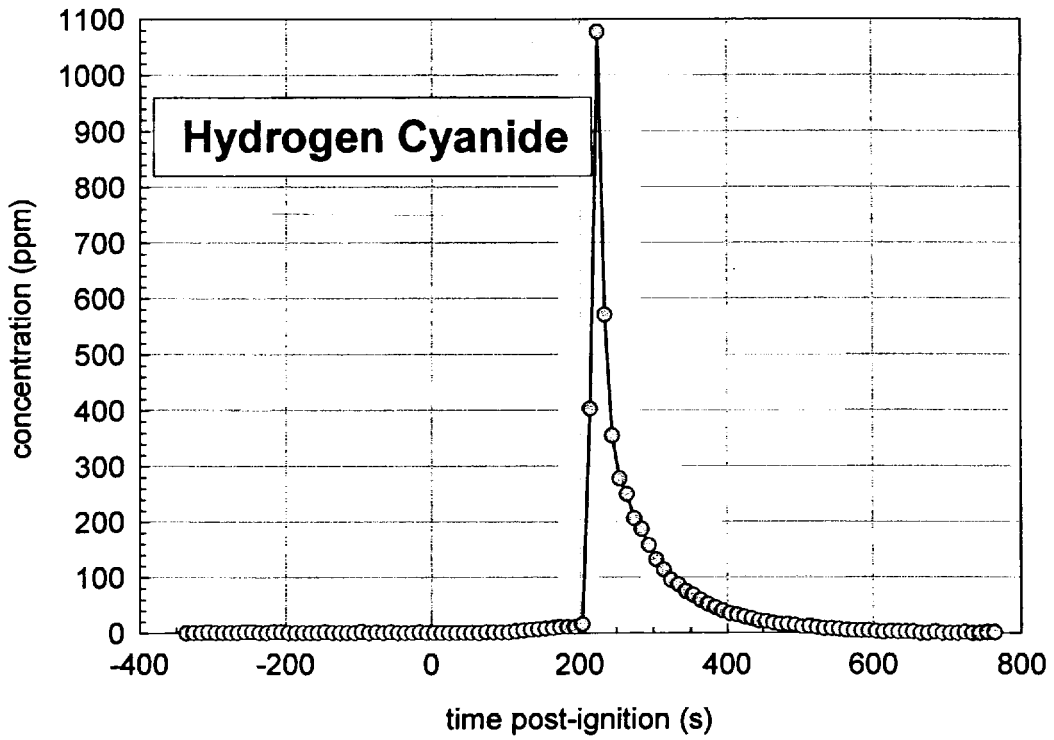
Plot H7. Fire Test F980609. Concentration of hydrogen cyanide (HCN) in the passenger compartment determined by FTIR analysis.

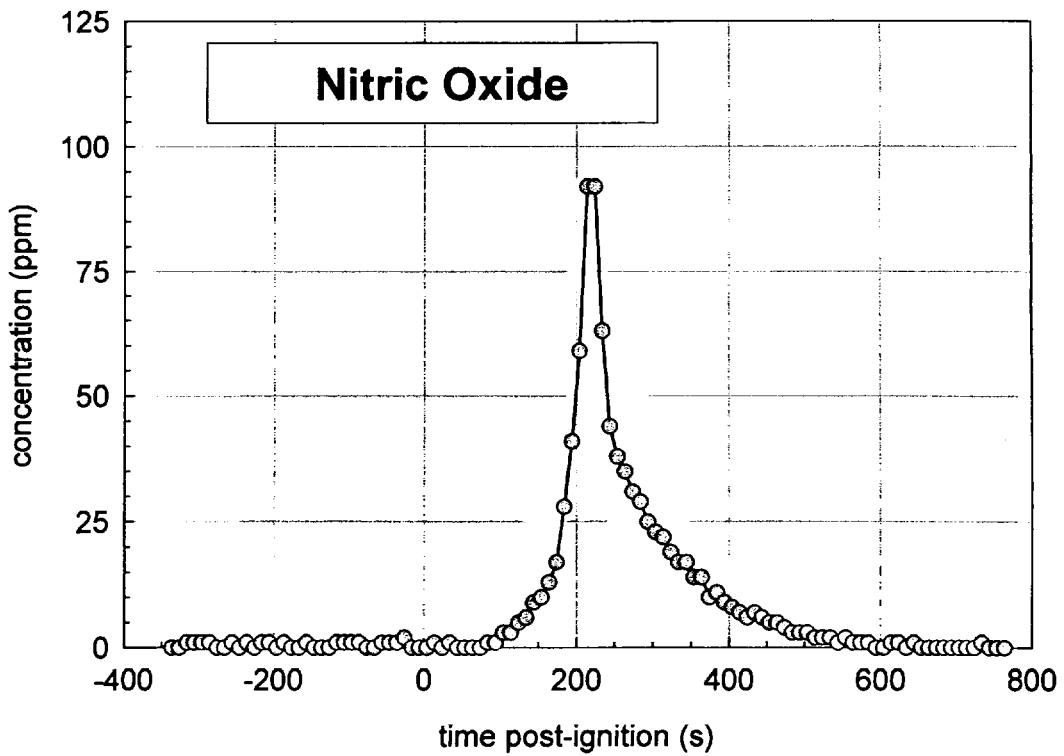
Plot H8. Fire Test F980609. Concentration of nitric oxide (NO) in the passenger compartment determined by FTIR analysis.
