Evaluation of Motor Vehicle Fire Initiation and Propagation

Part 2: Crash Tests on a Passenger Van

Jack L. Jensen, Jeffrey Santrock

General Motors Corporation

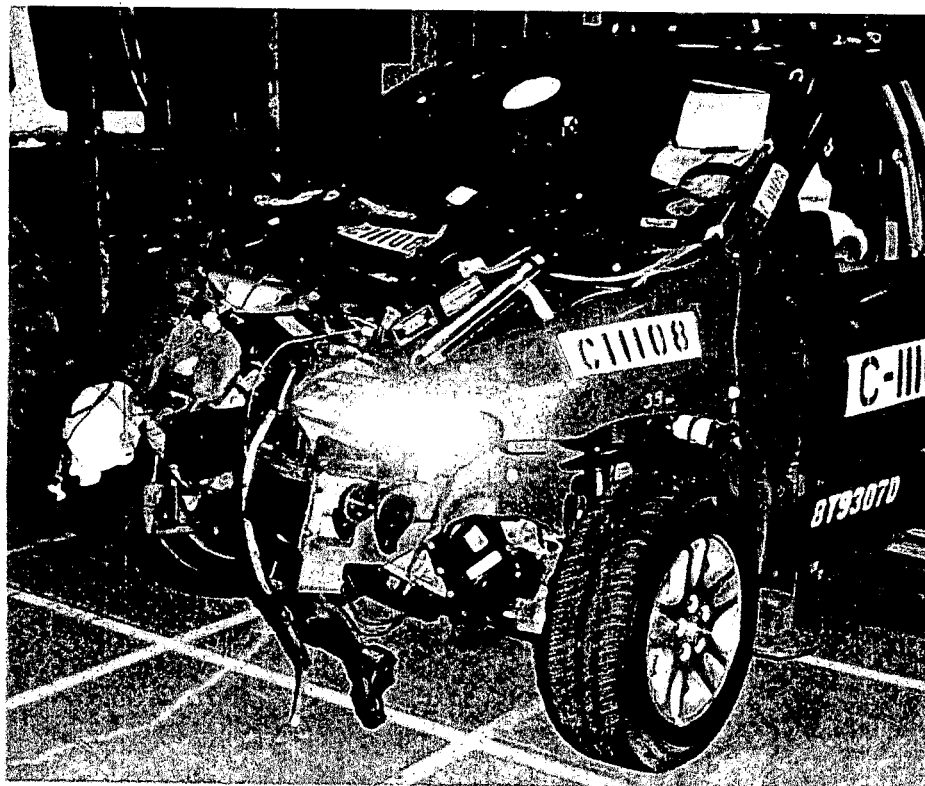
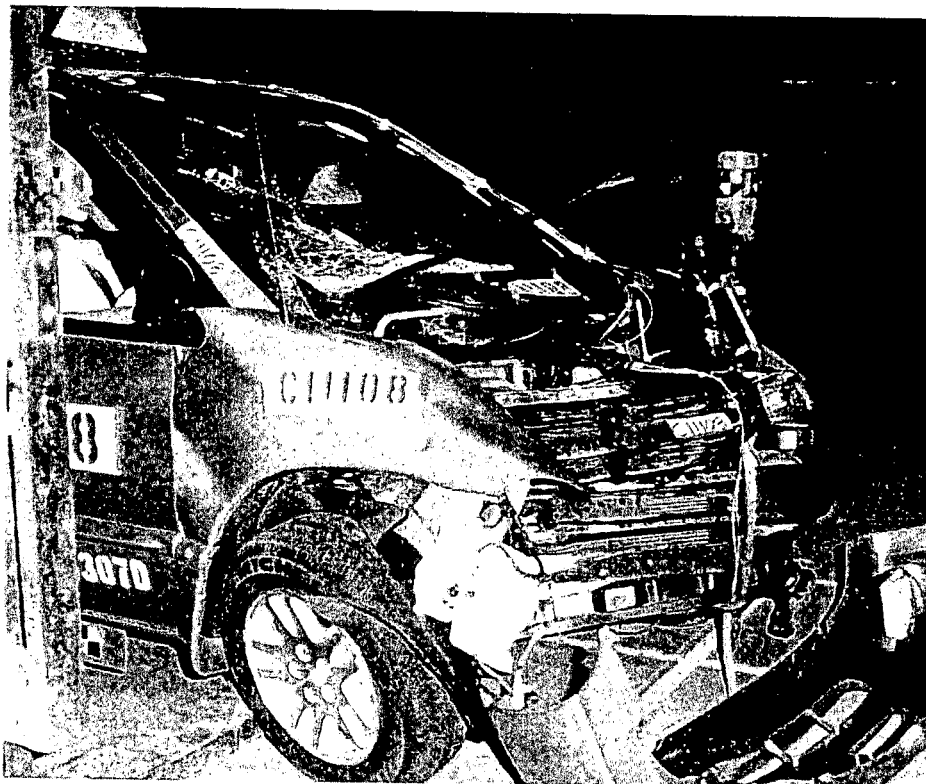
Post-Test Photograph of Test C11108, Front – Left View

Post-Test Photograph of Test C11108, Front – Right View

The other fluid pressure measurements were inconclusive. However, the post-test vehicle inspection and the high-speed film revealed that the engine oil, transmission fluid, brake fluid, engine coolant, power steering fluid, and washer fluid all leaked in the engine compartment during the test.

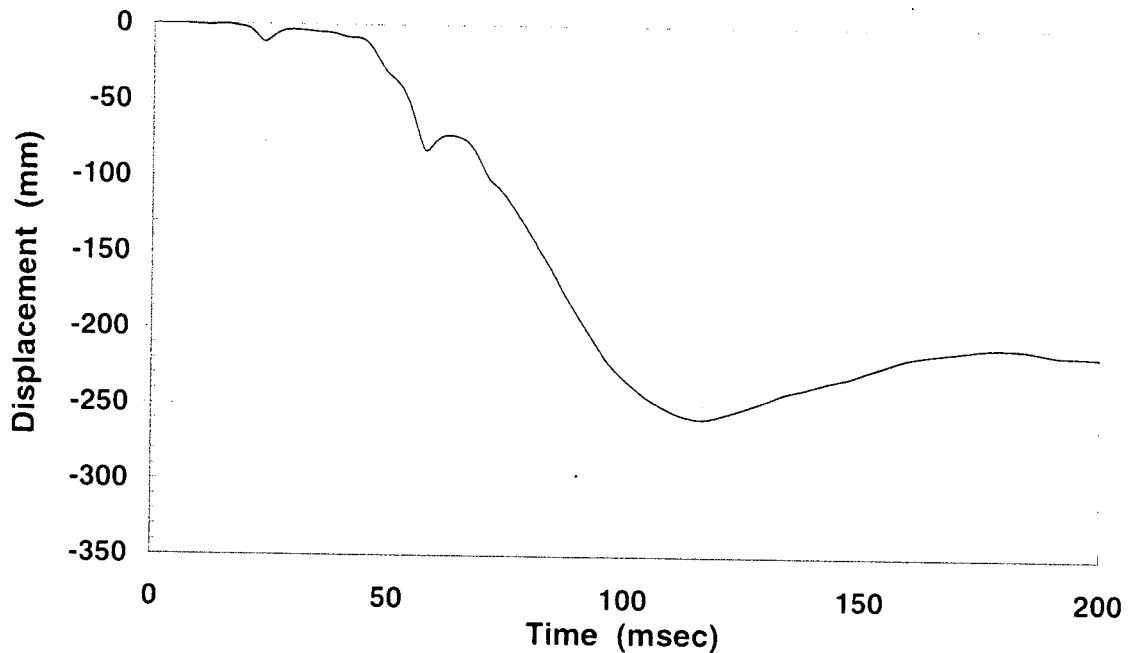
The displacement of the toe pan on the right (U.S. passenger) side relative to the vehicle's passenger compartment was approximately 255 mm as shown in Figure 7.

Figure 7
Right Toe Pan Displacement, Relative to Floorpan
Test C11108, filtered at SAE class 60 [6]

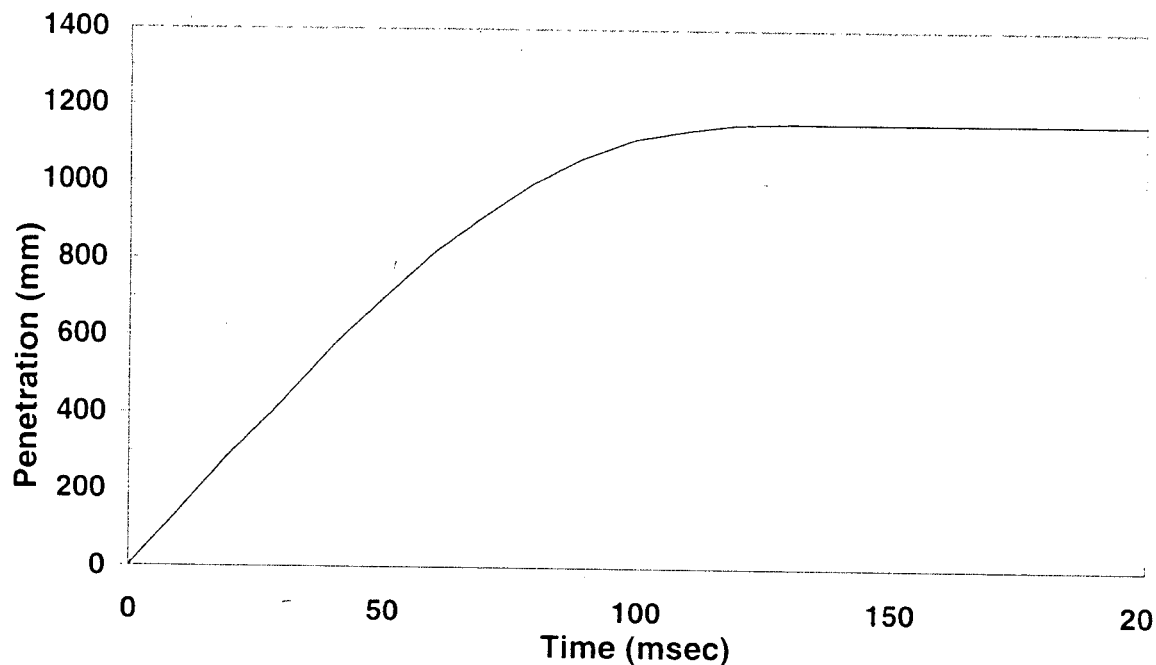
Figure 10.

The numeric analysis of the high speed film from above the vehicle indicated that the maximum dynamic pole penetration into the engine compartment was approximately 1157 mm at 129 msec after time zero, as shown in Figure 10, and plot 8 in Appendix C. This indicates that this crash configuration is quite severe from a penetration standpoint (by way of comparison many passenger vehicles will exhibit from 400 - 700 mm dynamic crush during a 30 mph rigid barrier test, such as an FMVSS 208 impact.) During a rigid frontal barrier test, the entire front vehicle structure is engaged, resulting in less penetration as compared to a concentrated load like a pole or tree. The fluid and electrical systems in the engine compartment are therefore more severely challenged during an impact of this type.

Pole Penetration

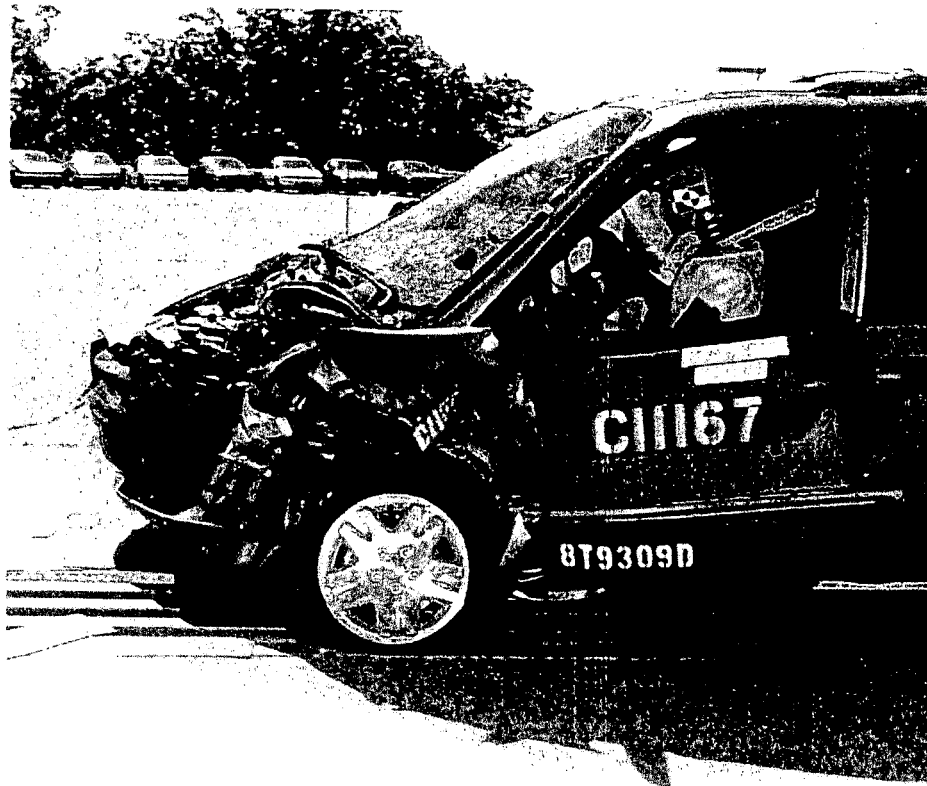
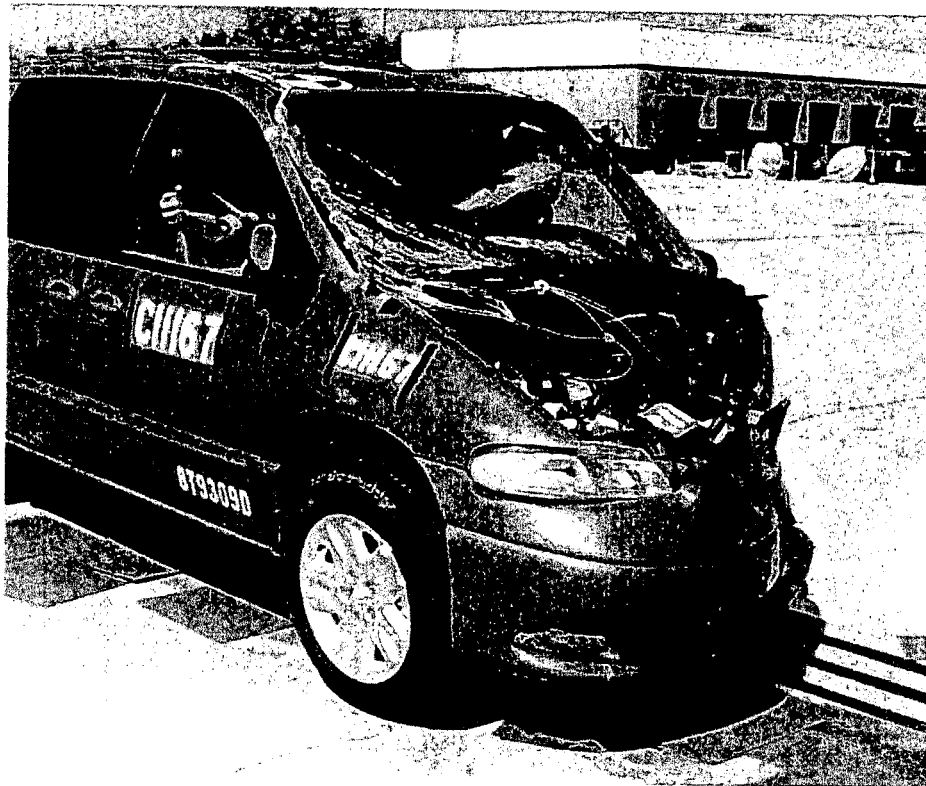
Post-Test Photograph of Test C11167, Left Side

Post-Test Photograph of Test C11167, Front – Right View

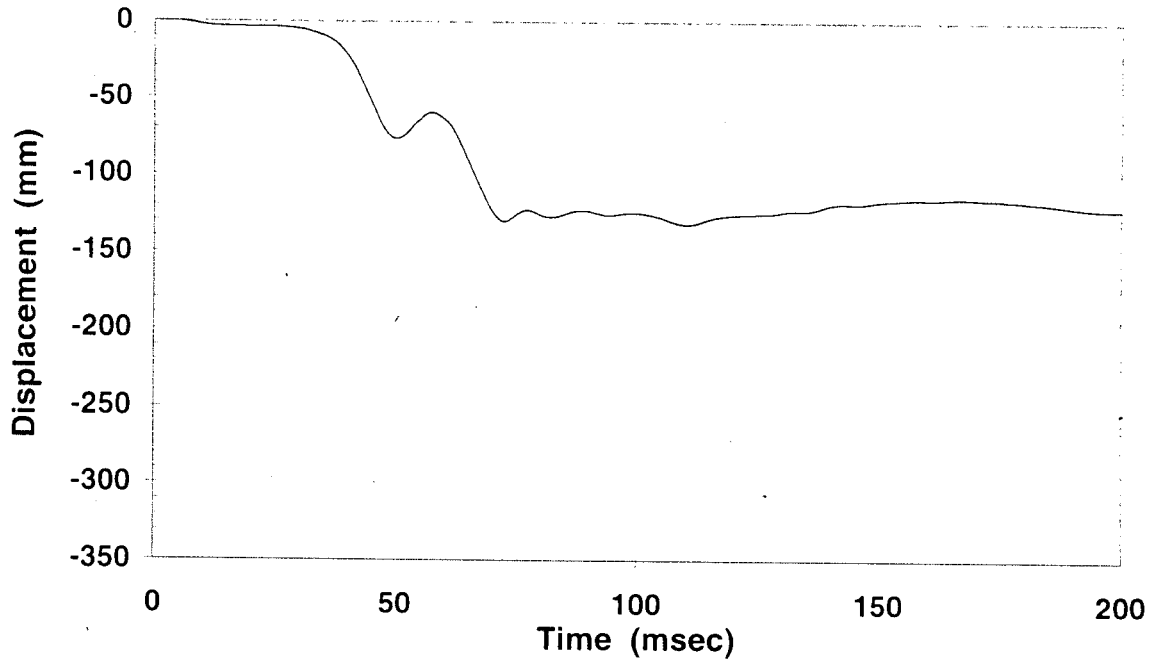
The displacement of the driver's side toe pan was approximately 130 mm as shown in Figure 20 and plot 112 Appendix D. This is roughly half of the displacement measured on passenger's side toe pan during the first pole impact test (test #C11108). This oblique moving deformable barrier resulted in less toe pan penetration because the pole subjects the vehicle to a more concentrated load than does the deformable barrier and also because the longitudinal change in velocity of the test vehicle for the pole impact (62 km/h) was greater than for the oblique moving barrier (53 km/h).

Figure 20
 Left Toe Pan Displacement, Relative To Floorpan
 Test C11167, filtered at SAE class 60 [6]

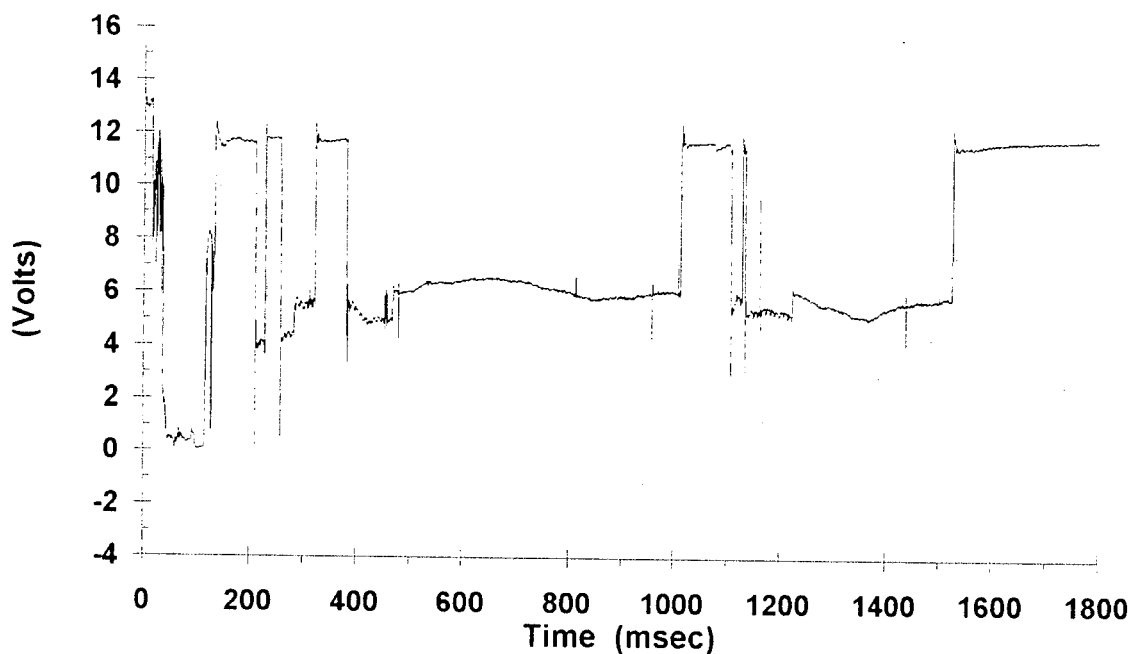
The voltage measured at the engine speed sending unit indicated that the engine was still turning at least through 40 msec (Appendix D, plot 116). This recorded trace, however, becomes inconclusive after about 40 msec. Similar to Test C11108, the vehicle's electrical system temporarily lost voltage at about 40 msec, thus affecting this recorded measurement. Several of the recorded voltage traces verified that electrical power was lost at about 40 msec. The auxiliary transducers to make this measurement independent of the vehicle power were not yet available for this test. The temporary loss of vehicle (ignition) voltage (shown in Figure 21 and plot 113, Appendix D) was due to the negative battery terminal separating from the negative battery plates as the top of the battery moved upwards, partially separating from the battery during the test. Note that Figures 21 and 22 display the recorded measurements for a duration of 1800 msec (1.8 seconds), unlike previous figures which have displayed 240 msec of data. This displacement of the battery top was observed in the high speed film of the crash test. The re-establishment of ignition voltage at 120 msec is described in later sections.

Figure 21
 Ignition Voltage
 Test C11167

One event was the pinching and partially severing of a wiring harness between the front edge of the left frame rail and the transaxle housing as shown in Figure 25. Several wires in this harness, including the starter cable, were shorted to chassis. The insulation on the starter cable showed signs of melt/flow and there was evidence of corrosion caused by electrical arcing at the tips of the copper wire. Also, electrical arcing eroded a small area of the frame rail. An inspection of the ignition voltage (Figure 21) indicates a drop in ignition voltage from 13

volts to about 10 volts beginning at 15 msec. It is likely, but impossible to verify, that this was the time at which the wiring harness was severed, causing additional load on the battery due to the starter cable short. The physical inspection of the starter cable short also revealed some possible cross shorting of the starter cable to other wires in the wiring harness including the headlight low-beam circuit. An inspection of the headlight low-beam voltage (Figure 26 and plot 115, Appendix D) also suggests that this cross shorting started at about 15 msec. This voltage was initially at zero (because the low beam lights were not on for the test) but intermittently raised beginning at about 15 msec. This suggests that the wiring harness was physically crushed at about 15 msec and both the starter cable short to chassis and the cross shorting between cables in the bundle likely occurred at about this time.

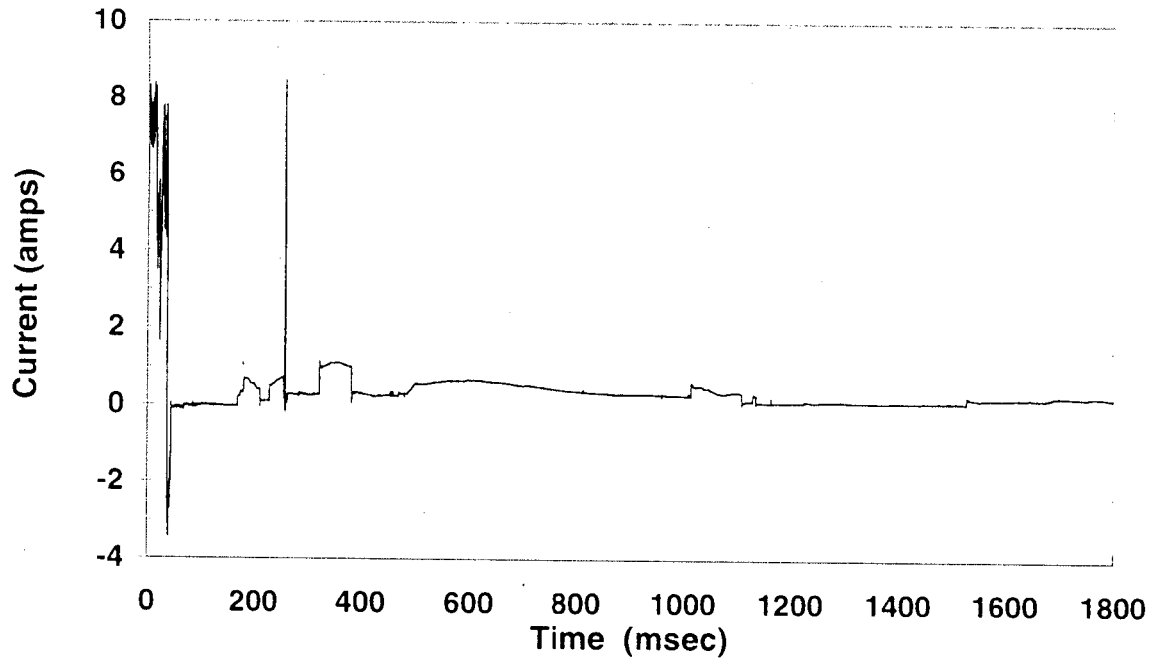
Figure 22 and plot 124 (Appendix D) show the current measurement at the auxiliary fuel pump (the one operating before the impact and supplying gasoline to the engine from the auxiliary fuel tank). The fuel pump drew about 7 amps until about 37 msec, when the current dropped to zero. This is also likely due to the temporary loss of the vehicle's electrical power as shown in Figure 21. The fuel pump did not re-start at 120 msec when the ignition (system) voltage was temporarily re-established. Similar to test C11108, this pump did not require to be "timed out" after a fixed period of engine stoppage (as described in section 2.2.1).

Figure 22
 Fuel Pump Current
 Test C11167

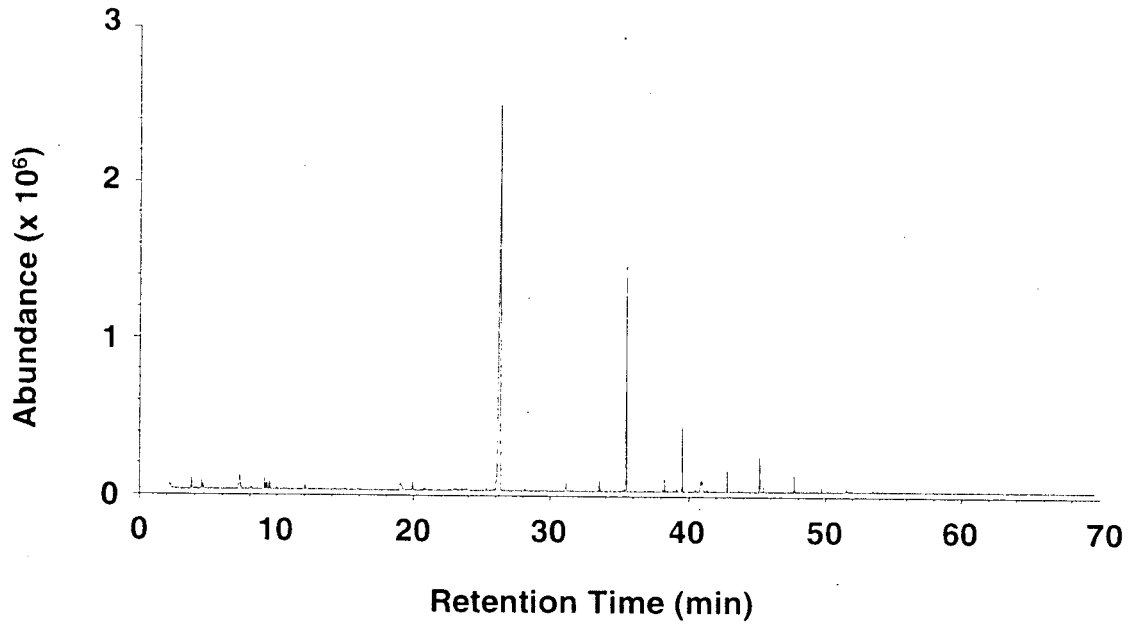
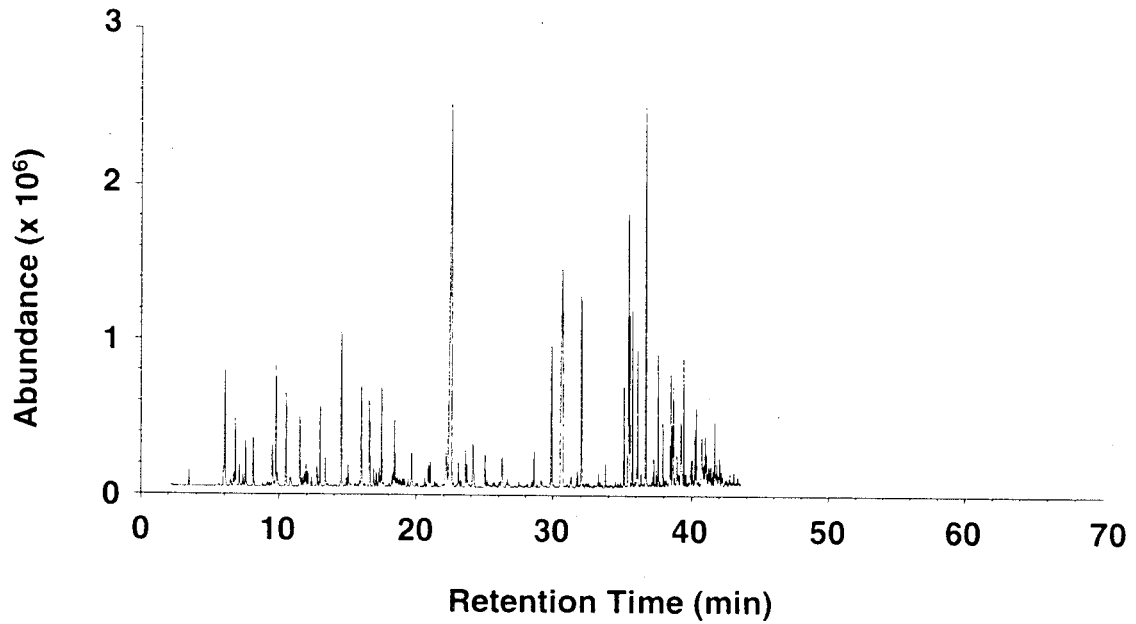
Background Chromatogram from GC/MS Analysis from Left Lower Engine (Location #3)
Test C11167

Test Chromatogram from GC/MS Analysis from Left Lower Engine (Location #3)
Test C11167

The peaks in the mass chromatogram of the background from the left lower engine (location #3) were identified as a homologous series of cyclic poly(dimethyl siloxanes). These compounds were produced during the GC/MS analysis by thermal decomposition of reagent used to deactivate the glass surfaces in the sorbent tubes. None of the engine compartment fluids was siloxane-based. The peaks in the mass chromatogram of the test sample were identified as a mixture of aliphatic and aromatic hydrocarbons in the range of C5 to C10. Higher molecular weight hydrocarbons were not detected. Gasoline was the only fluid in the test vehicle that contains hydrocarbons in this molecular weight range. The mass chromatograms of samples from the other locations where a hydrocarbon vapor was detected were similar to that shown in Figure 29. The abundances of the each hydrocarbon species were lower, however.

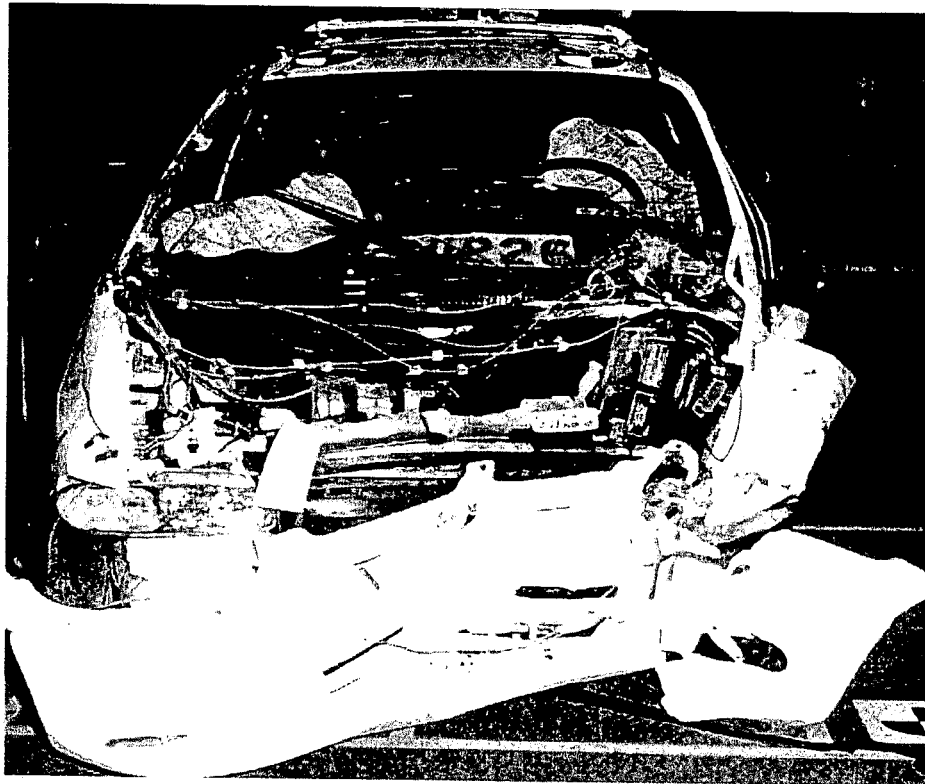
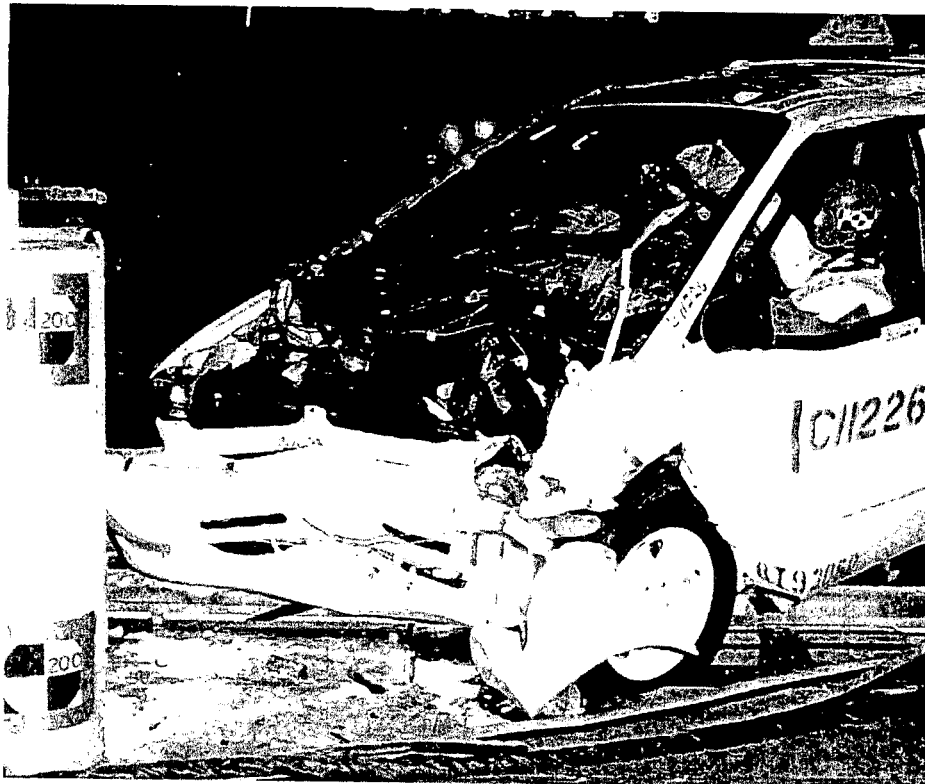
Post-Test Photograph of Test C11226, Front View

Post-Test Photograph of Test C11226, Front – Left View

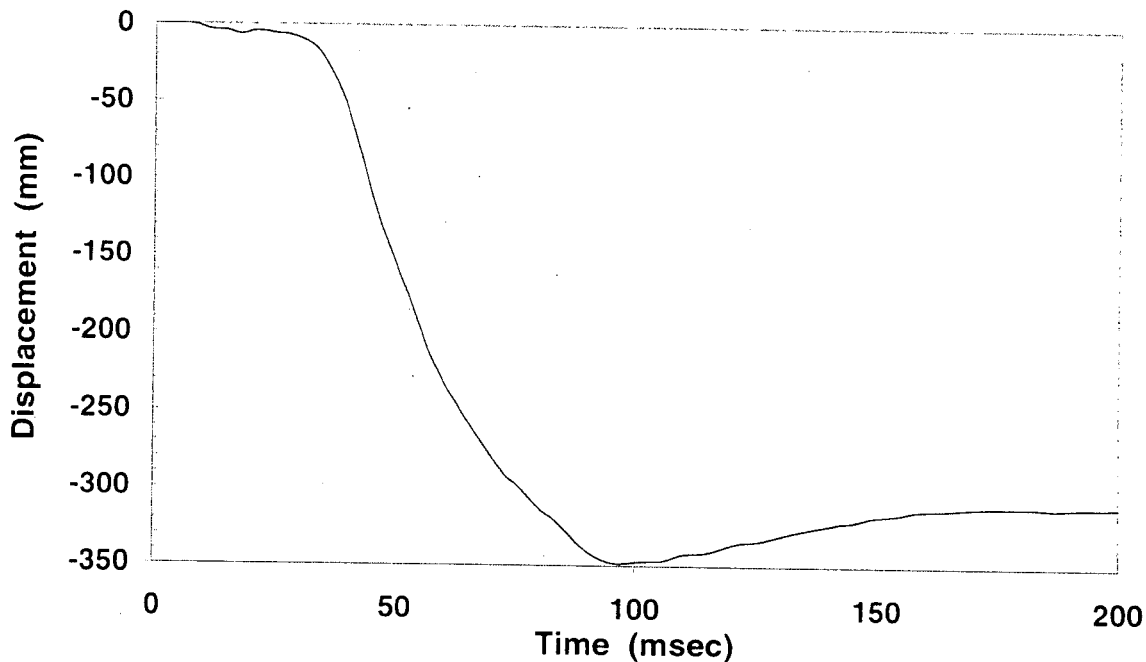
The displacement of the left toe pan, which indicated approximately 350 mm toe pan intrusion is shown in Figure 36 and plot 117 (Appendix F).

Figure 36
 Left Toe Pan Displacement, Relative to Floorpan
 Test C11226, filtered at SAE class 60 [6]

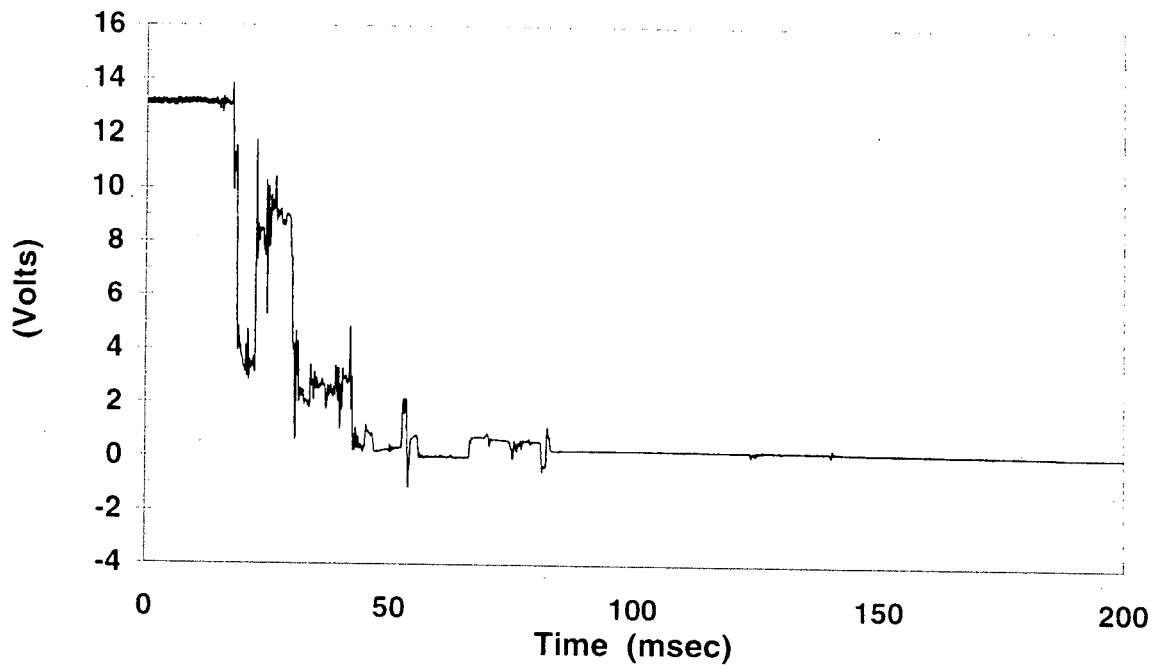
Figure 38
 Ignition Voltage
 Test C11226

The ignition voltage (plot 120 and also Figure 38) dropped beginning at about 20 msec and continued to near zero at 40 msec. The battery was inspected following the test and an internal short was identified through a continuity test. The drop in ignition voltage is due to internal shorting of the battery and possibly also due to electrical shorts external of the battery, although none were identified during the post-test inspection.

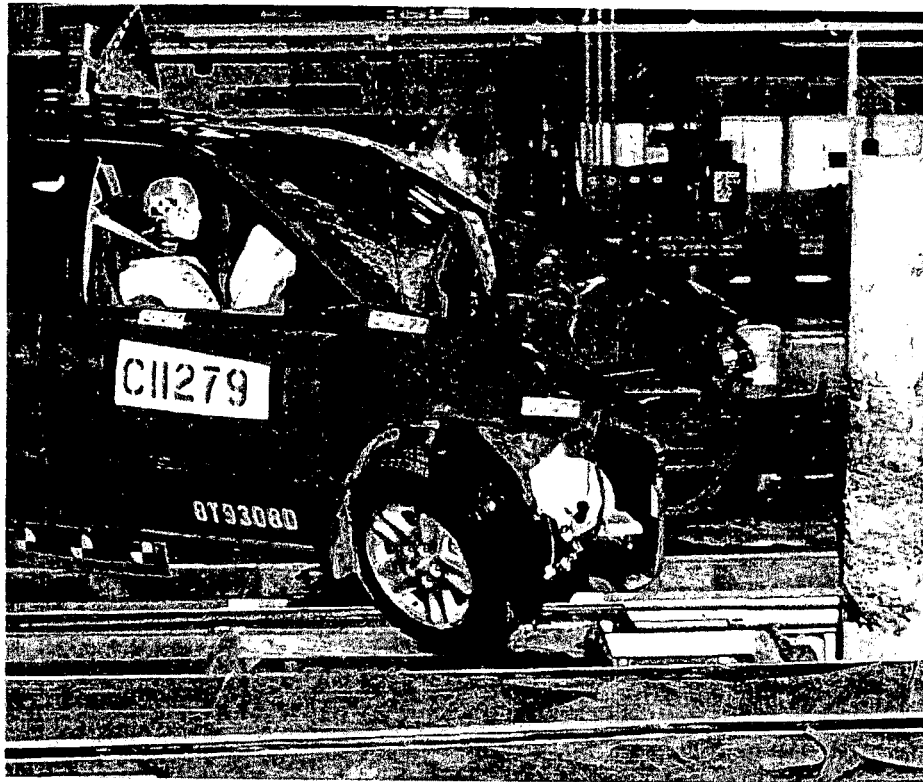
Post-Test Photograph of Test C11279, Front-Right View

Post-Test Photograph of Test C11279, From Above with the Hood Removed

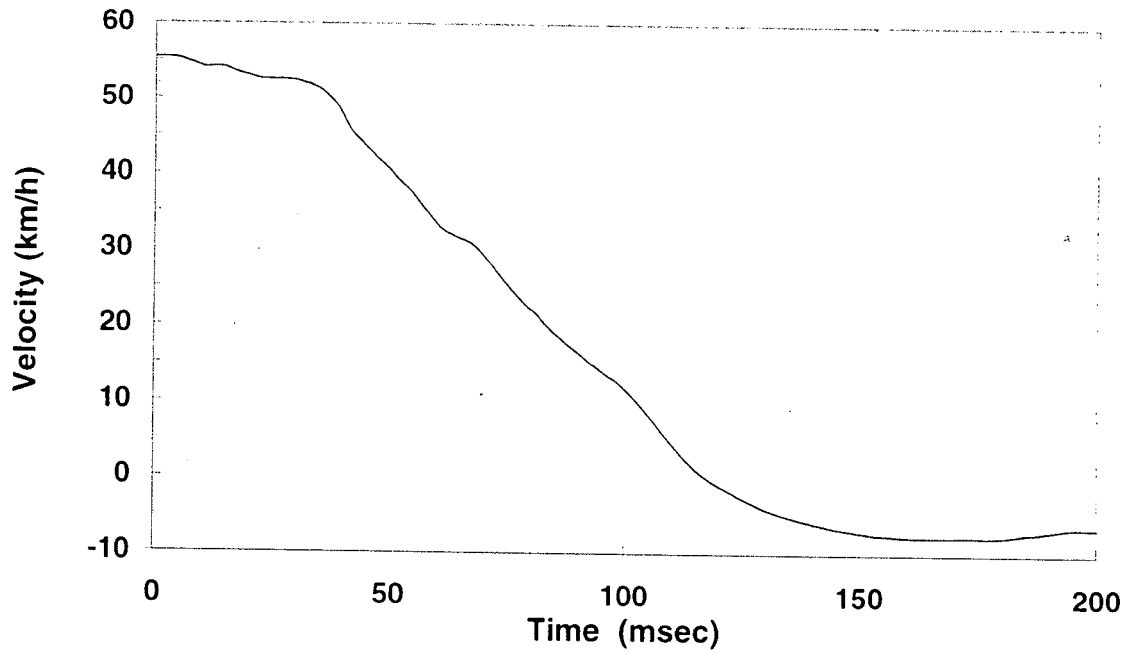
The two rear rocker panel longitudinal acceleration measurements were averaged and integrated to compute the change in vehicle velocity, and integrated again to compute vehicle displacement. The peak vehicle longitudinal acceleration (after filtering at SAE class 60 [6]), was 28 g and the maximum longitudinal change in vehicle velocity was 63 km/h (39.1 mph), with the velocity crossing zero at 118 msec past time zero (impact.) The averaged rear rocker longitudinal acceleration and velocity is shown in Figures 43 and 44, and plots 95 and 96, (Appendix H.)

Figure 44
Averaged (Left & Right) Rear Rocker Panel Longitudinal Velocity
Test C11279

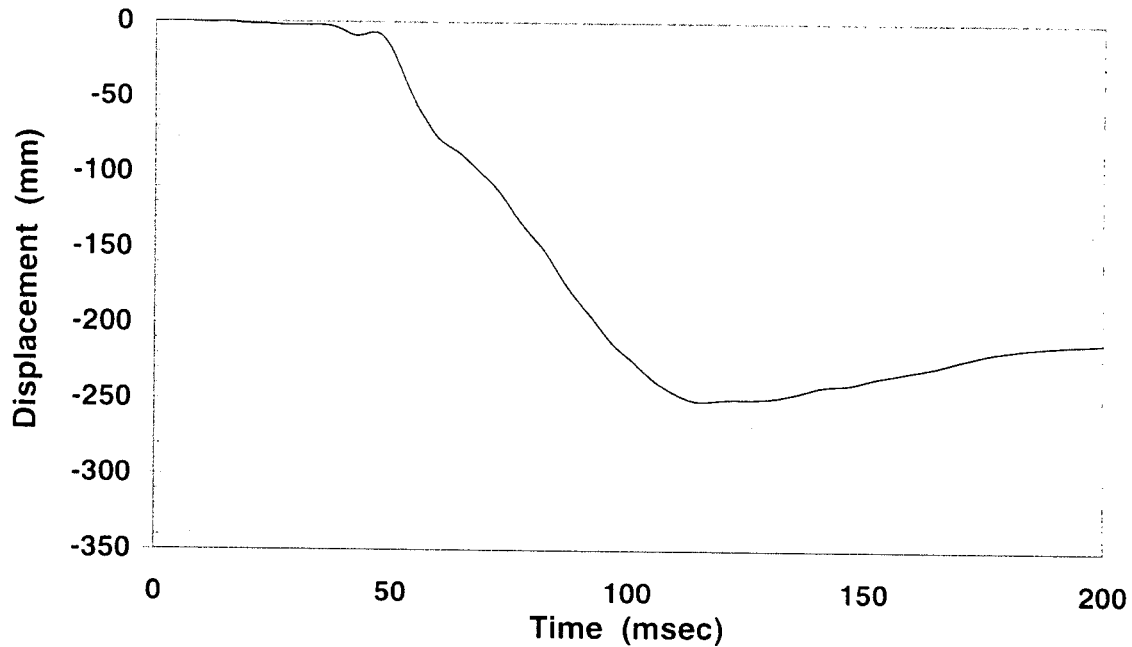
The displacement of the right toe pan, relative to the passenger compartment, was approximately 250 mm and is shown in Figure 45 and also plot 117 Appendix H.

Right Toe Pan Displacement, Relative to Floorpan
 Test C11279, filtered at SAE class 60 [6]

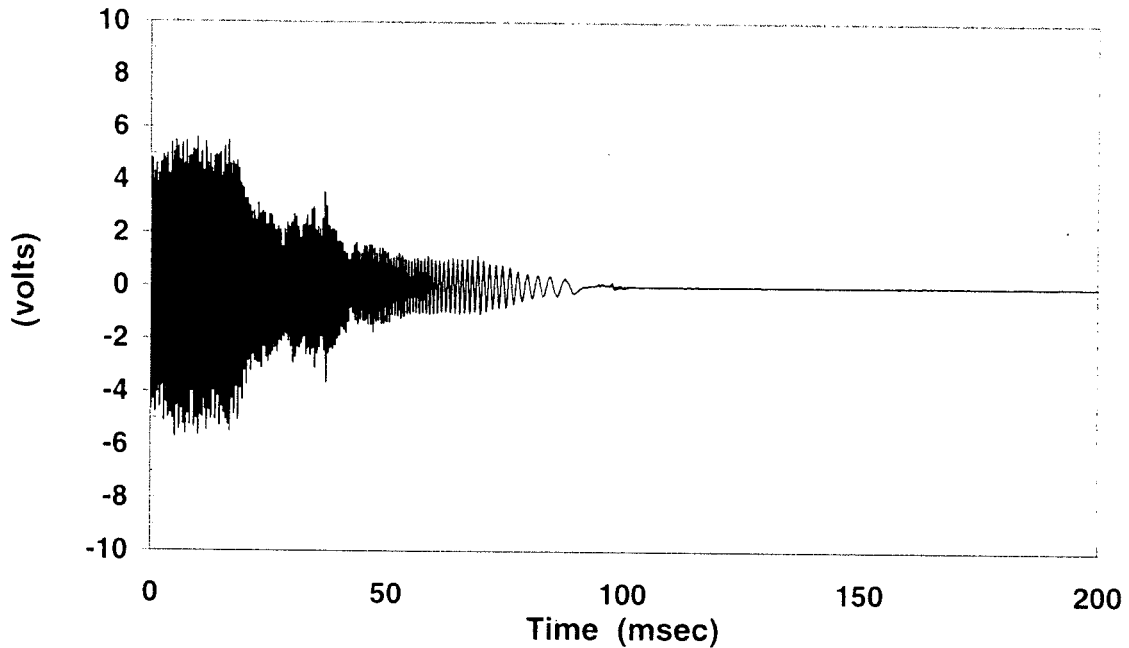
The engine motion measurement using an auxiliary magnetic pickup transducer indicated that the flywheel rotation began to decrease at about 40 msec and stopped by 90 msec. (See plot 122, Appendix H and Figure 46.) This measurement technique was more reliable than using the vehicle's own engine speed transducer (plot 123, Appendix H) and will be used in future testing.

Figure 46
 Engine Motion, Measured at Flywheel
 Test C11279

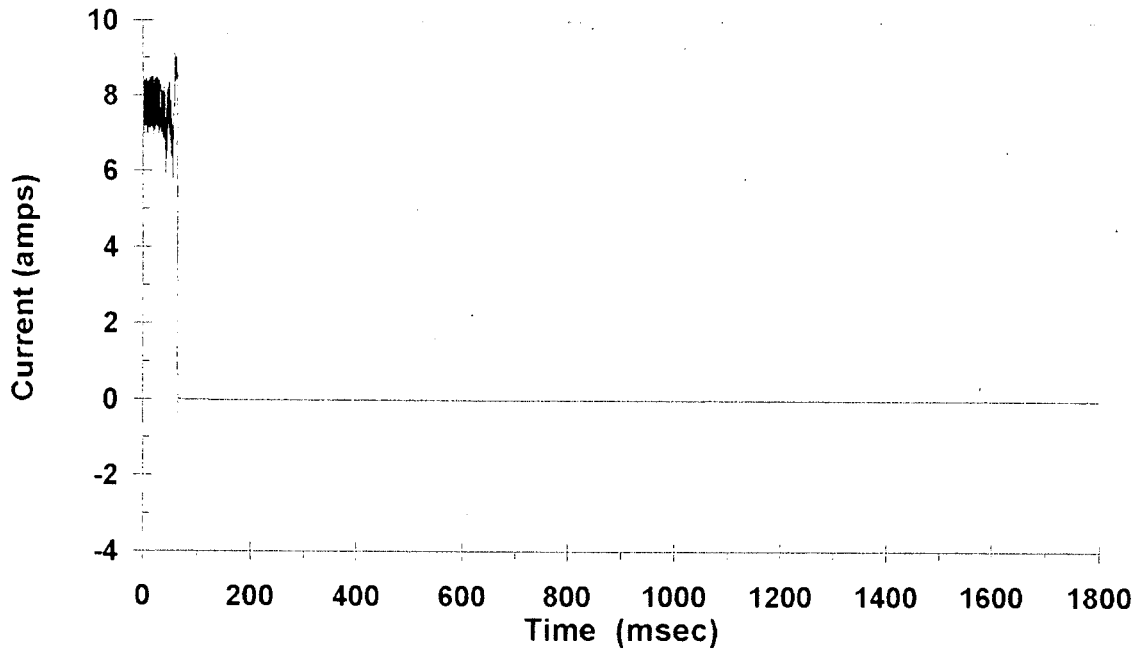
Figure 47 (and plot 131, Appendix H) shows the current measured at the auxiliary fuel pump. Note that Figures 47 and 48 display data through 1800 msec (1.8 seconds) after impact. The fuel pump drew 8 amps until about 60 msec, when the current dropped to zero. The ignition voltage also dropped from 13 volts to 6 volts at around 60 msec as shown in Figure 48, but later recovered back to 13 volts at about 1590 msec. The fuel pump remained off through 1590 msec when ignition voltage was restored. Similar to other frontal tests, this drop in system voltage is likely the reason the fuel pump shuts down relatively early during the impact.

Figure 47
 Fuel Pump Current
 Test C11279

The pressure in the auxiliary fuel line dropped to zero around 70 msec (plot 141). The post-test inspection indicated that the fuel line was severed in the engine compartment, on the passenger (right) side, near the shock tower. The separation was near where the rubber fuel line connects to a metal swage fitting. The fuel pump was likely off by the time the line was severed as indicated by the fuel pump current (Figure 47).

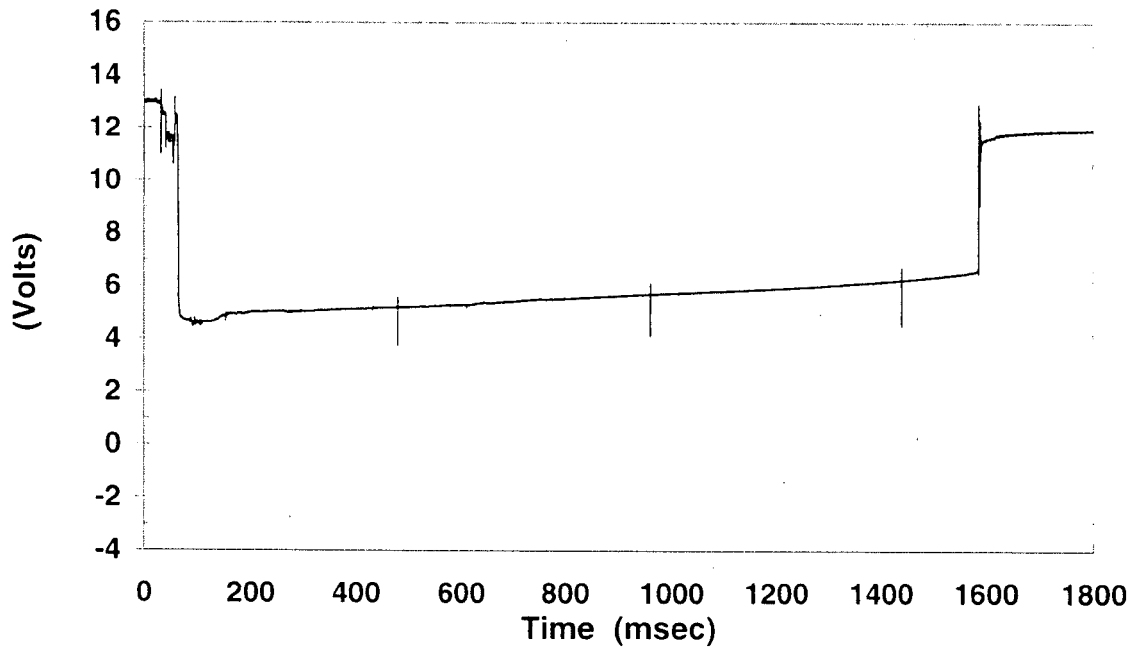
Figure 48
 Ignition Voltage
 Test C11279

The ignition voltage (Figure 48) dropped from 13 volts to about 5 volts at about 65 msec. The ignition voltage returned to 13 volts at around 1590 msec (1.6 seconds).

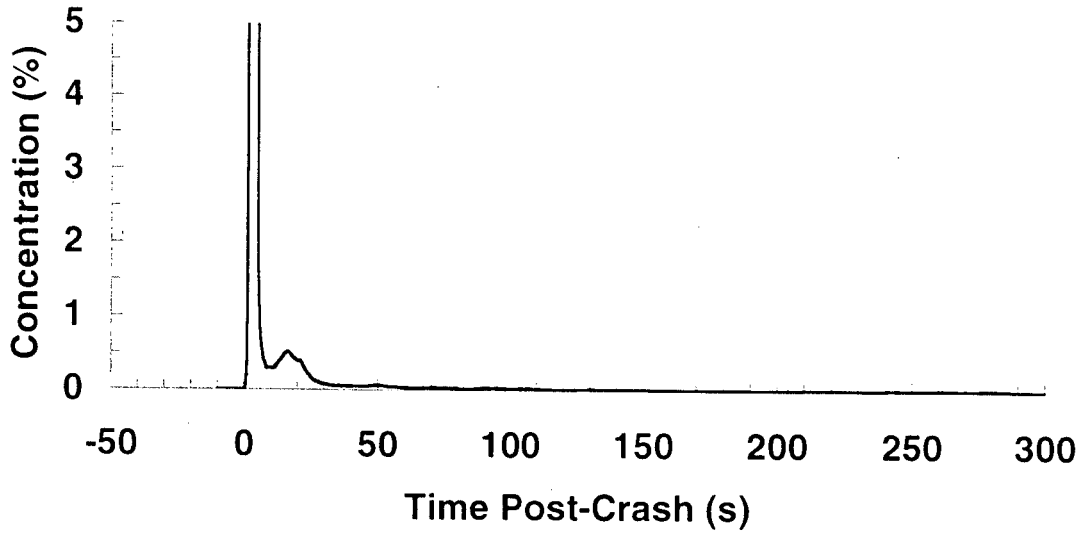
Figure 49

The electrical cables to two of the five gas sensors were severed during the crash test. The signal from the sensor at the left upper engine (location #1) was lost at 120 msec. The signal from the sensor at the right upper engine (location #2) was lost at 80 msec. Sensors at the left lower engine (#3) and the right lower engine (#4) detected high concentrations of a hydrocarbon vapor in the lower engine compartment. The concentration of hydrocarbon vapor in the left lower engine compartment (#3) exceeded 5%, the upper limit of calibration of these sensors, from 0 to 10 seconds after impact (Figure 49). The concentration of hydrocarbon vapor in the right lower engine compartment (#4) exceeded 5% from 10 to 20 seconds after impact (Figure 50). The concentration measured by Sensor 5 did not exceed 0.3% from impact to 5 minutes after impact.

Concentration of Hydrocarbon Gas Measured at Left Lower Engine (Location #3)

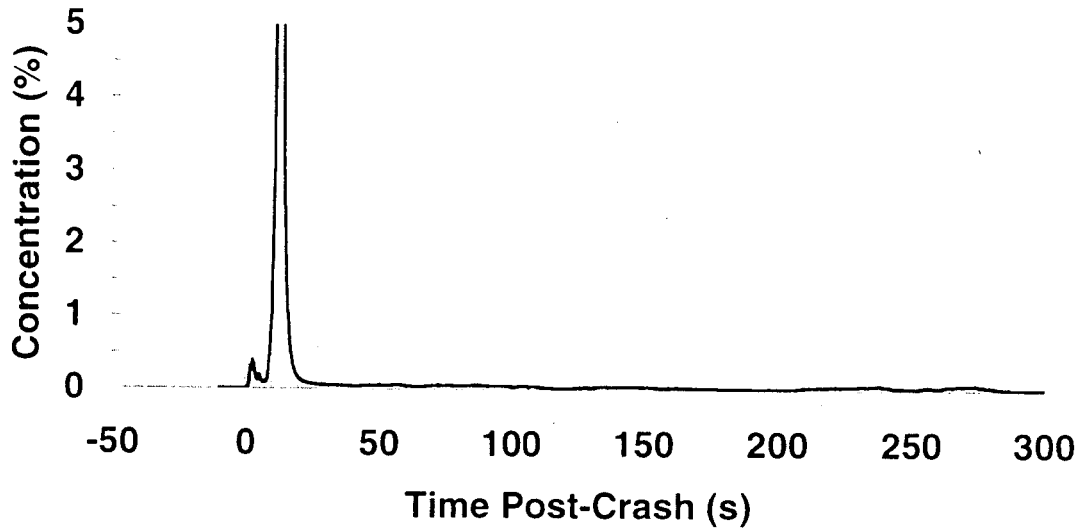
Figure 50

Concentration of Hydrocarbon Gas Measured at Right Lower Engine (Location #4)

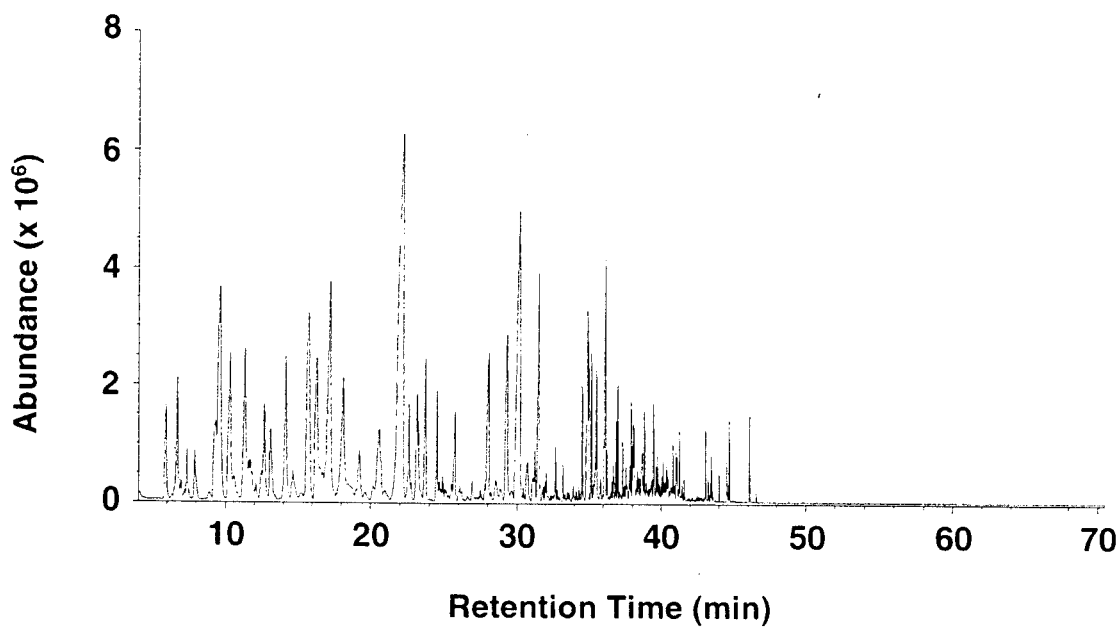
Figure 52

Analysis of the gas sampled from the engine compartment indicated that the sensors were responding to gasoline vapor. For example, the mass chromatogram of the background from the left lower engine compartment contained only deuterated hydrocarbons (Figure 51), which were internal standards added to each sorbent tube immediately before analysis. The backgrounds from the other locations contained only the deuterated standards (Appendix I, Figures II1 through II5). In addition to the deuterated standards added to the sorbent tubes, the mass chromatogram of the test sample acquired from the left lower engine compartment during the crash test contained a mixture of aliphatic and aromatic hydrocarbons in the range of C5 to C10 (Figure 52). Gas sampled from the other locations during the crash test contained the same hydrocarbons (Appendix I, Figures II1 through II5). The abundance of the hydrocarbons in the mass chromatogram was proportional to the hydrocarbon vapor concentration measured by the gas sensor at that location.

Test Chromatogram from GC/MS Analysis from Left Lower Engine (Location #3)
Test C11279

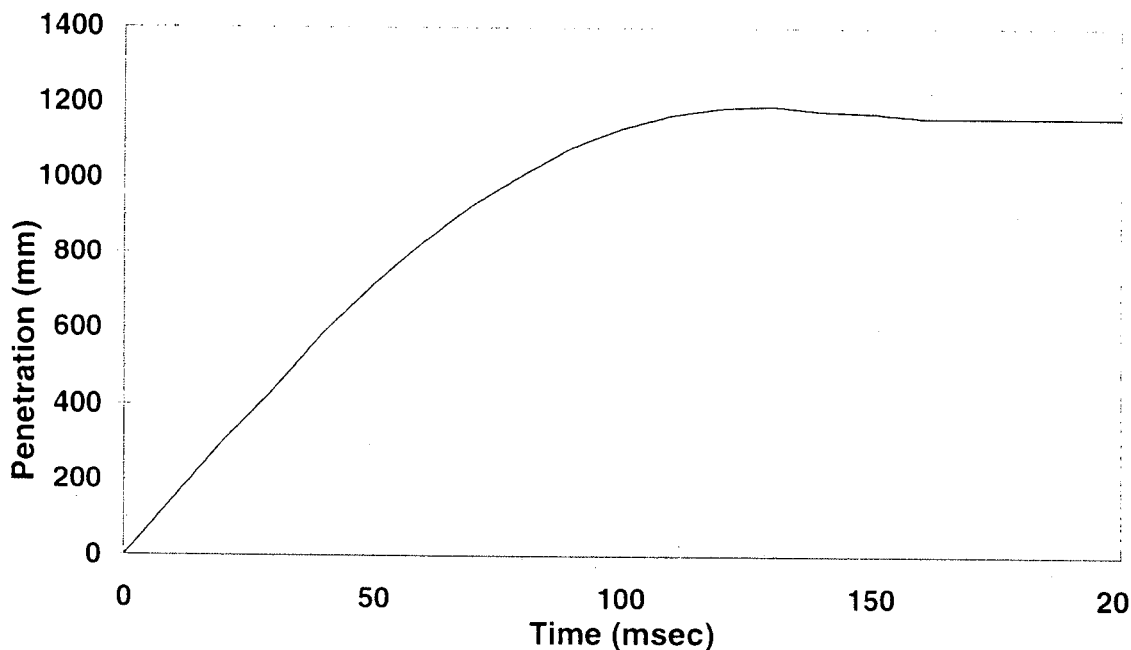
The numerical analysis of the overhead film indicated that the pole penetration into the engine compartment was approximately 1192 mm at 130 msec after time zero, as shown in Figure 54 and plot 7. This compares to a maximum pole penetration of 1157 mm for test #C11108 (Figure 10 and Appendix C, plot 8).

Figure 54.
Pole Penetration
Test C11279, Numerically Measured from High Speed Film
