**Development of Inspection Technology  
for NGV Fuel Tanks**

## **Development of Inspection Technology for NGV Fuel Tanks**

Failure Analysis Associates, Inc.  
Menlo Park, California

May 1997  
(Revised August 1997)

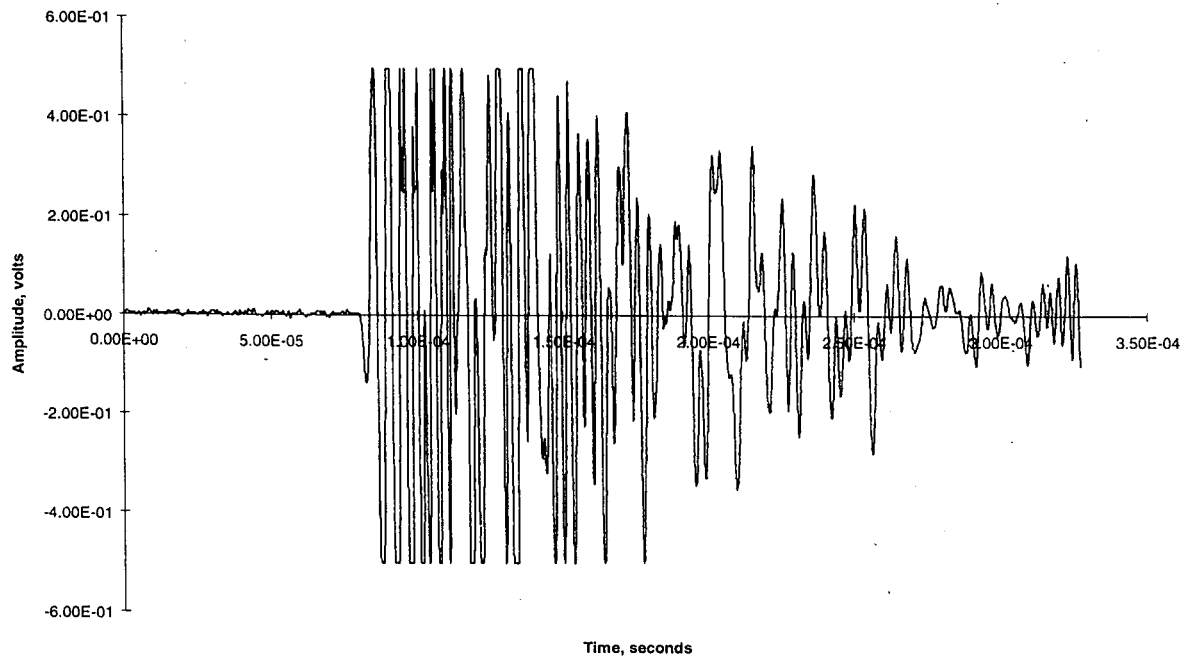
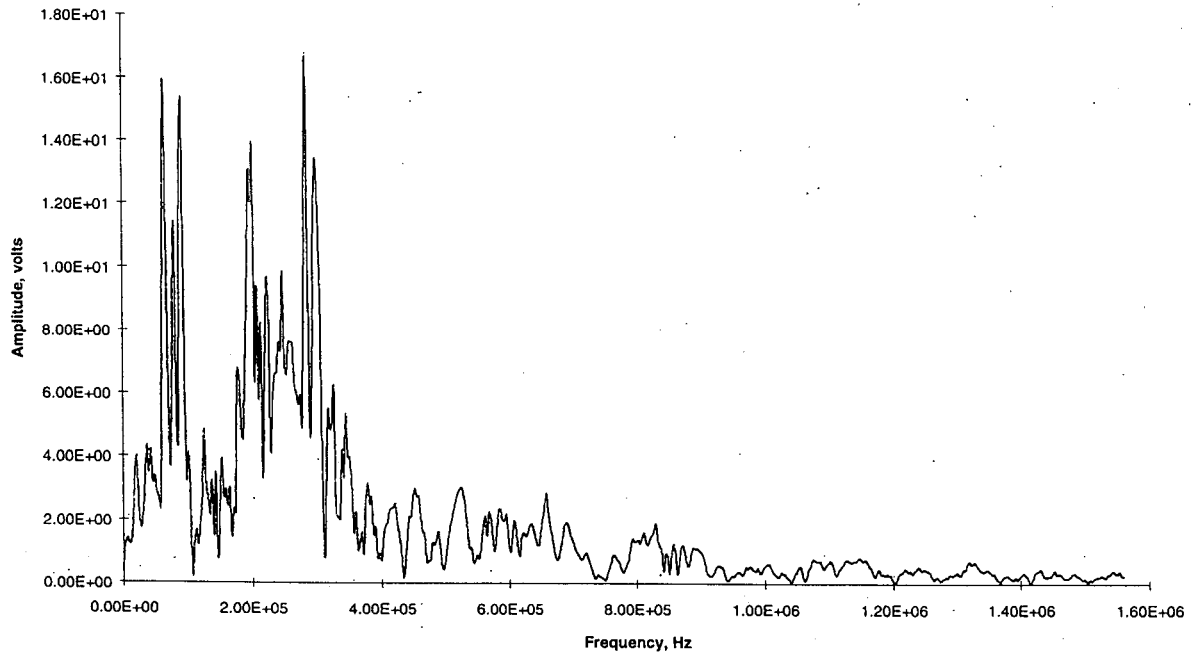
The observed cracking and delamination from the slits was reflected in the acoustic emission data, which was attributed primarily to matrix cracking rather than fiber breakage. Large amplitude flexural mode signals, Figure 36, were seen to be originating from the slits. As the

Figure 36. Matrix Splitting Signal and FFT of Signal – Tank 004 with Slits

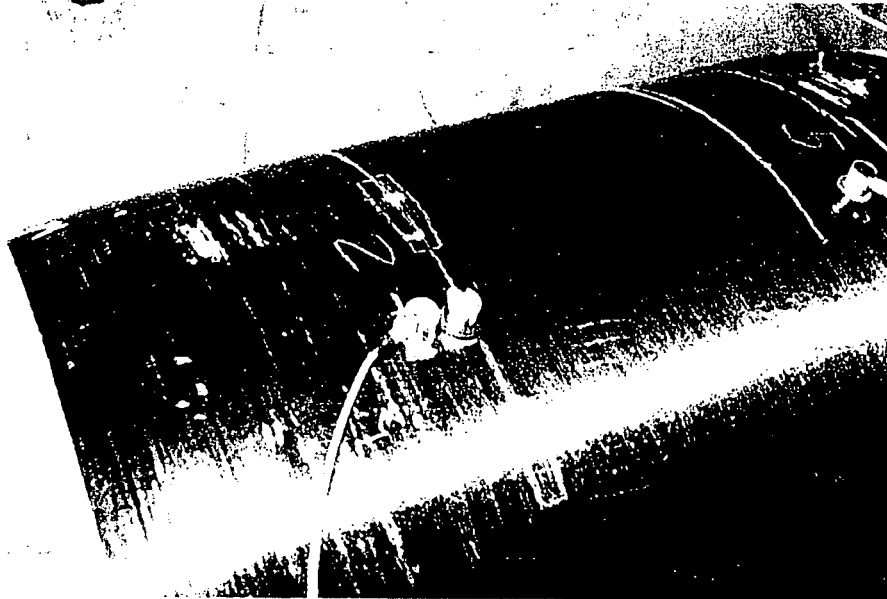
Weight was added to the pendulum impact fixture in order to increase the impact energy to 221 ft-lbs, as shown in Figure 52. The tank was also rotated so that the impact occurred at approximately the same longitudinal location but at a circumferential location approximately the same distance from Sensor 2 as the 22.1 ft-lbs impact. The appearance of the 221 ft-lbs impact damage, which includes circumferential cracks, fibers lifted off the surface, a 0.125 inch deep dent, and a shallow dent, is shown in Figure 53. The size of the visibly damaged area is approximately 2.25 inches circumferentially  $\times$  0.5 inches axially. No change in the damage was observed following pressurization of the tank to 5529 psig.

Figure 53. Impact Site Following 221 ft-lbs Impact

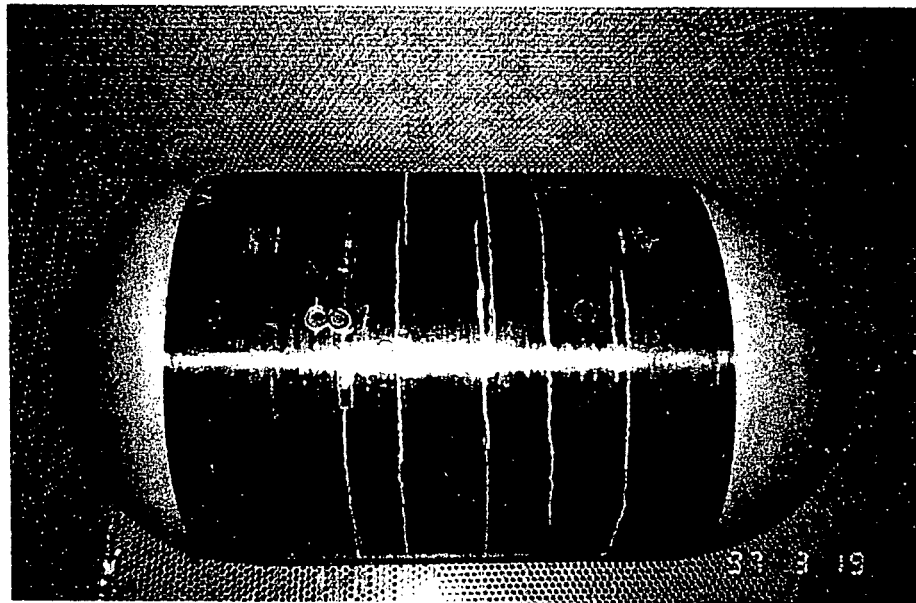
illustrate the circumferential crack growth. In Figure 54, the 2 inch long slit is visible in the upper right above Sensor 5, with yellow lines indicating the circumferential cracks emanating from each end of the slit. The pair of yellow lines in the center of the tank are associated with cracks from the 3 inch long slit, which is seen in the upper center of Figure 55 between Sensors 3 and 6. Due to fatigue cycling, the ends of the two slits separated and the slits delaminated from the underlying overwrap. The two impact damaged areas and their associated cracks are shown in the left of Figure 54 near Sensors 2 and 7. Notice that the crack propagates between the two damage areas and continues around the circumference of the tank.

Figure 54. Tank 013 in the Fatigue Test Chamber, 0° View

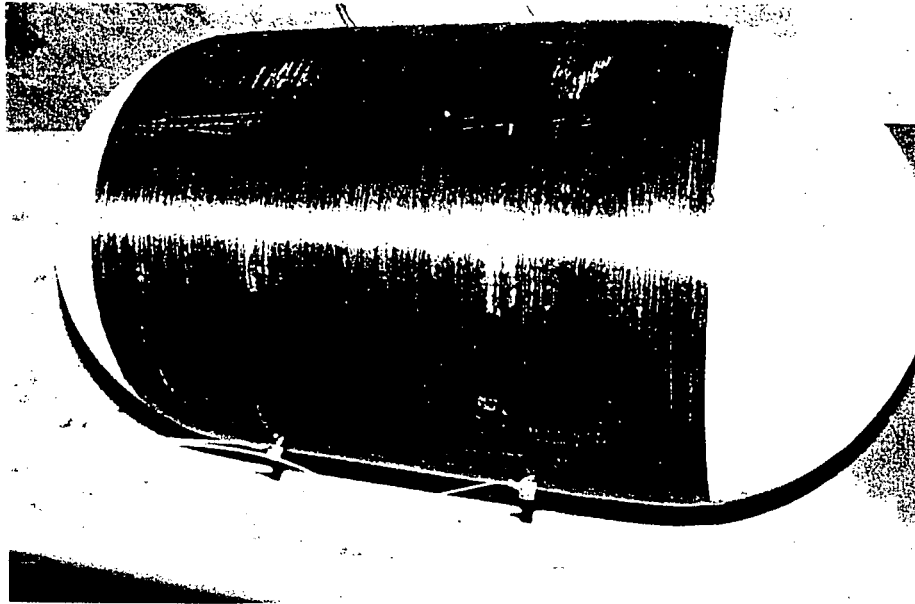
Tests and results for Tank 014 are summarized in Table 9. The as-received Tank 014 is shown in the burst test chamber in Figure 56. In Figure 57, notice the circumferential cracks in Tank 014, which are presumed to be associated with the autofrettage pressurization. The white areas on the top of the tank are typical scuff-type damage observed on the as-received tanks. The four acoustic emission sensor locations are shown in Figure 57. For practical reasons of schedule and convenience, four sensors, rather than seven, were used on Tank 014. The sensors were located at the same axial locations as on the other Type 2 tanks, but the sensors were located 180° rather than 120° apart. Previous testing of Tank 013 indicated that four sensors was the minimum required to cover the overwrap.

Figure 57. Acoustic Emission Sensors on Tank 014

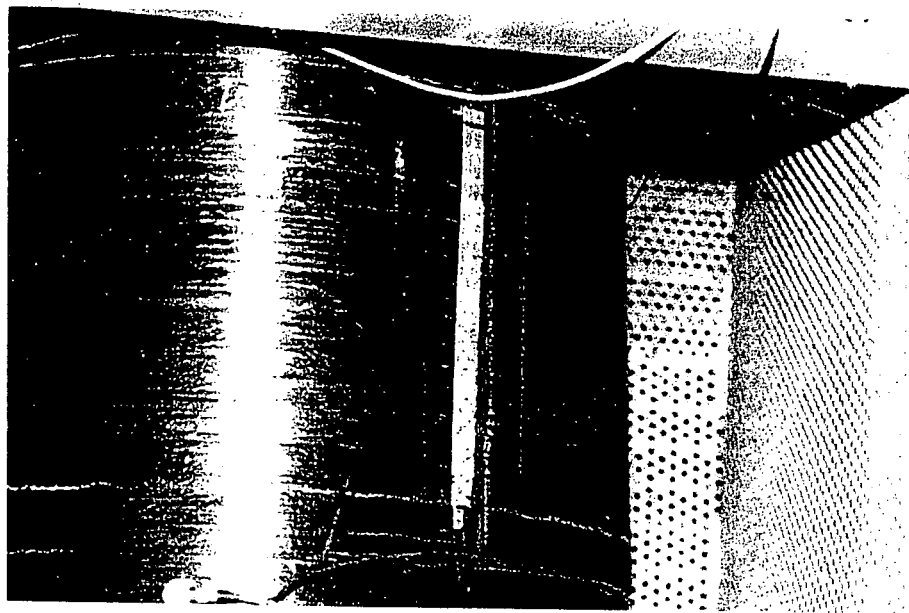
Figure 69. Ends of Slit Separated Following Fatigue Cycling, Overall View

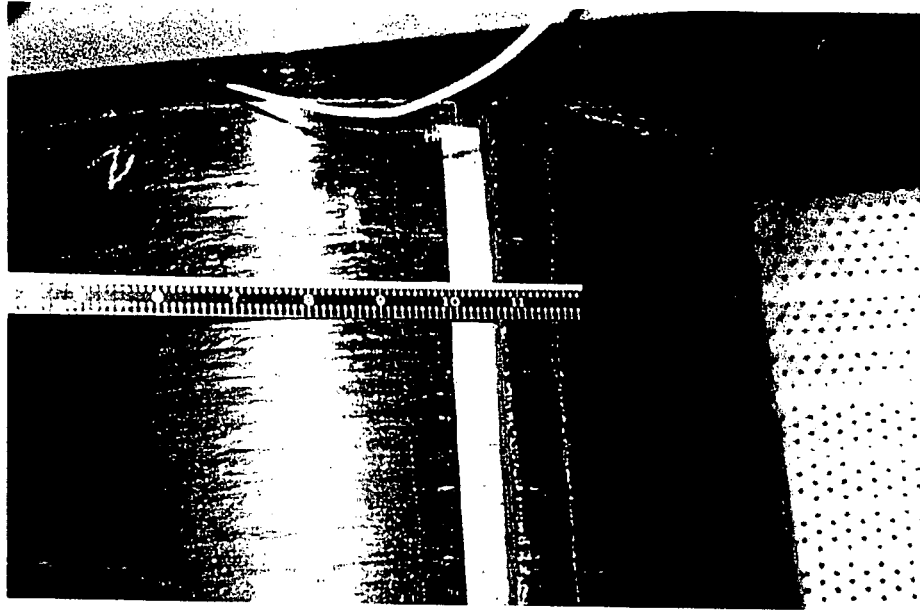
Figure 70. Ends of Slit Separated Following Fatigue Cycling, Close-up

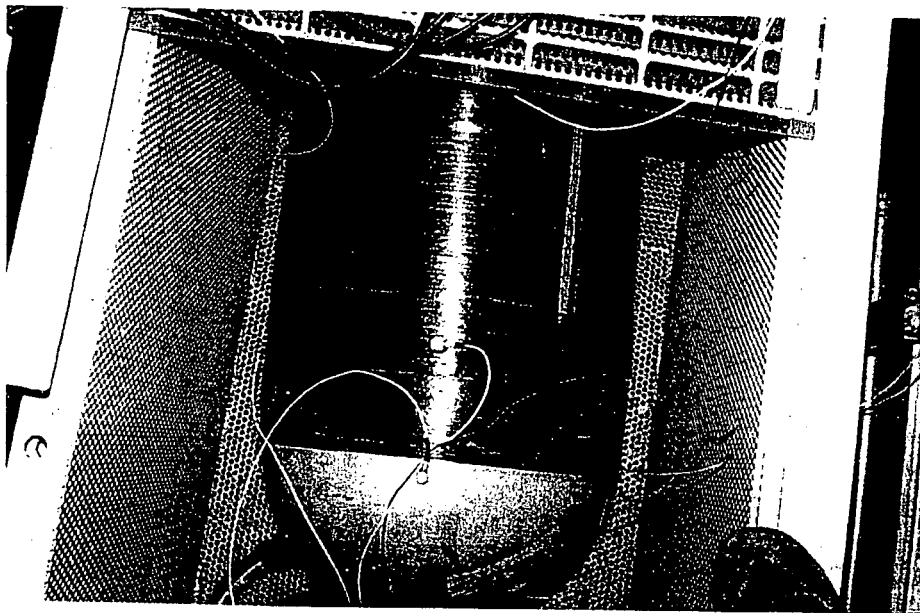
The 8 inch long  $\times$  0.18 inch deep slit in the overwrap of Tank 018 is shown in Figure 65. The tank was pressurized to 4,530 psig, which produced significant acoustic emission. Following one pressure cycle, the ends of the slit separate, as shown in Figure 66, and circumferential cracks propagate from the ends of the slit, as shown by the yellow lines in Figure 67. Prior to fatigue testing, a few remaining fibers were cut so that the slit penetrated through the entire thickness of the overwrap, as shown in Figure 68. After 3,000 pressure cycles in the fatigue chamber, the ends of the slit separate further, as shown in Figures 69 and 70. Views of the tank after 15,000 cycles, shown in Figures 71 and 72, show that the ends of the slit are separated by approximately the same distance as after 3,000 cycles. Cracks emanating from the ends of the slit propagated all the way around the circumference of the tank, indicated by the yellow lines in Figure 71. Also, the entire band of the overwrap was observed to be delaminated from the liner.

Figure 71. Tank 018 Following 15000 Pressure Cycles

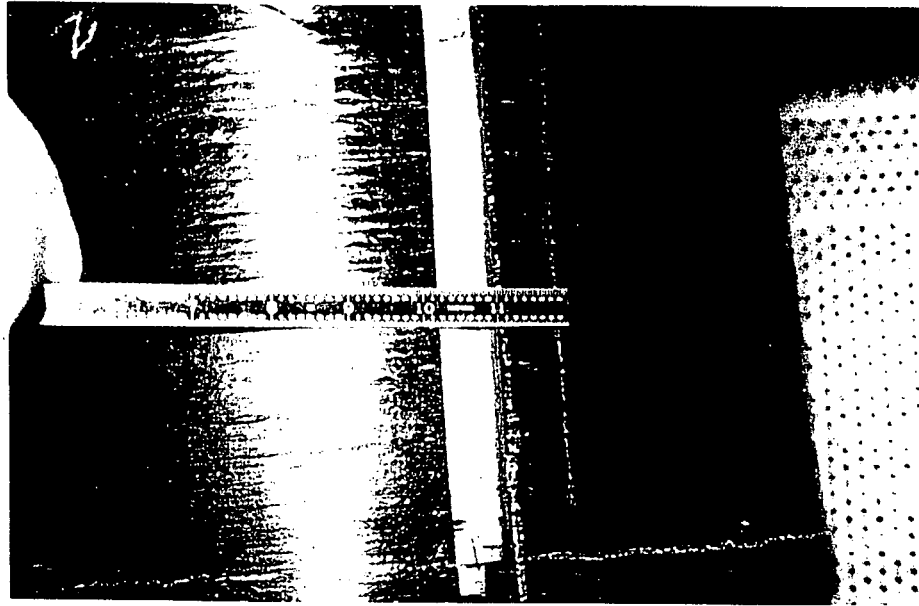
Figure 72. Tank 018 Following 15000 Pressure Cycles, Close-up of Slit

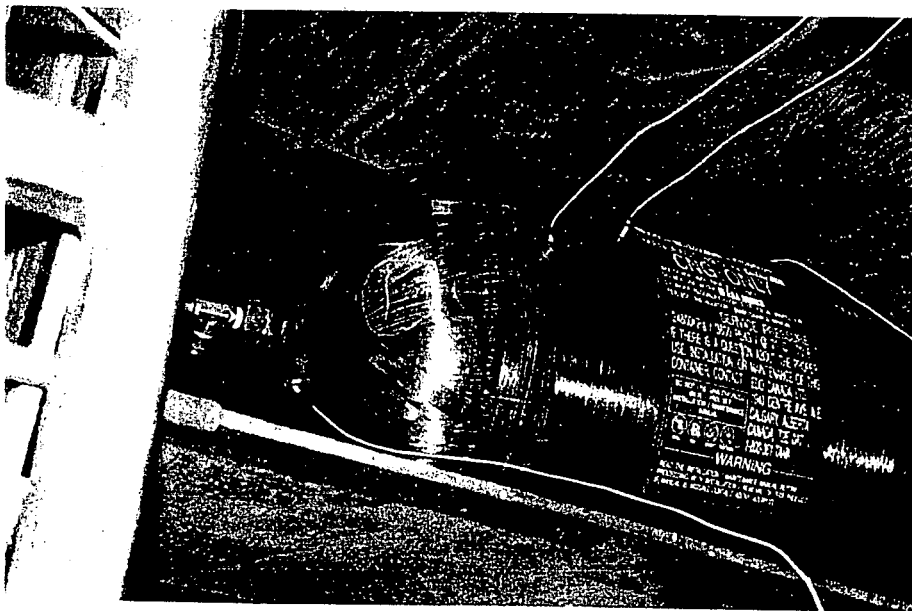
Following the drop test, Tank 003 was pressurized in the burst test chamber to characterize the response of the damaged tank. The tank is shown in the chamber in Figure 83, which also shows the relative position of acoustic emission sensors near the damaged area. Pressurization of the tank to 3667 psig produced significant acoustic emission and no visible change in the tank.

Figure 83. Tank 003 in the Burst Test Chamber, Following the Drop Test

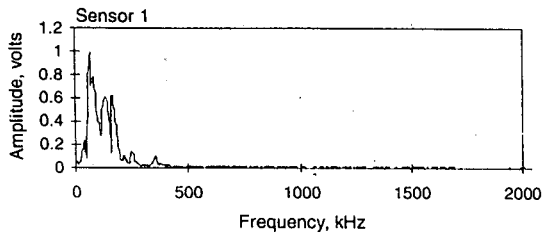
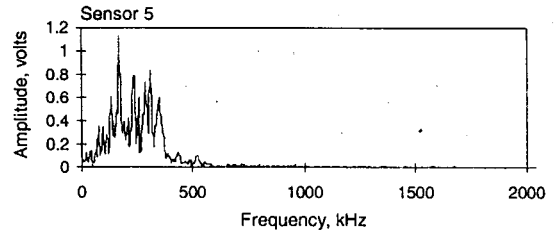
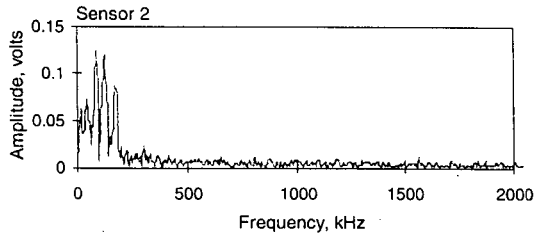
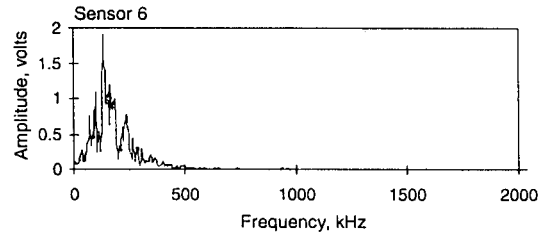
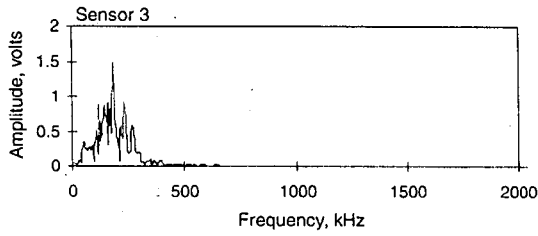
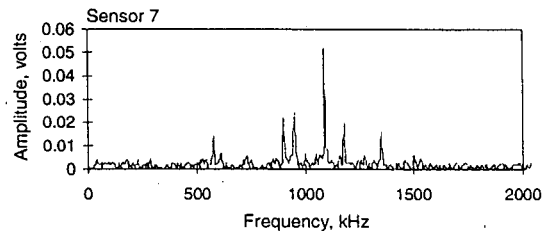
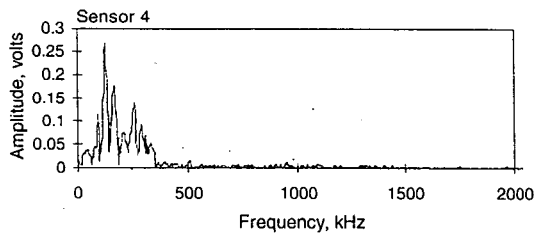
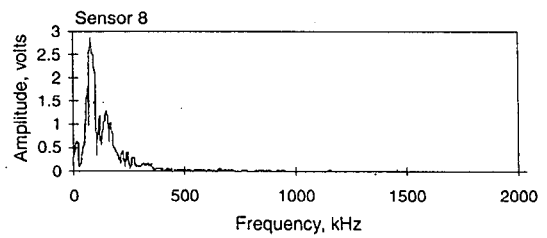
Figure 90a. Waveform from a Typical Event Recorded During Pressurization of the As-Received EDO Type 4 Tank

A typical waveform and FFT from pressurization of the as-received Type 4 tank is shown in Figure 90. As with the Type 2 tanks, the recorded acoustic emission events were consistent with matrix cracking. No waveforms with high frequency components characteristic of fiber breakage were obtained.

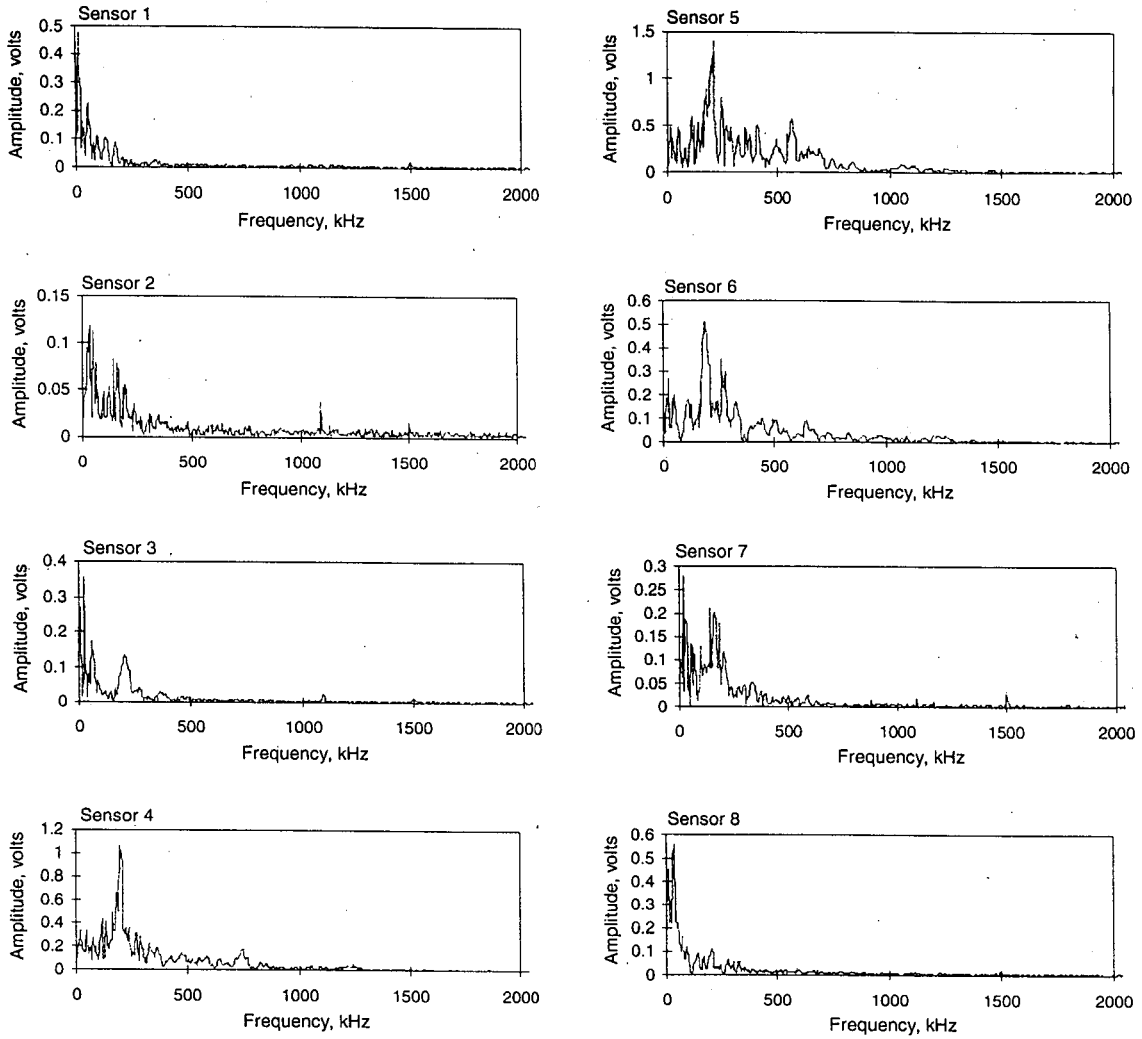
Figure 91a. Waveform from a Typical Event Recorded During Pressurization of a Type 2 Tank with a Saw Cut

Typical waveforms from the pressurization of a Type 2 tank with a saw cut and impact damage are shown in Figures 91 and 92, respectively. The waveforms recorded from these damaged tanks were similar to each other. In addition, the waveforms were not significantly different from the waveforms produced by the as-received tanks, which were attributed only to matrix cracking. No signals were attributed to fiber breakage. Post-pressurization visual inspection of the damaged tanks revealed circumferential cracks in the overwrap originating from the ends of the saw cut and the impact damaged area. These matrix cracks were consistent with the acoustic emissions from the tanks.

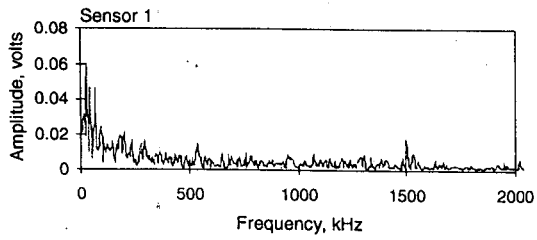
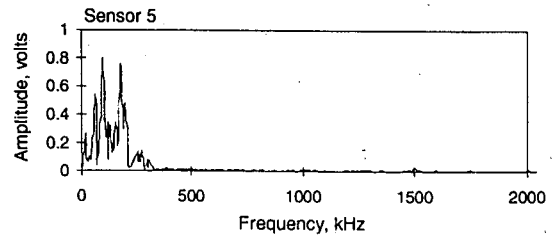
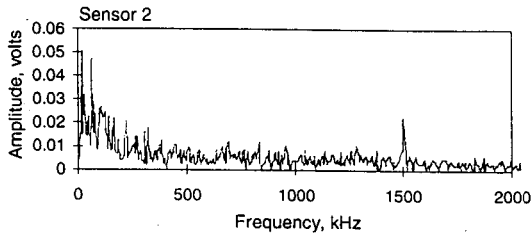
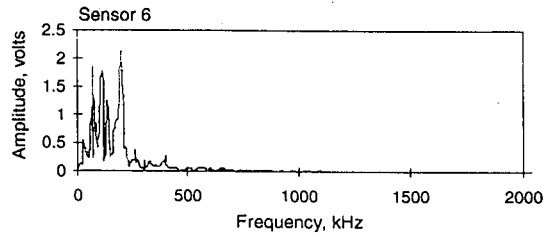
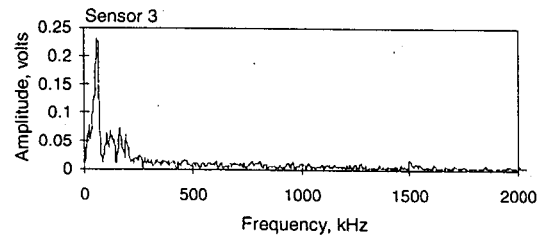
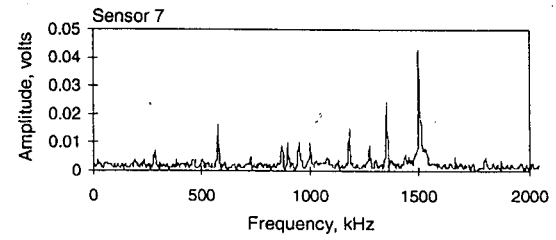
Figure 93a. Waveform from a Typical Event Recorded During Pressurization of the Type 4 Tank with Impact Damage

A typical waveform produced during the pressurization of the damaged Type 4 tank is shown in Figure 93. The impact damage area was identified as the primary source of acoustic emission events during the post-damage pressurization. Over 80% of the signals recorded originated in the damaged area. No high frequency waveforms indicative of fiber breakage were recorded. Visually, no changes were observed in the damaged Type 4 tank following pressurization. However, matrix cracking could have occurred within the overwrap without being detected on the surface of the tank.

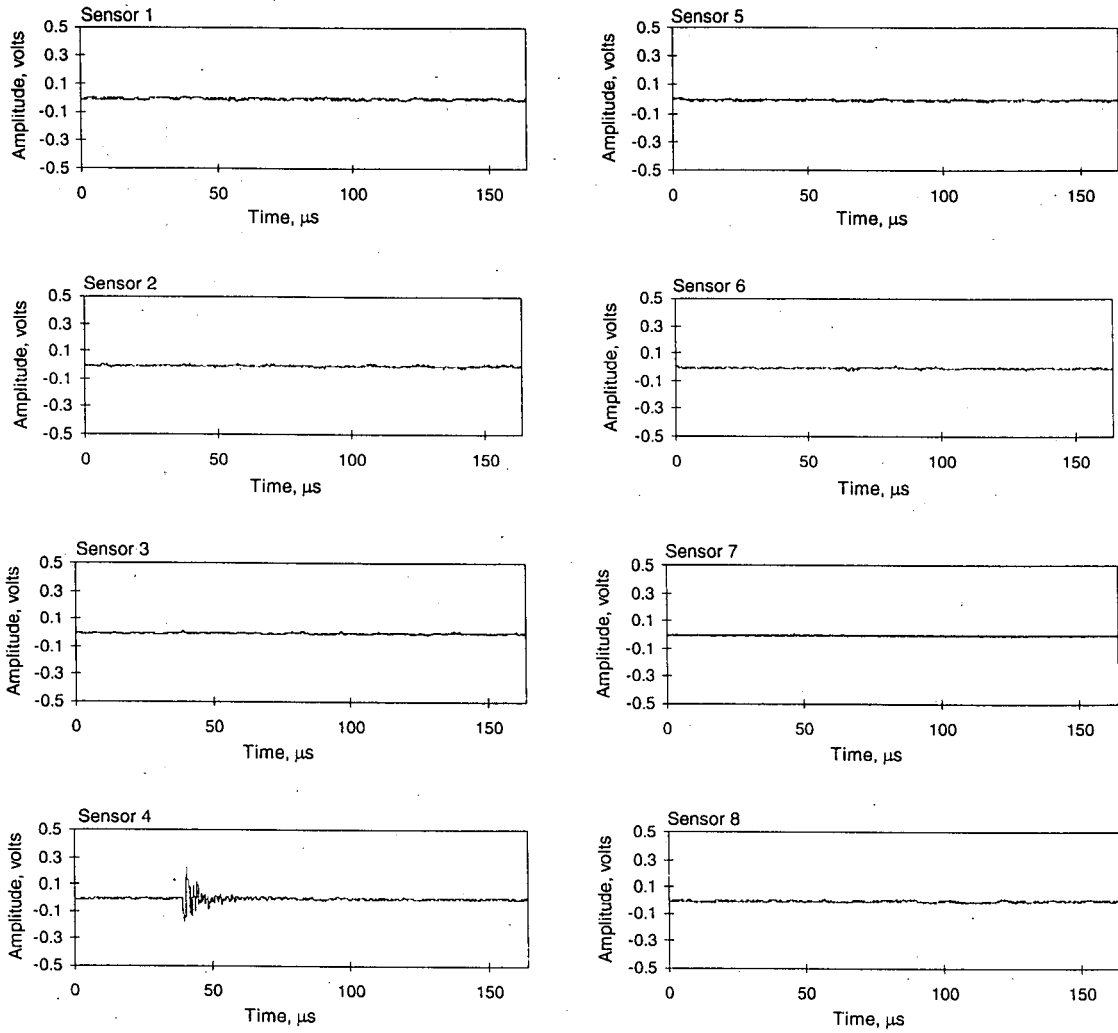
Figure 96. Waveform from a Typical Small Amplitude Event Recorded During Fatigue Cycling of the Type 4 Tank

During fatigue testing of the Type 4 tank, two types of signals were recorded. The small amplitude signal from sources all over the tank is shown in Figure 96. These signals were likely produced by small cracks in the matrix. The signals that originated in the damaged area of the tank, which are likely from matrix cracking, are shown in Figure 97. On single channels, a few high frequency events were recorded. These events were similar to those seen during tow testing and attributed to fiber breakage. Just before failure of the Type 4 tank, a large increase in the number of events per cycle occurred. The majority of the events, similar to the event in Figure 97, was associated with matrix cracking in the impact damaged area. Just prior to failure, low amplitude, high frequency events, such as the waveform shown in Figure 98, were recorded.

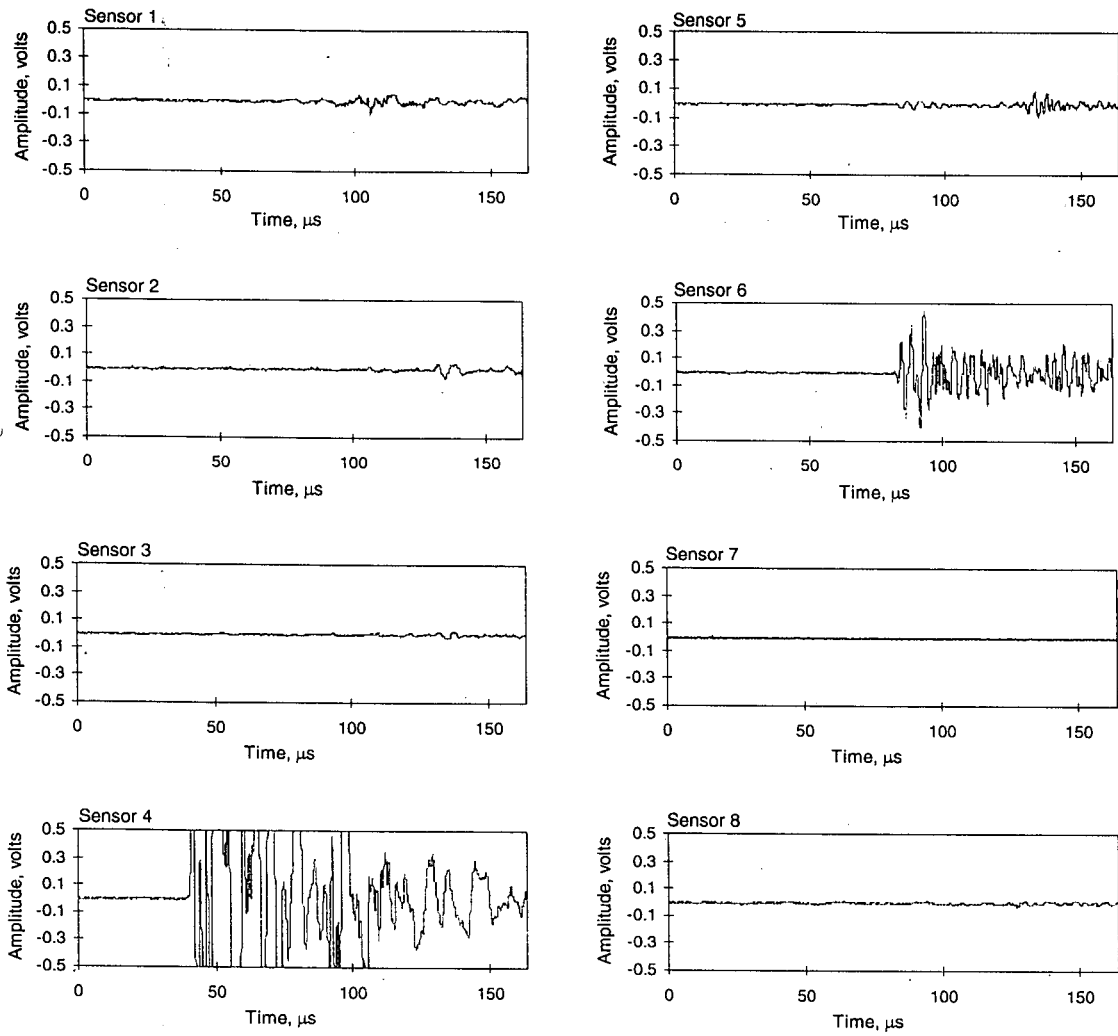
Figure 99. Waveform Recorded During Pressurization Hold After Fatigue Cycling of a Type 2 Tank

After each set of 3,000 pressure cycles, tanks were pressurized to 4,500 psig and held at that pressure for 100 seconds. A typical waveform generated in a Type 2 tank during a pressure hold is shown in Figure 99. Waveforms recorded under these constant pressure conditions were similar to the waveforms recorded from damaged tanks (Section 6.3.2). For Tank 013, a plot of the number of acoustic emission events versus time following 6,000 pressure cycles is shown in Figure 100. This plot is typical of the response of Tank 013 during the pressure holds.

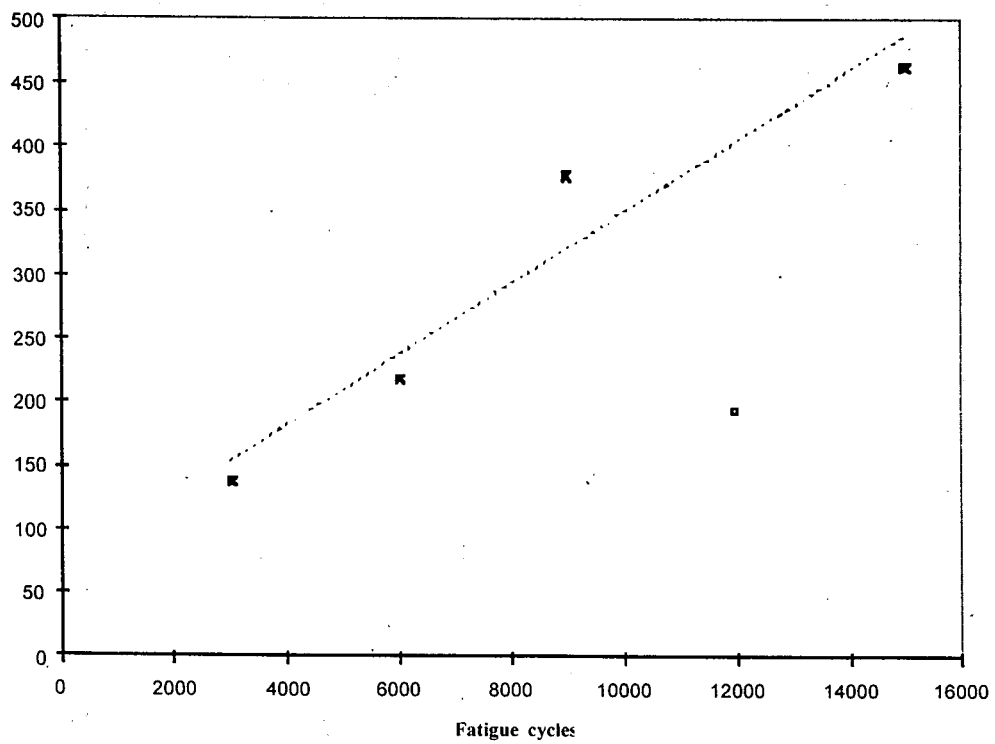
Figure 101. Number of Events During Each Pressure Hold After Fatigue Cycling of Tank 013

A plot of acoustic emission events recorded during each pressure hold for Tank 013 is shown in Figure 101. With the exception of the data point following 12,000 fatigue cycles, the amount of acoustic emission generated during a hold increases with the number of fatigue cycles. The data at 12,000 cycles is in question and was not included in the data analysis. This data is different from all of the other pressure hold data for all tanks. The invalid data point may have been caused by a software problem, which occurred just prior to the completion of the 12,000 cycles.

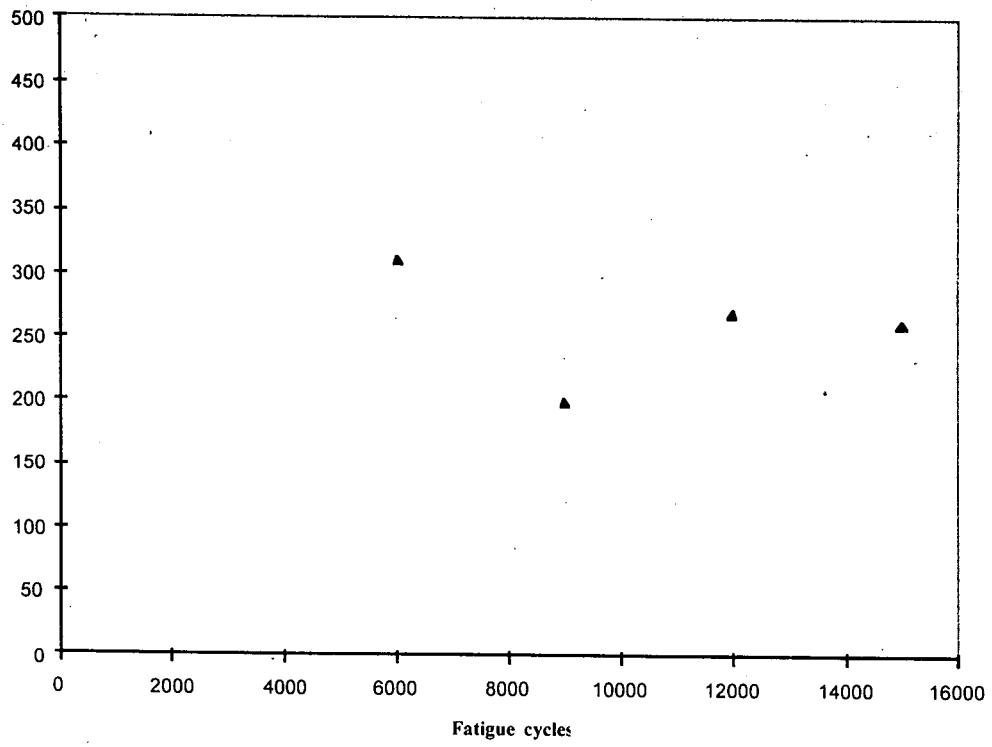
Figure 102. Number of Events During Each Pressure Hold After Fatigue Cycling of Tank 018

For Tank 018, a plot of the number of acoustic emission events during pressure holds versus the number of fatigue cycles is presented in Figure 102. Data for 3,000 cycles is missing, because the high rate of acoustic emission events saturated the A/D boards. The remaining data points in Figure 102 approximate a constant number of events with fatigue cycles. This response may be explained by the physical condition of the tank caused by propagation of the slit during pressurization. Visual examination of the tank early in the fatigue testing revealed that the hoop cracks from the ends of the slit and the delamination under the slit had propagated around the entire circumference of the tank. Consequently, the band of material associated with the slit was completely separated from the underlying liner and from the adjacent overwrap. Therefore, no further damage and associated acoustic emission would occur during subsequent pressure cycling. The recorded acoustic emission events may be from the portion of the overwrap on either side of the slit, which was still bonded to the liner.

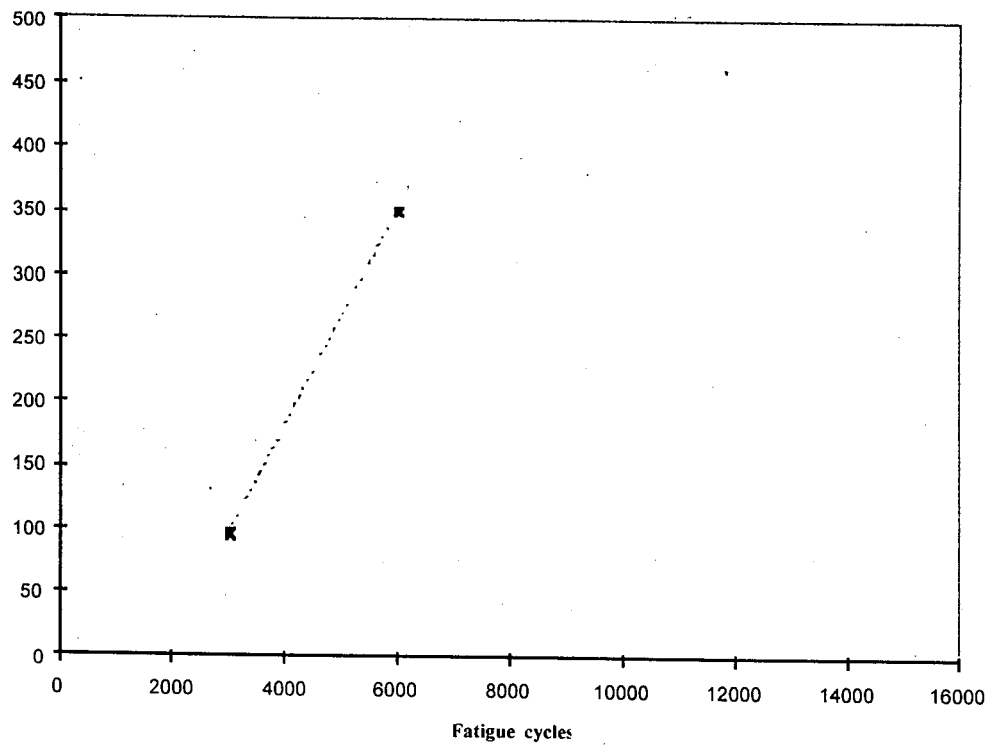
Figure 103. Number of Events During Each Pressure Hold After Fatigue Cycling of Tank 003

For Tank 003, the Type 4 tank, a plot of the number of acoustic emission events during pressure holds versus the number of fatigue cycles is shown in Figure 103. Data were obtained following 3,000 and 6,000 pressure cycles before the tank failed. The number of events at pressure hold increases with fatigue cycles, as it did in Tank 013. However, the rate of increase is much greater for Tank 014. This acoustic emission response is consistent with the progressive failure exhibited by Tank 014, leading to catastrophic failure of the tank during fatigue testing.
