Enclosed is the final report prepared by EXponent (formerly Failure Analysis Associates) entitled, "Development of Inspection Technology for NGV Fuel Tanks." This report relates to Project B.7 (Development of Criteria and Methodologies for In-Service Inspections of Gaseous Fuel Pressure Vessels).

Exponent Failure Analysis Associates, Inc. (FaAA) is pleased to submit the revised report, Development of Inspection Technology for NGV Fuel Tanks. The report was revised in response to comments received from Southwest Research Institute (SwRI) and Powertech Labs (Powertech) documented in the letter of March 20, 1998, from the National Highway Traffic Safety Administration (NHTSA). The following changes were made:

GM contracted with Failure Analysis Associates, Inc. (FaAA), to evaluate techniques for in-service inspection of natural gas vehicle (NGV) fuel tanks. The fuel tank is typically a composite overwrapped pressure vessel (COPV), which stores the gas at approximately 3,000 psig. The fuel tank consists of an inner liner, made either of metal or plastic, to contain the gas and a composite overwrap, typically filament wound with carbon or glass fibers, to resist the internal pressure.

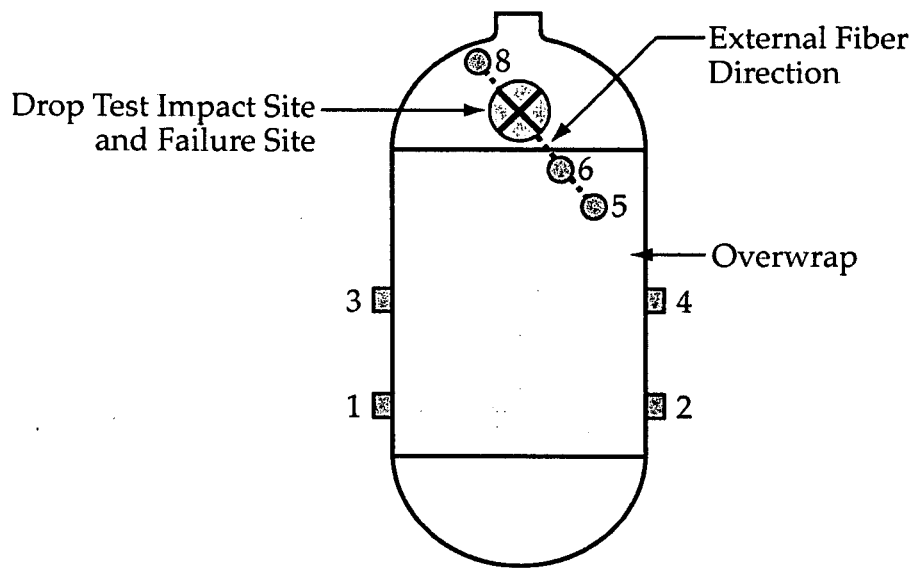
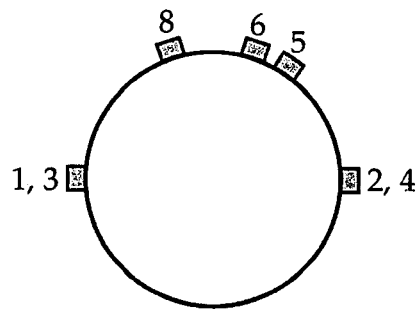
Figure 41. Configuration of Tank 003 Sensors and Damage

Seven sensors were used on Tank 003, four to monitor the overall response of the overwrap and three to monitor the response of the damaged area (Figure 41). The four sensors were located 180° apart at two longitudinal locations. The three sensors were positioned on either side of the damaged area and oriented along an external fiber, as shown in Figure 41.

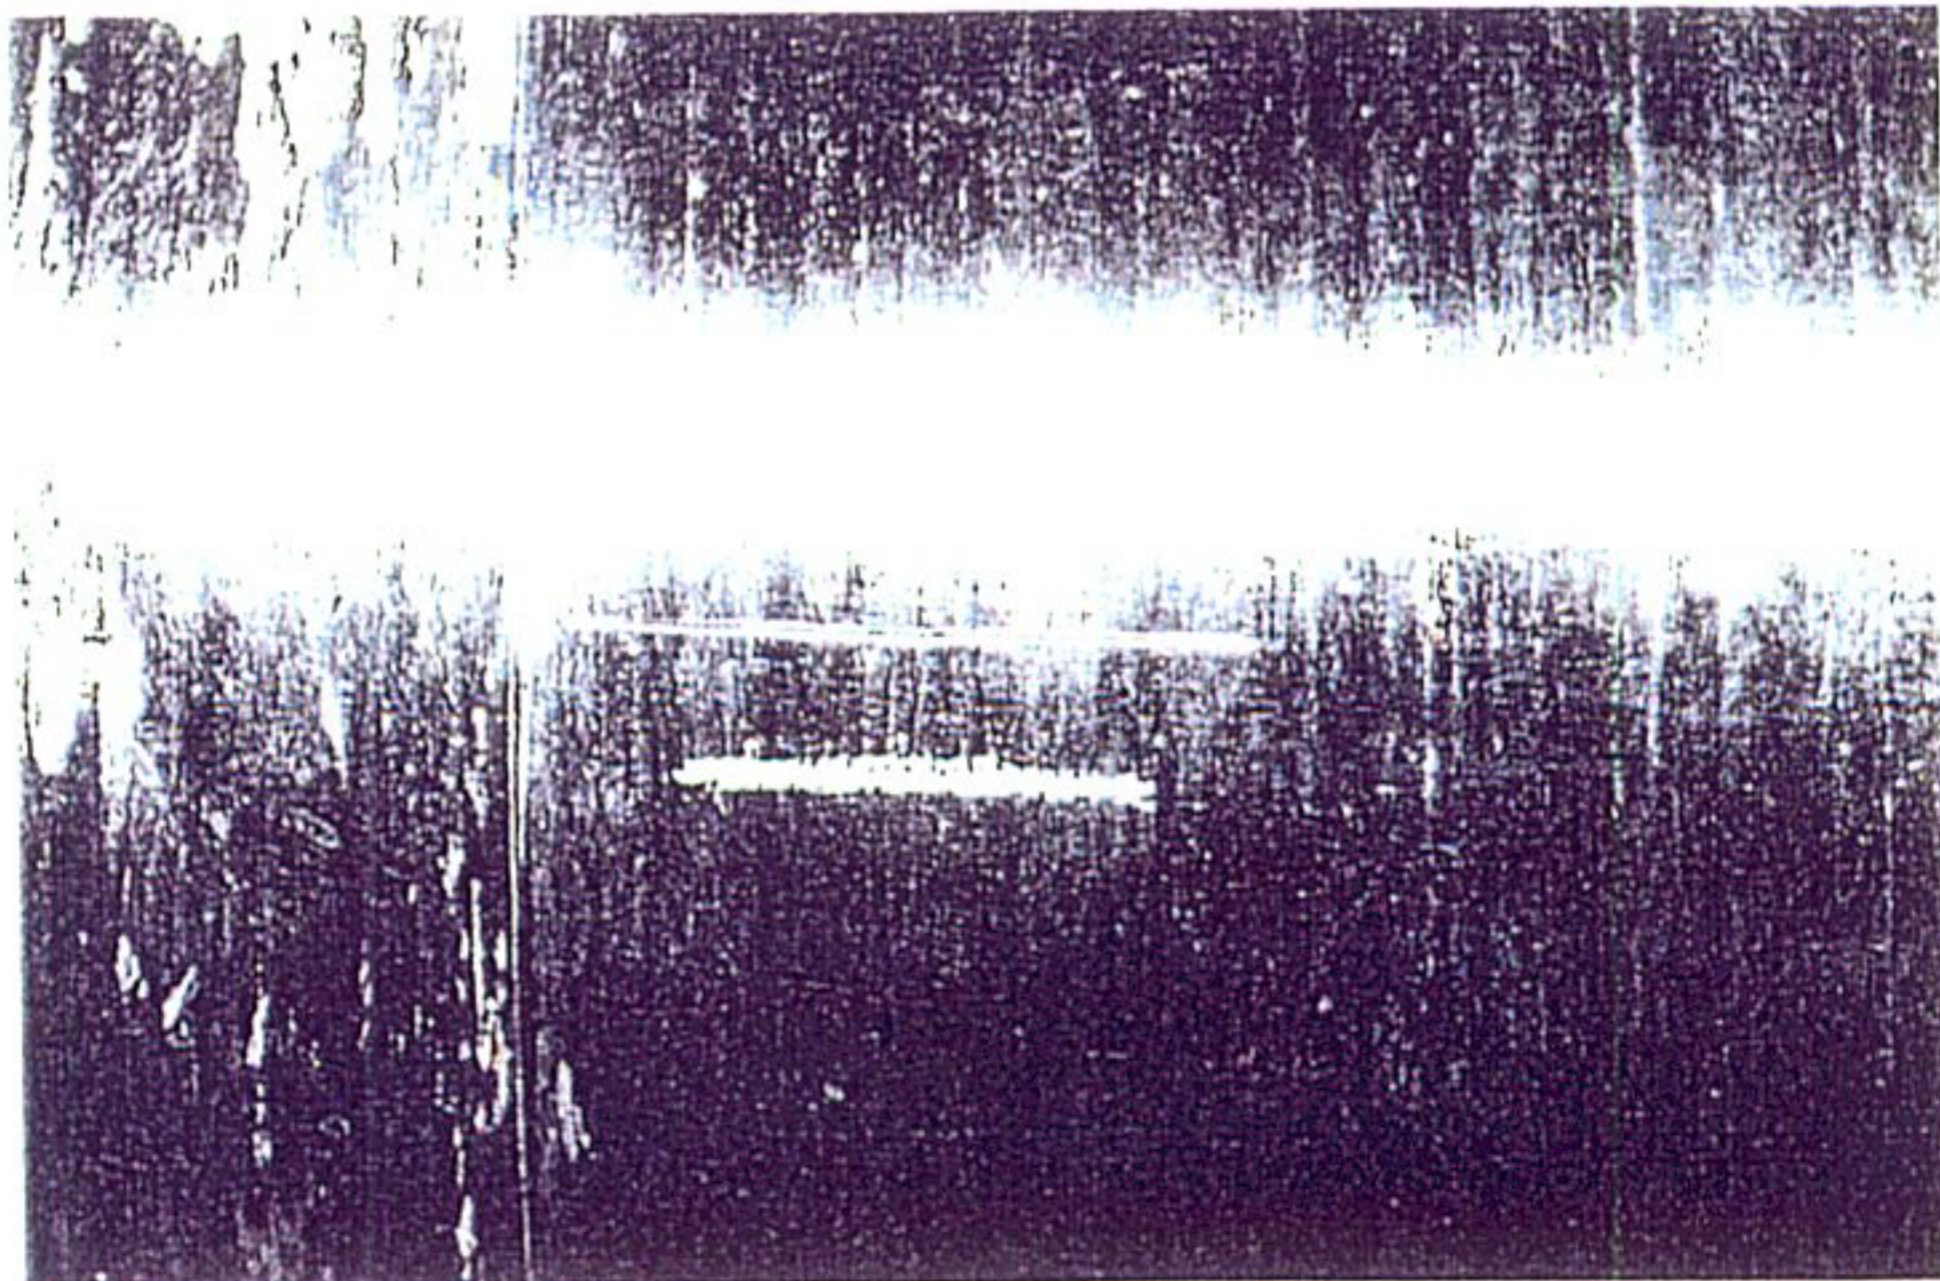
Figure 46. 2-inch Slit in the Overwrap of Tank 013

The 2 inch slit in the overwrap (near Sensor 5) is shown in Figure 46. The slit was located 4.5 inches from the open end of the overwrap. The circumferential crack to the left of the slit in Figure 46 was present in the overwrap of the as-received tank and was attributed to the autofrettage pressurization. Tank 013 containing the 2-inch slit was pressurized to 5,533 psig, which produced audible noise and significant acoustic emission. Visual examination of the tank following pressurization revealed that the autofrettage cracks were more prominent. It also revealed two new circumferential cracks from the ends of the slit, indicated by the yellow lines in Figure 47. These cracks eventually propagated all the way around the circumference of the tank after fatigue cycling. Subsequent pressurization of the tank also caused the ends of the slit to separate circumferentially and to delaminate from the underlying overwrap.

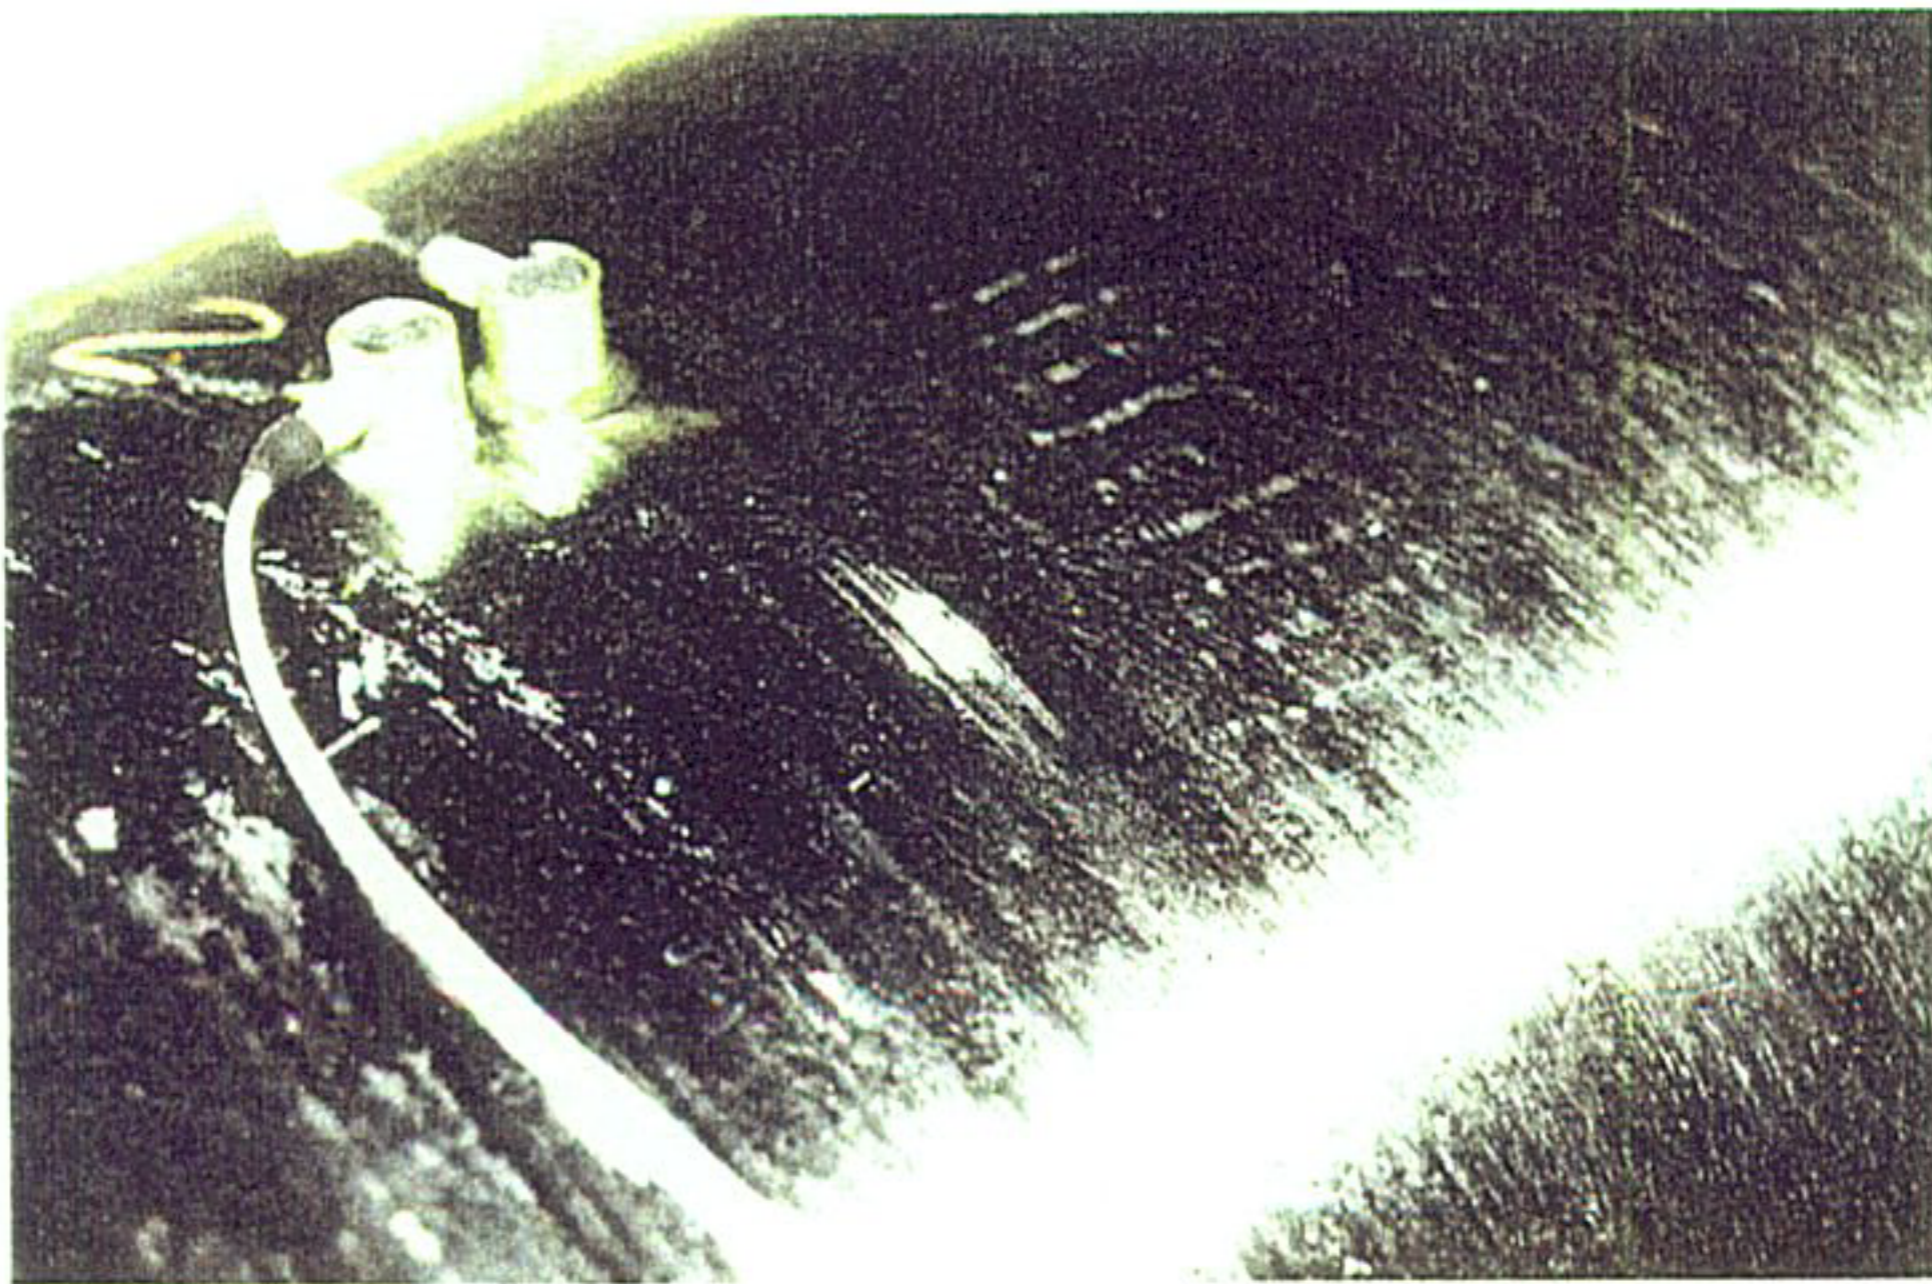
Figure 50. Impact Site Following 22.1 ft-lbs Impact

The pendulum impact fixture was designed to impact the tank while it was in the burst test chamber, as shown in Figure 48. A close-up view of the pyramid-shaped impactor is shown in Figure 49. The impact site following the 22.1 ft-lbs impact is shown in Figure 50. Several hoop cracks and two shallow dents were created by the impact. The visual extent of the damage, indicated by the rectangular region in Figure 51, is approximately 1.5 inches circumferentially \times 0.5 inches axially. Pressurization of the tank to 5504 psig produced audible noise and significant acoustic emission. Following pressurization, the fibers in the damaged area were lifted from the surface, but no apparent crack growth was observed.

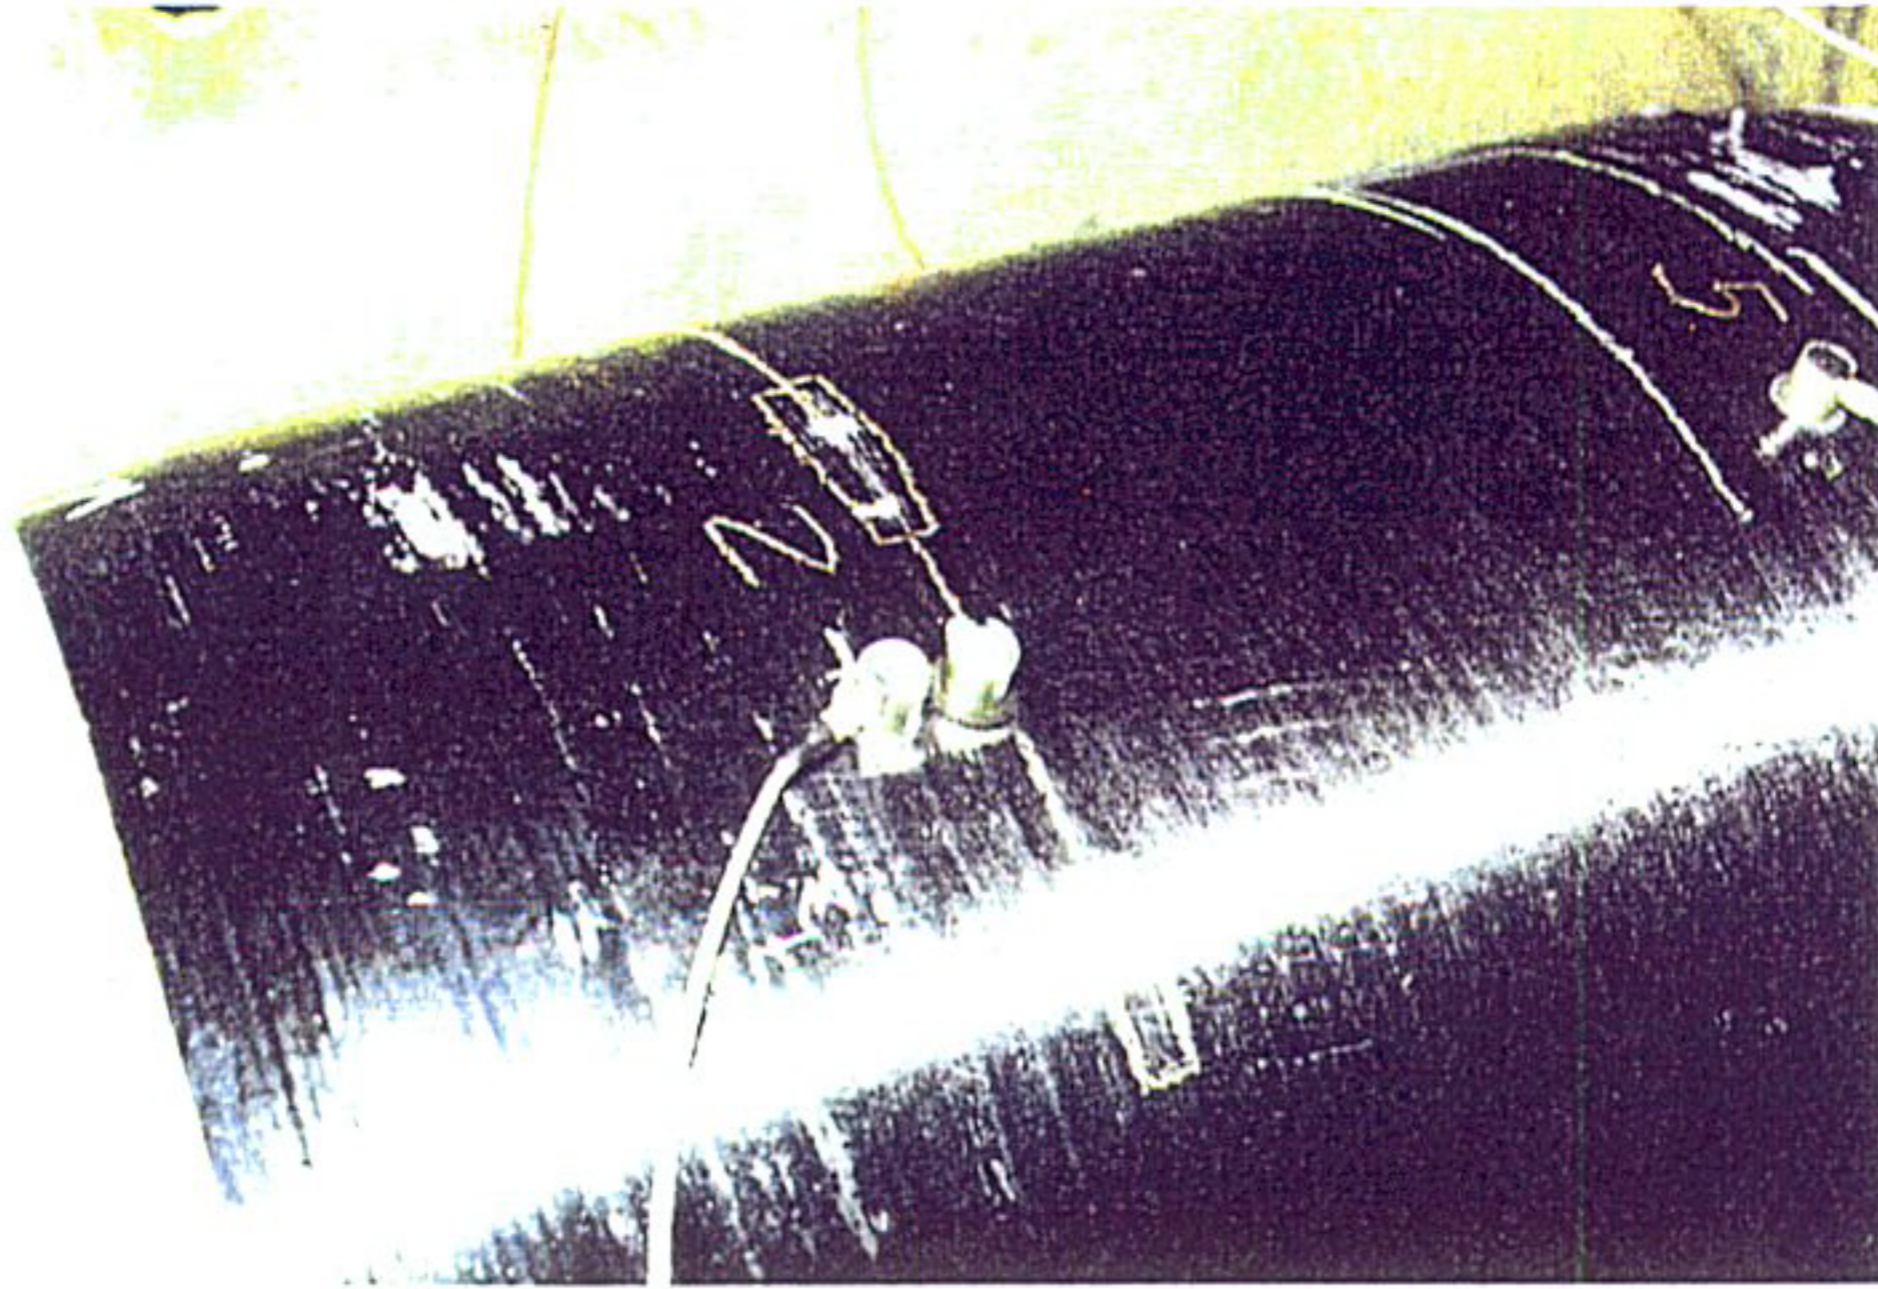
Figure 53. Impact Site Following 221 ft-lbs Impact

Weight was added to the pendulum impact fixture in order to increase the impact energy to 221 ft-lbs, as shown in Figure 52. The tank was also rotated so that the impact occurred at approximately the same longitudinal location but at a circumferential location approximately the same distance from Sensor 2 as the 22.1 ft-lbs impact. The appearance of the 221 ft-lbs impact damage, which includes circumferential cracks, fibers lifted off the surface, a 0.125-inch deep dent, and a shallow dent, is shown in Figure 53. The size of the visibly damaged area is approximately 2.25 inches circumferentially \times 0.5 inches axially. No change in the damage was observed following pressurization of the tank to 5529 psig.

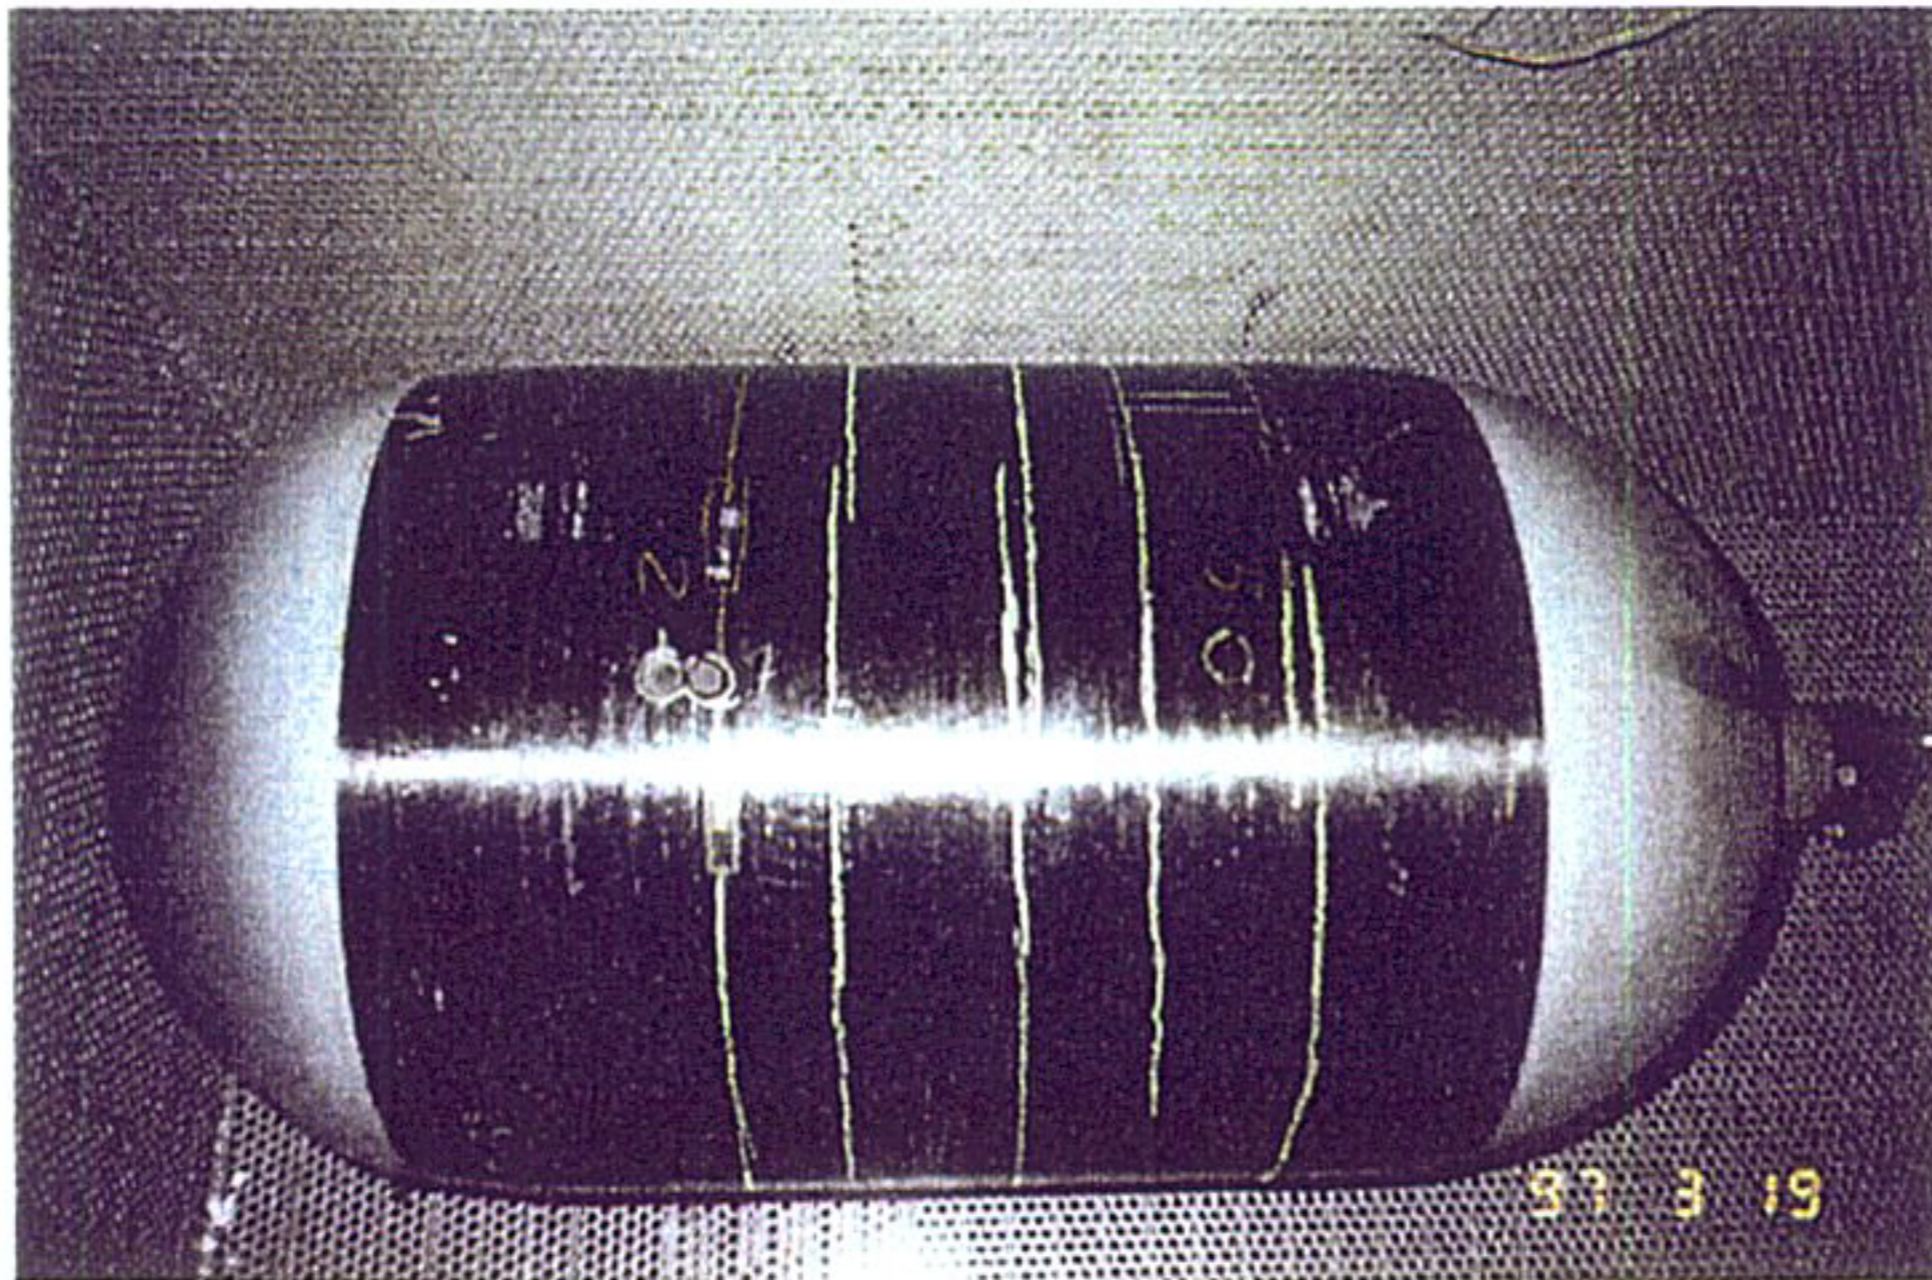
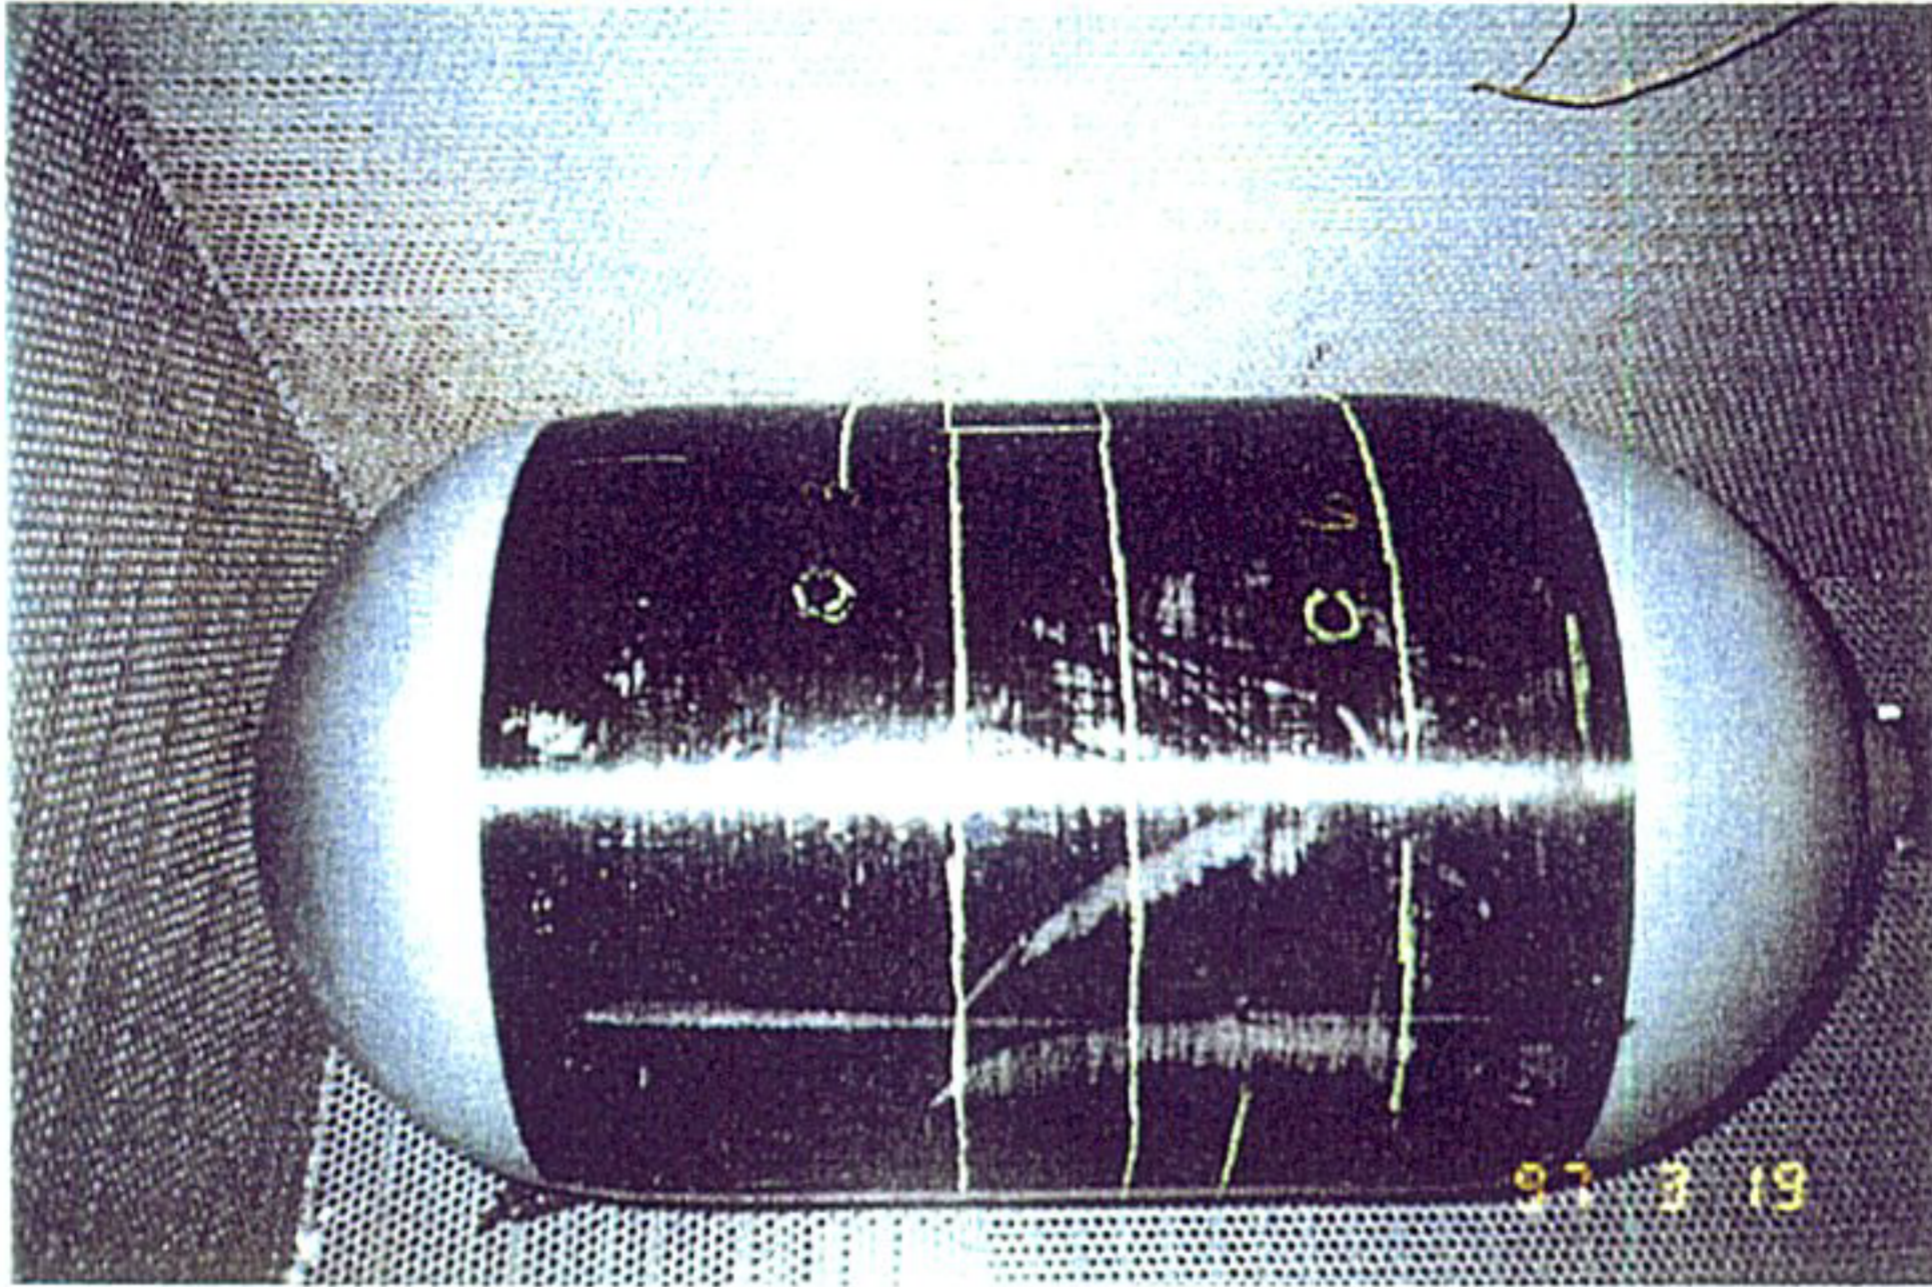
Figure 54. Tank 013 in the Fatigue Test Chamber, 0° View

Following post-damage characterization in the burst test facility, Tank 013 was moved to the fatigue test facility for cyclic pressure testing. Views of the tank in the fatigue test chamber are shown in Figures 54-55. Cyclic loading was stopped every 3,000 cycles to allow a visual examination and acoustic emission damage characterization. Under cyclic loading, circumferential cracks grew from the two areas of impact damage and from the ends of the two slits. These cracks were marked on the surface of the tank with yellow and red markers, so that they would be easier to track and photograph. These lines are seen in Figures 54-55, which illustrate the circumferential crack growth. In Figure 54, the 2 inch long slit is visible in the upper right above Sensor 5, with yellow lines indicating the circumferential cracks emanating from each end of the slit. The pair of yellow lines in the center of the tank is associated with cracks from the 3-inch long slit, which is seen in the upper center of Figure 55 between Sensors 3 and 6. Due to fatigue cycling, the ends of the two slits separated and the slits delaminated from the underlying overwrap. The two impact damaged areas and their associated cracks are shown in the left of Figure 54 near Sensors 2 and 7. Notice that the crack propagates between the two damage areas and continues around the circumference of the tank.

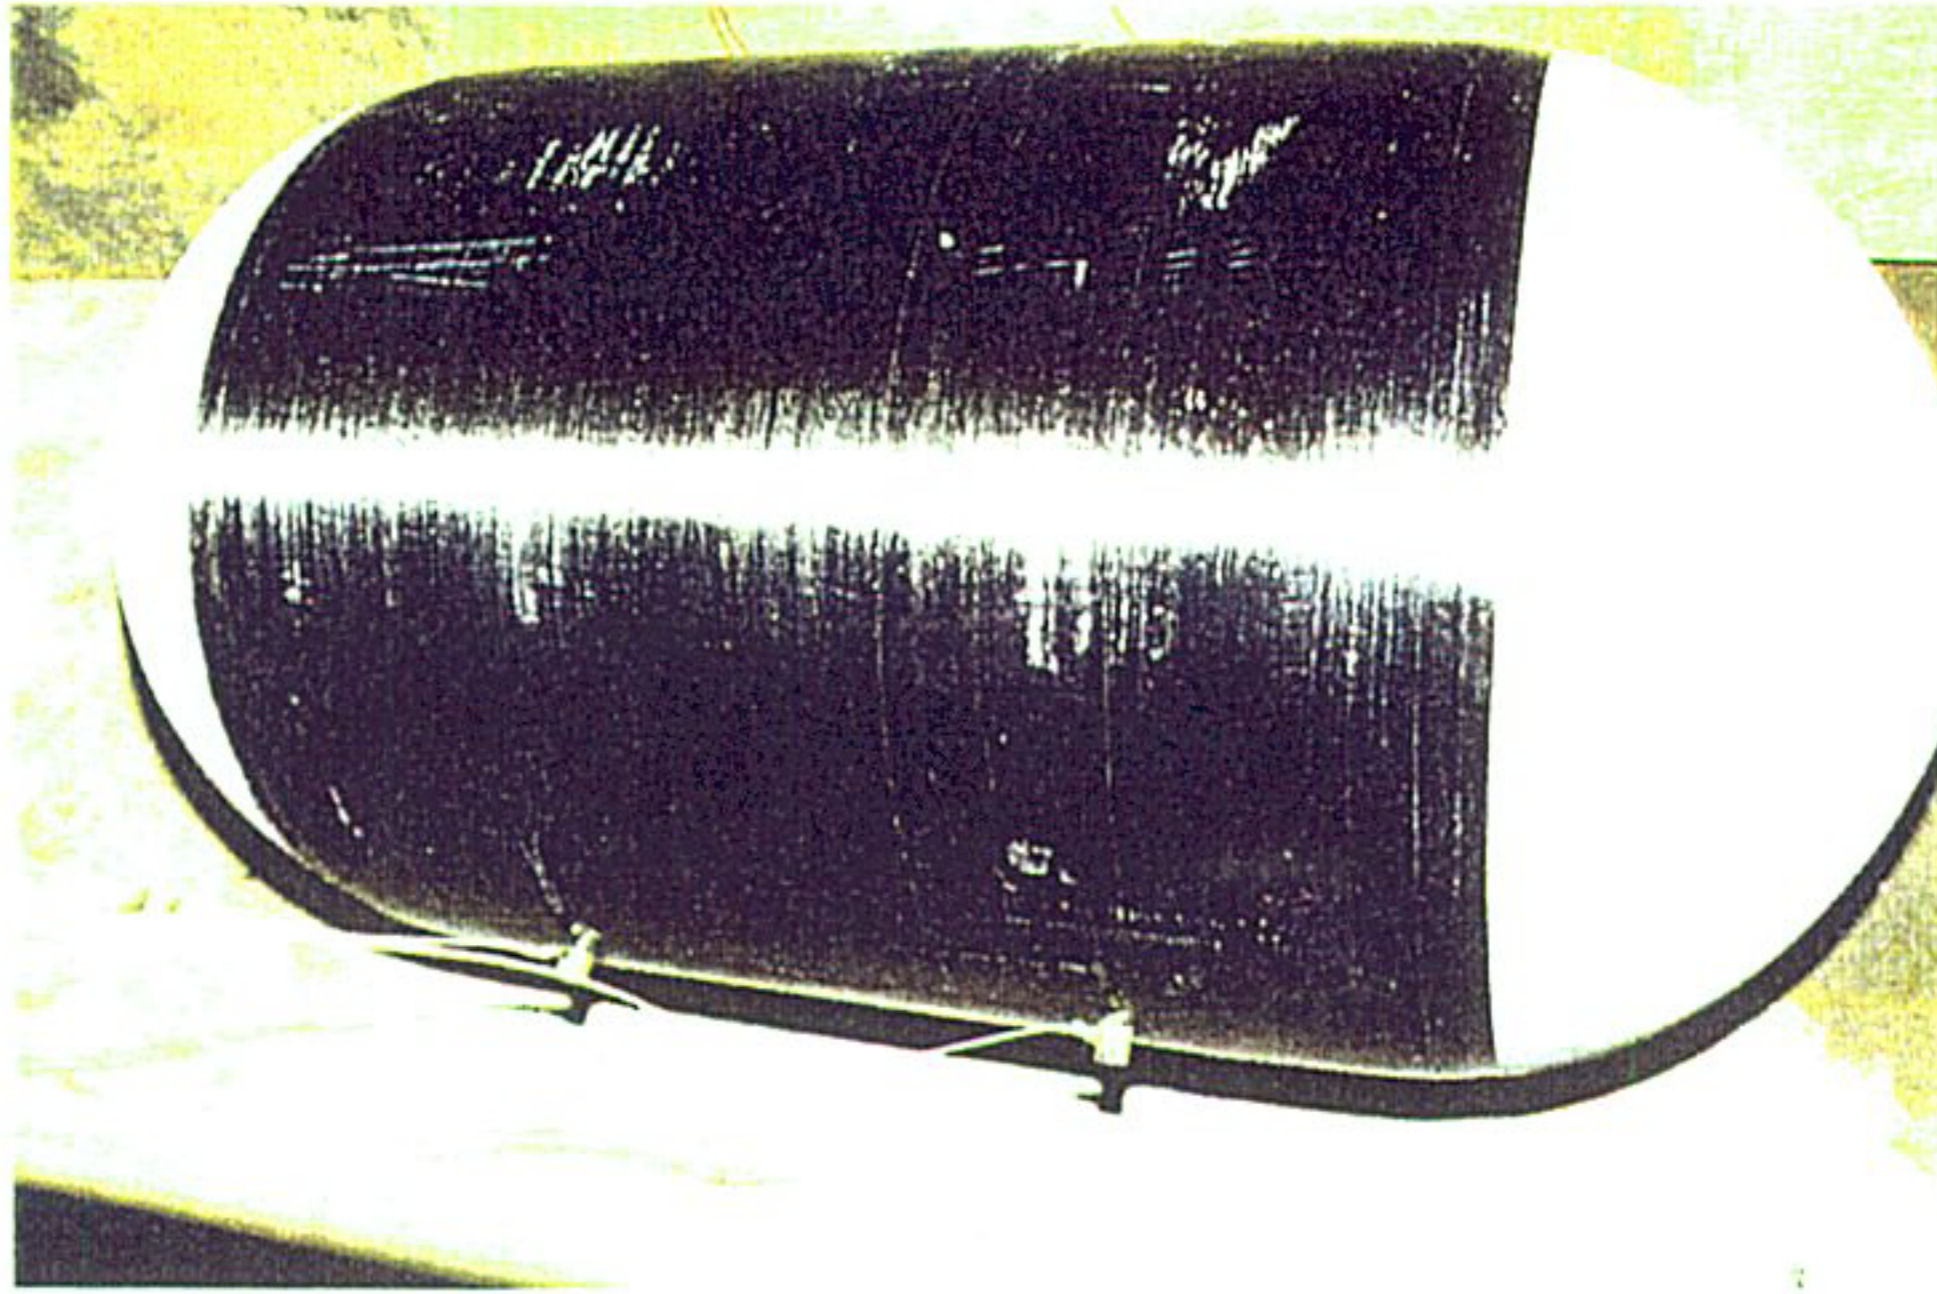
Figure 57. Acoustic Emission Sensors on Tank 014

Tests and results for Tank 014 are summarized in Table 9. The as-received Tank 014 is shown in the burst test chamber in Figure 56. In Figure 57, notice the circumferential cracks in Tank 014, which are presumed to be associated with the autofrettage pressurization. The white areas on the top of the tank are typical scuff-type damage observed on the as-received tanks. The four acoustic emission sensor locations are shown in Figure 57. For practical reasons of schedule and convenience, four sensors, rather than seven, were used on Tank 014. The sensors were located at the same axial locations as on the other Type 2 tanks, but the sensors were located 180° rather than 120° apart. Previous testing of Tank 013 indicated that four sensors was the minimum required to cover the overwrap.

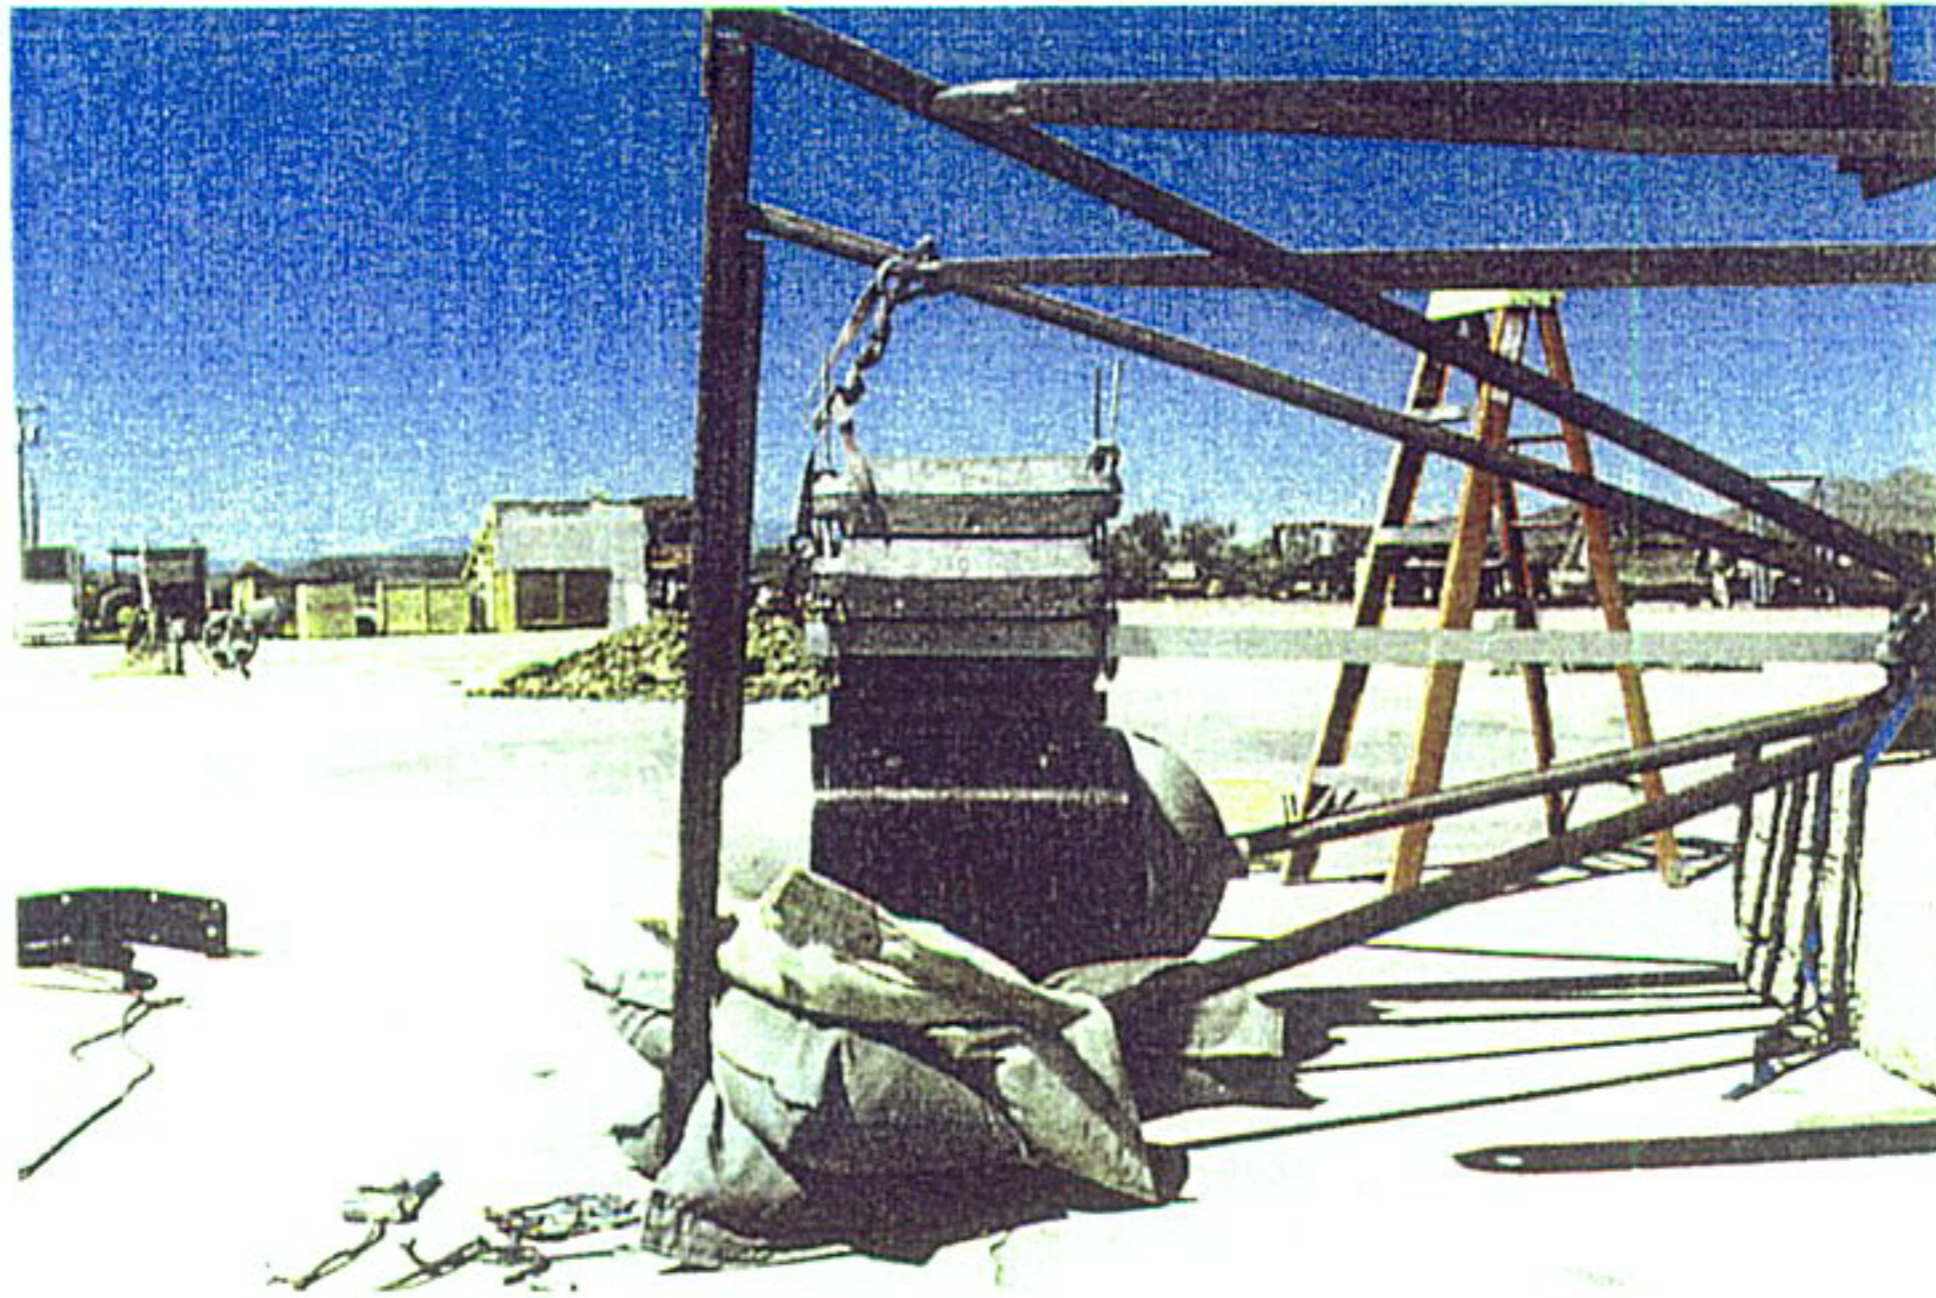
Figure 60. Large Impact Fixture Set-up for Tank 018, Side View

The test set-up for impacting Tank 018 in the large impact test facility at an impact energy of 2,050 ft-lbs is shown in Figures 60 and 61. As shown in the figures, the impactor is a steel box section 2 inches wide \times 17 inches long, so that the impactor contacted the tank along the entire length of the overwrap over a 2 inch circumferential length. The test facility, just prior to release of the pendulum, is shown in Figure 62. Views of the post-impact damage are shown in Figures 63 and 64. The damage appears as a series of light circumferential lines approximately equally spaced along the length of the overwrap. The circumferential extent of the damage is greater toward the closed end of the tank. The post-impact Tank 018 was pressurized to 7,200 psig and exhibited no significant difference in acoustic emission response from the as-received tank, indicating no significant effect of the impact on the overwrap.

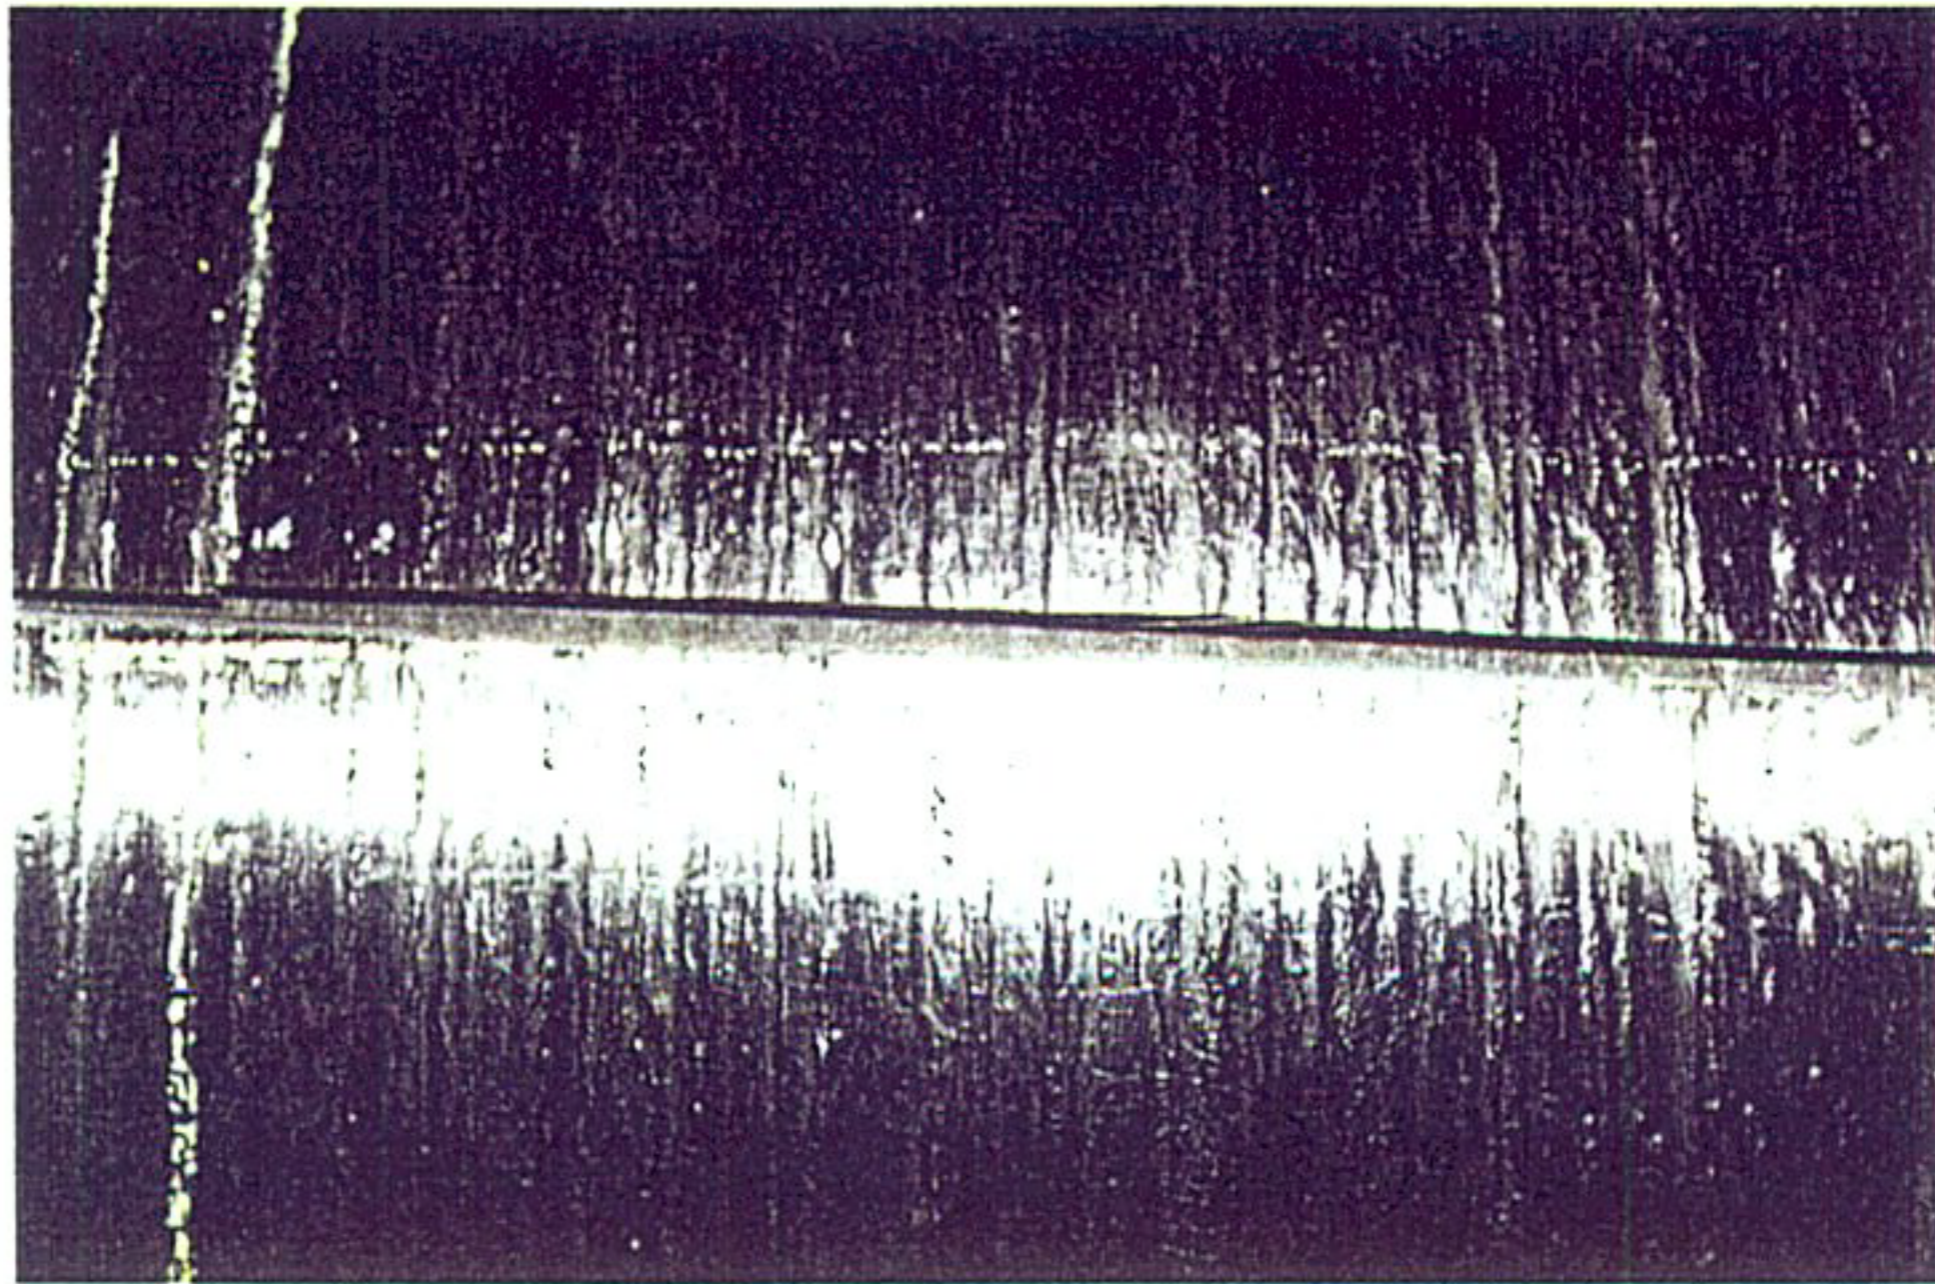
Figure 66. Ends of Slit Separated Following Pressurization

The 8 inch long \times 0.18 inch deep slit in the overwrap of Tank 018 is shown in Figure 65. The tank was pressurized to 4,530 psig, which produced significant acoustic emission. Following one pressure cycle, the ends of the slit separate, as shown in Figure 66, and circumferential cracks propagate from the ends of the slit, as shown by the yellow lines in Figure 67. Prior to fatigue testing, a few remaining fibers were cut so that the slit penetrated through the entire thickness of the overwrap, as shown in Figure 68. After 3,000 pressure cycles in the fatigue chamber, the ends of the slit separate further, as shown in Figures 69 and 70. Views of the tank after 15,000 cycles, shown in Figures 71 and 72, show that the ends of the slit are separated by approximately the same distance as after 3,000 cycles. Cracks emanating from the ends of the slit propagated all the way around the circumference of the tank, indicated by the yellow lines in Figure 71. Also, the entire band of the overwrap was observed to be delaminated from the liner.
