Enclosed is the final report prepared by EXponent (formerly Failure Analysis Associates) entitled, "Development of Inspection Technology for NGV Fuel Tanks." This report relates to Project B.7 (Development of Criteria and Methodologies for In-Service Inspections of Gaseous Fuel Pressure Vessels).

Exponent Failure Analysis Associates, Inc. (FaAA) is pleased to submit the revised report, Development of Inspection Technology for NGV Fuel Tanks. The report was revised in response to comments received from Southwest Research Institute (SwRI) and Powertech Labs (Powertech) documented in the letter of March 20, 1998, from the National Highway Traffic Safety Administration (NHTSA). The following changes were made:

GM contracted with Failure Analysis Associates, Inc. (FaAA), to evaluate techniques for in-service inspection of natural gas vehicle (NGV) fuel tanks. The fuel tank is typically a composite overwrapped pressure vessel (COPV), which stores the gas at approximately 3,000 psig. The fuel tank consists of an inner liner, made either of metal or plastic, to contain the gas and a composite overwrap, typically filament wound with carbon or glass fibers, to resist the internal pressure.

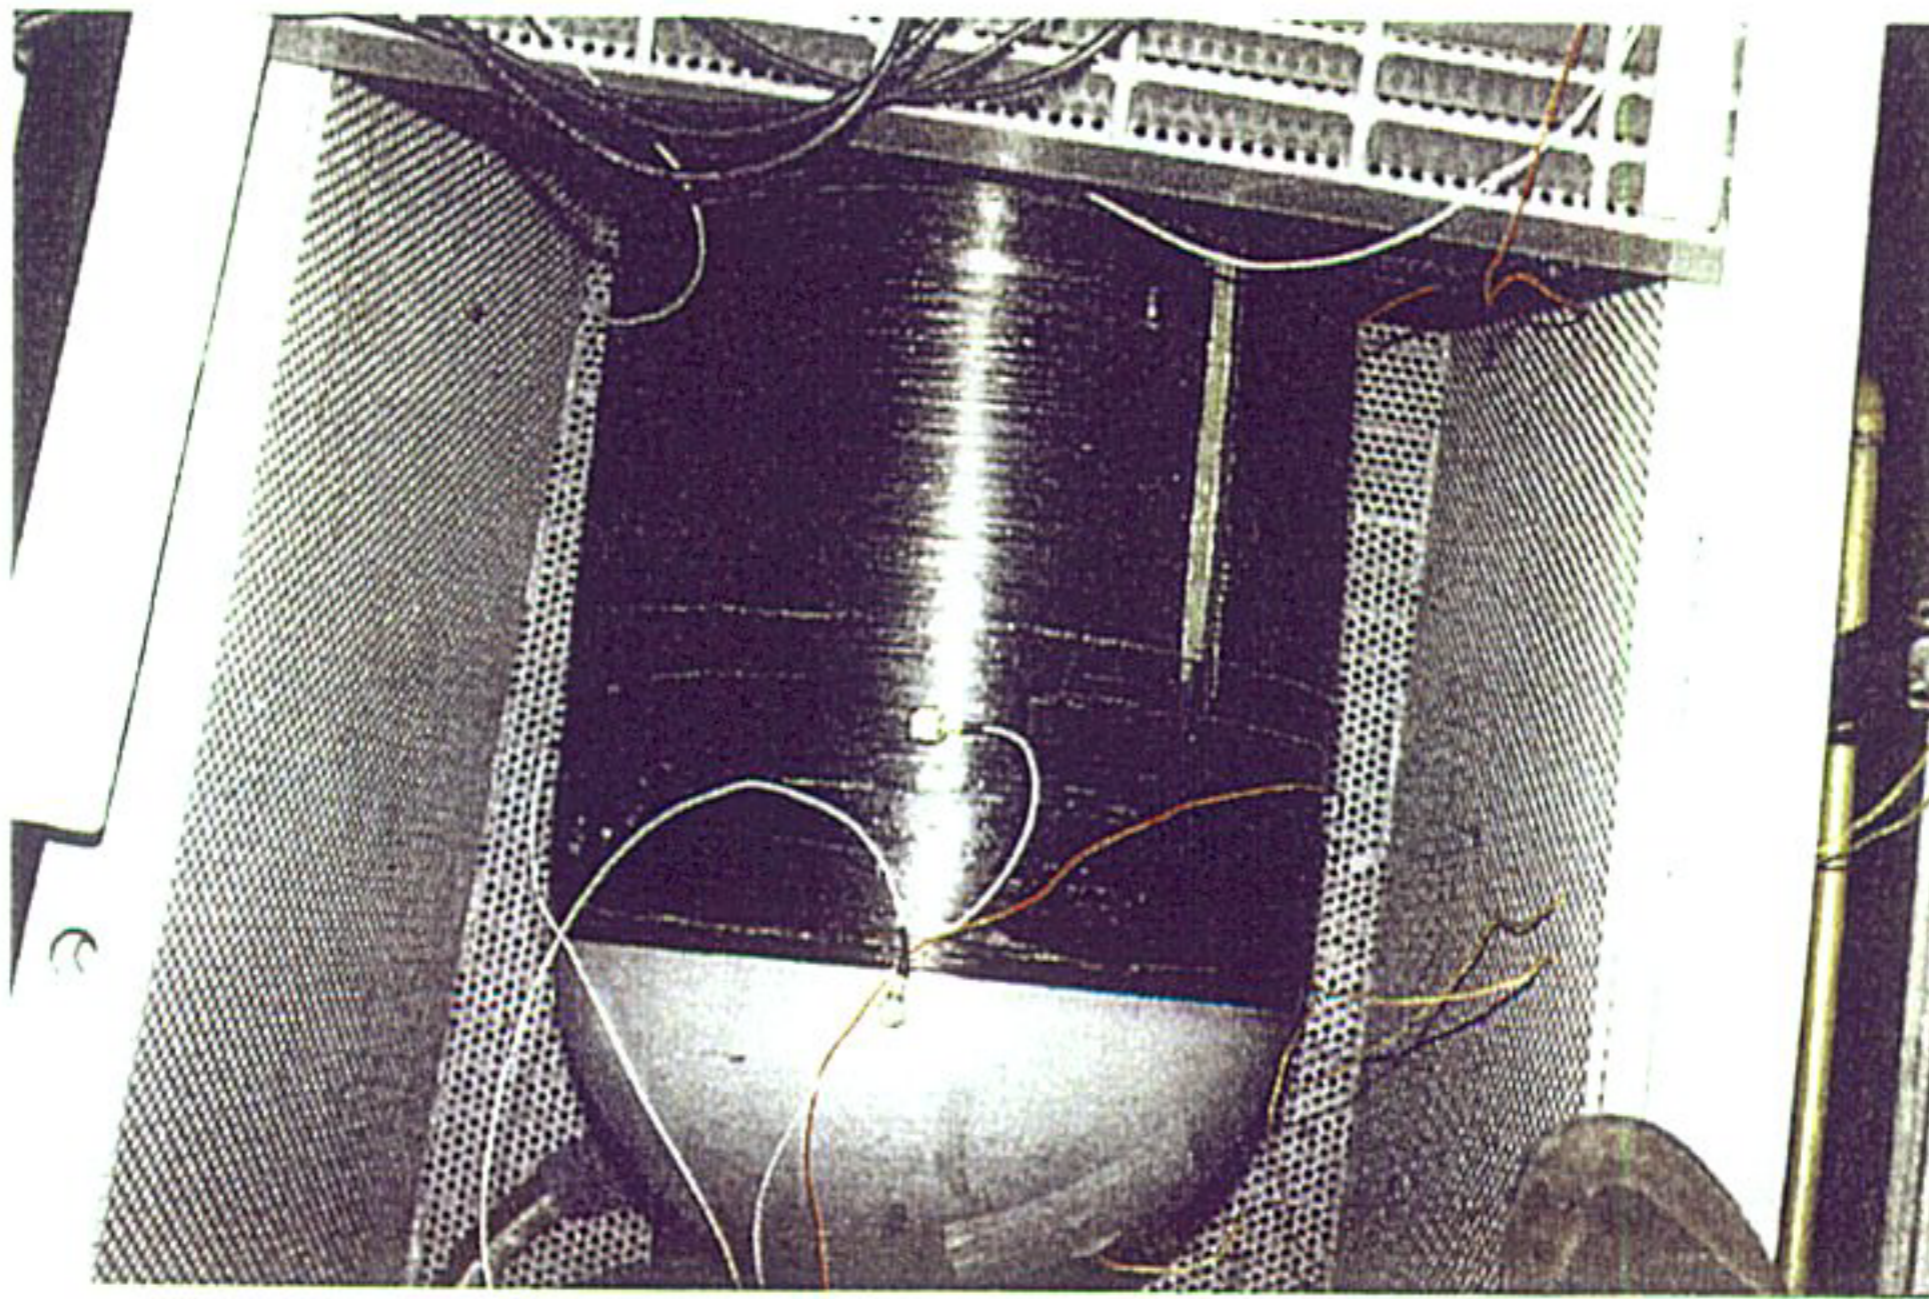
Figure 71. Tank 018 Following 15000 Pressure Cycles

The 8 inch long \times 0.18 inch deep slit in the overwrap of Tank 018 is shown in Figure 65. The tank was pressurized to 4,530 psig, which produced significant acoustic emission. Following one pressure cycle, the ends of the slit separate, as shown in Figure 66, and circumferential cracks propagate from the ends of the slit, as shown by the yellow lines in Figure 67. Prior to fatigue testing, a few remaining fibers were cut so that the slit penetrated through the entire thickness of the overwrap, as shown in Figure 68. After 3,000 pressure cycles in the fatigue chamber, the ends of the slit separate further, as shown in Figures 69 and 70. Views of the tank after 15,000 cycles, shown in Figures 71 and 72, show that the ends of the slit are separated by approximately the same distance as after 3,000 cycles. Cracks emanating from the ends of the slit propagated all the way around the circumference of the tank, indicated by the yellow lines in Figure 71. Also, the entire band of the overwrap was observed to be delaminated from the liner.

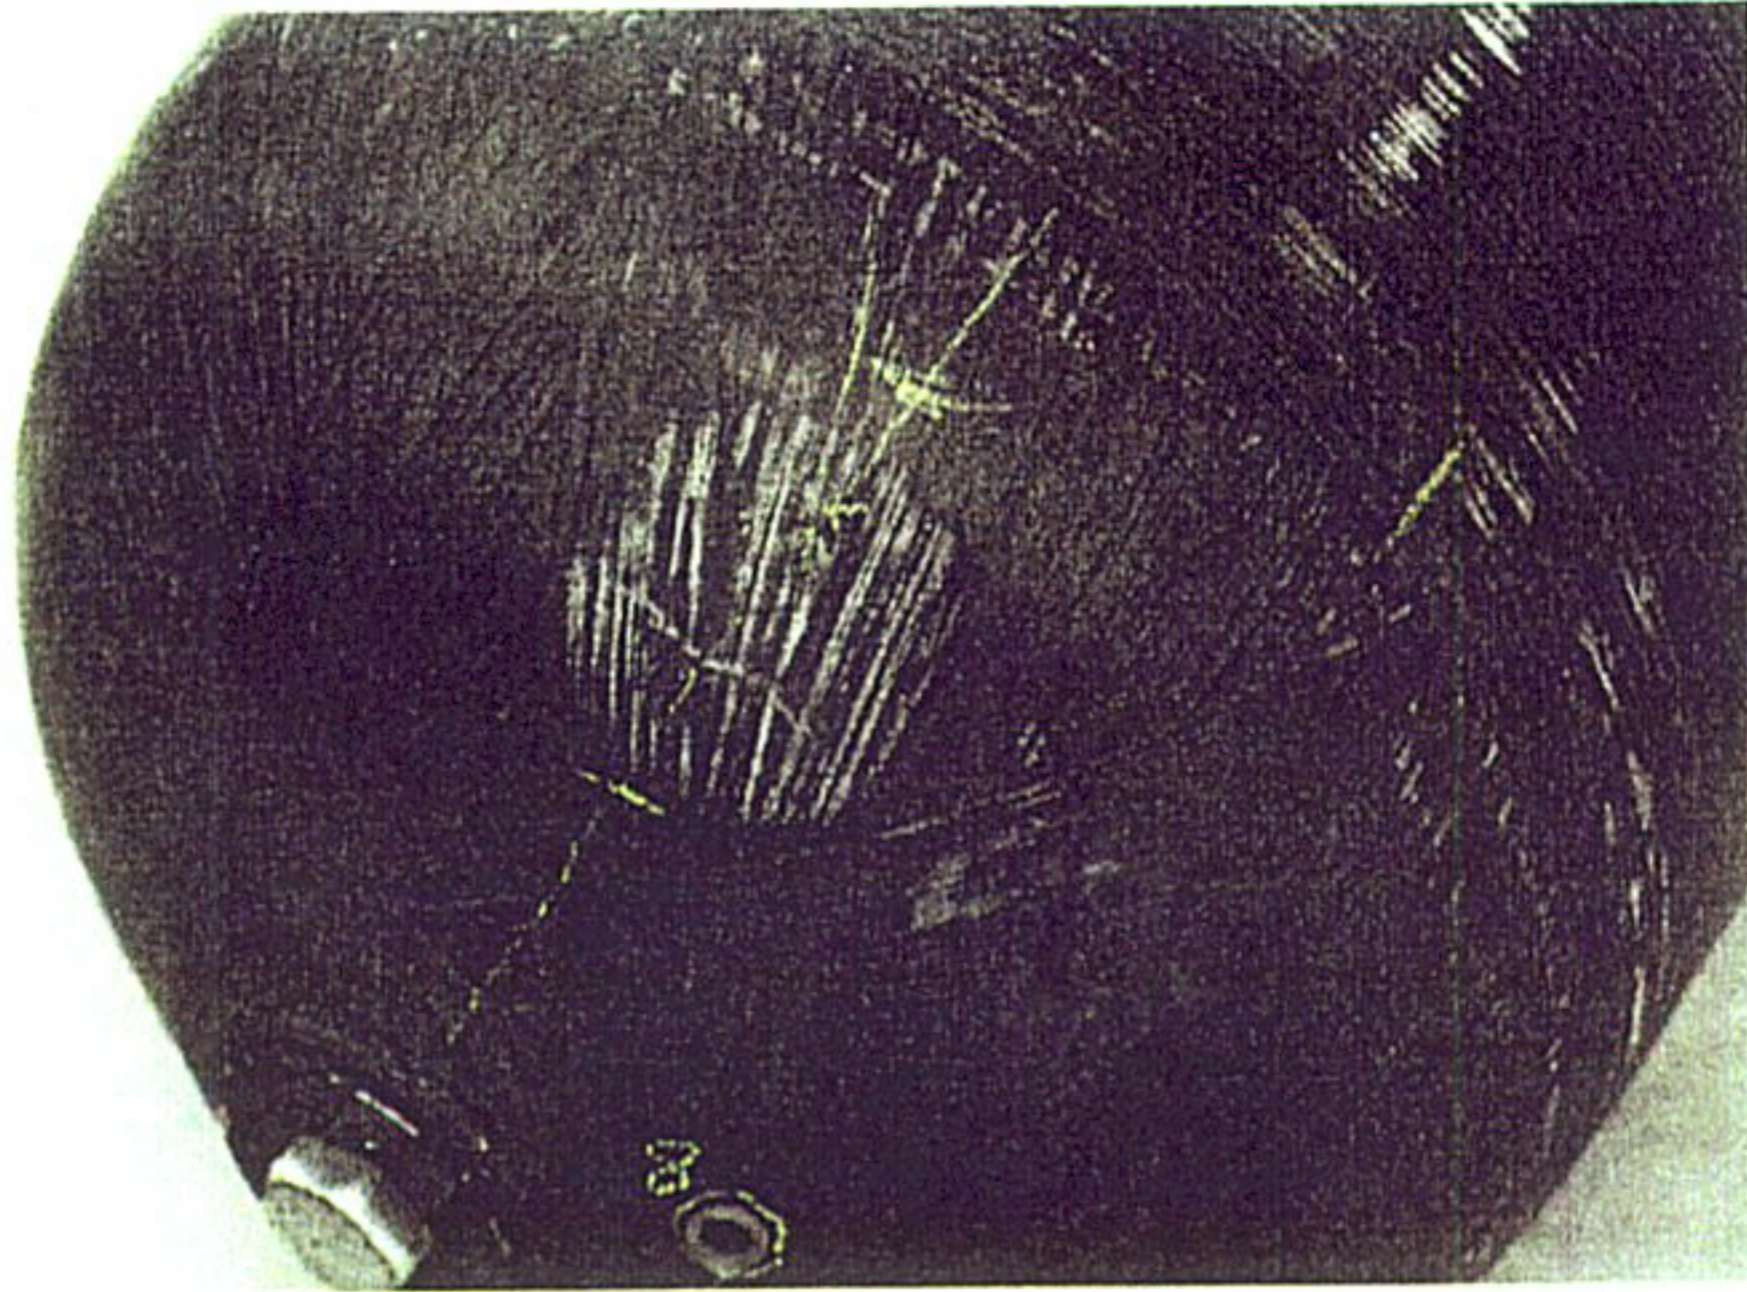
Figure 80. Impact Site on Tank 003

The set-up for the drop test of Tank 003 is shown in Figure 78. The tank was positioned at a 45° angle with its center of gravity 5 feet above the concrete pad, as shown in Figure 79. Following the drop, the primary area of damage occurred at the impact site on the shoulder of the tank, as shown in Figures 80 and 81. The visible damage appears as a circular area approximately 3 inches in diameter containing a 2.25-inch long crack. Two smaller areas of damage at the opposite end of the tank are shown in Figure 82.

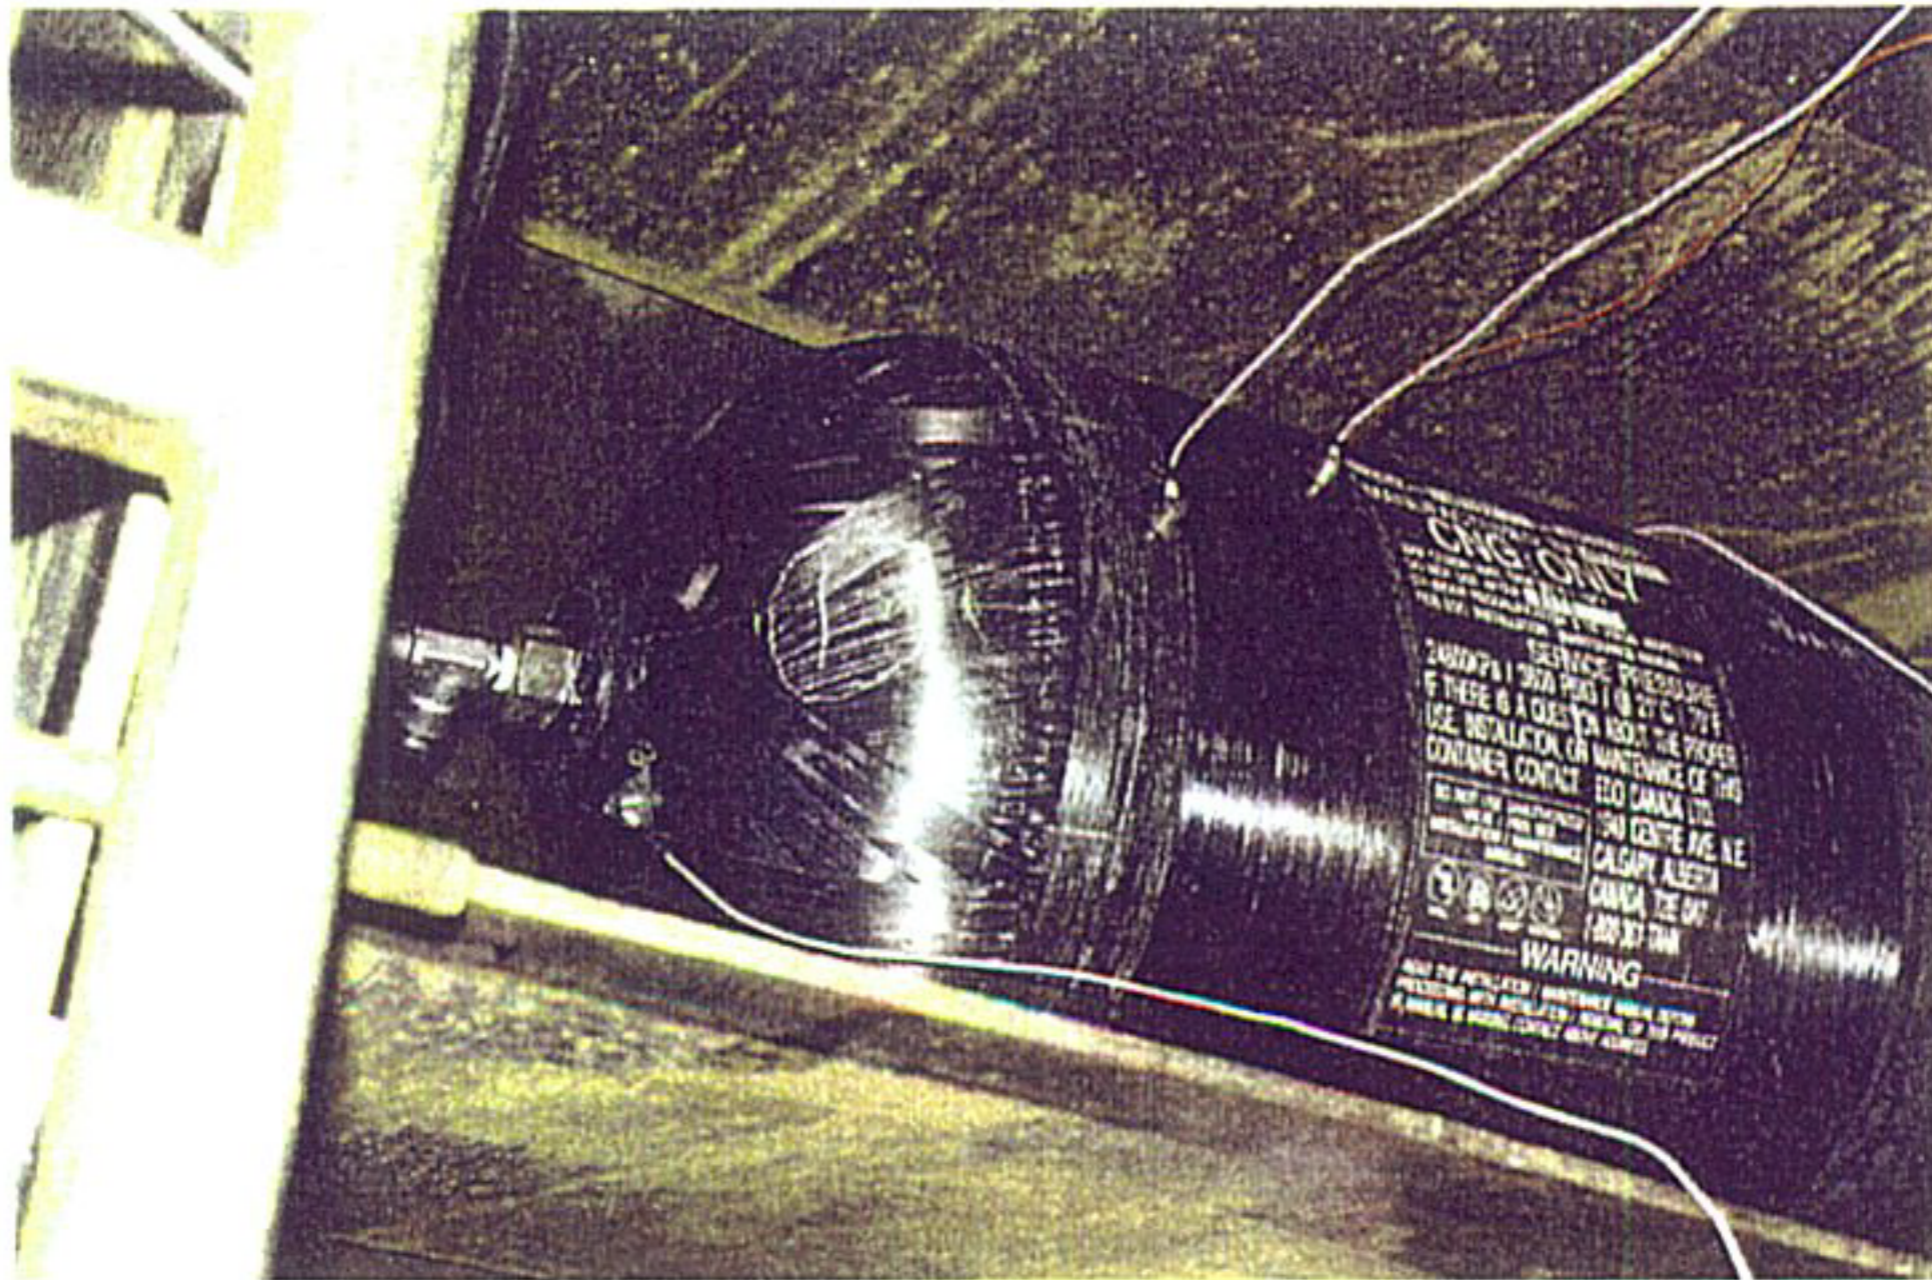
Figure 83. Tank 003 in the Burst Test Chamber, Following the Drop Test

Following the drop test, Tank 003 was pressurized in the burst test chamber to characterize the response of the damaged tank. The tank is shown in the chamber in Figure 83, which also shows the relative position of acoustic emission sensors near the damaged area. Pressurization of the tank to 3,667 psig produced significant acoustic emission and no visible change in the tank.

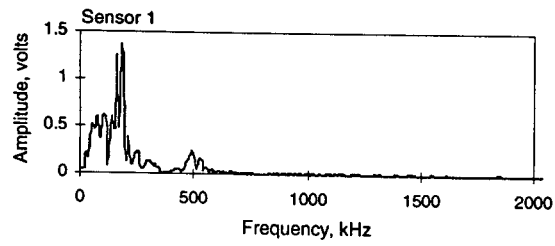
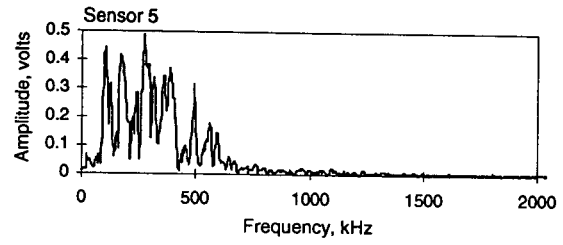
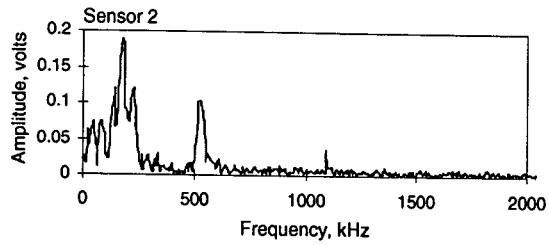
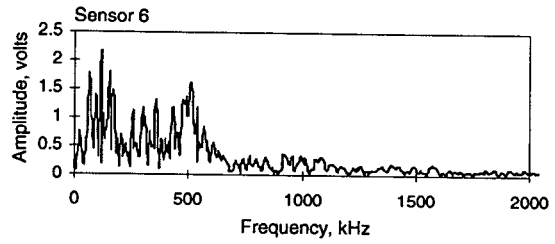
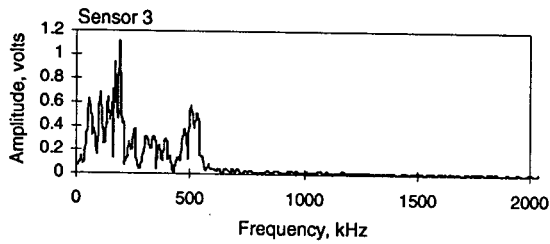
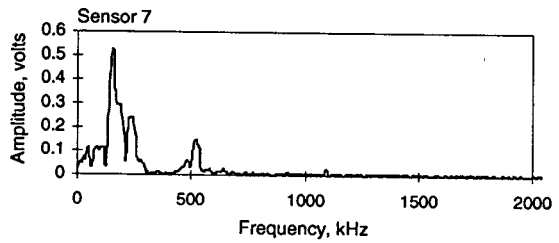
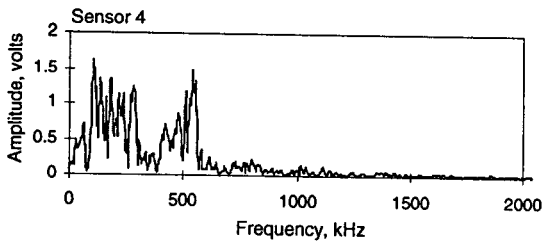
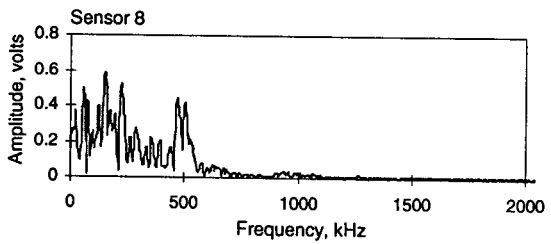
Sources of acoustic emission during pressurization of as-received tanks was attributed to the overwrap and to noise from outside sources. Determination of which signals were from the overwrap and which were from external noise was accomplished through examination of signal arrival times, amplitudes, frequency content, and event duration. Most signals were sorted by their frequency content and duration. A typical waveform and its FFT for a signal attributed to mechanical noise are shown in Figure 87. The duration of the waveform is very long, a characteristic of mechanical noise. The FFT of the waveform shows that the waveform consists entirely of low frequency components below 100 kHz, another mechanical noise characteristic. A typical waveform attributed to the overwrap in an as-received Type 2 tank is shown in Figure 88. The arrival times, indicated by the arrows, suggest that the source for the acoustic emission is on the bottom of the tank, between sensors four and six. The FFT of the waveform, shown in Figure 88b, exhibits a broad low frequency content to 500 kHz but little high frequency content above 1 MHz. Another typical waveform recorded during pressurization of an as-received Type 2 tank is shown in Figure 89. The signals shown in Figures 88 and 89 are representative of the signals associated with the response of the overwrap. No waveforms were recorded with significant high frequency content, which is characteristic of fiber breakage. Visual inspection of the tanks after initial pressurization revealed that the autofrettage cracks were more prominent. This observation combined with the acoustic emission data support the conclusion that the acoustic emission events obtained during pressurization of as-received Type 2 tanks were generated by matrix cracking.

Figure 88a. Waveform from a Typical Structural Event Recorded During Pressurization of the As-Received Type 2 Tanks

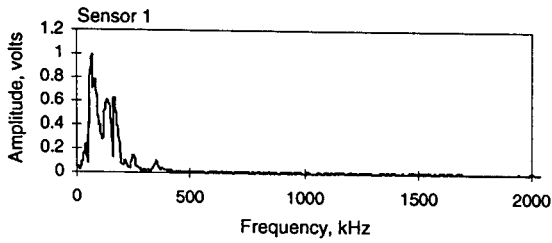
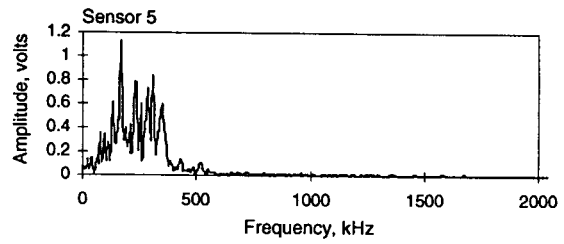
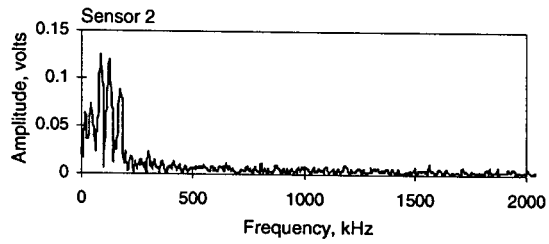
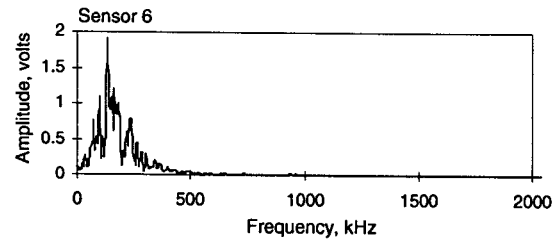
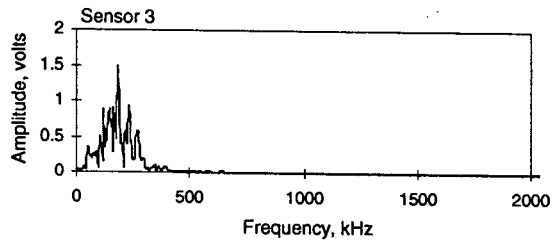
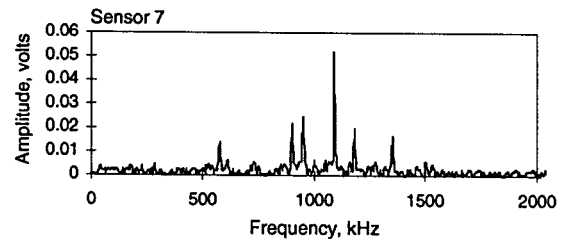
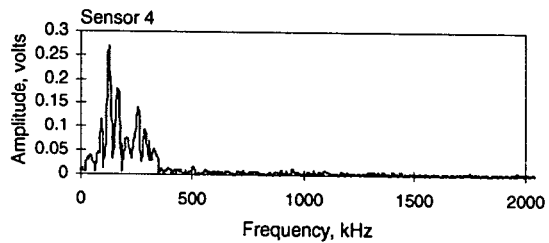
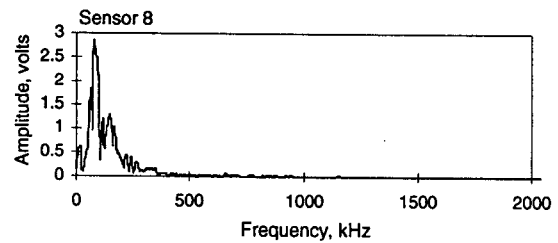
Figure 90b. FFT from a Typical Event Recorded During Pressurization of the As-Received Type 4 Tank

A typical waveform and FFT from pressurization of the as-received Type 4 tank is shown in Figure 90. As with the Type 2 tanks, the recorded acoustic emission events were consistent with matrix cracking. No waveforms with high frequency components characteristic of fiber breakage were obtained.

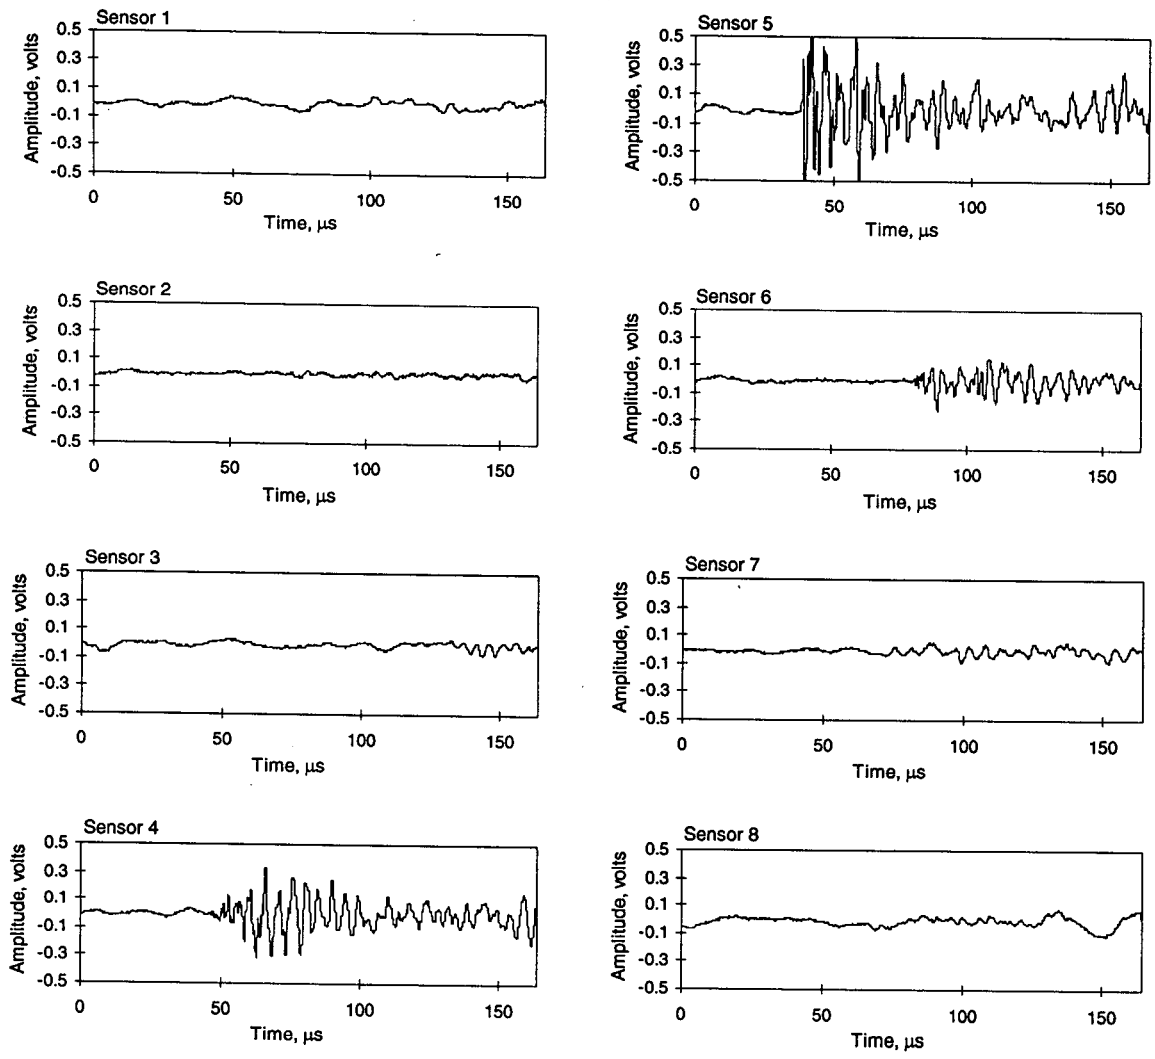
Figure 91a. Waveform from a Typical Event Recorded During Pressurization of a Type 2 Tank with a Saw Cut

Typical waveforms from the pressurization of a Type 2 tank with a saw cut and impact damage are shown in Figures 91 and 92, respectively. The waveforms recorded from these damaged tanks were similar to each other. In addition, the waveforms were not significantly different from the waveforms produced by the as-received tanks, which were attributed only to matrix cracking. No signals were attributed to fiber breakage. Post-pressurization visual inspection of the damaged tanks revealed circumferential cracks in the overwrap originating from the ends of the saw cut and the impact damaged area. These matrix cracks were consistent with the acoustic emissions from the tanks.

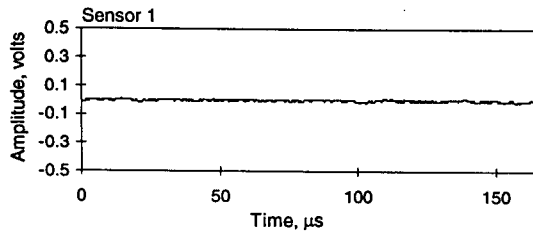
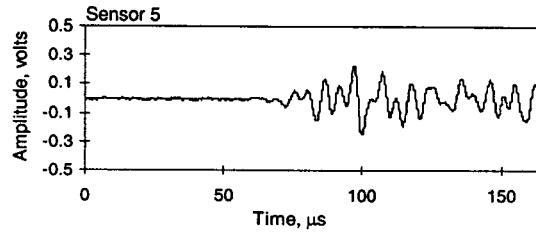
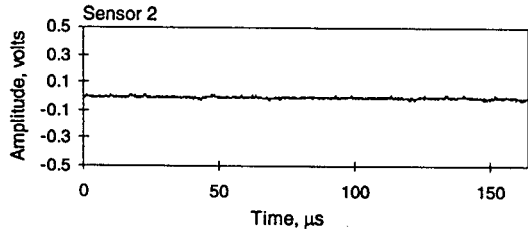
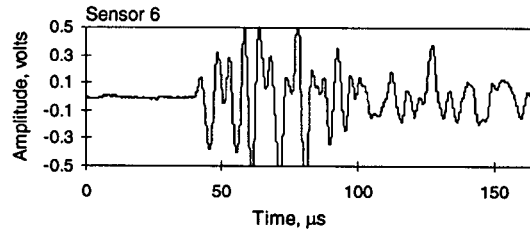
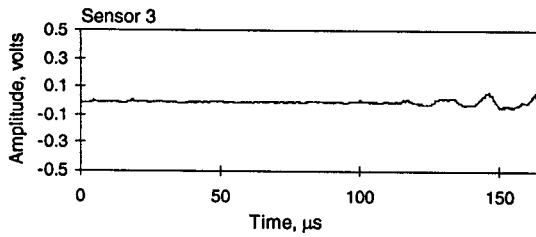
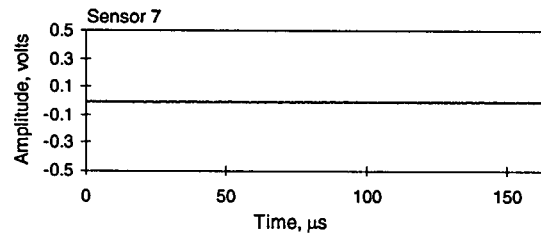
Figure 93a. Waveform from a Typical Event Recorded During Pressurization of the Type 4 Tank with Impact Damage

A typical waveform produced during the pressurization of the damaged Type 4 tank is shown in Figure 93. The impact damage area was identified as the primary source of acoustic emission events during the post-damage pressurization. Over 80% of the signals recorded originated in the damaged area. No high frequency waveforms indicative of fiber breakage were recorded. Visually, no changes were observed in the damaged Type 4 tank following pressurization. However, matrix cracking could have occurred within the overwrap without being detected on the surface of the tank.

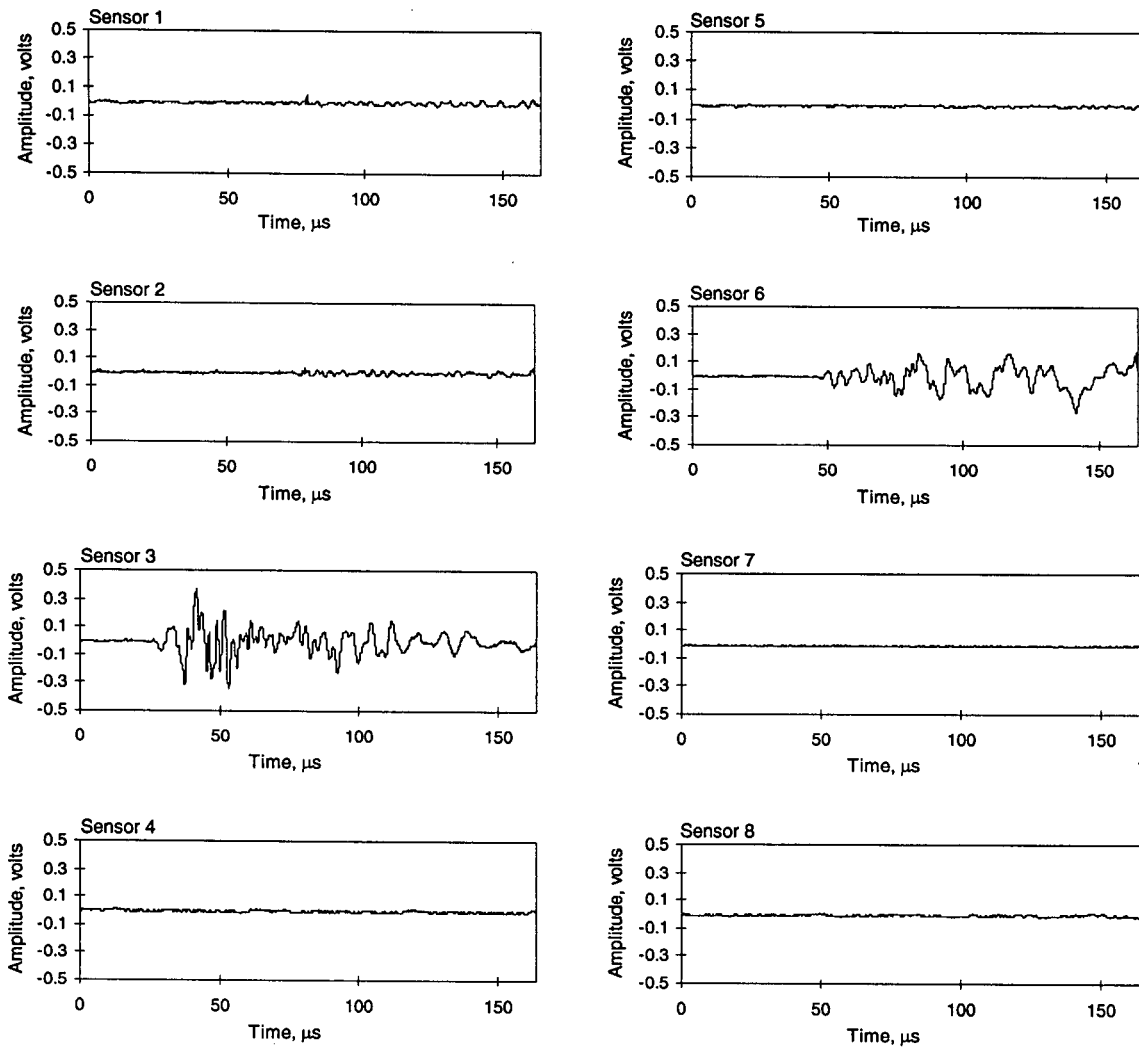
Figure 94. Waveform from a Typical Fretting Event Recorded During Fatigue Cycling of a Type 2 Tank

Tanks were subjected to cyclic pressure loading to determine the effect of repeated pressurization on damage growth and lifetime. Acoustic emissions from Type 2 tanks included a large number of fretting and rubbing events. A typical fretting event signal, which is characterized by long duration and low frequency components, is shown in Figure 94. This signal was identified as a fretting event, in part, because of the number of times that it was

repeated during the fatigue testing. In some cases, the identical waveform was generated in the overwrap during more than 50 consecutive fatigue cycles. Physically, fretting was associated with crack growth in the damaged area, as cracked and delaminated surfaces of the overwrap plies rubbed against each other. A signal from a noise event, which was also repeated over a large number of consecutive pressurization cycles, is shown in Figure 95. Acoustic emission events, similar to those shown in Figures 88 and 89, were interspersed in the noise data and attributed to matrix cracking. No signals indicative of fiber breakage were found in the acoustic emission during fatigue testing of the Type 2 tanks. The acoustic emission events indicated that fretting and matrix cracking were the primary mechanisms of damage growth during fatigue testing.

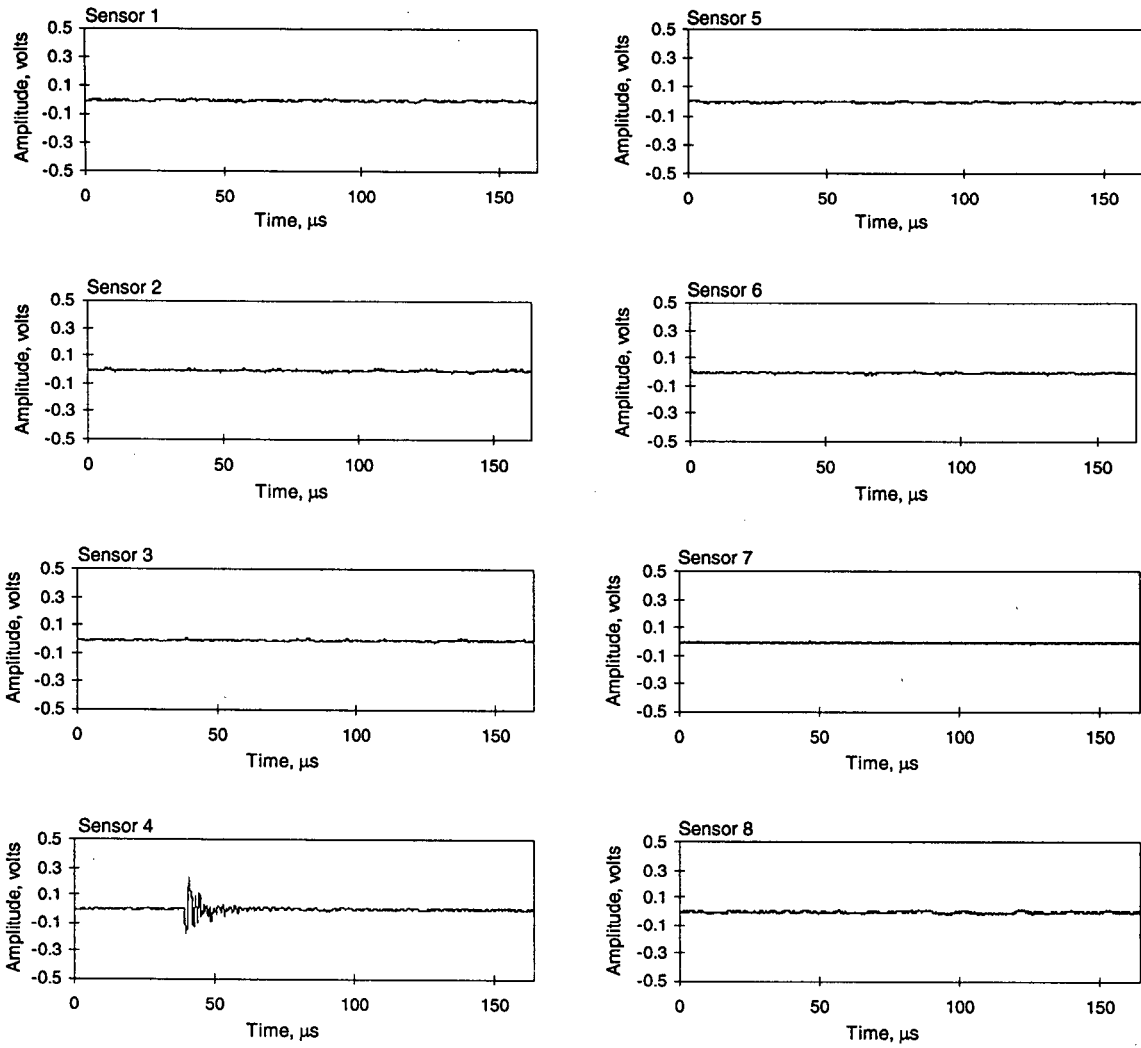
Figure 96. Waveform from a Typical Small Amplitude Event Recorded During Fatigue Cycling of the Type 4 Tank

During fatigue testing of the Type 4 tank, two types of signals were recorded. The small amplitude signal from sources all over the tank is shown in Figure 96. These signals were likely produced by small cracks in the matrix. The signals that originated in the damaged area of the tank, which are likely from matrix cracking, are shown in Figure 97. On single channels, a few high frequency events were recorded. These events were similar to those seen during tow testing and attributed to fiber breakage. Just before failure of the Type 4 tank, a large increase in the number of events per cycle occurred. The majority of the events, similar to the event in Figure 97, were associated with matrix cracking in the impact-damaged area. Just prior to failure, low amplitude, high frequency events, such as the waveform shown in Figure 98, were recorded.

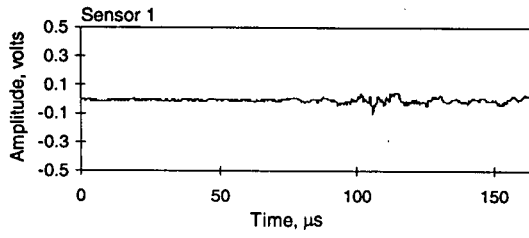
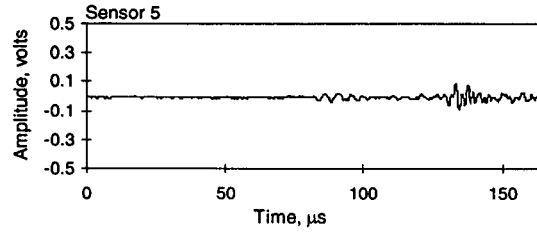
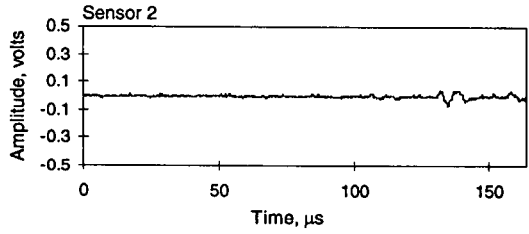
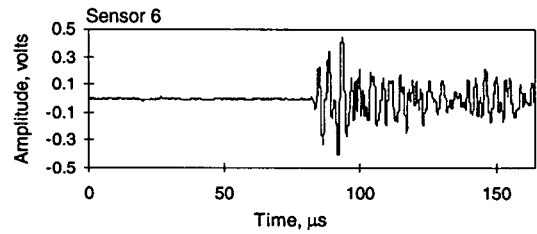
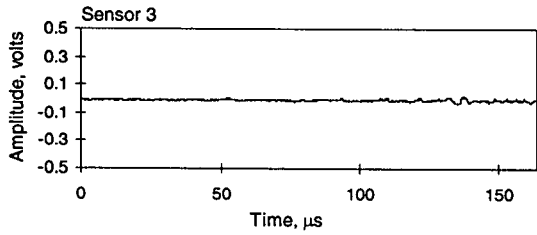
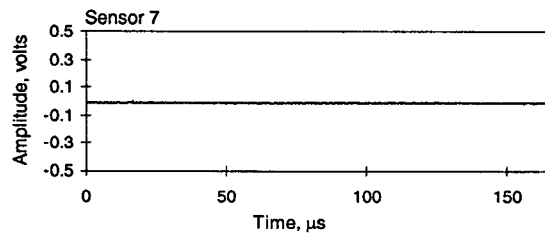
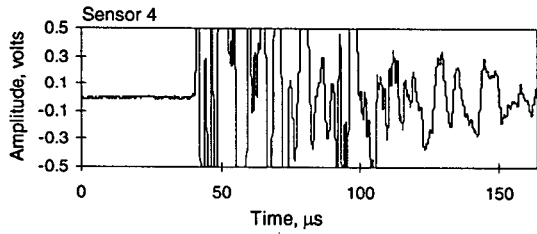
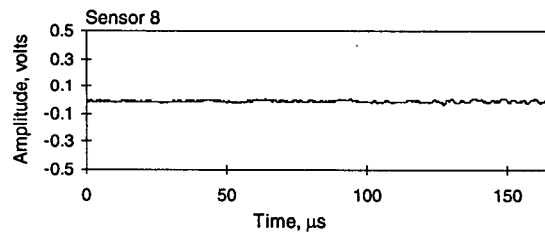
Figure 99. Waveform Recorded During Pressurization Hold After Fatigue Cycling of a Type 2 Tank

After each set of 3,000 pressure cycles, tanks were pressurized to 4,500 psig and held at that pressure for 100 seconds during which acoustic emission data was acquired. In this way, the acoustic emission response of the tanks was measured as a function of pressure cycles. A typical waveform generated in a Type 2 tank during a pressure hold is shown in Figure 99. Waveforms recorded under these constant pressure conditions were similar to the waveforms

recorded from damaged tanks (Section 6.3.2). For Tank 013, a plot of the number of acoustic emission events versus time following 6,000 pressure cycles is shown in Figure 100. This plot is typical of the response of Tank 013 during the pressure holds.

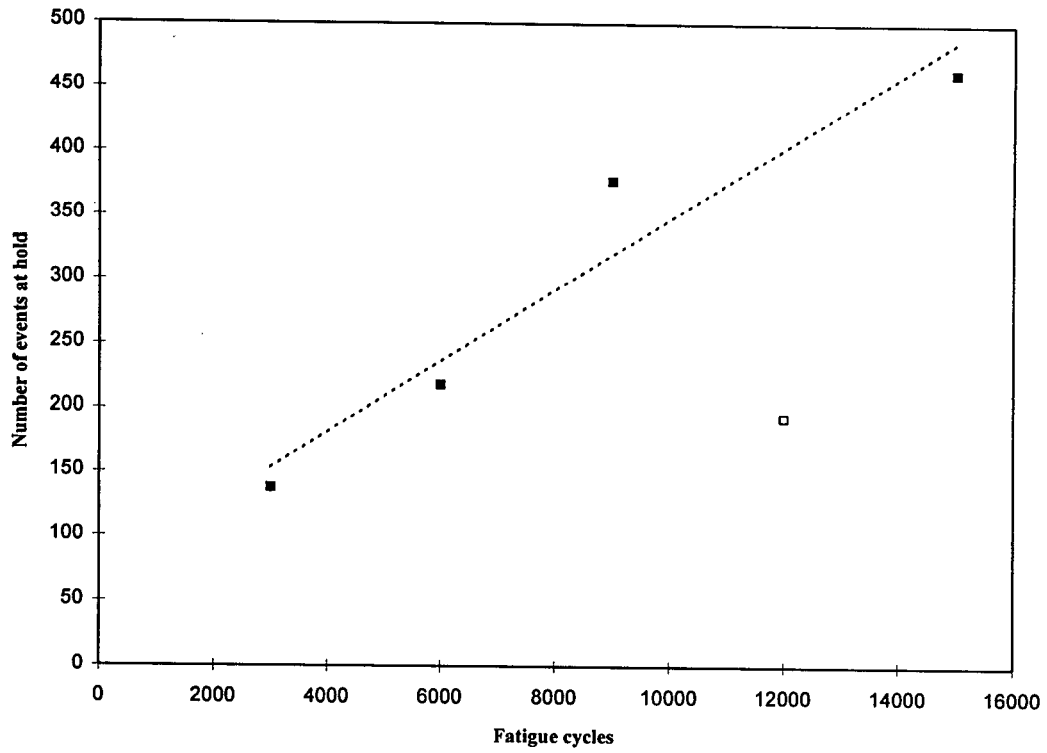
Figure 101. Number of Events During Each Pressure Hold After Fatigue Cycling of Tank 013

A plot of acoustic emission events recorded during each pressure hold for Tank 013 is shown in Figure 101. With the exception of the data point following 12,000 fatigue cycles, the amount of acoustic emission generated during a hold increases with the number of fatigue cycles. The data at 12,000 cycles is in question and was not included in the data analysis. This data is different from all of the other pressure hold data for all tanks. The invalid data point may have been caused by a software problem, which occurred just prior to the completion of the 12,000 cycles.

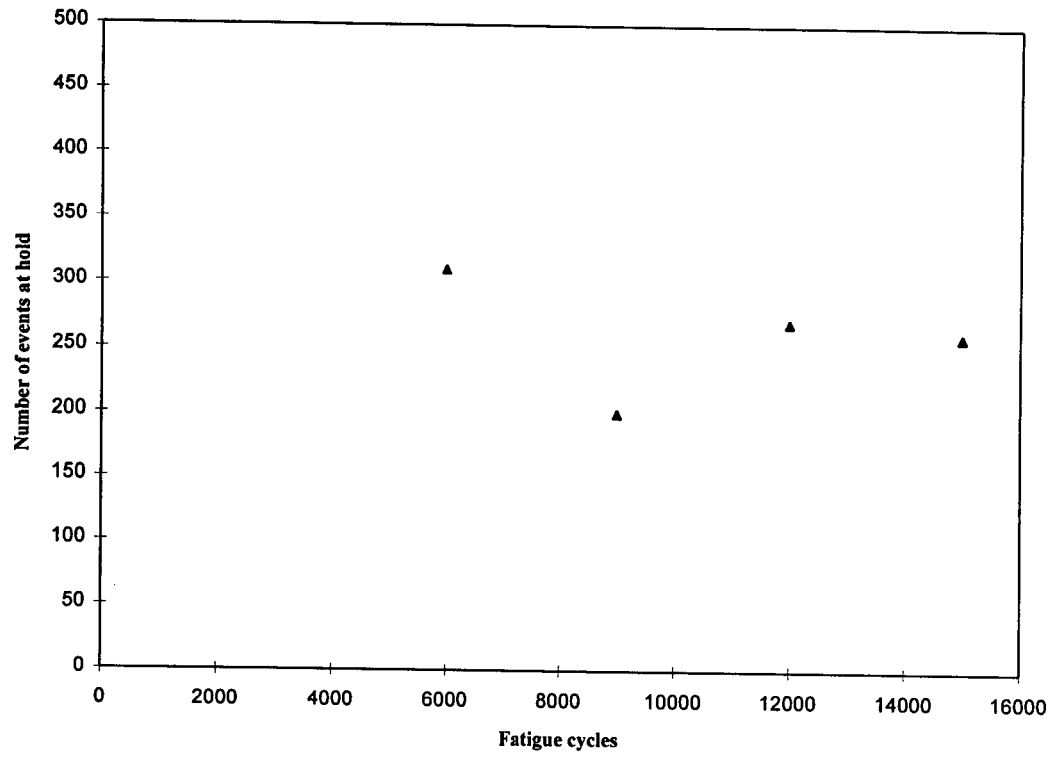
Figure 102. Number of Events During Each Pressure Hold After Fatigue Cycling of Tank 018

For Tank 018, a plot of the number of acoustic emission events during pressure holds versus the number of fatigue cycles is presented in Figure 102. Data for 3,000 cycles is missing, because the high rate of acoustic emission events saturated the A/D boards. The remaining data points in Figure 102 approximate a constant number of events with fatigue cycles rather than the increase in events exhibited by Tank 013. The acoustic emission response of Tank 018 may be explained by the observed physical condition of the tank. Recall that in Tank 018 the slit was cut completely through the overwrap. Visual examination of the tank early in the fatigue testing revealed that the hoop cracks from the ends of the slit and the delamination under the slit had propagated around the entire circumference of the tank. This initial damage growth is reflected in the large number of acoustic emission events recorded after 3,000 pressure cycles. Subsequent pressure cycling produced no observable changes to the damage, which explains the decrease in acoustic emission to an approximately constant level. These acoustic emission events may be caused primarily by damage in the portion of the overwrap on either side of the slit, which was still bonded to the liner.

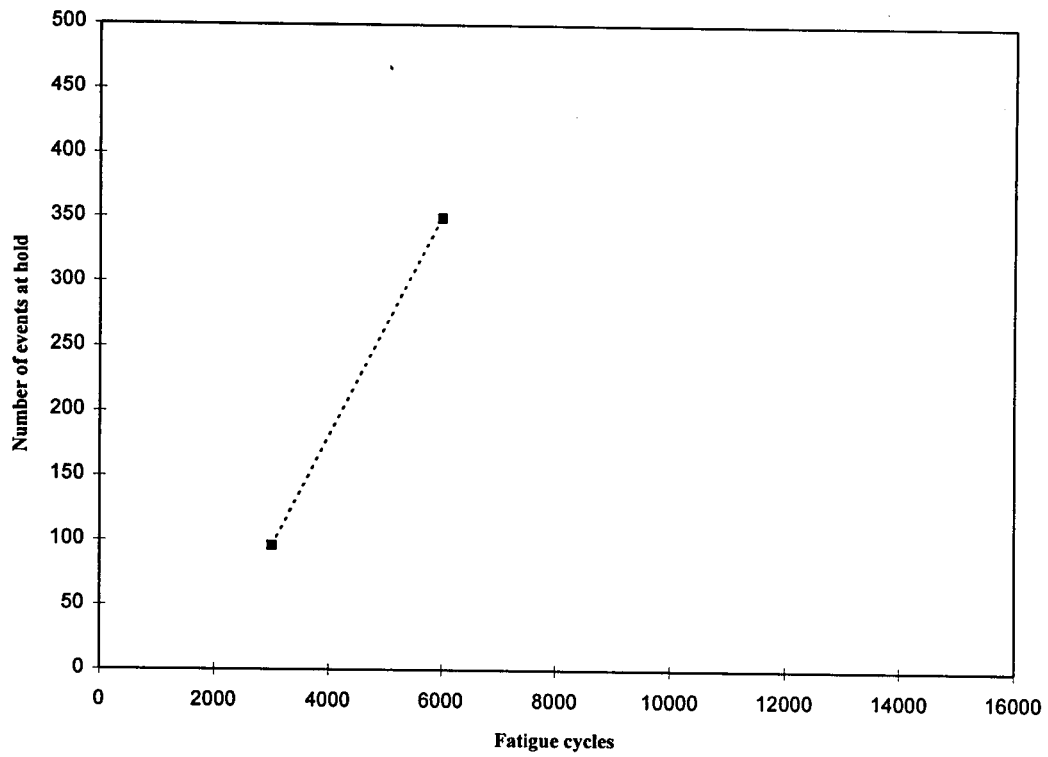
Figure 103. Number of Events During Each Pressure Hold After Fatigue Cycling of Tank 003

For Tank 003, the Type 4 tank, a plot of the number of acoustic emission events during pressure holds versus the number of fatigue cycles is shown in Figure 103. Data were obtained following 3,000 and 6,000 pressure cycles before the tank failed. The numbers of events at pressure hold increases with fatigue cycles, as it did in Tank 013. However, the rate of increase is much greater for Tank 003. This acoustic emission response is consistent with the progressive failure exhibited by Tank 003, leading to catastrophic failure of the tank during fatigue testing.
