NHTSA-98-3588-190

Project B.14 – Demonstration of Enhanced Fire Safety Technology – Fire Retardant Materials

Part 1: Full Scale Vehicle Fire Tests of a Control Vehicle and a Test Vehicle Containing an HVAC Module Made from Polymers Containing Flame Retardant Chemicals

**Jeffrey Santrock
General Motors Corporation**

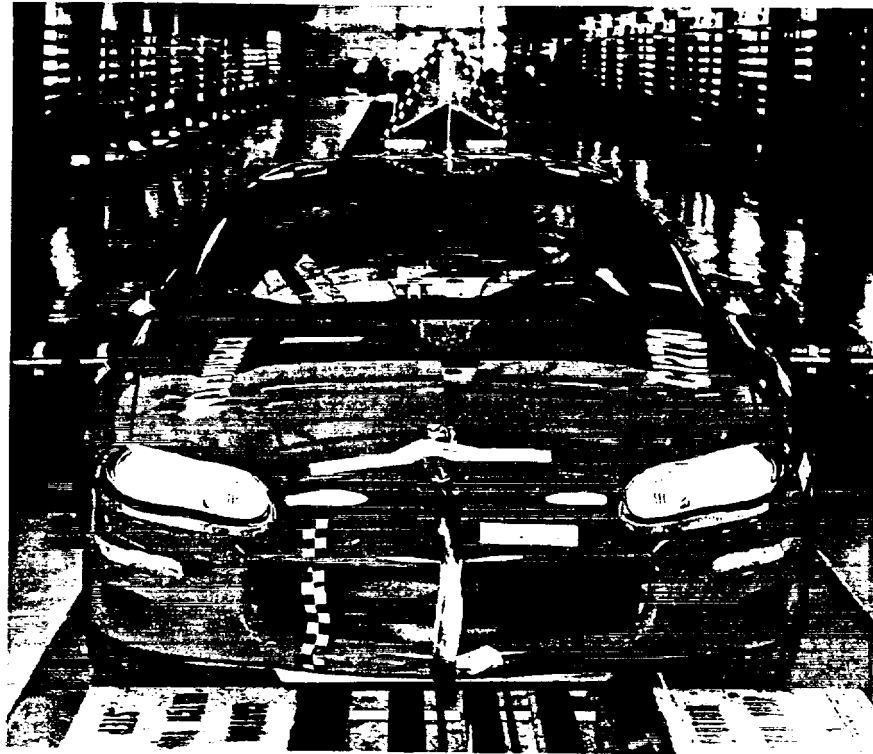
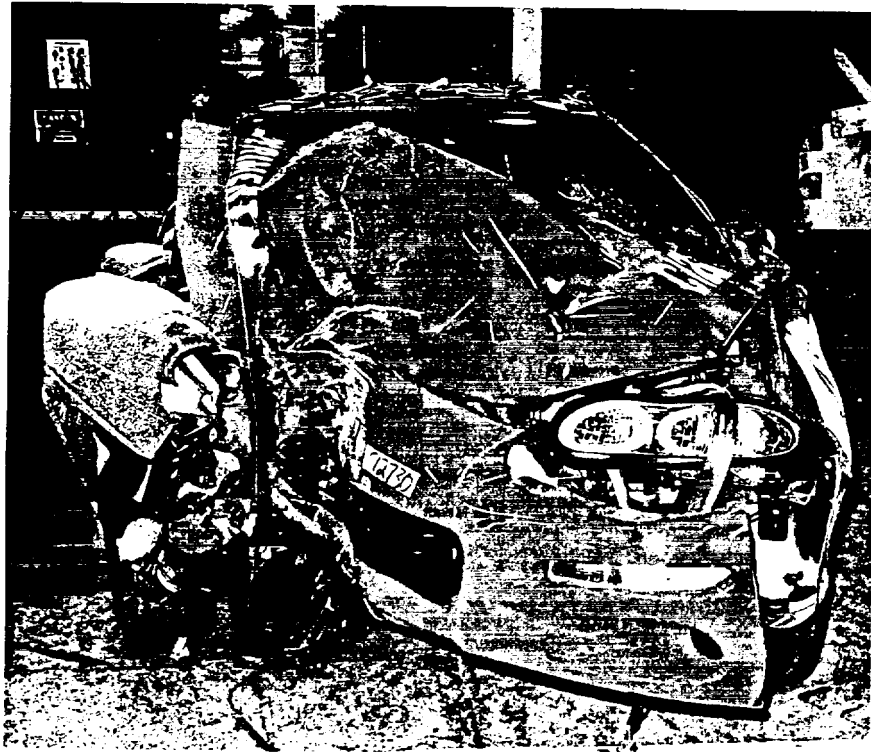
Figure 2. Crash Test C12730. Photographs of the Control Vehicle before (upper) and after (lower) the crash test.

Figures 2 and 3 show photographs of the Control and FR vehicles before and after the crash test, respectively. Table 4 summarizes the vehicle mass, vehicle speed at impact, engine speed at impact, location of impact, average change in velocity, and maximum dynamic crush for the Control and FR Vehicles as tested. The velocities at impact differed by < 0.1 kmh (< 0.2%). The masses of the two test vehicles were identical (1848.0 kg). The impact locations were identical

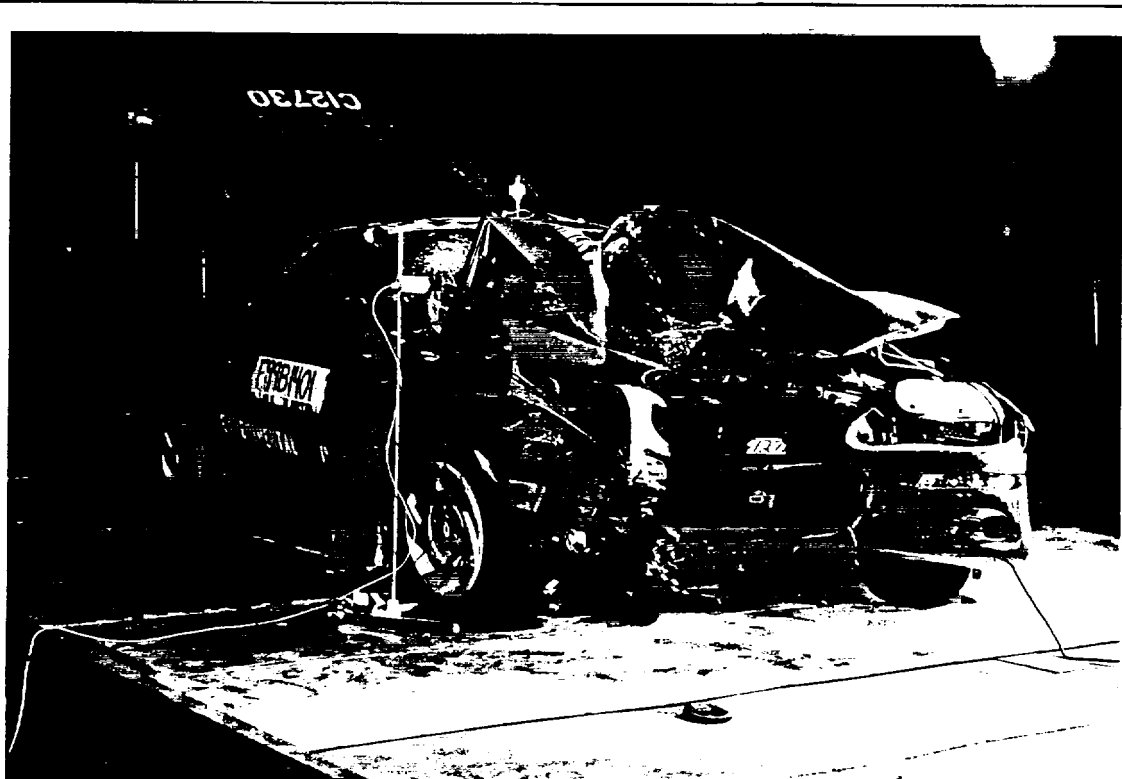
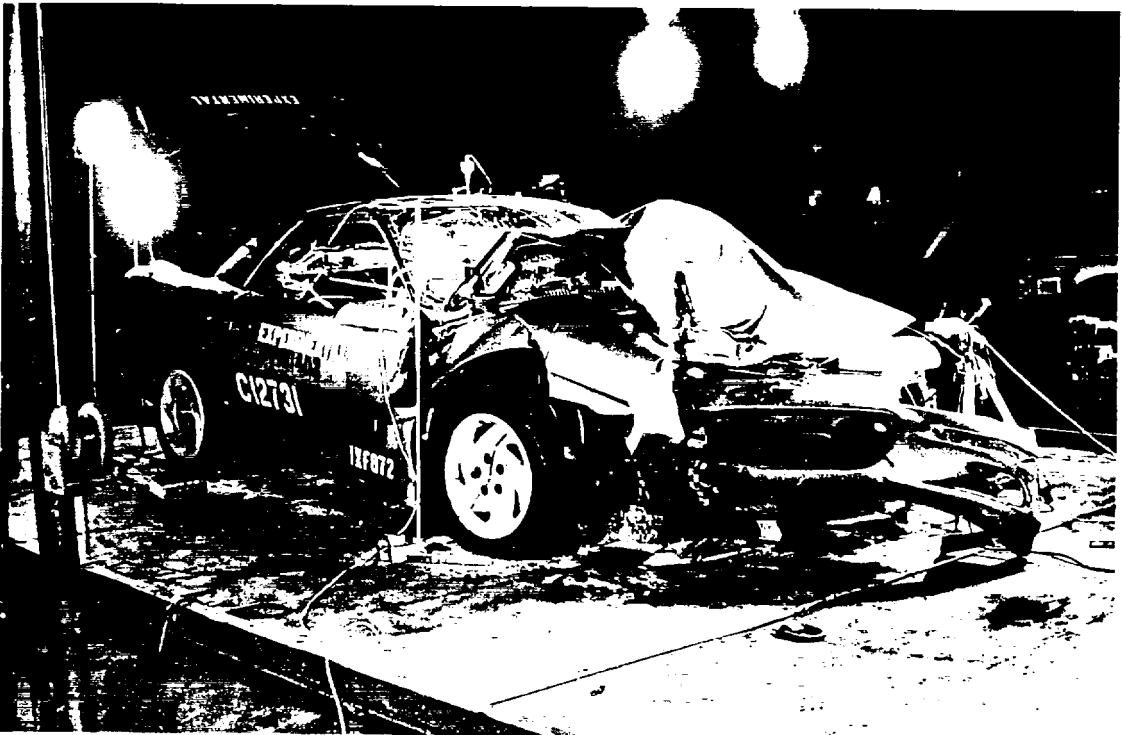
Figure 6. Photographs of the test vehicle in the fluid containment pan before the fire tests: Fire Test F99B1401 (upper photograph); and Fire Test F99B1402 (lower photograph).

The test vehicles were placed in the center of the pan (Fig. 6). All doors were closed, and the door window glasses were raised to the fully closed position in each door. The glass outer-layers in the windshields of both the Control and FR Vehicles were broken in the crash tests. The windshields remained attached to the frames of the test vehicles, with the windshield inner-layer **supporting** the glass fragments. The right window glasses (passenger's door) in both the Control **and** FR Vehicles were broken during the crash tests, and were not replaced for the fire test.

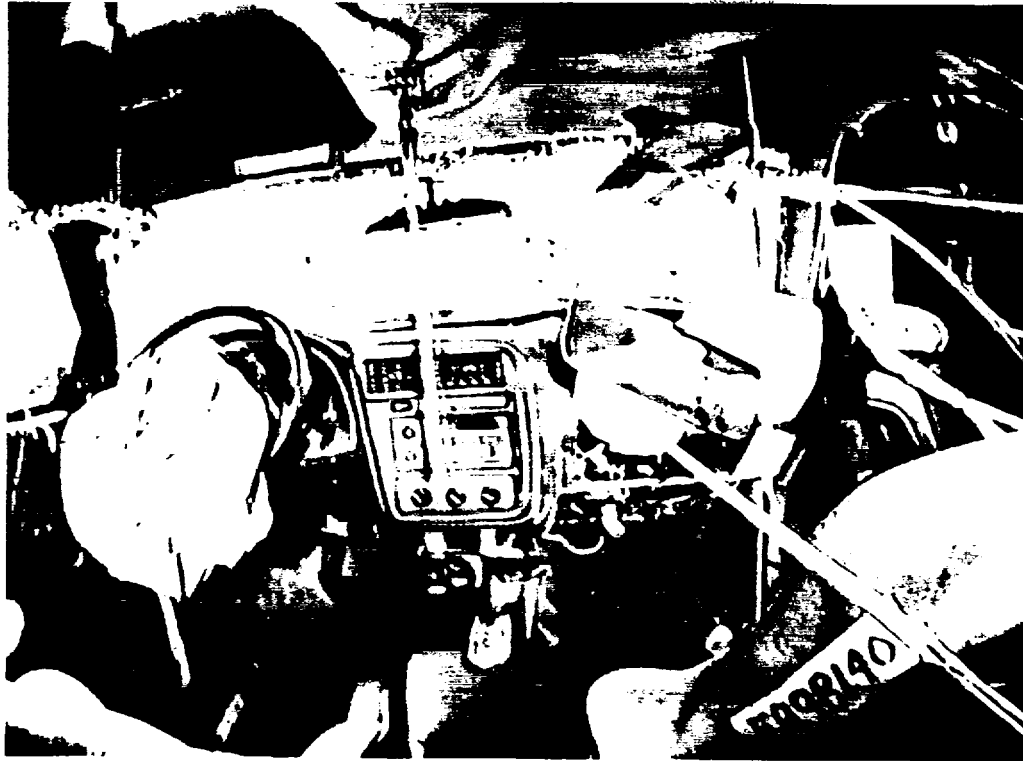
Figure 16. Fire Test F99B1401. Video Stills from Camera 1 at the time of ignition (upper video still) and at 7 minutes post-ignition. (lower video still).

Figures 16 and 17 show video stills from Camera 1 at the time of ignition and at 7 minutes post-ignition in F99B1401 and F99B1402, respectively. The video stills in these figures show that in both test vehicles the windshields had sagged further onto the instrument panel top covers than at the start of these tests. The estimated temperature profiles in Figure 15 indicate that the temperature along the right sides of the windshields was $>100^{\circ}\text{C}$ at 7 minutes post-ignition in both test vehicles. Continued heating of the right sides of the windshields caused the windshield inner layers to soften further. Sections of the right sides of the windshields fell on the instrument panel top covers between 7 and 8 minutes post-ignition. Pieces of windshield had separated and fallen into the passenger compartments of both test vehicles by 8 minutes post ignition (Fig. 18). Pieces of windshield fell onto the instrument panel top cover, the passenger air bag covers, and the deployed passenger air bags (Fig. 19). Flames had spread rearward along the top of the instrument panels to the passenger air bag covers and deployed passenger air bags in both test vehicles by 12:30 min:sec post-ignition (Fig. 20). The lower sections of the right A-Pillar trim panels had ignited and were burning by this time (Fig. 20). Pieces of windshield where the innerlayer had ignited and was burning had fallen onto the right front seat cushion in F99B1401 and onto the deployed passenger air bag in F99B1402. The pieces of burning windshield extinguished before igniting the seat cushion in F99B1401 (upper video still, Fig. 20) and the deployed passenger air bag in F99B1402 (lower video still, Fig. 20).

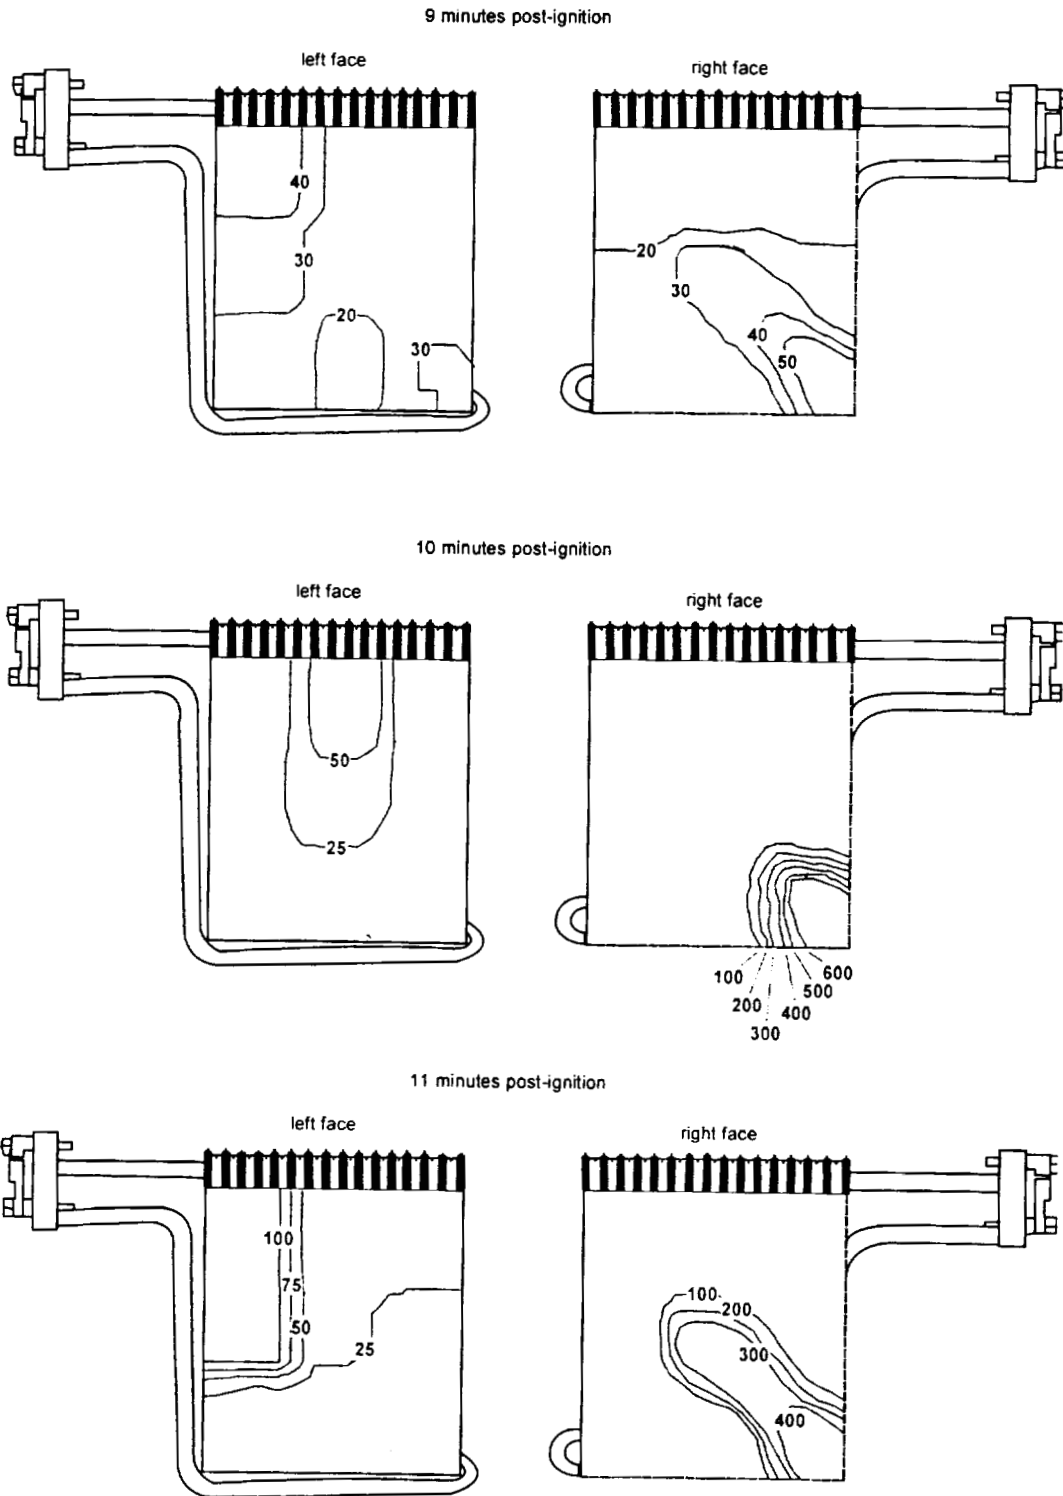
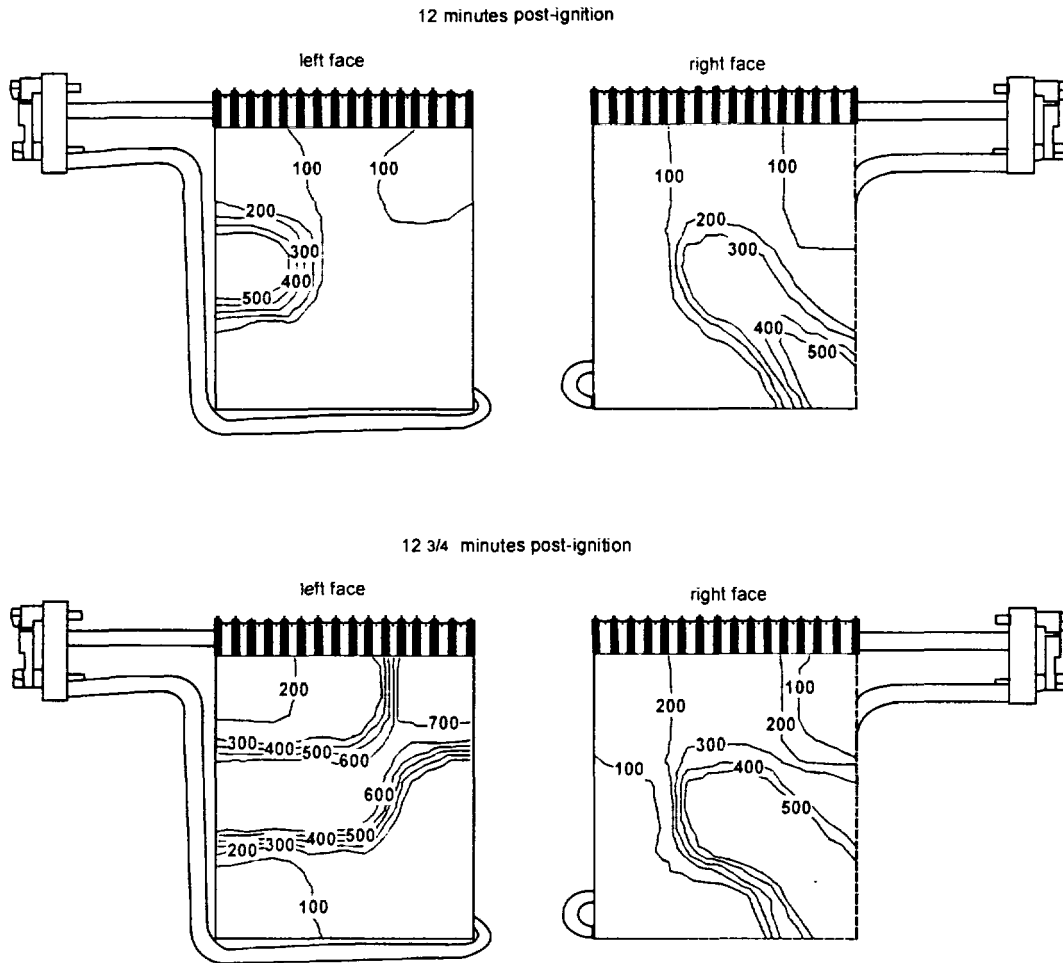
Data recorded from thermocouples located inside the HVAC module indicate that both faces of the A/C evaporator core were heated by gases and flames between about 10 and 13 minutes post-ignition in F99B1401, and that the A/C evaporator core was not exposed to heated gases and flames at any time during this test in F99B1402. Figure 25 shows estimated temperature profiles on both faces of the A/C evaporator core in F99B1401 from 10 to 12:45 min:sec. The isothermal contours in this figure were calculated from temperature data recorded from the thermocouples using a three-dimensional interpolation algorithm.⁷

Figure 25. Fire Test F99B1401. Estimated temperature distributions on both faces of the A/C evaporator core of the test vehicles at 9, 10, 11, and 12 minutes post-ignition, and at 12:45 min:sec post-ignition.

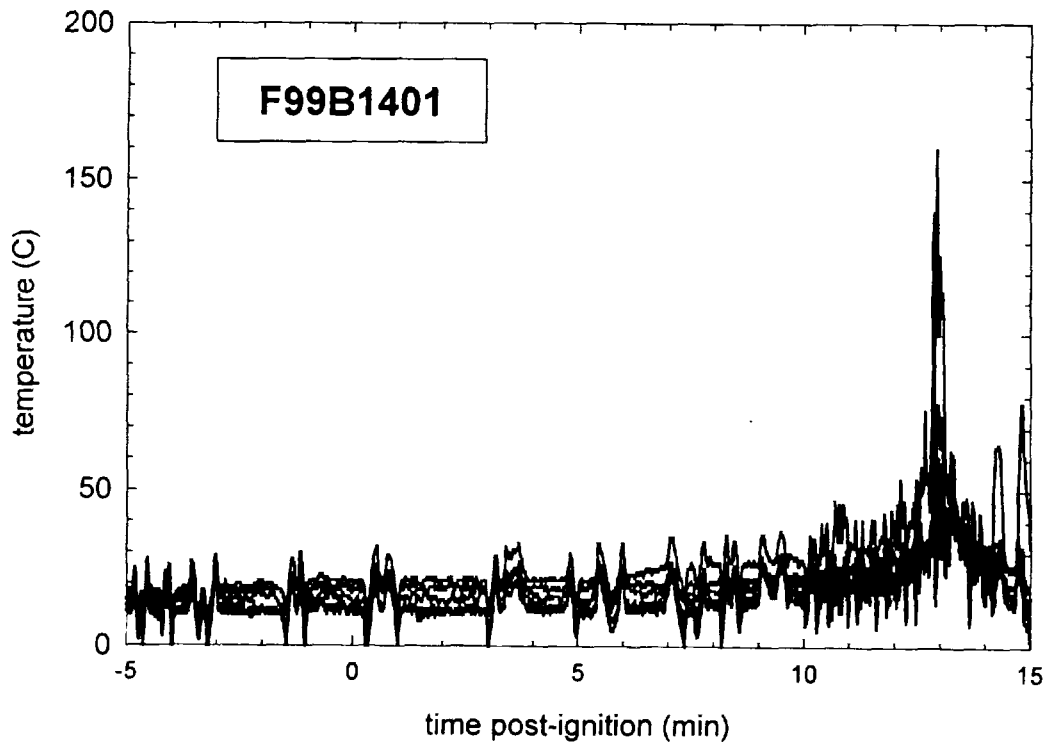
Air temperatures in the passenger compartments of the test vehicles were measured with aspirated thermocouple assemblies (**Appendix I**). One aspirated thermocouple assembly was installed between the front seats in each of the test vehicles and was oriented vertically. The aspirated thermocouple assemblies contained 6 thermocouples each. The spacing between thermocouples was 3 inches, with the upper-most thermocouple located between $\frac{1}{2}$ to 1 inch below the lower surface of the headlining trim panels. Figures 29 and 30 show plots of temperature data recorded from the aspirated thermocouples in F99B1401 and F99B1402, respectively. Air temperatures just below the headlining trim panel started to increase between 5 and 10 minutes post-ignition in both test vehicles, reaching maxima of 160°C at 12:56 min:sec post-ignition in F99B1401 and 114°C at 12:58 min:sec post-ignition in F99B1402. Air temperature decreased as distance below the headlining trim panel increased. For example, air temperatures recorded approximately 18 inches below the lower surface of the headlining trim panel reached maxima of 50°C at 13:15 min:sec post-ignition in F99B1401 and 44°C at 13:19 min:sec post-ignition in F99B1402. This data indicates that a burning upper layer did not develop in either of the test vehicles at any time during these tests.

Figure 29. Fire Test F99B1401. Plots of temperature data recorded from the aspirated thermocouple assembly.

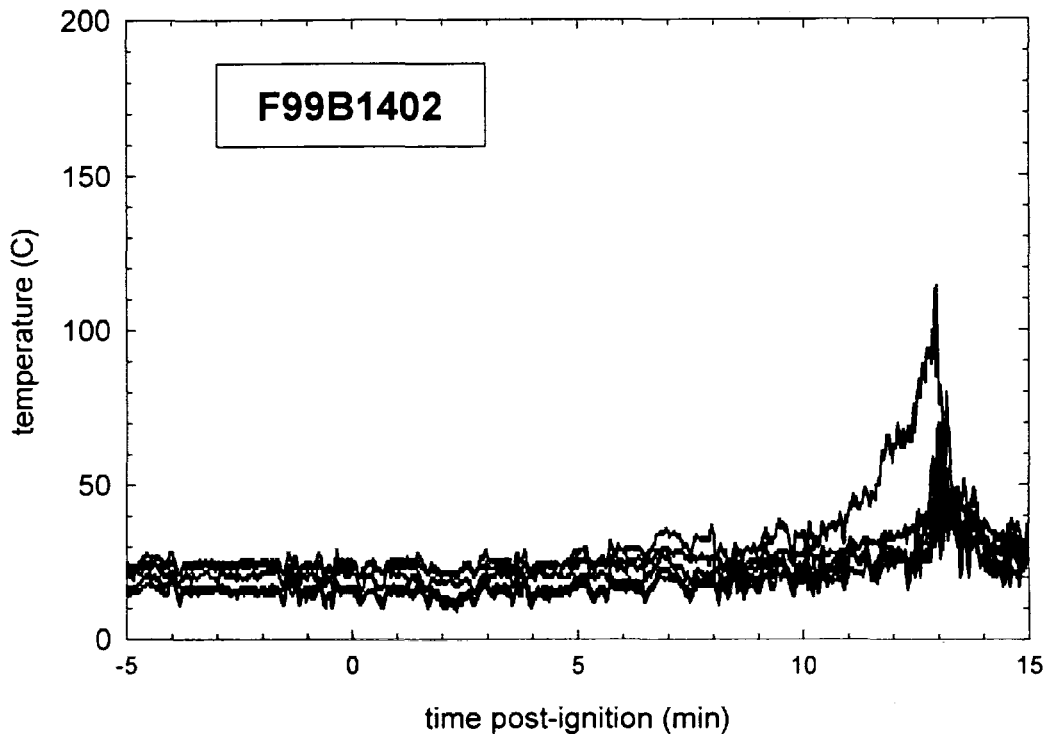
Figure 30. Fire Test F99B1402. Plots of temperature data recorded from the aspirated thermocouple assembly.

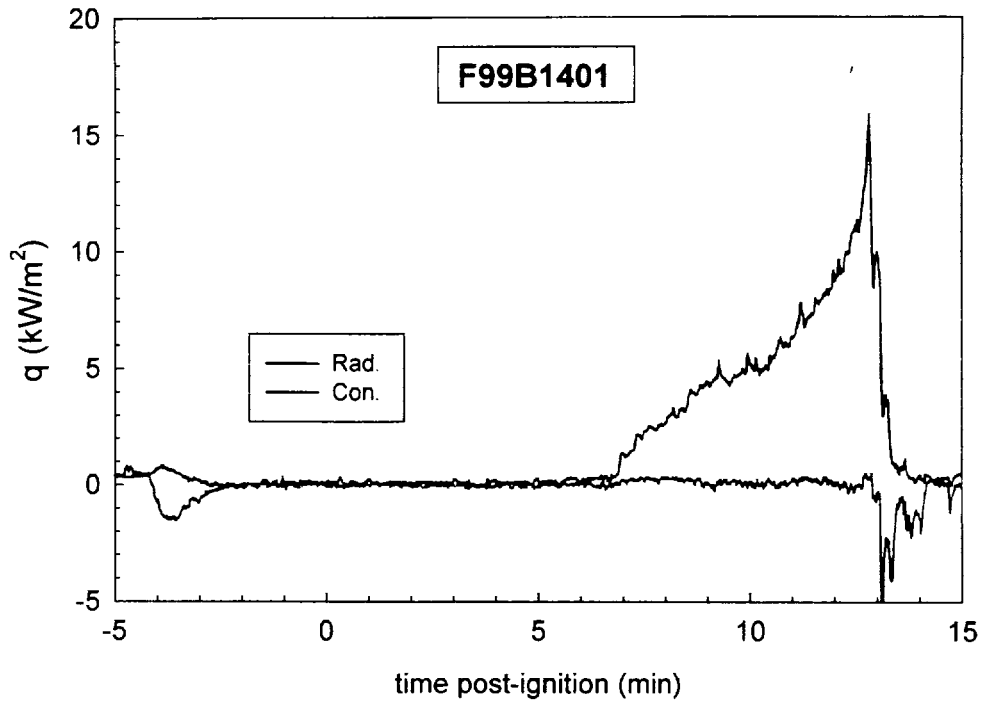
Heat flux transducer/radiometer assemblies were located above both front seats in the test vehicles (**Appendix J**). These transducers measured the convective and radiative heat fluxes to vertical, forward-facing planes approximately 30 inches above the centers of the seat cushions. Figures 31 and 32 show plots of temperature data recorded from the heat flux transducer/radiometer assemblies above the left front seats in F99B1401 and F99B1402. In both tests, the radiative heat fluxes increased from background levels at about 7 minutes post-ignition (Fig.'s 31 and 32), which was coincident with the timing of sections of the windshields first starting to fall onto the instrument panel upper trim panel and holes developing in the windshield. The radiative heat fluxes increased exponentially until the tests were ended and the fires extinguished just before 13 minutes post-ignition, (Fig.'s 31 and 32). The peak heat flux recorded during F99B1401 was 15.9 kW/m² at 12:49 min:sec post-ignition and the peak heat flux recorded during F99B1402 was as 15.8 kW/m² at 12:51 min:sec post-ignition (Fig.'s 31 and 32). The convective heat fluxes to these transducers did not change significantly from background levels during these tests (Fig.'s 31 and 32).

Figure 31. Fire Test F99B1401. Plots of radiative and convective heat fluxes measured by a heat flux transducer/radiometer assembly above the left front seat.

This heat flux data indicates that thermal radiation from the fire plume at the rear of the deformed hoods started to reach the surfaces of the heat flux transducer/radiometer assemblies when holes started to develop in the windshields of the test vehicles. The radiative heat fluxes to these transducers increased as the size of the openings in the windshields increased and the intensities of the fires in the engine compartments of the test vehicles increased. The measured convective heat fluxes remained constant from the times of ignition to the times these tests were ended. The temperatures of the transducers were maintained between 60 and 70°C by circulation of a thermostated fluid through the transducer bodies. The convective heat flux data plotted in Figures 31 and 32 indicates that the temperature of the air surrounding these transducers was not substantially greater than the temperatures of the transducer bodies themselves, resulting in no net heat exchange between the transducers and the surrounding air and no measured convective heat flux. This is consistent with air temperatures < 100°C at the elevation of the heat flux transducer/radiometer assemblies measured in the passenger compartments of the test vehicles during these tests (Fig.'s 29 and 30). The negative deflections in the convective heat flux plots occurring between 13 and 15 minutes post-ignition indicate cooling of the transducer bodies caused by the water spray used to extinguish the fires.

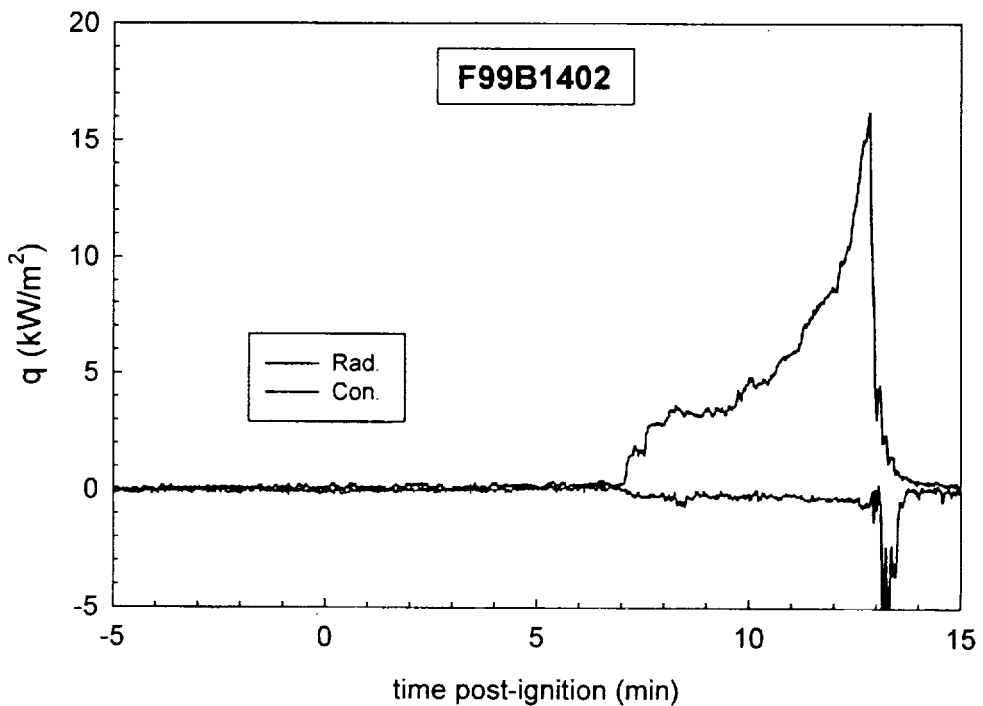
Figure 32. Fire Test F99B1402. Plots of radiative and convective heat fluxes measured by a heat flux transducer/radiometer assembly above the left front seat.

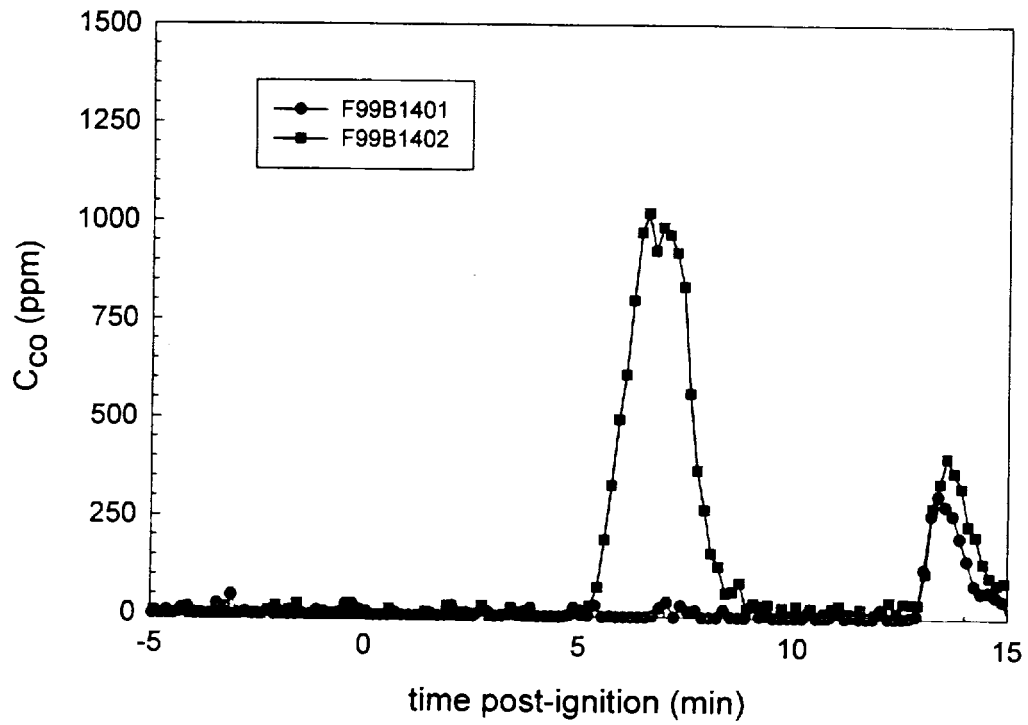
During these tests, combustion products such as smoke and carbon monoxide entered the passenger compartments of the test vehicles before flames spread to the instrument panel upper trim panel. The amount of smoke and the concentration of carbon monoxide in the passenger compartment of F99B1402 was substantially greater than the amount of smoke and the concentration of carbon monoxide in the passenger compartment of F99B1401. For example, a few diffuse streams of smoke were visible emanating from the broken HVAC module in F99B1401 by 7 minutes post-ignition (lower video still, Fig. 16). In contrast, smoke visible in F99B1402 at 7 minutes post-ignition almost totally obscured the headlining trim panel (lower video still, Fig. 17). Figure 33 shows plots of the carbon monoxide concentrations in the passenger compartments of F99B1401 and F99B1402 during these tests (Appendix L). The concentrations of carbon monoxide in the passenger compartments show peaks of 38 ppm at 7:03 min:sec in F99B1401 and 1024 ppm at 6:35 min:sec in F99B1402 (Fig. 33). Smoke and carbon monoxide cleared from the passenger compartments of both test vehicles starting at about 7 minutes post-ignition, which was coincident with the timing of the development of openings in the windshields of both test vehicles. In both test vehicles, thermal convection created by the fire plume above the engine compartment caused air to be drawn out of the passenger compartment through the opening in the windshield. Clean outside air flowed into the passenger compartment through the open right side window, which resulted in dilution of the smoke and carbon monoxide.

Figure 33. Plots of carbon monoxide concentration measured in the passenger compartments of the control vehicle (F99B1401) and FR vehicle (F99B1402).
