NHTSA-98-3588-202

Project B.14 – Demonstration of Enhanced Fire Safety Technology – Fire Suppression Systems

Part 2A: Evaluation of Fire Suppression Systems in a Full Scale Vehicle Fire Test and Static Vehicle Fire Tests

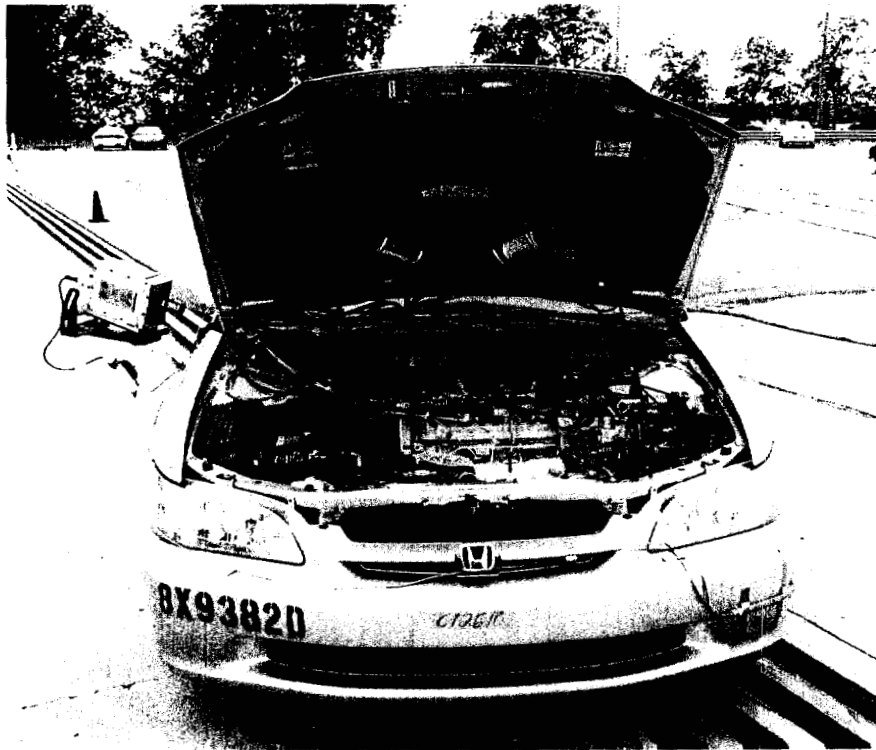
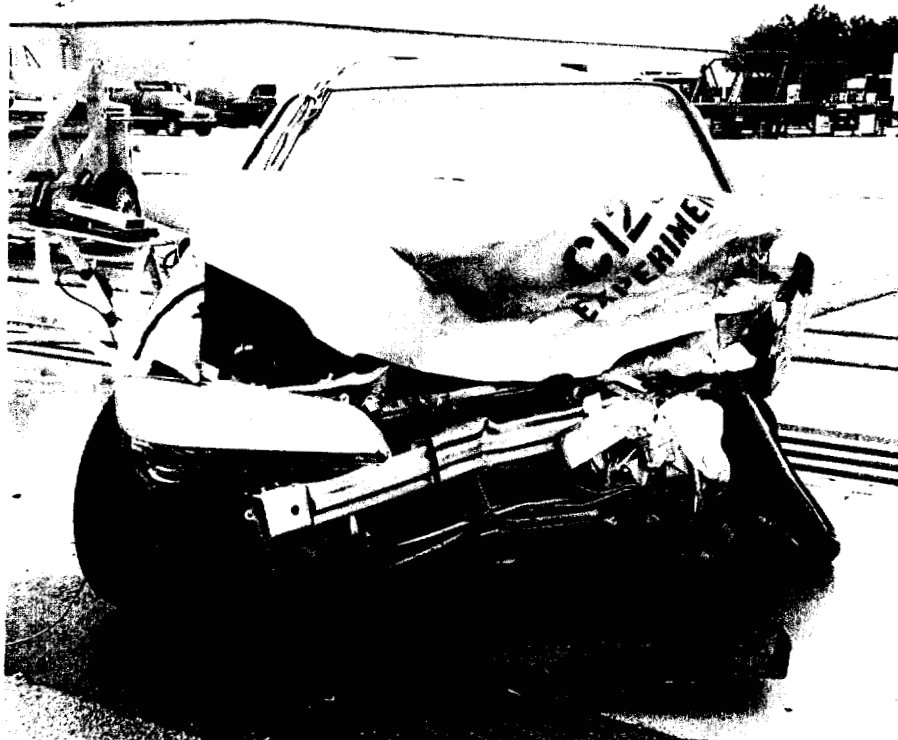
Figure 3. Crash Test C12610. Photographs of the test vehicle before (upper) and after (lower) this crash test.

The fire suppression system installed in the engine compartment of the test vehicle for this test included two prototype solid propellant gas generator fire suppression units (Atlantic Research Corporation, Knoxville, TN) and two prototype optical flame detectors (SRS Technologies, Huntsville, AL). The solid propellant gas generator flame suppression units were bolted to the lower surface of the hood using two U-bolts for each unit. The optical flame detectors were attached to the lower surface of the hood using two through-bolts for each unit. Flame Suppression Unit 1 and Flame Detector 1 were attached to the left side of the hood rearward of the crush initiator in the inner hood panel. Flame Suppression Unit 2 and Flame Detector 2 were attached to the right side of the hood rearward of the crush initiator in the inner hood panel. See Figure 3.

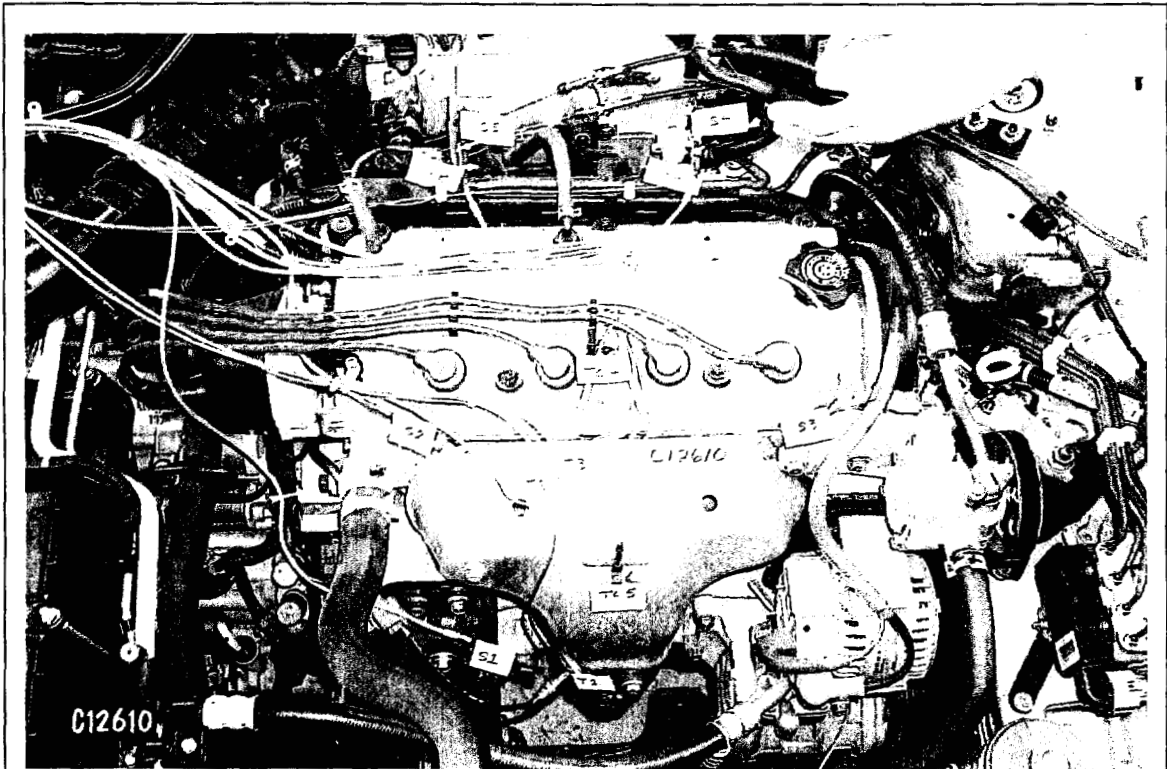
Figure B1. Crash Test C12610. Photograph of the engine compartment of the test vehicle before this crash test.

Gas Sensor S1 was located to the right of the oxygen sensor in the exhaust manifold. Gas Sensor S2 was located at the upper right of the exhaust manifold heat shield. Gas Sensor S3 was located at the upper left of the exhaust manifold heat shield. Gas Sensor S4 was located above the left side of the fuel rail. Gas Sensor S5 was located above the right side of the fuel rail.

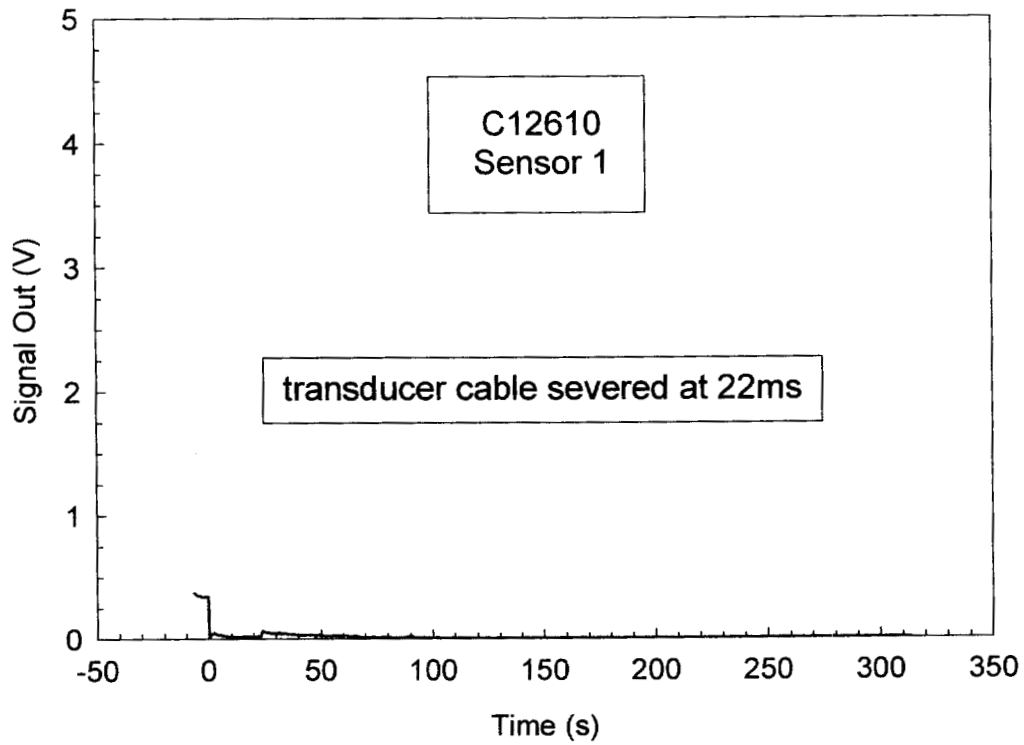
exposed to a flammable gas. It is not known to what extent these sensors were effected by exposure to the effluent from the SPGGs, which activated at approximately 300 milliseconds after time-zero. Plots B1 through B5 show plots of voltages recorded from Sensors 1 through 5, respectively. Flammable vapor concentrations were not calculated because of likely interference from the SPGG effluent.

Plot B1. Crash Test C12610. Plot of voltage recorded from flammable gas sensor at Location 1.

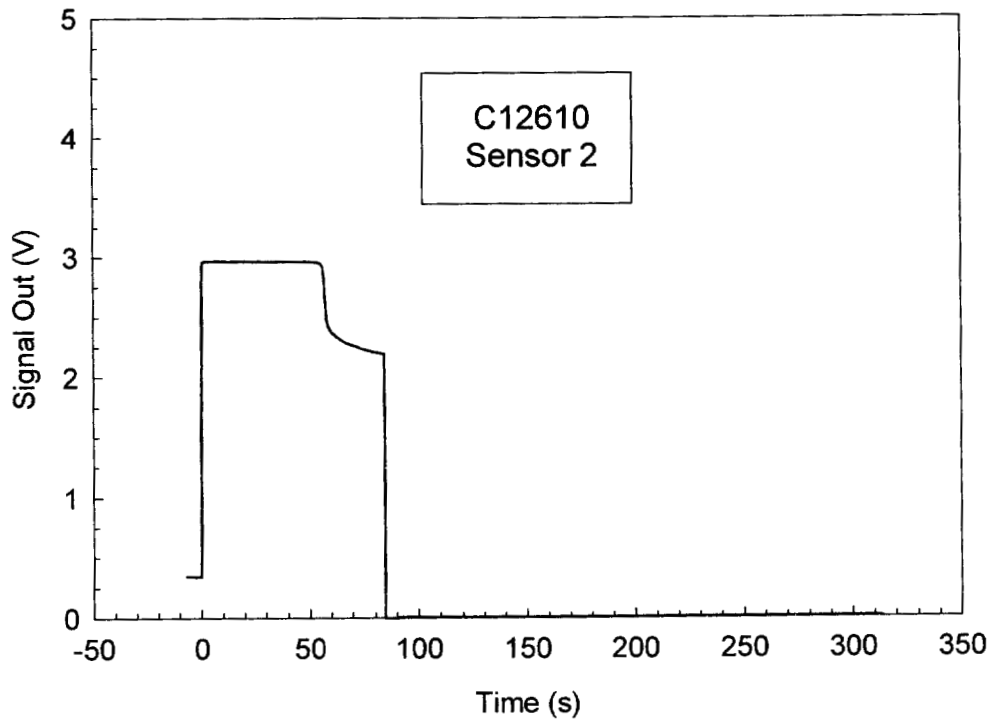
Plot B2. Crash Test C12610. Plot of voltage recorded from the flammable gas sensor at Location 2.

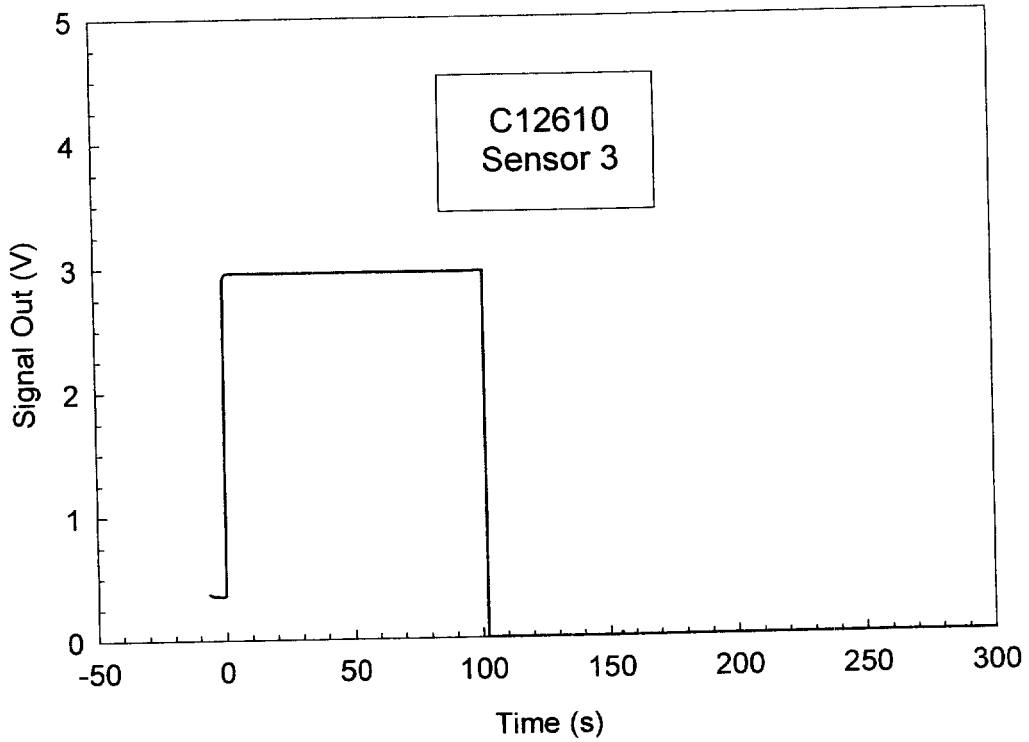
Plot B3. Crash Test C12610. Plot of voltage recorded from the flammable gas sensor at Location 3.

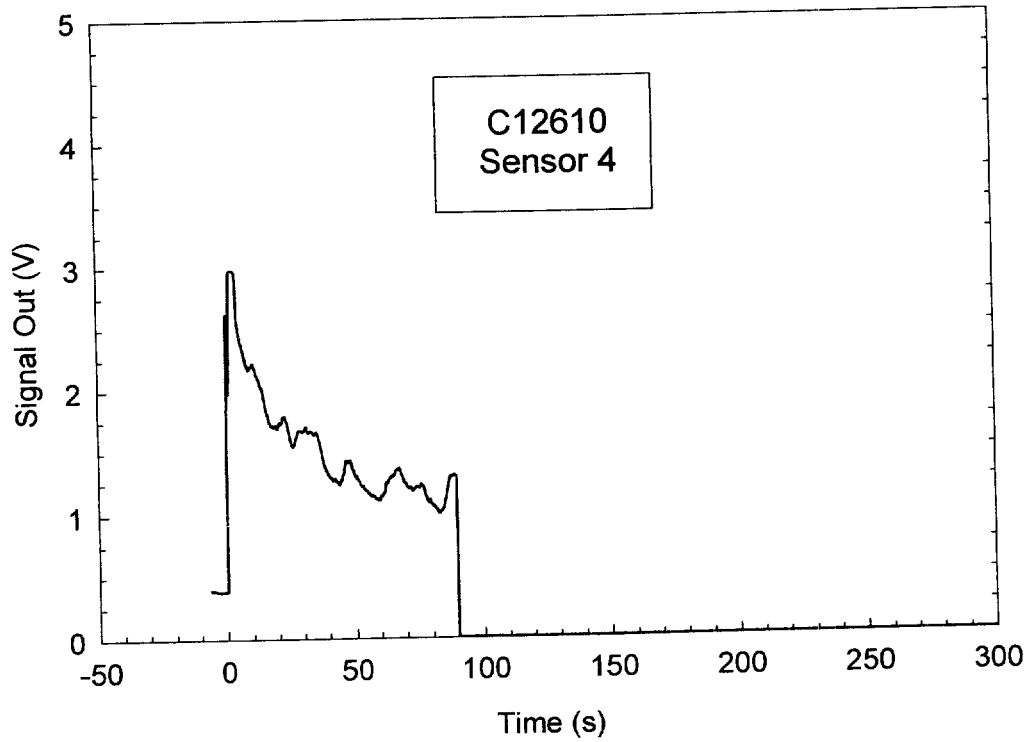
Plot B4. Crash Test C12610. Plot of voltage recorded from the flammable gas sensor at Location 4.

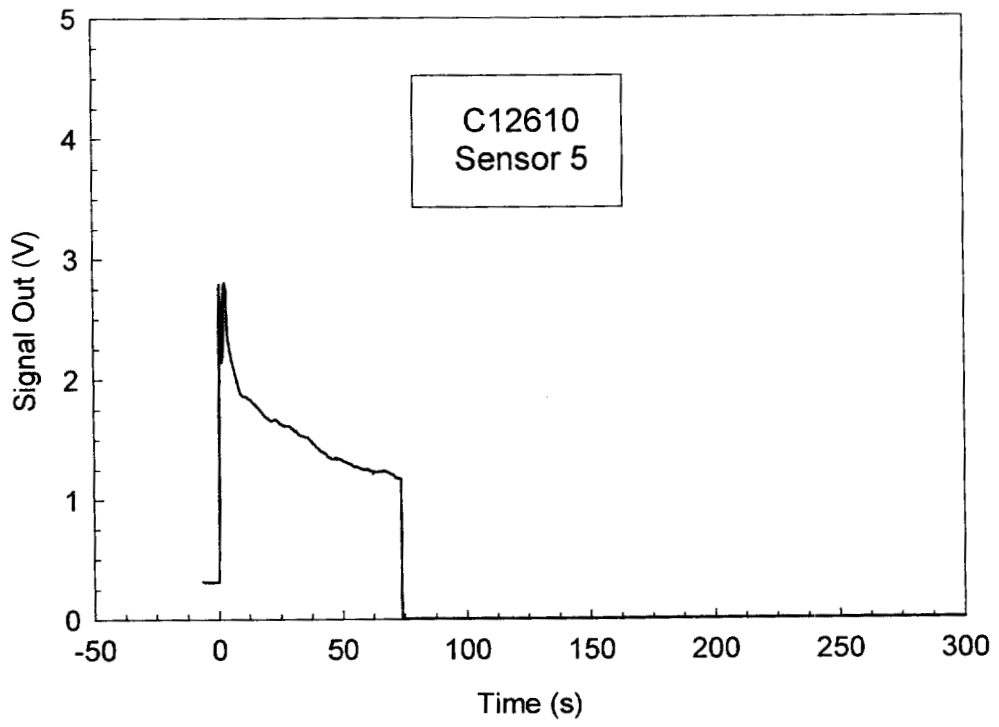
Plot B5. Crash Test C12610. Plot of voltage recorded from the flammable gas sensor at Location 5.

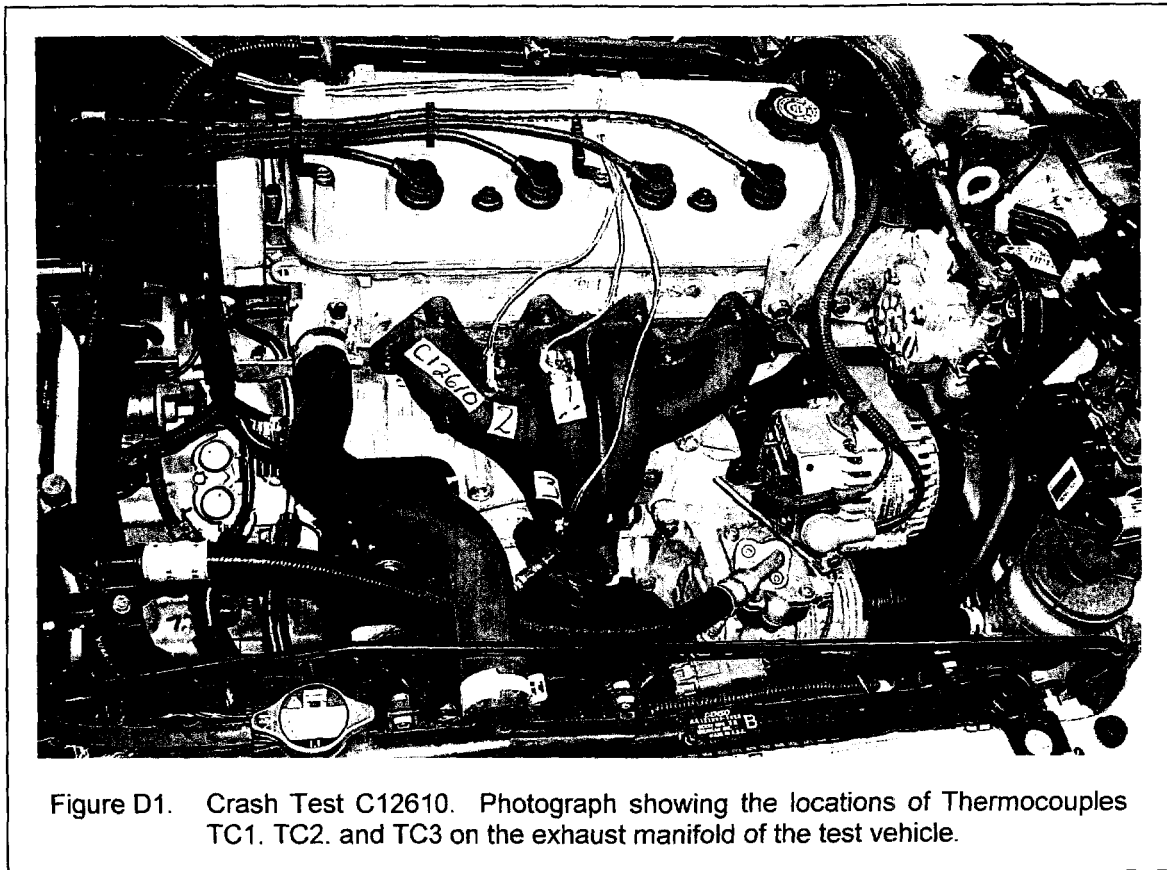
Five thermocouples were installed in the engine compartment of the test vehicle for this crash test. Figure D1 is a photograph showing the locations of Thermocouples TC1, TC2, and TC3 on the exhaust manifold of the test vehicle. Thermocouple TC1 was intrinsically welded to the runner from cylinder number 2 (Fig. D1). Thermocouple TC2 was intrinsically welded to the webbing between the runners from cylinders number 1 and 2 (Fig. D1). Thermocouple TC3 was intrinsically welded to the collector just above the oxygen sensor (Fig. D1).

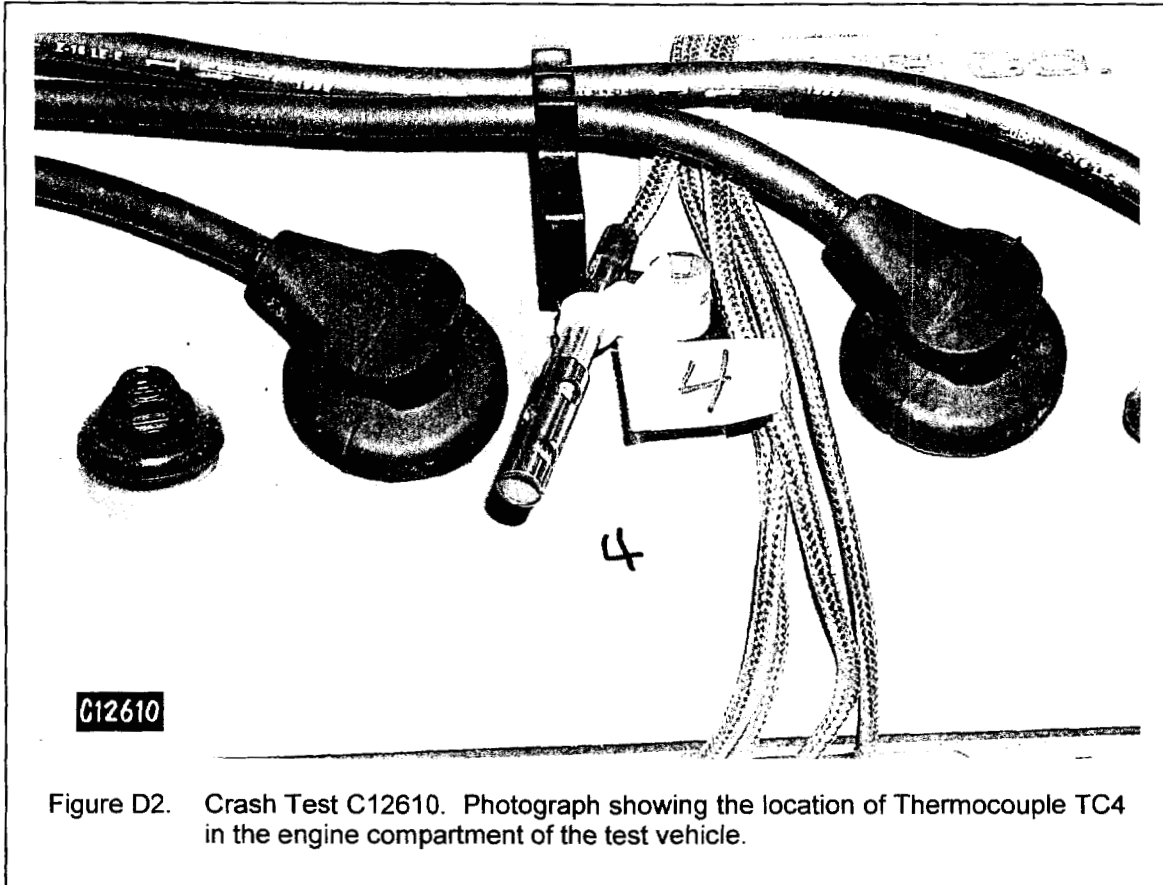
Figure D2. Crash Test C12610. Photograph showing the location of Thermocouple TC4 in the engine compartment of the test vehicle.

Figure D2 is a photograph showing the location of Thermocouple TC4 in the engine compartment of the test vehicle. Thermocouple TC4 was a shielded thermocouple located at the center of the front edge of the valve cover (Fig. D2).

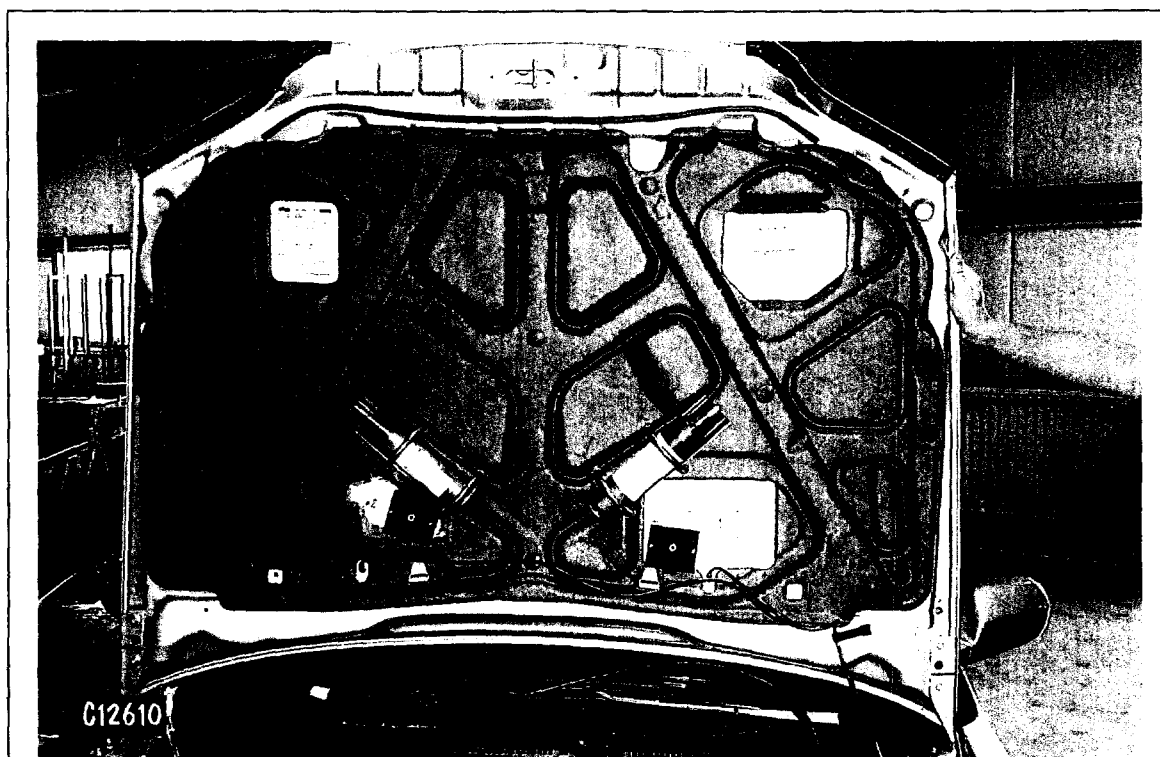
Figure E1. Crash Test C12610. Photograph showing the locations of the solid propellant gas generator flame suppression units and optical flame detectors on the hood of the test vehicle before the crash test.

The solid propellant gas generator flame suppression units were bolted to the lower surface of the hood using two U-bolts for each unit (Fig. E1). The optical flame detectors were attached to the lower surface of the hood using two through-bolts for each unit (Fig. E1). Flame Suppression Unit 1 and Flame Detector 1 was attached to the left side of the hood rearward of the crush

initiator in the inner hood panel. Flame Suppression Unit 2 and Flame Detector 2 was attached to the right side of the hood rearward of the crush initiator in the inner hood panel.

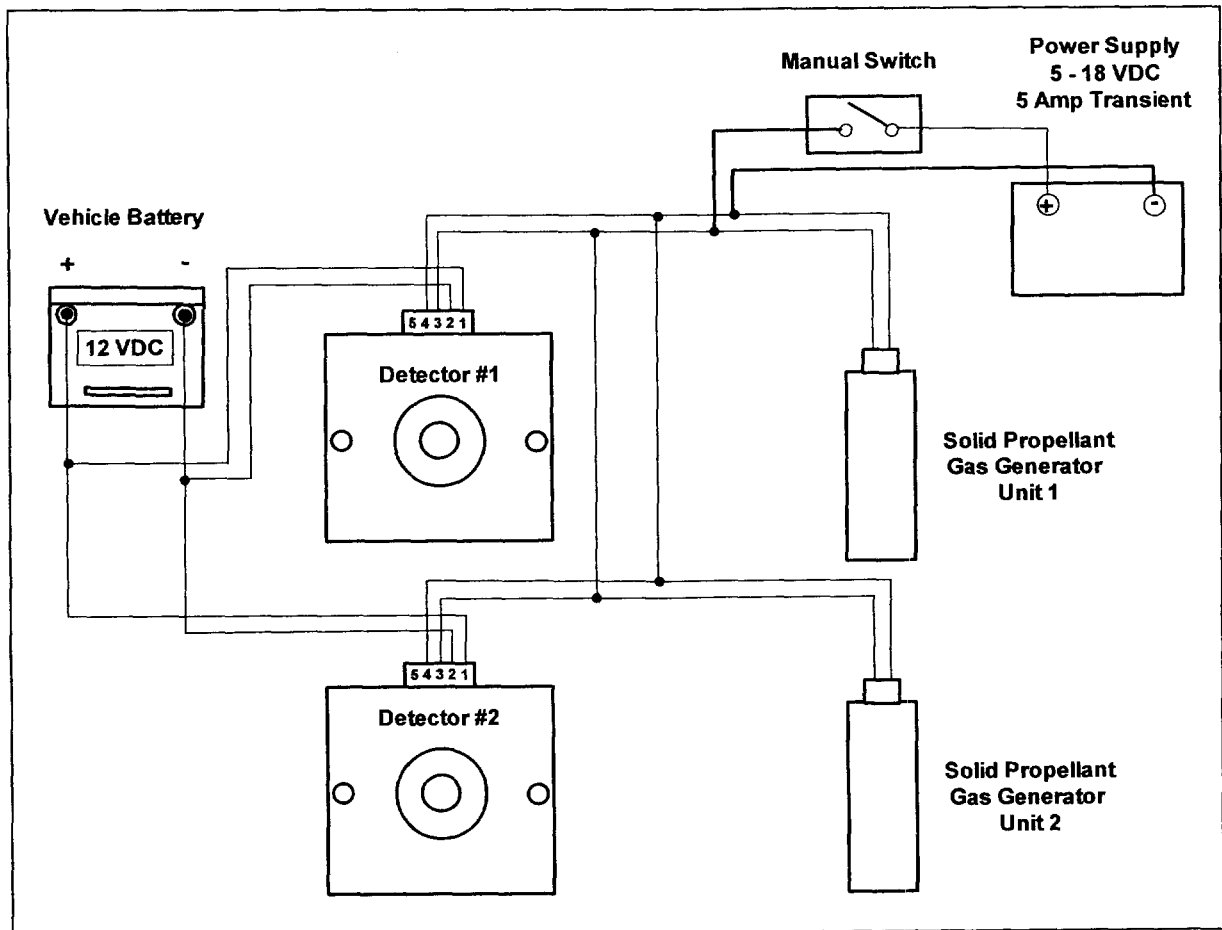
Figure E2. Crash Test C12610. Wiring schematic of the fire suppression system used in this test.

The vehicle battery supplied electrical power to the optical flame detectors. The flame suppression units were connected to the optical flame detectors in parallel so that detection of flame by either flame detector would activate both flame suppression units. A 5 to 18 VDC power supply was connected to the squib leads to the fire suppression units so that they could be activated manually during or after the crash test.
