ESCAPE WORTHINESS OF VEHICLES FOR OCCUPANCY SURVIVALS AND CRASHES. SECOND PART: APPENDICES

OKLAHOMA UNIV. RESEARCH INST., NORMAN

DOT HS-800 737

Second Part: Appendices

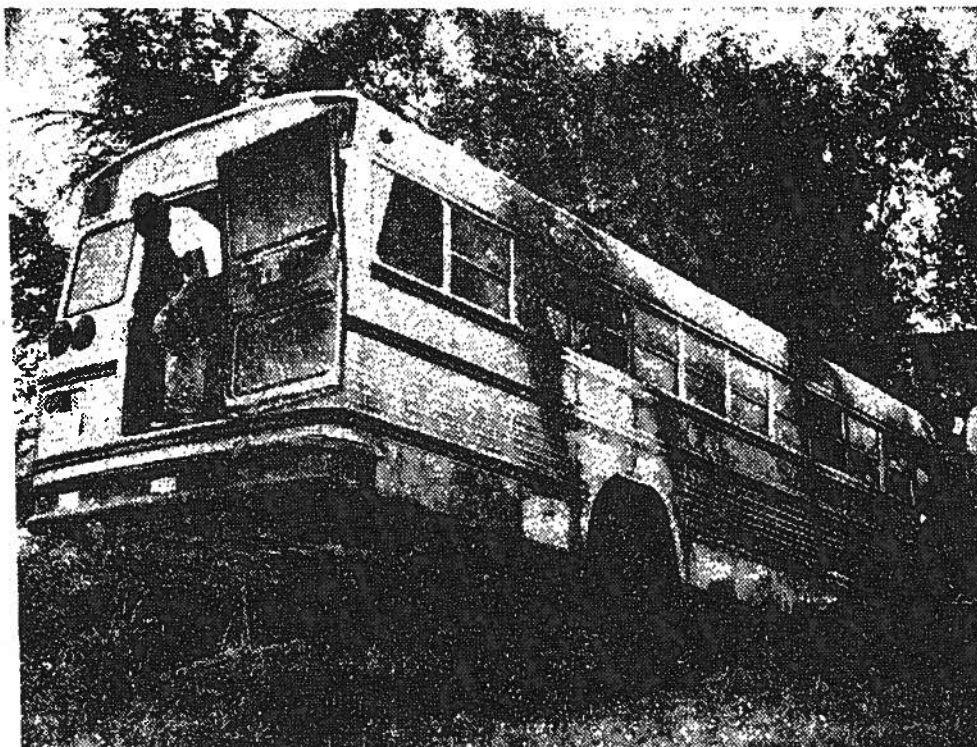
Bus came to rest nose down in ditch. (Times Staff Photo by [REDACTED])

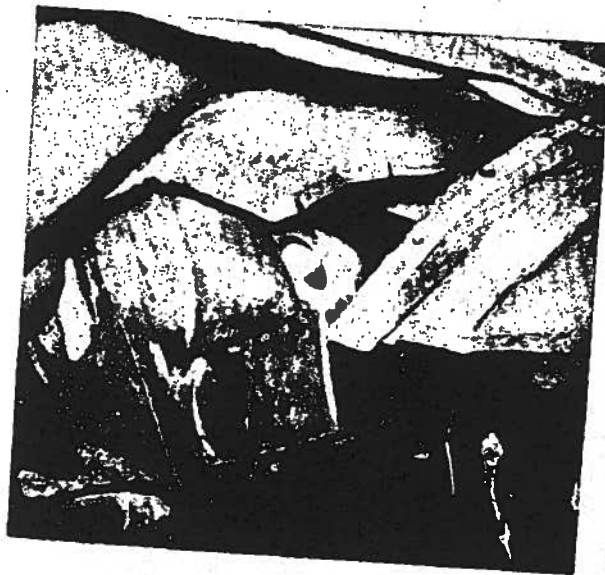
Figure 6. Gas tank of vehicle #1. Note filler neck opening aligned with hole at step well, bent skirt which directed fuel into bus interior.

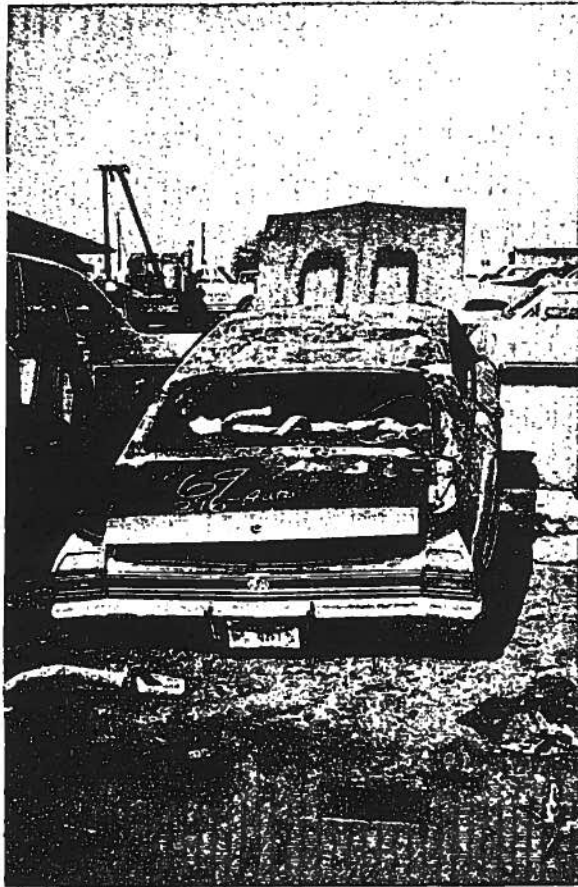
Figure 2. Rear view. Note rear deck lid has only slight paint blistering.

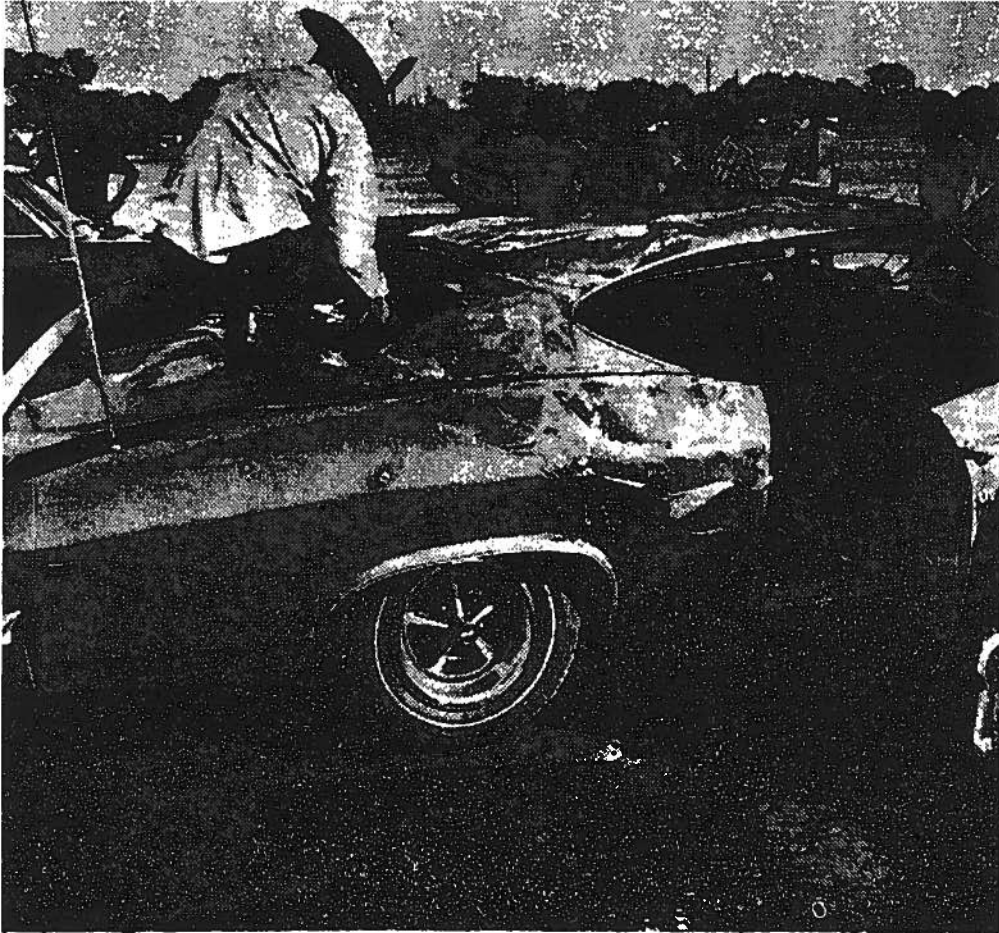
EXPLOSION BURNS STUDENT. A propane gas explosion and fire Wednesday afternoon gutted car of ██████ College student ██████, 20, of ██████, and hospitalized him in "fair" condition with burns on his arms, face and back. Firemen said fumes leaked from rubber pressure hose on propane tank in trunk ignited when ██████ started the car. First person on the scene at college's Shepler Center, ██████, 20, a classmate, took ██████ to nearby Memorial Hospital. Above, Fireman ██████ extinguishes hot embers. (Staff Photo)

Police found a leak in a gas line running from the trunk tank of the vehicle.
