# **FUEL TANK PROTECTION**

## **FINAL REPORT**

FHR 3771  
30 June 1969

An Investigation of Fuel, Exhaust and  
Electrical Systems as Related to Post  
Crash Fire Safety

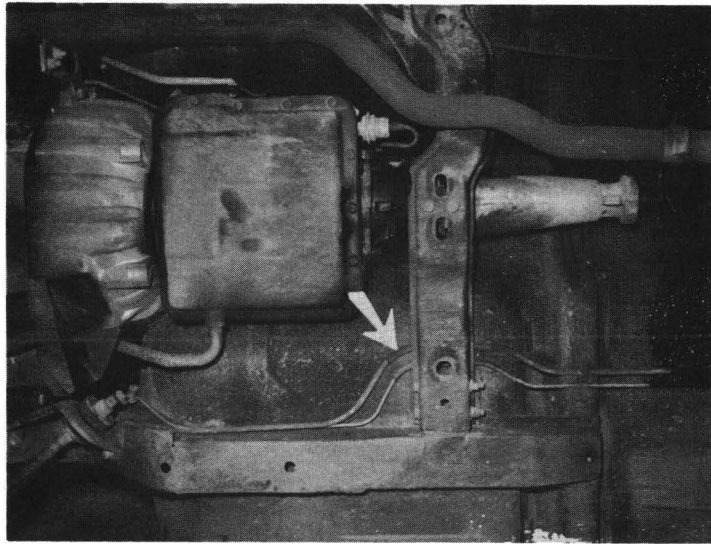
Figure 3-6. 1967 Rambler Fuel Line Routing at Transmission

The metal fuel supply and return lines are protected by rubber sleeving as they pass between the transverse transmission support member and the floor pan (Figure 3-6).

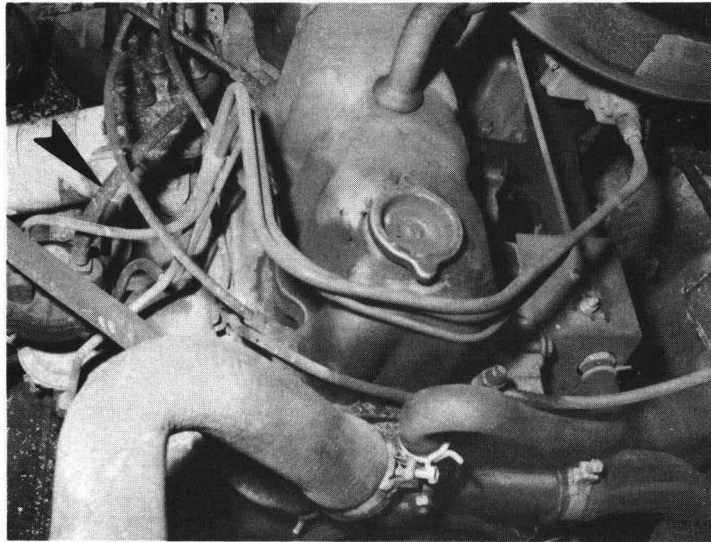
Figure 3-7. 1967 Rambler Fuel Line Routing at Engine

The fuel supply line incorporates a flexible hose at the end of its run to the fuel pump. Figure 3-7 shows the undesirable characteristic of a flexible hose passing between the distributor and the engine block. However, in the same illustration, the metal line which carries the fuel pump discharge to the carburetor inlet is well-formed to run to the top of the cylinder head, then forward before it turns and goes around the coolest part of the engine to terminate at the carburetor.

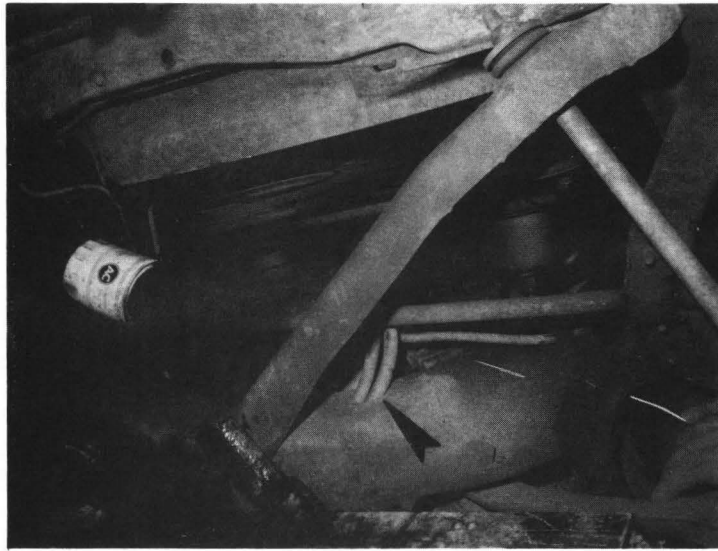
Figure 3-8. 1967 Buick Riviera Fuel Line Passing Through Structural Member

This vehicle has flexible hose fuel lines running through a punched hole in a structural member. Grommets, to act as cushions, would prevent cutting of these fuel lines in a crash or abrasive deterioration during normal operation. Figure 3-8 shows the fuel supply and return lines as viewed from below, looking toward the rear of the vehicle.

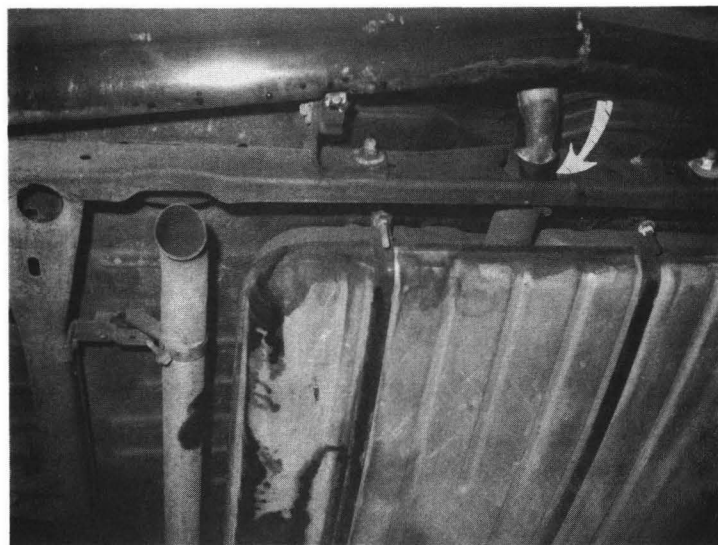
Figure 3-9. 1966 Cadillac Coupe de Ville Filler Pipe Passing Through Structural Member

Figure 3-9 is an illustration of the filler pipe as it passes through the rear frame rail, using a flexible hose connector. Rear impact, causing transverse deformation of the rear rail, could break the connection. These illustrations also show the two longitudinal straps that adequately support the fuel tank.

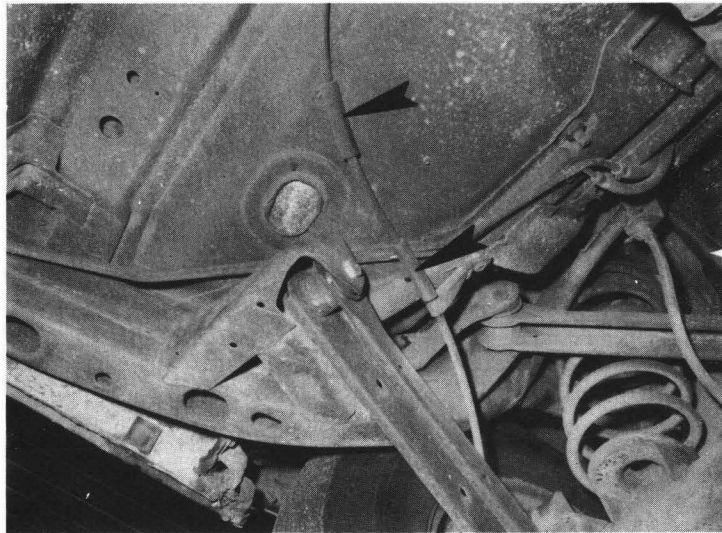
Figure 3-10. 1966 Cadillac Coupe de Ville Fuel Line Cushioning Sleeves

Figure 3-10 shows the cushioning sleeves that protect the fuel line as it is routed forward of the rear axle.

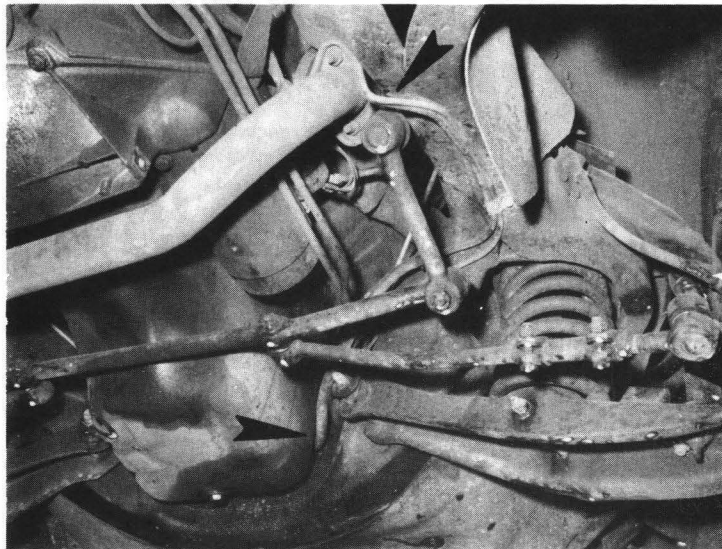
Figure 3-11. 1966 Cadillac Coupe de Ville Fuel Line Routing

Figure 3-11 shows two undesirable features. The flexible hose of the fuel line passes between the oil pan and the A-frame. Displacement could pinch the hose. Also, the metal fuel supply and return lines are routed around a flange of the exhaust piping.

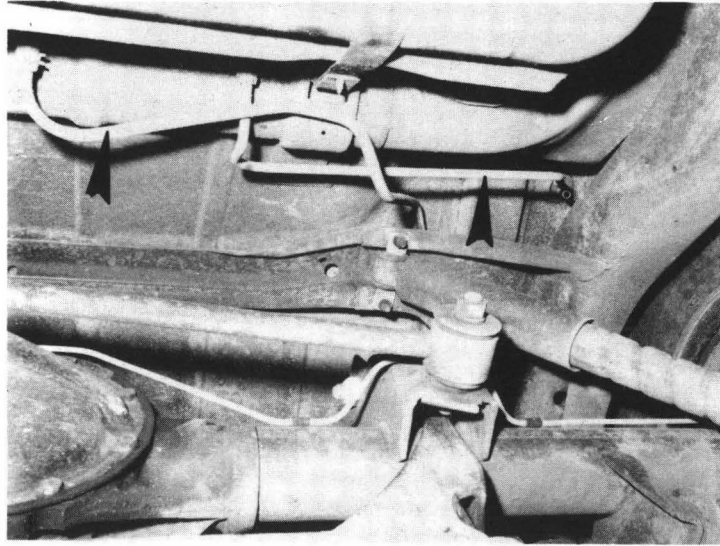
Figure 3-12. 1968 Chevrolet Impala Fuel Line and Vent

Figure 3-12 shows the desirable feature of ample space between the front of the fuel tank and the stabilizer bar attachment. Undesirable construction details are also indicated. The fuel line passes between the floor pan and a cross brace member, with the possibility of crushing the fuel line if crash displacement occurs. The illustration also shows the vent line which runs upward and then down to form an inverted "V" near the right rear wheel housing. This type of vent (used by General Motors, Chrysler and Ford) may permit fuel spillage during rollover.

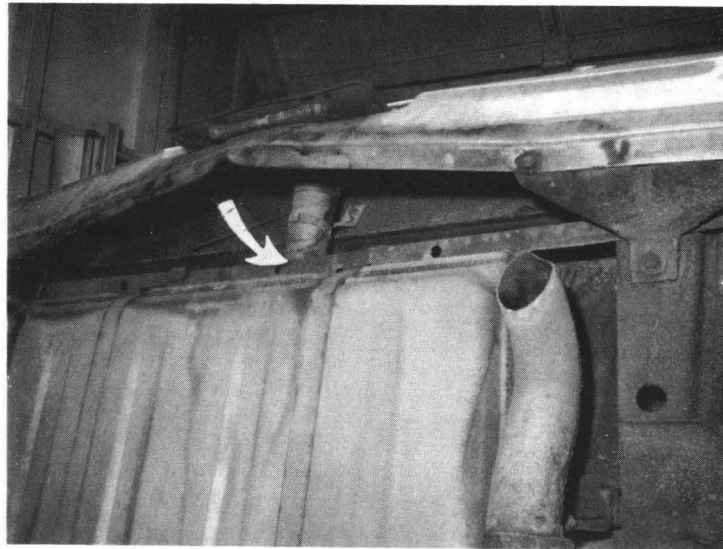
Figure 3-13. 1968 Chrysler New Yorker Rear Crossrail Proximity to Fuel Tank

Figure 3-13 shows the fuel tank location at the extreme rear of the vehicle. The flanged edge of the rear crossrail (indicated by the arrow) is very close to the tank and rear impact could easily drive the flange against the tank with possibility of rupture.

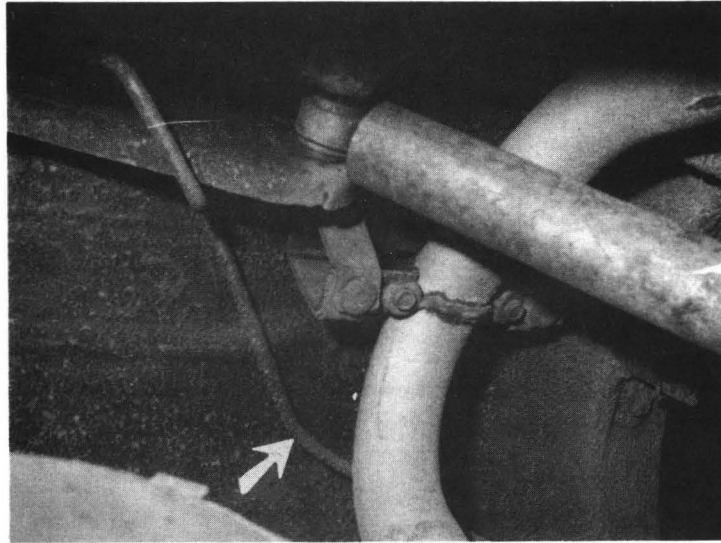
Figure 3-14. 1968 Chrysler New Yorker Fuel Line Routing around Exhaust Pipe

Figure 3-14 shows the fuel line passing between the floor pan and exhaust pipe. The line is about 3 inches above the top of the gooseneck of the front pipe. Minor rerouting of the fuel line would have provided more clearance.

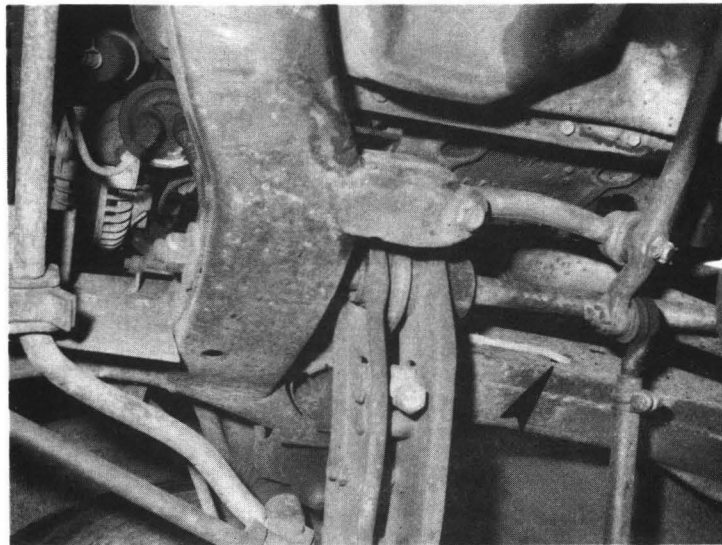
Figure 3-15. 1968 Chrysler New Yorker Fuel Line Passing Through Structural Member

Figure 3-15 shows the metal fuel line emerging from the bottom of the right side frame rail through a punched hole. A grommet would help to prevent fuel line abrasion.

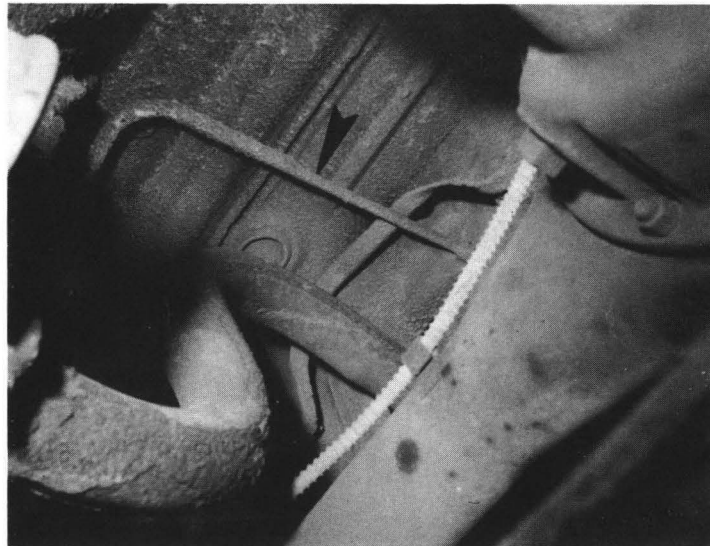
Figure 3-17. 1966 Dodge Coronet 500 Fuel Line Routing around Exhaust Pipe

Figure 3-17 shows good routing of the fuel line to clear the exhaust pipe gooseneck. Figure 3-18 shows the same fuel line passing through a punched hole in a frame cross member.

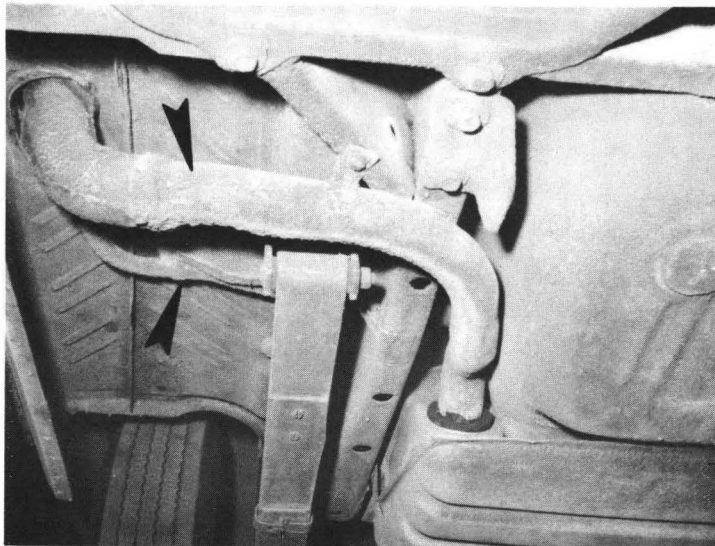
Figure 3-19. 1967 Dodge Coronet 500 Filler Pipe and Vent Line

Figures 3-19 and 3-20 show two undesirable fuel system features. The filler pipe and vent line run through a punched flanged hole in the floor pan (Figure 3-19). The spare wheel well, which is formed in the floor pan, is immediately behind the fuel tank (Figure 3-20). Since there is a small space between the wheel well and the rear crossrail, rear impact could drive the depressed wheel well into the fuel tank.

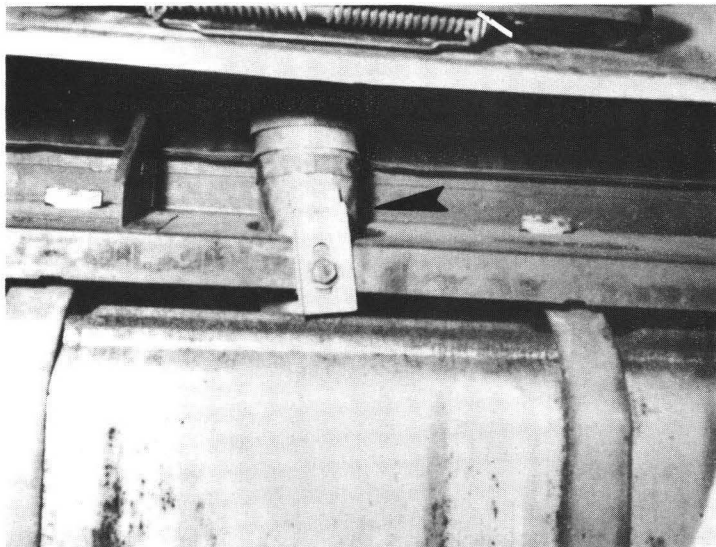
Figure 3-21. 1968 Dodge Coronet 440 Filler Pipe Arrangement

Figure 3-21 shows the fuel tank at the extreme rear of the vehicle. The small space between the rear crossrail flange and the rigidly anchored filler pipe could cause a failure of the fuel tank assembly if rear impact occurred.

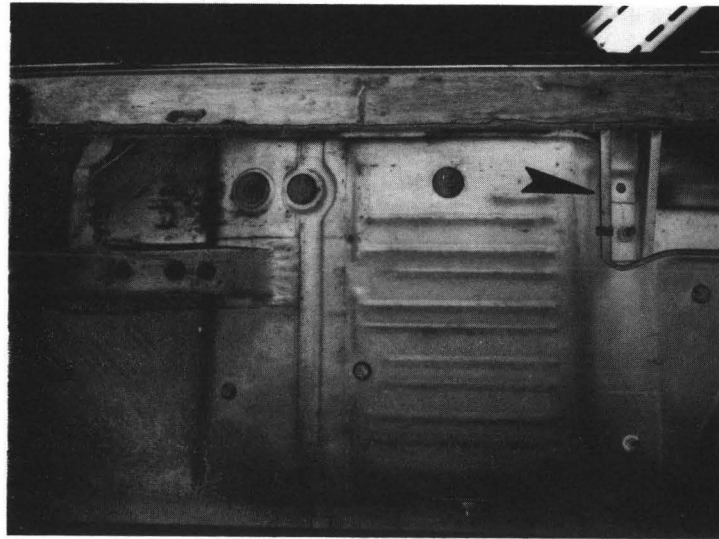
Figure 3-22. 1967 Dodge Dart Fuel Line Routing

Figure 3-22 shows the fuel line bent around a floor pan attachment bracket. Distortion in this area could rupture the line.

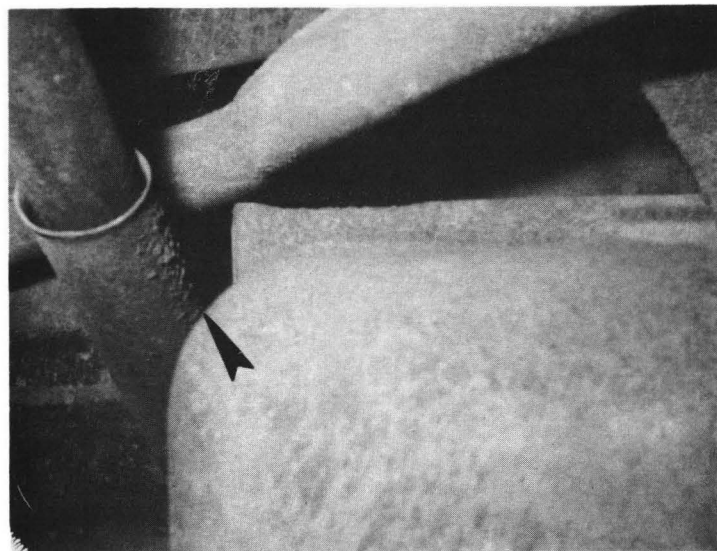
Figure 3-25. 1967 Dodge Dart Fuel Tank Proximity to Shock Absorber

Figure 3-25 shows the proximity of the left rear shock absorber to the fuel tank.

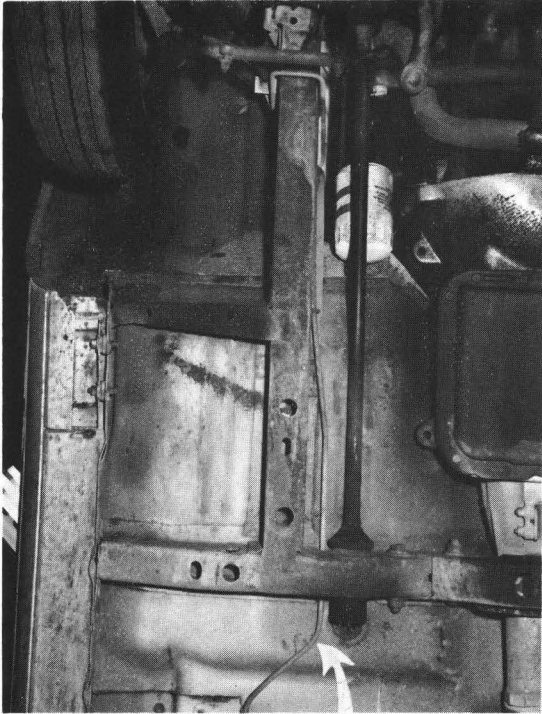
Figure 3-26. 1967 Dodge Dart Fuel Line Routing

Figure 3-26 illustrates another instance of a fuel line running through unprotected holes in sheet metal.

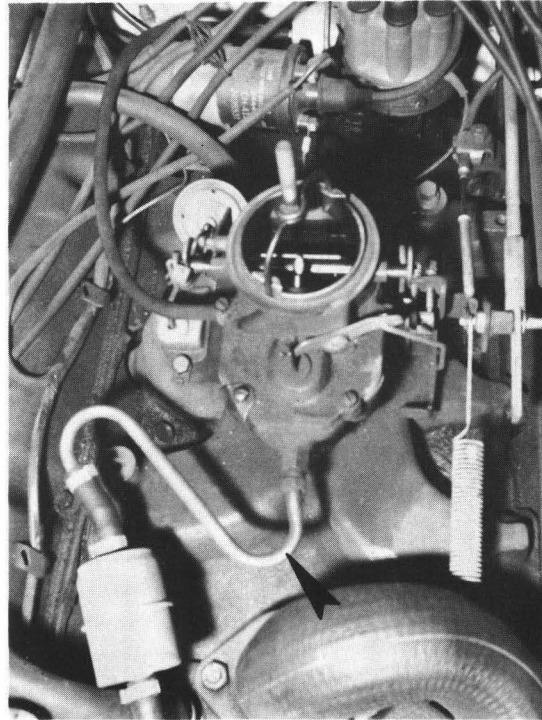
Figure 3-27. 1967 Dodge Dart Fuel Line at Engine

Figure 3-27 shows the fuel line at the carburetor. The "S" shaped metal tubing from filter to carburetor provides adequate support and impact flexibility.

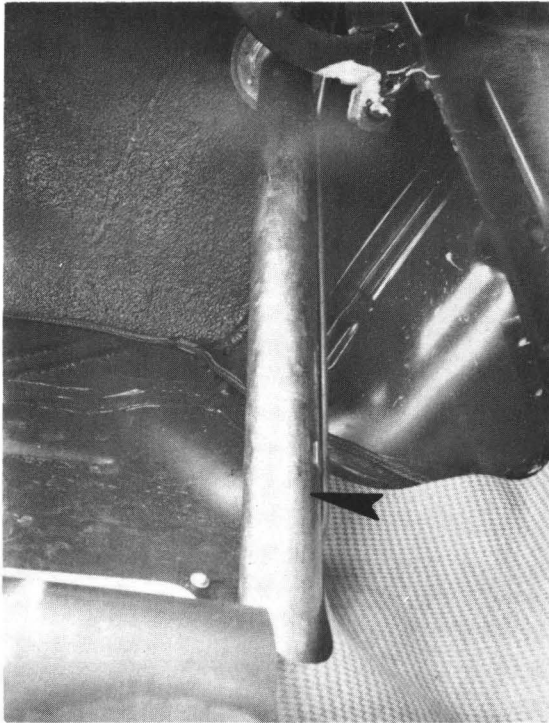
Figure 3-28. 1968 Dodge Dart  
Filler Pipe

Figure 3-28 shows the long filler pipe, completely exposed and subject to impact by articles carried in the luggage compartment.

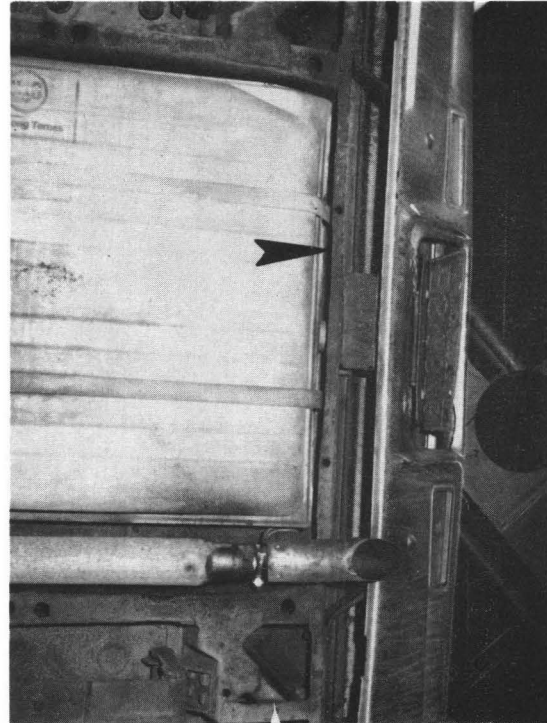
Figure 3-29. 1966 Dodge Polara Fuel Tank  
Proximity to Rear Crossrail

Figure 3-29 shows the fuel tank positioning and support. The two longitudinal straps appear adequate, but the rear of the tank is so close to the rear crossrail that rear impact vulnerability is high.

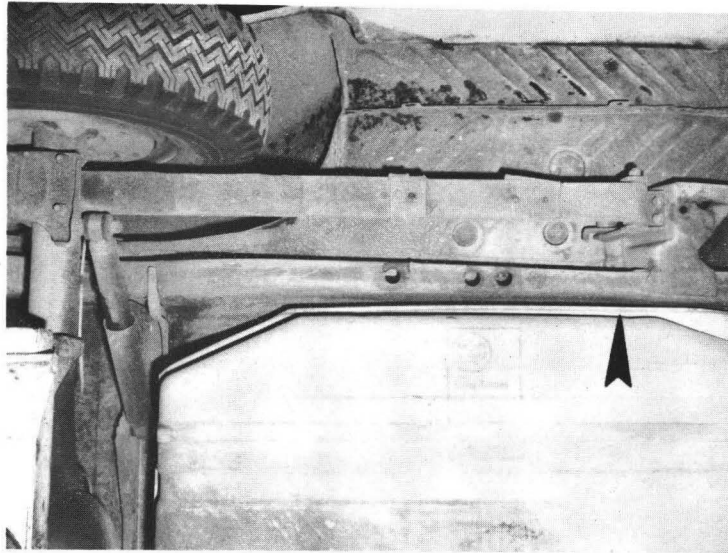
Figure 3-30. 1966 Dodge Polara Tank Proximity to Side Rail

Since the tank is placed off center longitudinally to clear the exhaust system resonator and tail pipe, the left rear shock absorber is very close to the front left corner of the tank (Figure 3-30). The left side rail is close to the tank, but since its web is adjacent to the tank, this frame member serves as protection from left side impacts.

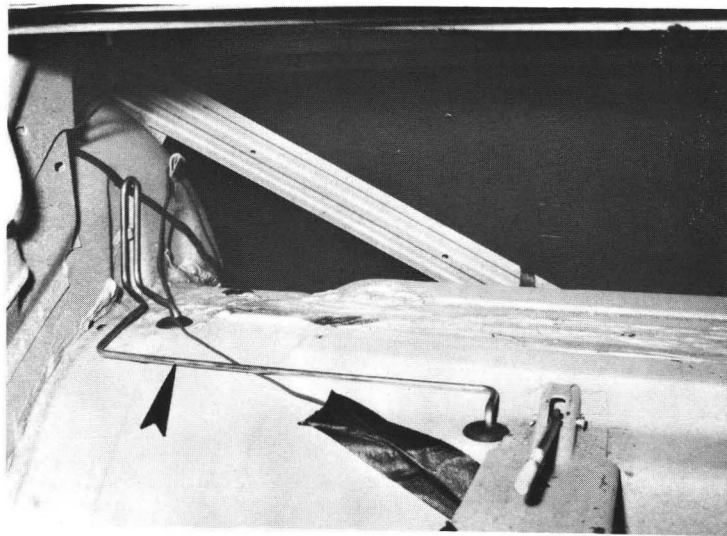
Figure 3-31. 1966 Dodge Polara Vent Line Routing

Figure 3-31 is a view looking forward into the luggage compartment. The vent line can be seen rising through the floor and then returning downward to discharge to the atmosphere.

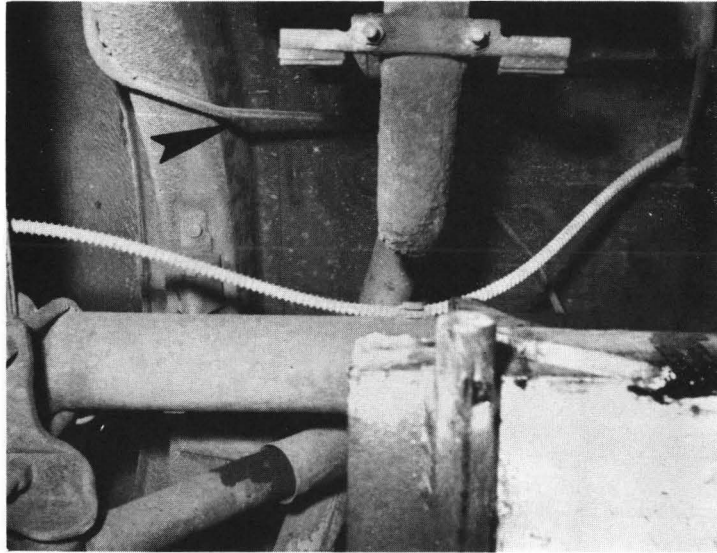
Figure 3-32. 1966 Dodge Polara Fuel Line Routing

Figure 3-32 shows the fuel line crossing above the exhaust system intermediate pipe gooseneck with ample clearance.

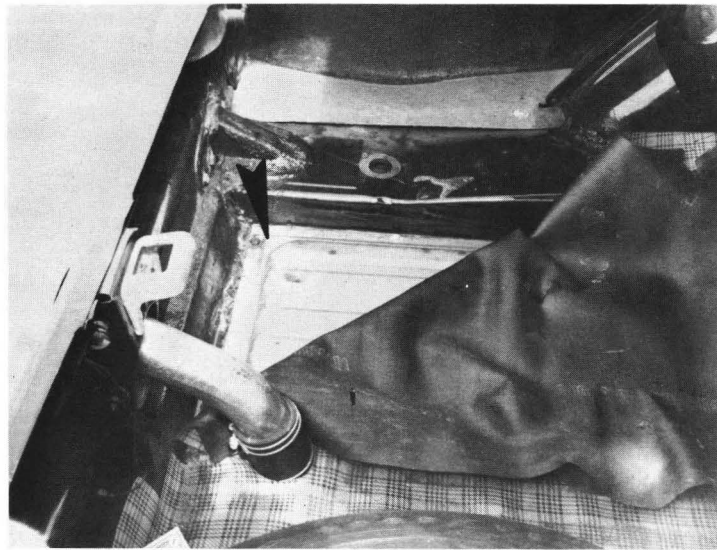
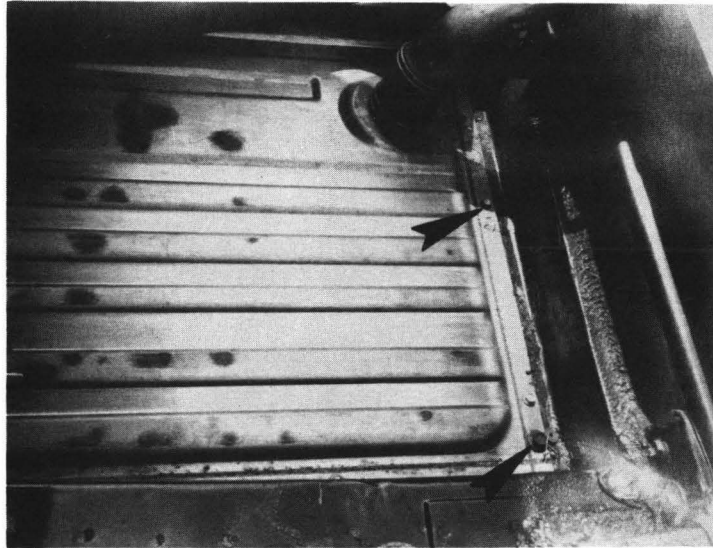
This model, as well as other Ford manufactured passenger vehicles, uses the top of the fuel tank as the floor of the luggage compartment. Heavy, sharp articles, if present at a crash, might penetrate the tank top. Figures 3-33 and 3-34 show the luggage compartment of a 1966 Mustang with the cover mat partially and completely removed. Notice that the tank is at the extreme rear of the vehicle with little crush space to absorb rear impact.

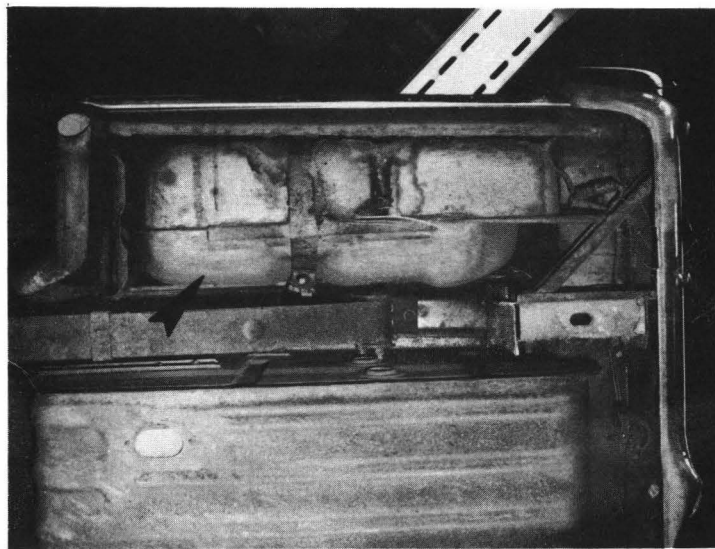
Figure 3-35. 1967 Ford Fairlane Station Wagon Fuel Tank Location

The fuel tank, as shown on Figure 3-35, is located between the outside body metal and the chassis frame at the left rear. The tank is susceptible to side impact damage.

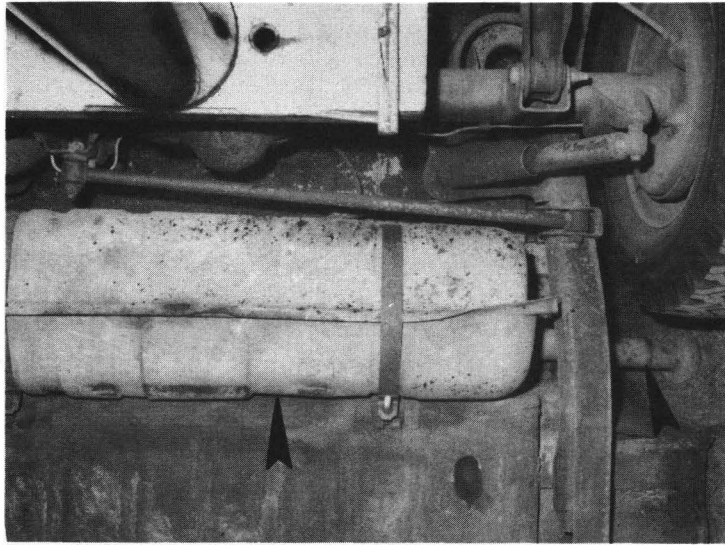
Figure 3-40. 1966 Mercury Monterey Fuel Tank and Filler Pipe

Figure 3-40 shows the fuel tank. The arrangement is the same as that shown on Figures 3-36 and 3-39 for the Ford Galaxie 500 and the Ford LTD, respectively.

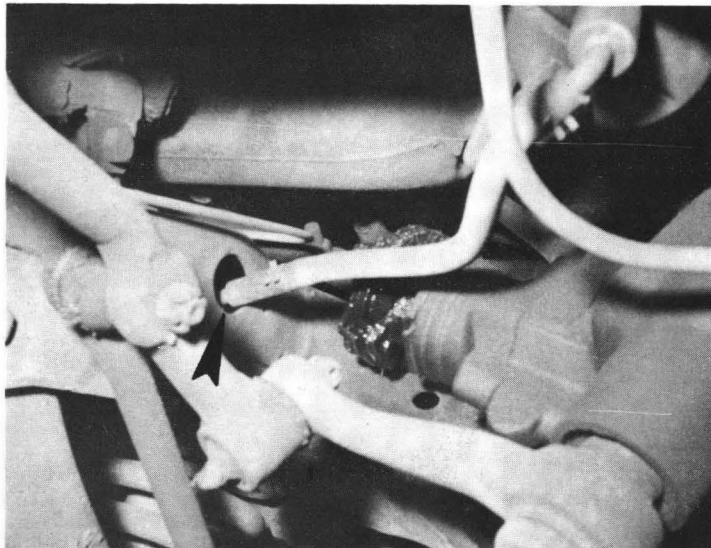
Figure 3-45. 1967 Pontiac LeMans Fuel Line

Figure 3-45 shows a flexible hose portion of the fuel line passing through an unprotected punched hole in the left front cross member.

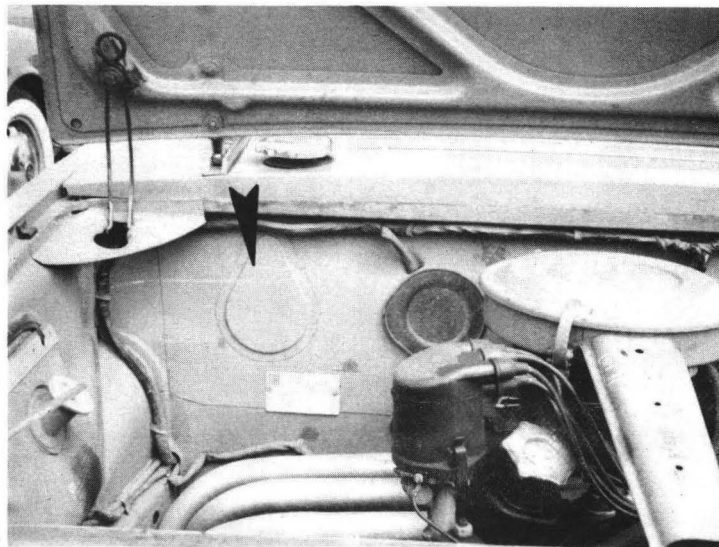
Figure 3-51. Fiat 850 Roadster Firewall

These vehicles are rear engine powered. A sheet metal partition is between the engine compartment and the fuel tank. The fuel tank is directly behind the passenger compartment. There are several apertures in the firewall, not all of which are sealed. Figure 3-51 (looking forward) shows part of the engine and the firewall. The tank in the Roadster fills from an exterior opening located behind the back window. Consequently, the large opening through which the filler pipe would pass is sealed. However, in Figure 3-52 the filler pipe and vent line in the Coupe pass through the opening which is grommetted but not sealed. Also note that the end of the vent line is in the engine compartment and only a tub-like structure around the filler pipe prevents spillage of fuel on engine components.

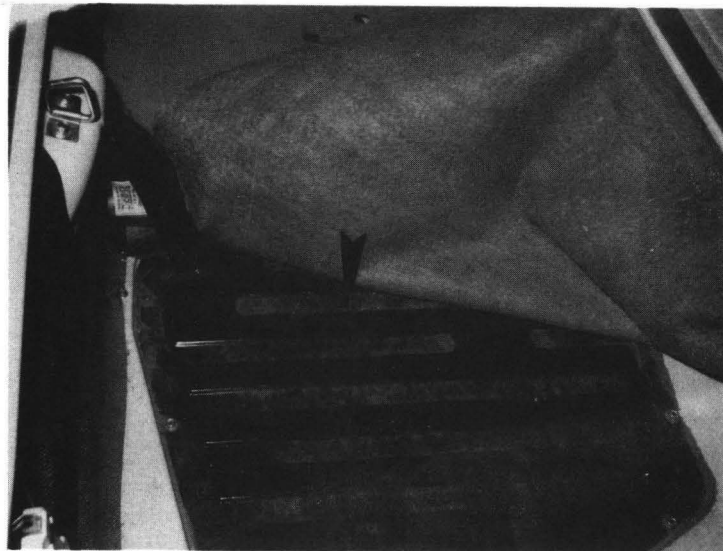
Figure 3-53. 1968 Toyota Hardtop Luggage Compartment

Figure 3-53 shows the luggage compartment floor mat partially removed and the top of the fuel tank exposed. This use of the integral tank and its inadequacies have been previously discussed (See discussion of 1966 Mustang).

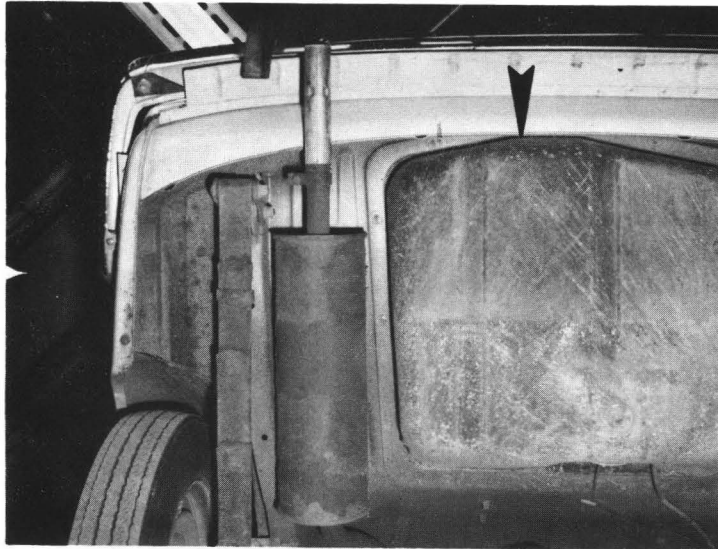
Figure 3-54. 1968 Toyota Hardtop Fuel Tank

Figure 3-54 shows the underside of the fuel tank and the small crush space between the rear of the tank and the rear crossrail.

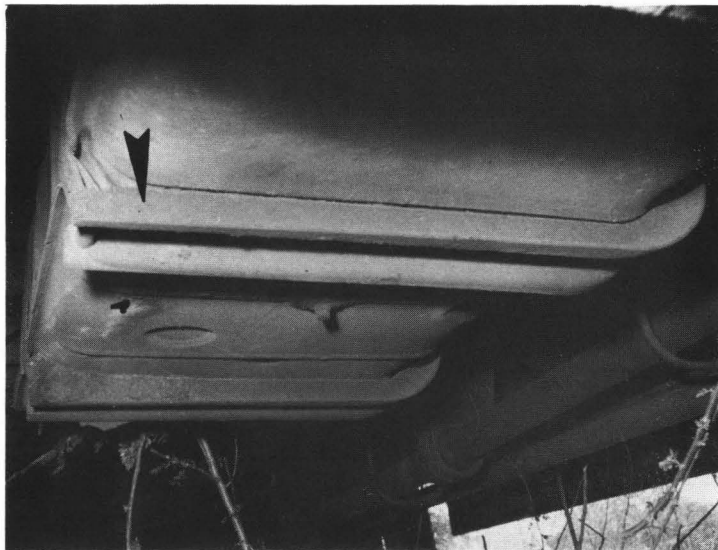
Figure 3-55. GMC School Bus Fuel Tank

Since busses have ample space, no problem exists relative to positioning fuel system components so that they are protected by the vehicle structure. Figure 3-55 shows the fuel tank with its sturdy support structure. The tank is at the right side, behind the door, under the floor of the passenger compartment. The exterior view, Figure 3-56, shows the location of the fuel filler cap.

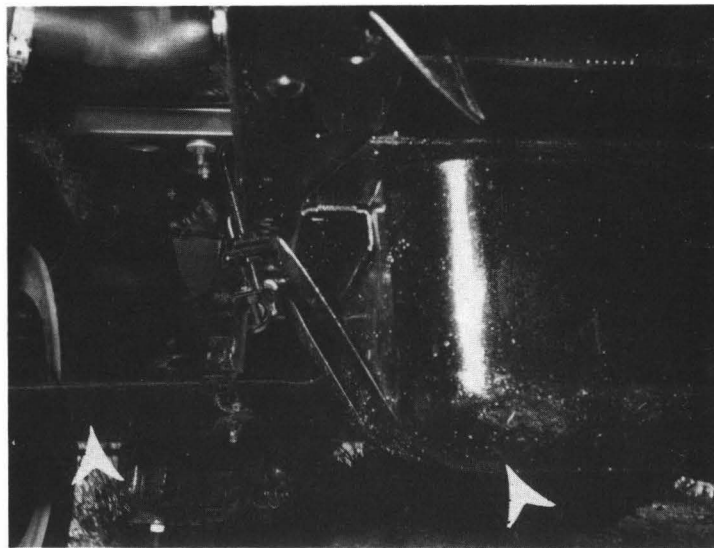
Figure 3-57. Chevrolet Small School Bus Fuel Tank

The fuel tank is centrally located behind the rear axle. Figure 3-57 shows the tank and the filler/vent pipe which is at the left side of the bus. The illustration also shows the support straps hooked and bolted to a longitudinal chassis frame strut. The arrangement shows a protected tank, with sturdy retention.

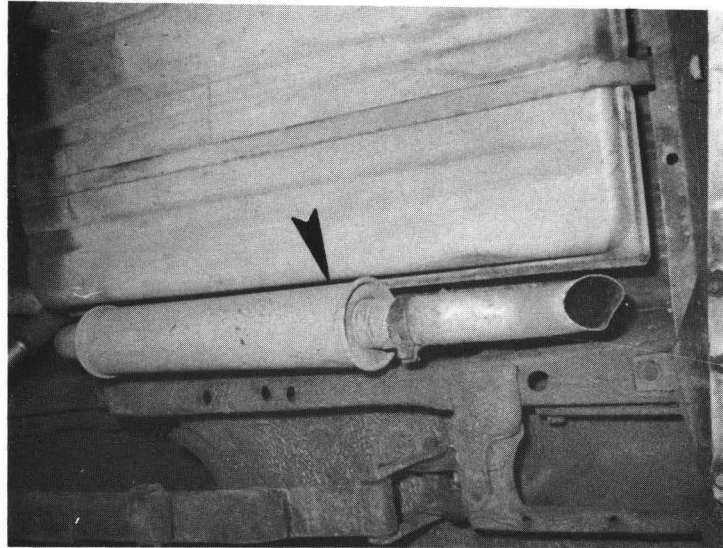
Figure 3-60. 1968 Chrysler New Yorker - Resonator Proximity to Fuel Tank

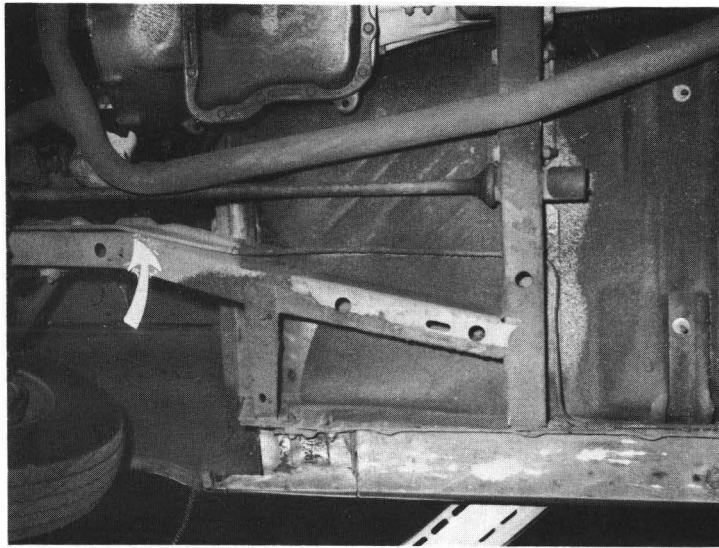
Figure 3-62. 1967 Dodge Coronet 500 - Fuel Line Proximity to Front Exhaust Pipe

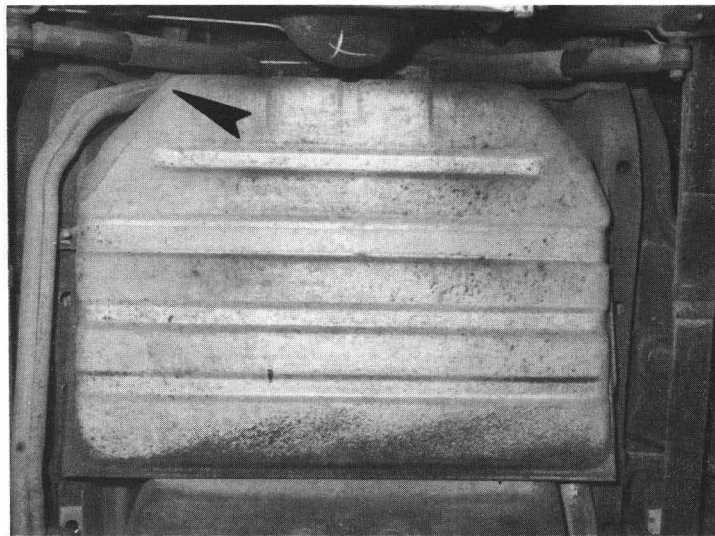
Figure 3-63. 1967 Dodge Coronet 500 - Tail Pipe Proximity to Fuel Tank

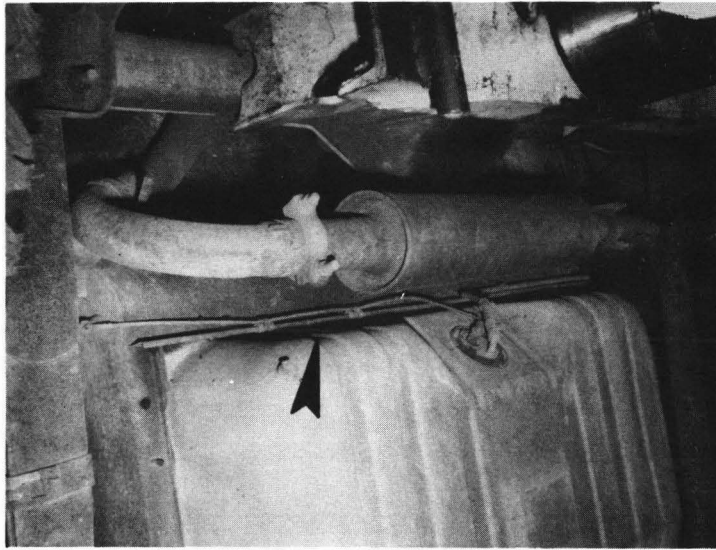
- 1966 Ford Mustang - The downstream end of the rear pipe, the muffler, and the upstream end of the tail pipe run transversely approximately 2 inches ahead of the fuel tank in proximity to the tank front, fuel pickup and metering unit, and fuel line. The differential housing is within one inch of the muffler (Figure 3-64).
- 1967 Ford Fairlane Station Wagon - The tail pipe runs into the well space and behind the right rear wheel, separated from the fuel tank by the tank's front shield (Figure 3-65).

Figure 3-64. 1966 Ford Mustang - Rear of Exhaust System Proximity to Fuel Tank and Accessories

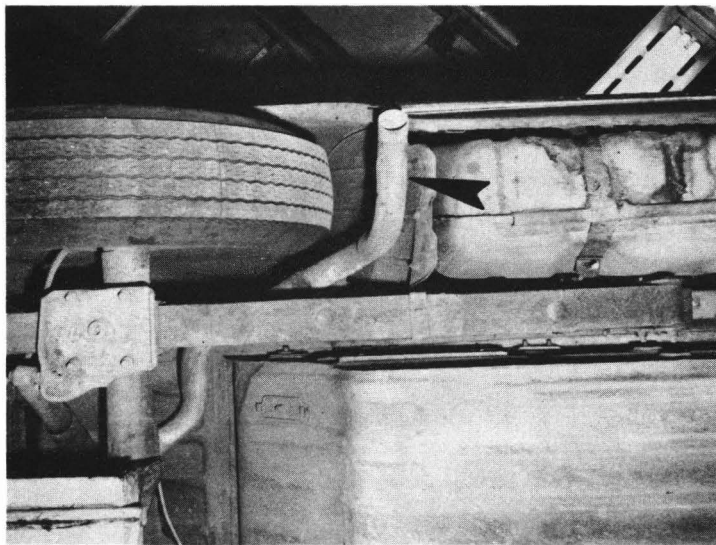
Figure 3-65. 1967 Ford Fairlane Station Wagon - Exhaust Exit Proximity to Fuel Tank

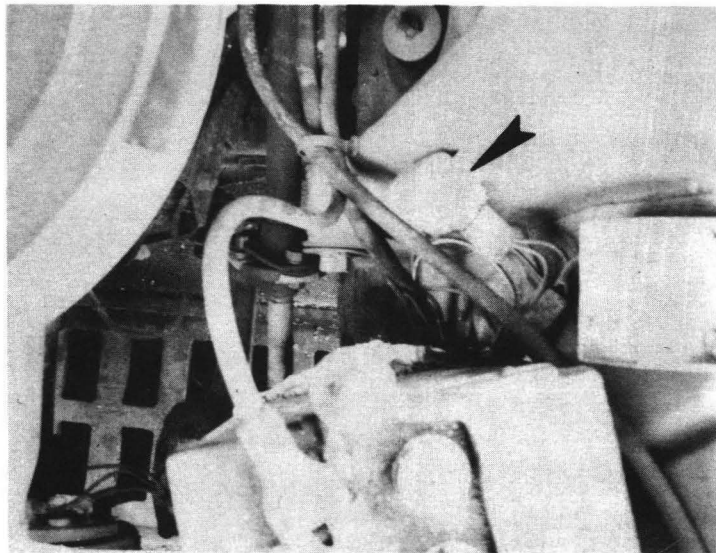
The battery is located at the front left of the engine compartment, and is therefore susceptible to frontal impact damage. Close to and below the battery are loose wires (Figure 3-72). These wires are subject to operational deterioration from acid droplet-splashing as well as from breakage due to displacement of the battery in a crash. Both situations could result in short circuits and possible fire.

Figure 3-72. 1967 Rambler Electrical Wiring around Battery

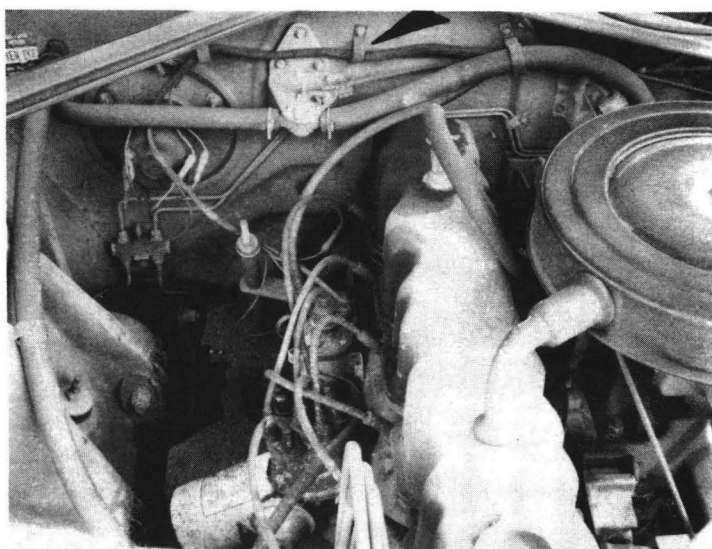
Figure 3-73 shows a harness on right side of the firewall that is adequately supported but with individual wires that hang loosely. These are subject to deterioration by vibration fatigue or damage by impacting loose objects.

Figure 3-73. 1967 Rambler Electrical Harness Support

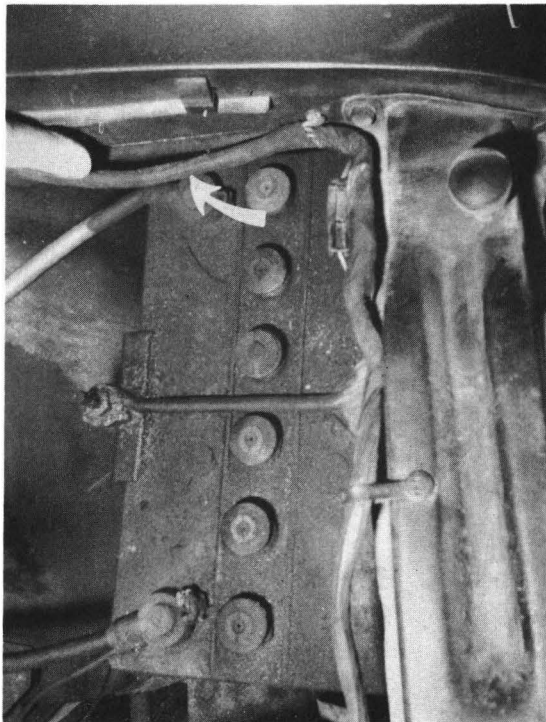
Figure 3-74. 1966 Buick Riviera - Harness Proximity to Battery

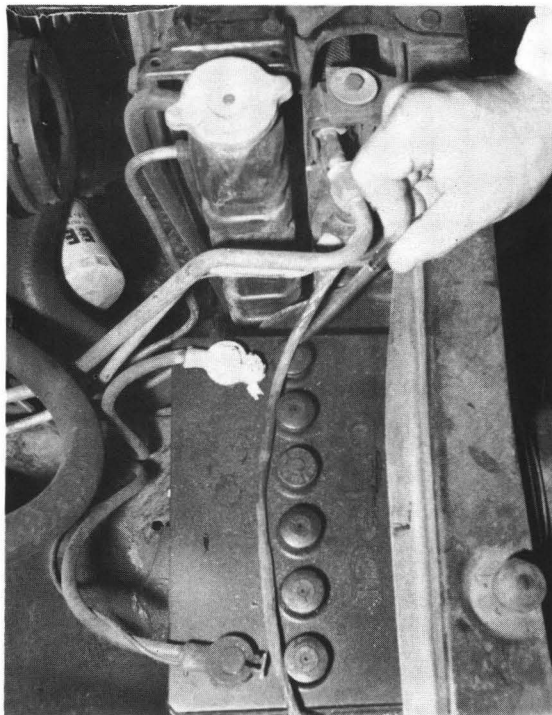
Figure 3-77. Buick LeSabre - Harness Proximity to Battery

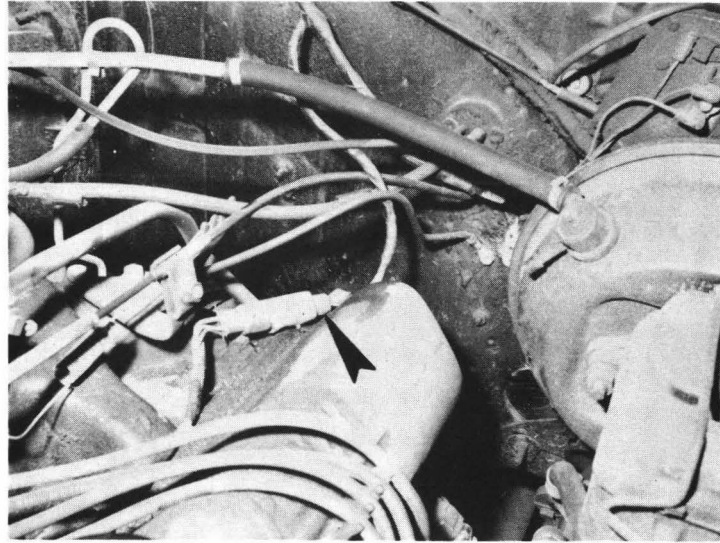
Figure 3-94. 1967 Ford LTD Electrical Wiring over Valve Cover

A harness coupling lying on the left valve cover is also not a desirable feature (Figure 3-94). The four high tension spark plug leads that are shown in this photograph are positioned by a rack that helps to keep these leads off the valve cover at one point, but does not succeed in holding them away at other points. In the event of a crash, good condition of the insulation may prevent short circuits from occurring.

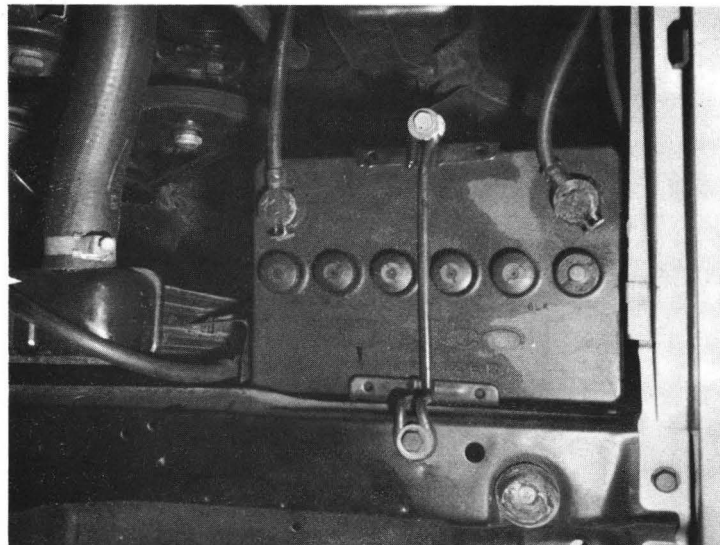
Figure 3-95. 1967 Pontiac LeMans Battery Location

The battery location at the extreme front left of the engine compartment provides little crush space protection against front impact (Figure 3-95).

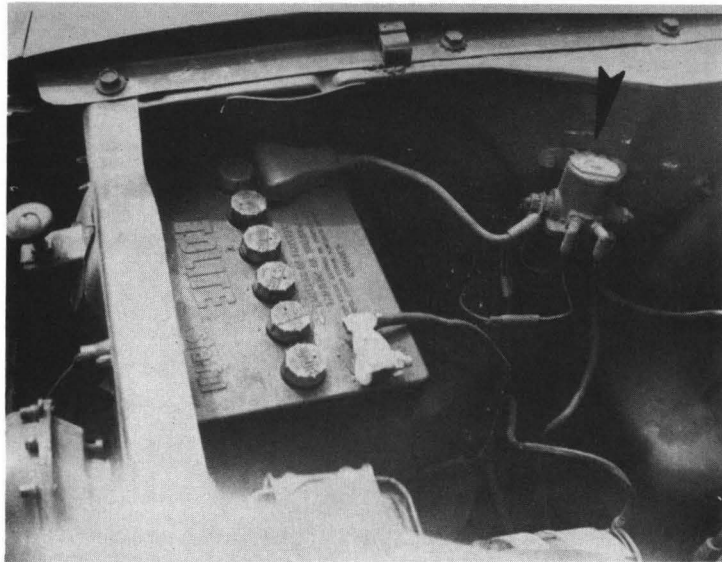
Figure 3-92. 1966 Ford Mustang Battery Location

The battery is at the extreme front right of the engine compartment, and the lack of crush space makes it vulnerable to front or front-side impact (Figure 3-92). The unprotected loose wires running from the relay are more vulnerable to damage than a grouped, insulation-covered harness and present another undesirable feature. The boot at the battery position terminal is an effective, economical shield against short circuit at a high capacity electrical point.

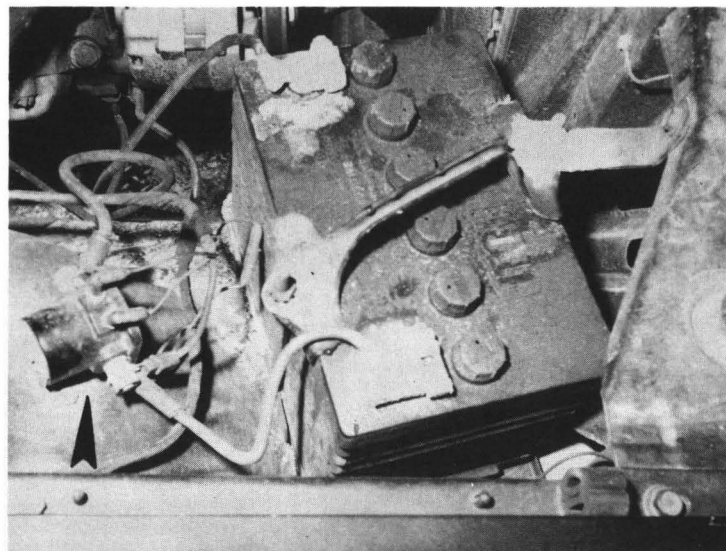
Figure 3-93. 1967 Ford LTD Relay Proximity to Battery

The battery is at the engine compartment front right, and, although the crush space is limited, the radiator support affords some protection against front impact. The relay, with its loose wires, below and behind the battery is not a desirable feature (Figure 3-93).

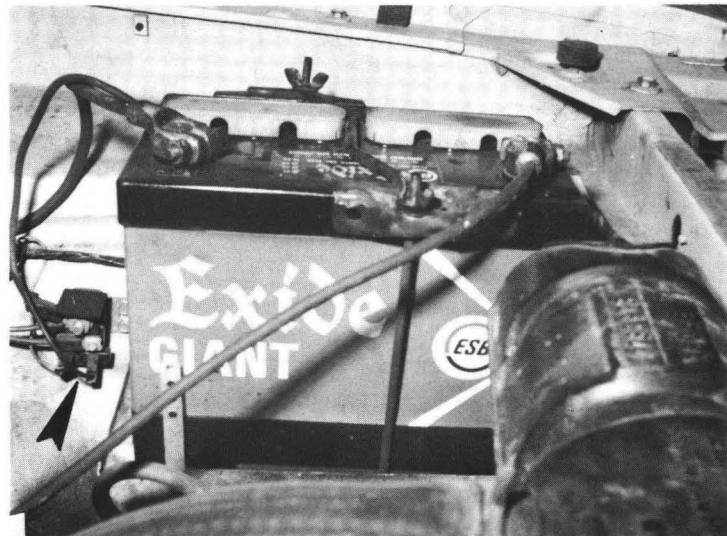
Figure 3-91. 1967 Dodge Dart Relay Proximity to Battery

The battery of this vehicle is at the extreme front end of the engine compartment, on the left side. The battery is vulnerable to front impact. Other undesirable electrical features are the relay and the wiring harness shown alongside the battery (Figure 3-91).

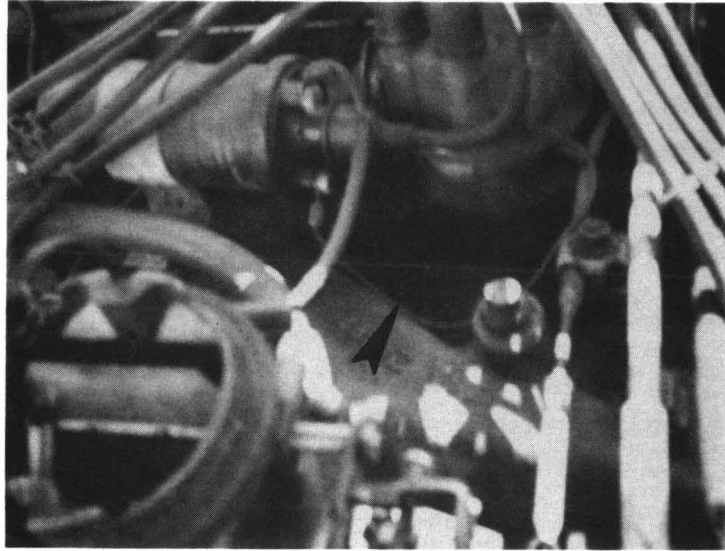
Figure 3-88. 1967 Dodge Coronet 500 High Tension Wire Location

An undesirable feature, however, is the high tension wire running from the ignition coil to the distributor. As shown in Figure 3-88, it lies against the intake manifold. Abrasion and temperature approximating 200° F may degrade the insulation with the possibility of short circuiting during operation or from impact effects.

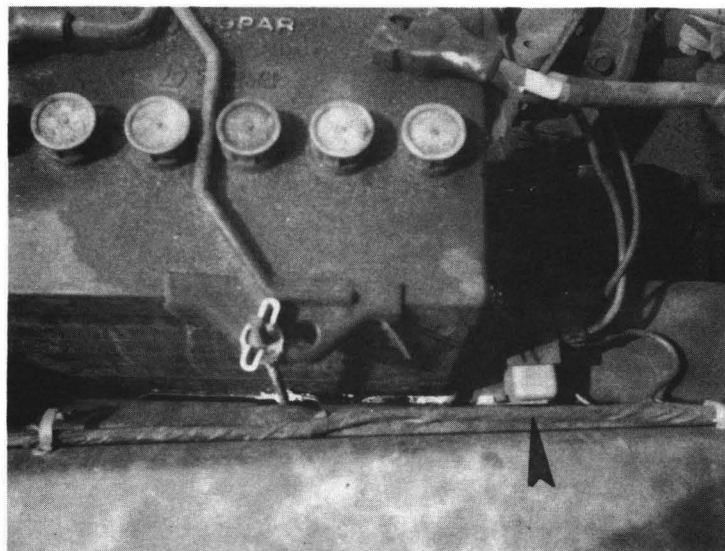
Figure 3-89. 1968 Dodge Coronet 440 Relay Proximity to Battery

A connector and relay are placed below the top and immediately behind the battery. This subjects a vulnerable electrical component to operational deterioration or to the effects of battery displacement from front impact, which could lead to short circuiting that could cause a fire (Figure 3-89).
