# **FUEL TANK PROTECTION**

## **FINAL REPORT**

FHR 3771  
30 June 1969

An Investigation of Fuel, Exhaust and  
Electrical Systems as Related to Post  
Crash Fire Safety

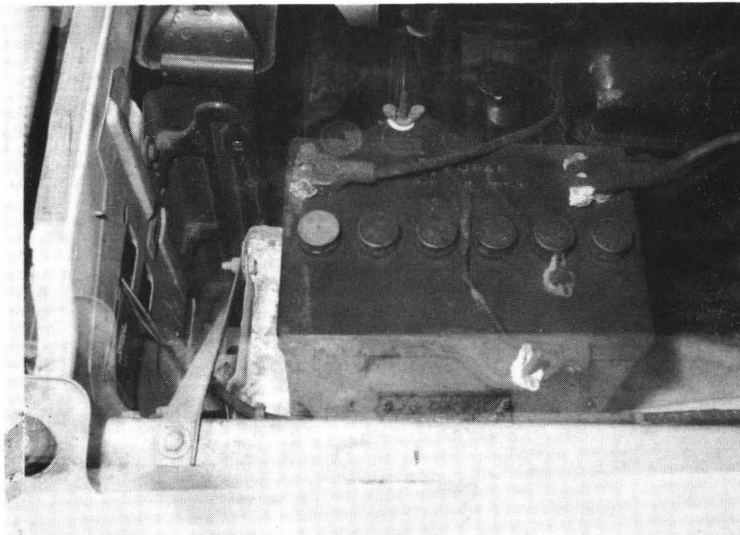
Figure 3-87. 1967 Dodge Coronet 500 Battery Location

The battery in this vehicle is at the left side, near the front of the engine compartment (Figure 3-87). The means of support are typical. A desirable feature is the space between the battery and the front structure, which gives a degree of protection against the effects of front impact.

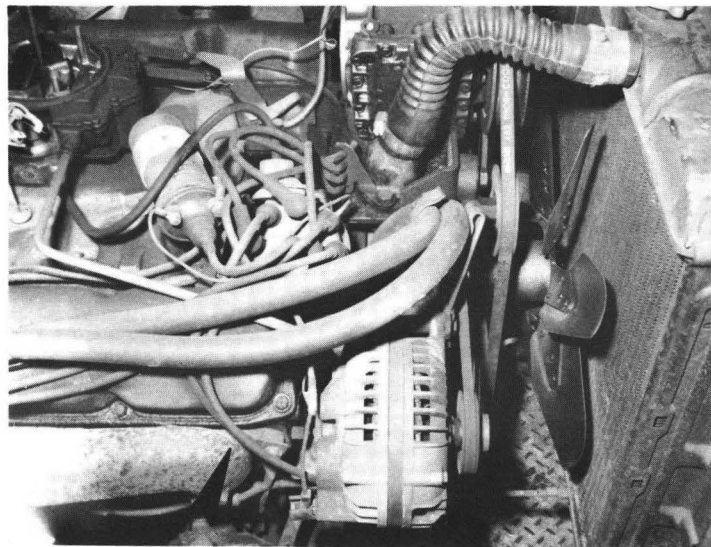
Figure 3-85. 1966 Dodge Polara High Tension Wires  
over Exhaust Manifold

High tension spark plug leads are shown lying on an exhaust manifold (Figure 3-85). Longer leads, with supports to keep the leads away from hot engine parts would lessen the possibility of short circuits in operation or crash situations. The wiring routing and retention at the left front fender shows good design (Figure 3-86). The harnesses are isolated from the exhaust components, and the engine and the fender structure act as barriers to crash damage to the wiring. It is interesting to note that in the same vehicle there are both desirable and undesirable electrical features.

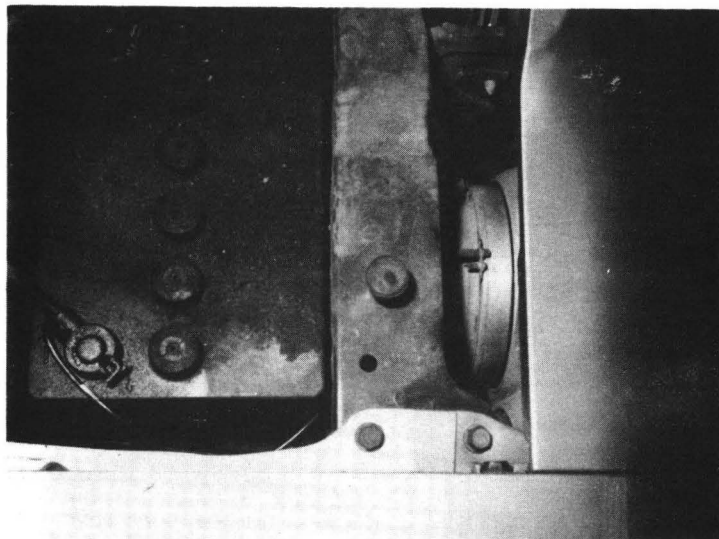
Figure 3-83. 1968 Chevrolet Impala SS Battery Location

The battery is at the right front of the engine compartment. The body metal, radiator support, and right front fender provide some protection against crash impact (Figure 3-83).

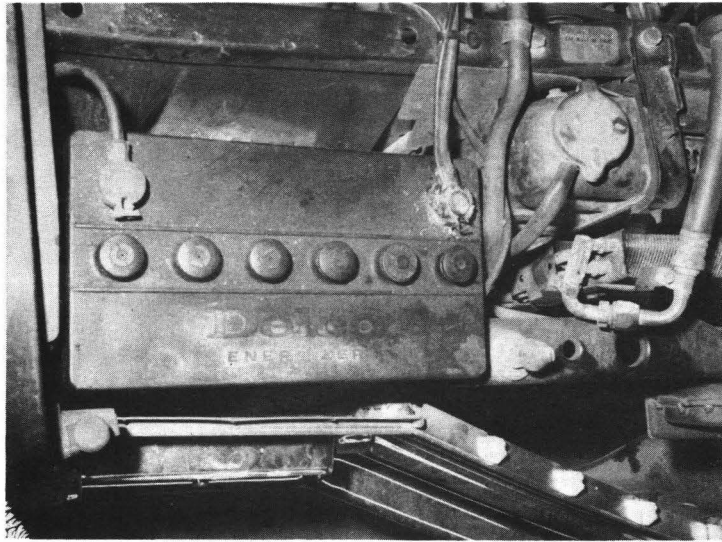
Figure 3-80. 1966 Cadillac Coupe de Ville Battery Location

The battery is at the extreme front right side of the engine compartment, and vulnerable to front impact damage and displacement (Figure 3-80). Except for a cable at the left end, the immediate battery area is clear of any other wiring which could be affected by the battery acid.

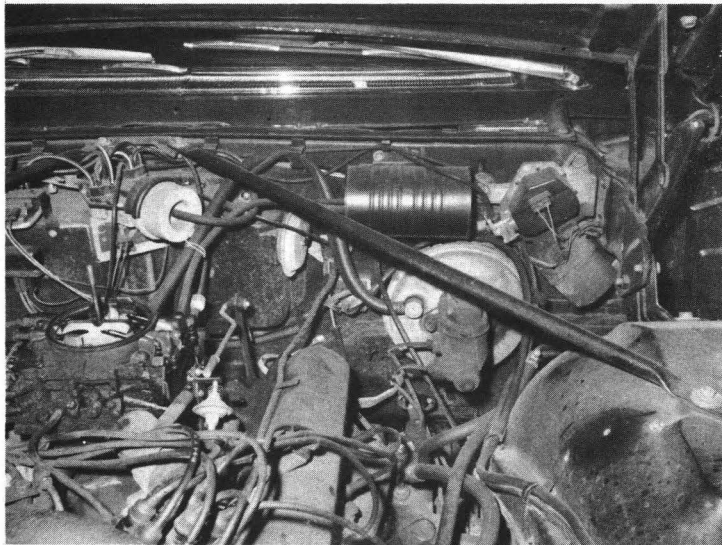
Figure 3-81. 1966 Cadillac Coupe de Ville Electrical Wiring

The left side of the firewall, as shown in Figure 3-81, carries a complex maze of wires that would probably not be electrically safe after damage in this region.

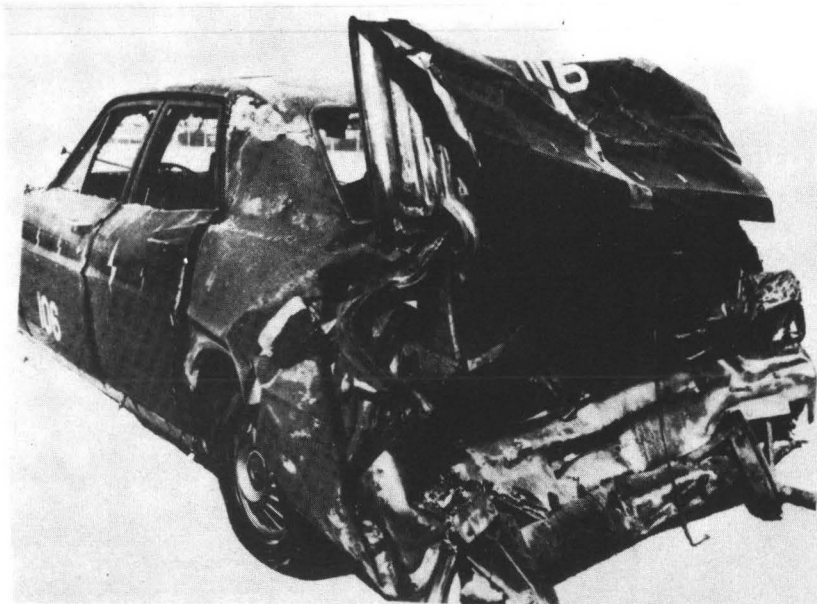
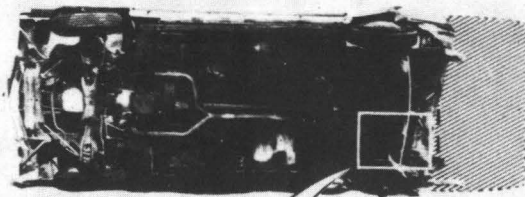
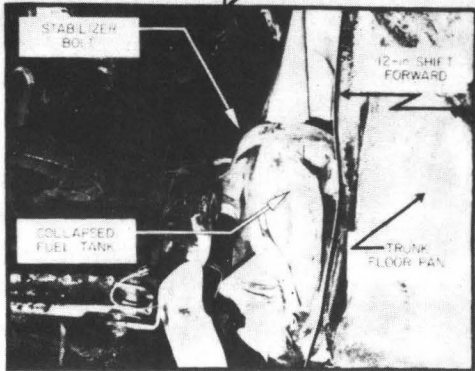
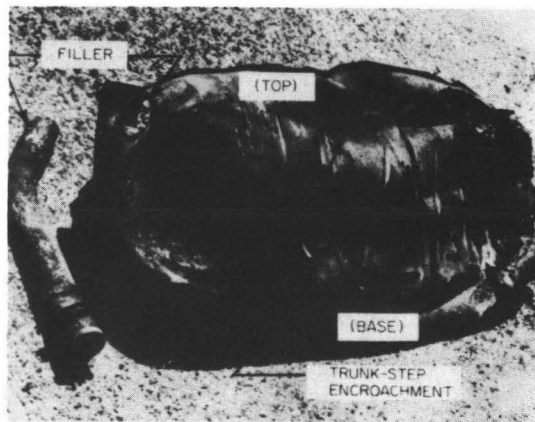
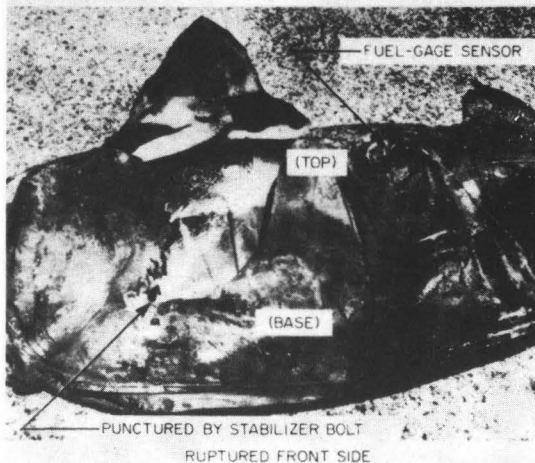
Figure 6-2. Results of Impact at 55 MPH

The striking car rolled squarely onto the layer of gasoline that the rear-ended car trailed from its ruptured tank as it was catapulted to its position of rest (Figure 6-2). Within 2 sec after the cars contacted each other, the striking car was also completely engulfed in flames. Successful escape from this car was also considered highly unlikely.

COLLAPSED REAR SIDE

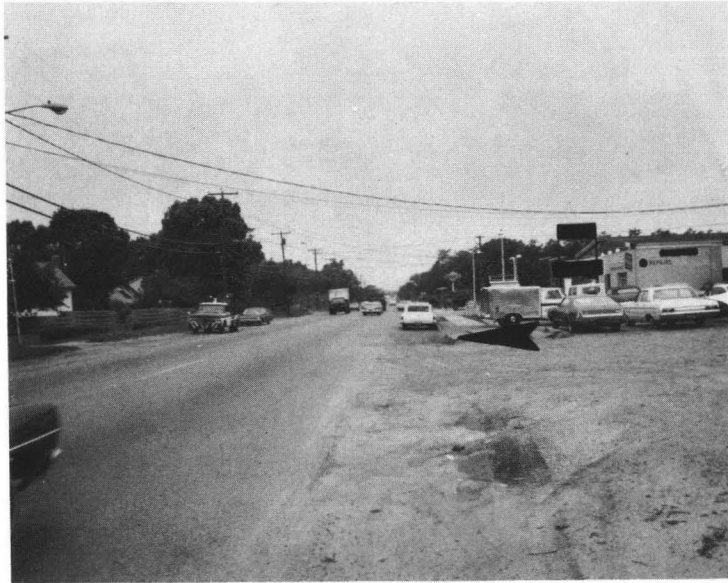
Figure 6-4. 1964 Volkswagen Accident Site

VEHICLES: 1964 Volkswagen convertible and garbage truck  
TYPE ACCIDENT: Collision with rear of parked garbage truck  
DATE AND TIME: Saturday, 15 June 1969, approximately 2:40 a. m.  
LOCATION: Bay Shore Road and Skidmore Road, Deer Park, L. I., N. Y.  
ROADWAY: Two lanes, one in each direction, running east and west, no separation. Roadway straight, with street lights every 200 feet; asphalt surface, each lane 14 feet wide with an 8-foot gravel and asphalt shoulder (Figure 6-4).

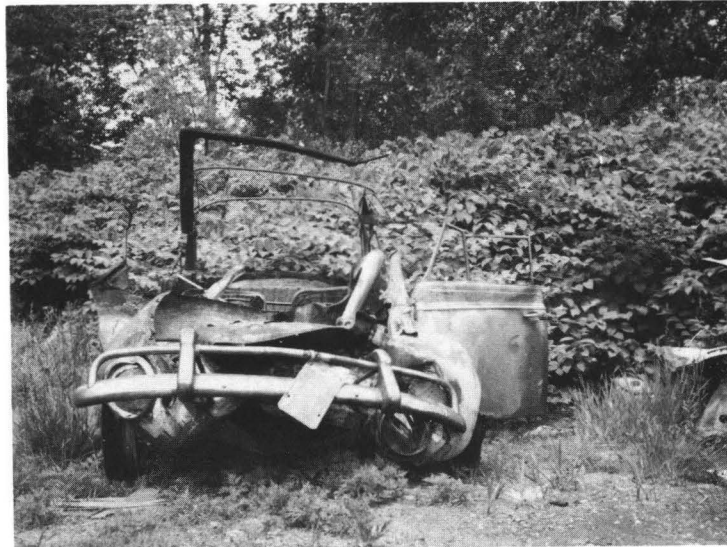
Figure 6-5. Front View of Volkswagen

THE ACCIDENT: The Volkswagen, traveling west, underran the rear of a parked garbage truck. The Volkswagen, which was crushed up to its windshield by the underside of the truck, caught fire (Figures 6-5 through 6-8).

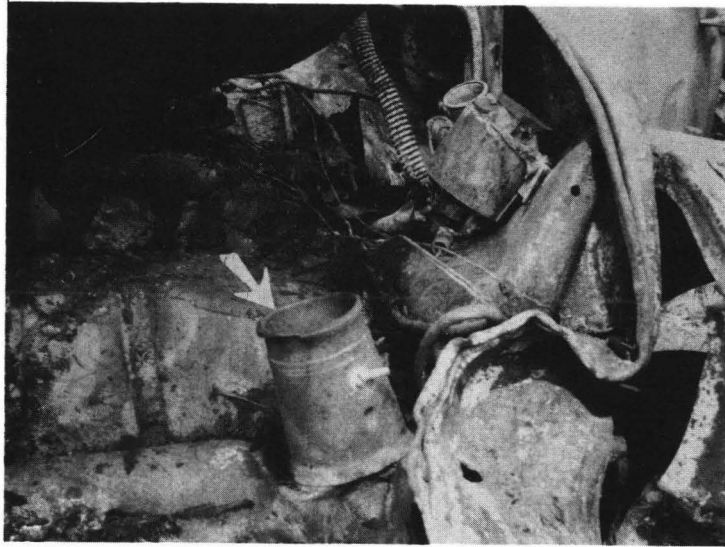
Figure 6-9. Volkswagen Filler Neck

The fuel tank, located forward of the passenger compartment was dislocated and the filler pipe was bent rearward (Figure 6-9). The 19 year old driver was removed from the burning car by a passing police officer. His 19 year old female companion, who was killed in the crash, could not be reached until the fire had been extinguished. The driver died several days after the accident.

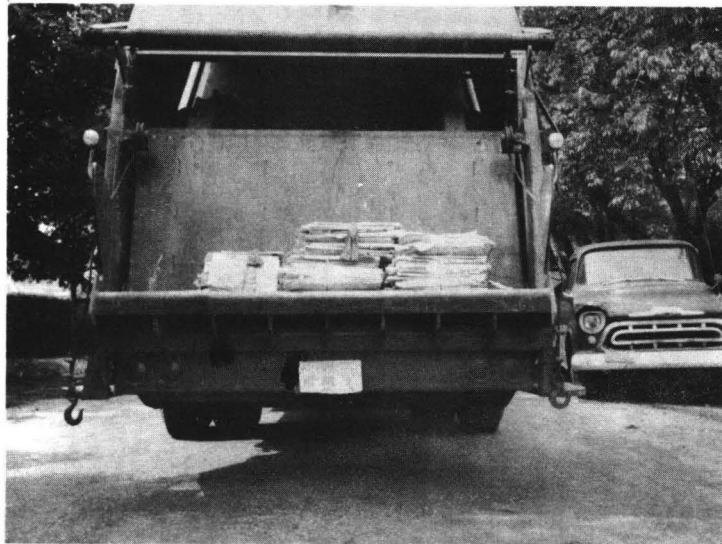
Figure 6-10. Rear View of Typical Garbage Truck

A typical garbage truck, similar to the one involved in the accident (93 inches across rear) is shown in Figure 6-10.

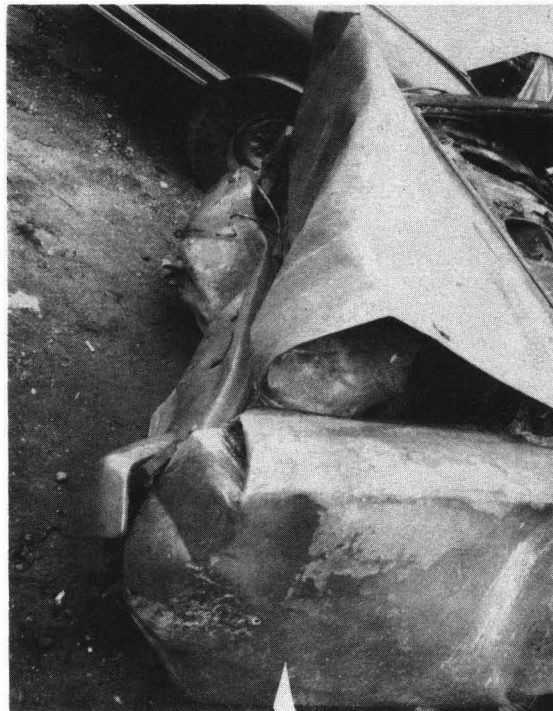
Figure 6-12. Side View of Mercury Showing Extent of Rear Deformation

The collision caused 24 inches of deformation to the rear of the Mercury (Figure 6-12). The fuel tank (which forms part of the trunk floor) was ruptured and turned downward from its normal horizontal position to a vertical position (Figure 6-13), causing it to contact the road surface (Figure 6-14). Both the driver and passenger of the Mercury were severely burned. The driver of the Pontiac was injured.

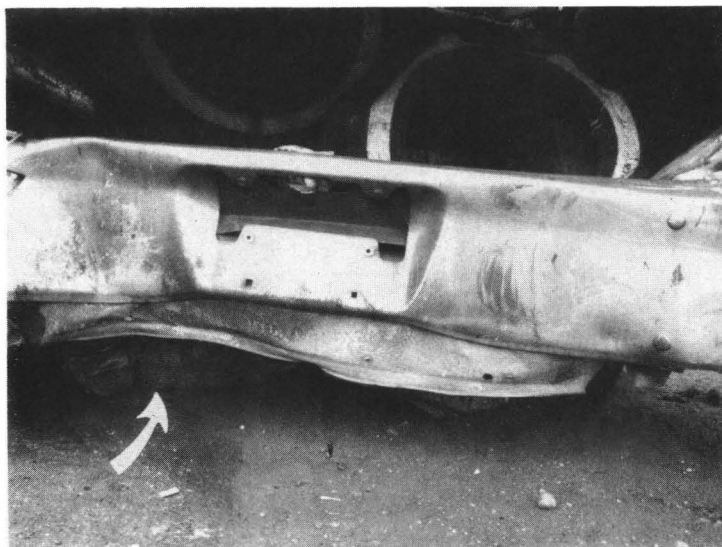
Figure 6-14. Mercury Fuel Tank in Contact with Ground

Probable causes of the fire were: (1) the rupture and dislocation of the fuel tank; and (2) sparks created by the fuel tank as it contacted the pavement. Figure 6-15 shows a view of the interior of the Mercury after the fire had been extinguished.

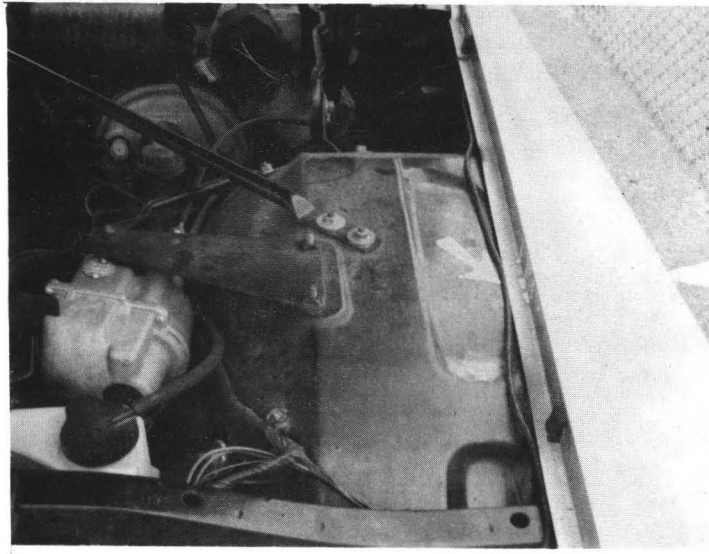
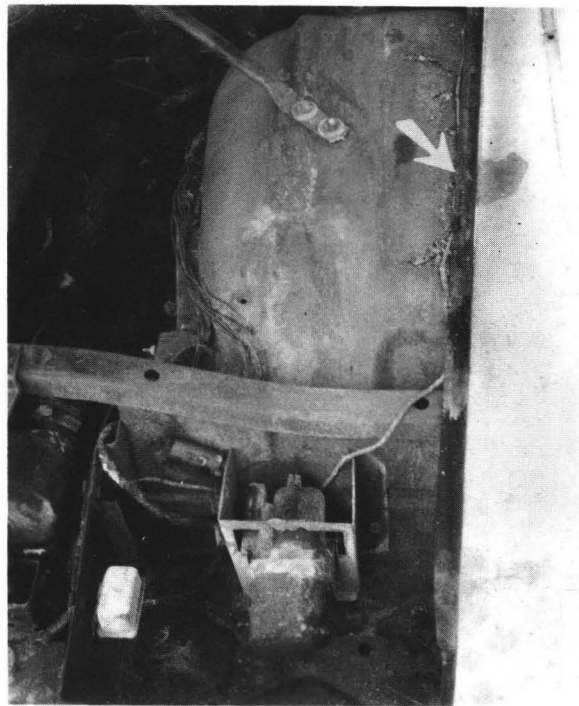
Figure 6-16. Cadillac Harness Passing Over Wheel Well

THE ACCIDENT: The Cadillac was side-swiped on the left side by an unknown vehicle. The impact, though minor, was sufficient to cause a short in the electrical system. The fire engulfed the engine, but did not travel beyond the engine compartment. Figures 6-16 through 6-21 show the results of the fire.

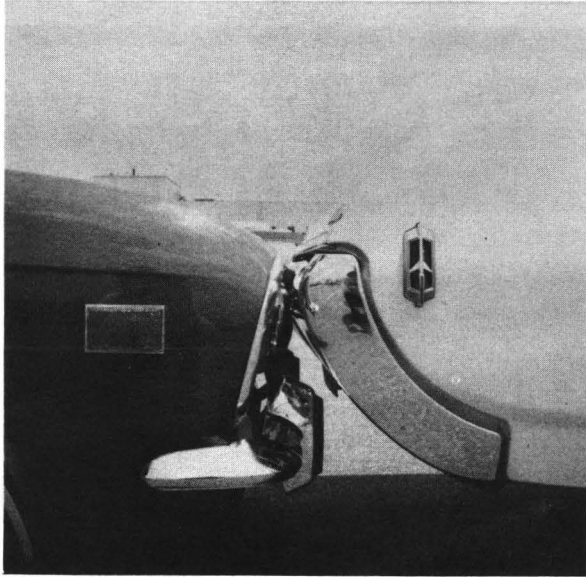
Figure 7-3. Bumper Height Comparison -  
1968 Ford Cortina and 1968  
Oldsmobile Cutlass

Examples of the existing disparity of passenger vehicle front-to-rear bumper heights are shown in Figures 7-3 through 7-5. All the vehicles shown were stationary.

The figures show that car manufacturers have made little or no effort to maintain uniform bumper heights and that the location and configuration of passenger car bumpers are determined more by styling aspects than by safety considerations.
