# CNG Vehicle Tank Burst During Filling

Motor Vehicle Fire Research Institute

On 26 May 2007 an airport shuttle van driver was killed when his CNG tank burst during filling.

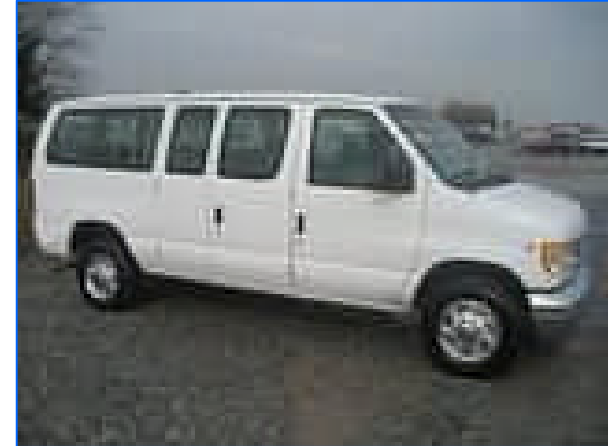
2001 Ford van – E350 Super Club  
Wagon XL

OEM manufactured with 3 CNG tanks

Two additional tanks were added in the  
aftermarket to extend range

- ⌘ One tank longitudinal on passenger side
- ⌘ One white tank behind rear axle – right in front of rear bumper
- ⌘ White tank manufactured by Comdyne

3600 psi nominal pressure tanks

- ⌘ Longitudinal aftermarket tank rated at 3000 psi and expired

Rear-most seats removed for luggage  
storage

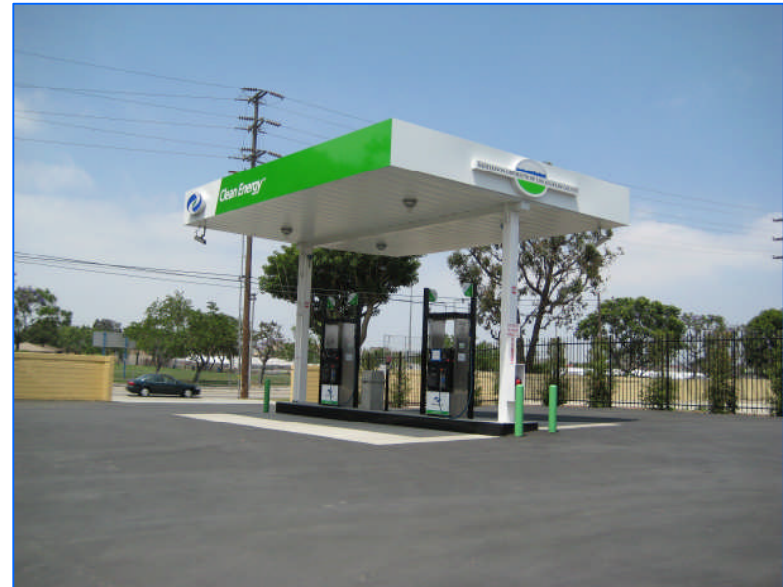
Station owned and located on the property of the LA County Sanitation District

Station operated by Clean Energy  
Station quite new – November 2006

Surveillance camera at station but was not recording

Fill data and measured OEM tanks pressure indicates that the station did not over-pressurize the tank
