## **MVFRI RESEARCH SUMMARY**

**Kennerly H. Digges, R. Rhoads Stephenson**

### **Research in Fire Safety for Hydrogen-Fueled Vehicles**

Based on contracts with:  
Southwest Research Institute  
Bob Zalosh (FIREXPLO)

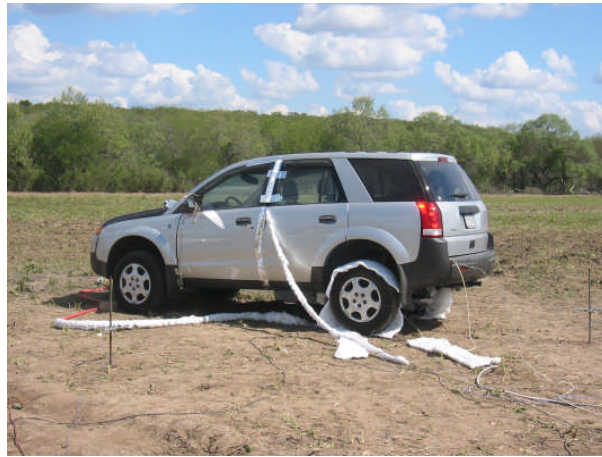
**Figure 2. Instrumented test vehicle**

The test vehicle was a popular SUV. The conventional gasoline tank was removed and the vehicle was fitted with a Type 3 (aluminum liner) hydrogen tank holding about 2 Kg of hydrogen at 5000 psig. The tank did not have a PRD. The vehicle and surroundings were instrumented with several video cameras, IR and high-speed cameras, blast probes, many thermocouples, and a CO sensor and thermocouple in the driver's position to assess tenability. The vehicle just prior to the test is shown in Figure 2.

The fire was initiated and portions of the vehicle became involved (plastic body panels, tires, and then the interior). The temperatures on the underside of the cylinder quickly rose in excess of 1200 °F (650 °C). Measurements inside the vehicle showed that the driver's position space became untenable (CO > 1% and temperature > 200C°) in about 4 minutes. The internal tank pressure remained fairly constant during the first 9 minutes, at which time the pressure transducer failed. The fire continued and grew and the hydrogen tank burst after 12 minutes. The fireball is shown in Figure 3.

The mechanical impulse from the tank burst did extensive damage to the vehicle, and parts of the vehicle were scattered as far as 350 feet. A large portion of the tank landed 135 feet away. Overpressures of 2 psi were measured at 32 feet, and thus the exclusion radius for no overpressure damage (0.3 psi) is about 150 feet.

The pressure relief device (PRD) in hydrogen tanks must work to prevent catastrophic rupture of the tank when exposed to a bonfire. The PRD must be highly reliable.
