AUTOMOTIVE FUEL TANK EVALUATION

COMPARATIVE EVALUATION OF AUTOMOTIVE FUEL TANKS IN GENERAL ACCORDANCE WITH THE ECE R34.01, ANNEX 5 SECTION 5.0 "RESISTANCE TO FIRE;" AND SECTION 1.0 "IMPACT RESISTANCE;" THE US DEPARTMENT OF TRANSPORTATION 49 CFR 393.67, SECTION E "DROP TEST;" AND ASTM D 638-00, "STANDARD TEST METHOD FOR TENSILE PROPERTIES OF PLASTICS"

FINAL REPORT Consisting of 228 Pages SwRI® Project No. 01.06081.01.001 August 2003

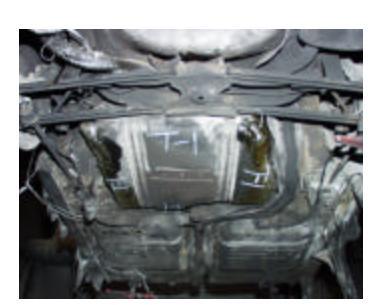
Figure 8. Test SCP1 After Exposure.

On December 18, 2002, Test SCP1 was conducted on the conditioned 1998 Saturn Twin Cam 4-Door fuel tank utilizing the original Saturn test buck. Test SCP1 demonstrated no leaks during the 2min ECE R34.01 fire exposure period. At 3 min 39 sec from the start of fuel tank fire exposure (or 1 min 39 sec into the extended fire exposure), the fuel tank leaked at the rear left side bottom corner of the fuel tank. Figure 8 provides a photograph of the fuel tank after the fire exposure. For additional photographs see Figures A-42 through A-51 in Appendix A.

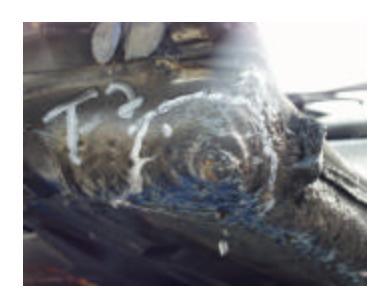
Figure 9. Test SNP1 After Exposure.

On December 18, 2002, Test SNP1 was conducted on the new 1998 Saturn Twin Cam 4-Door fuel tank. The Saturn test-buck combustible body panels were not installed. Test SNP1 demonstrated no leaks during the 2-min ECE R34.01 fire exposure period. At 3 min 36 sec from the start of fuel tank fire exposure (or 1 min 36 sec into the extended fire exposure), the fuel tank leaked at the rear left side bottom corner of the fuel tank. Figure 9 provides a photograph of the fuel tank after the fire exposure. For additional photographs see Figures A-52 through A-60 in Appendix A.

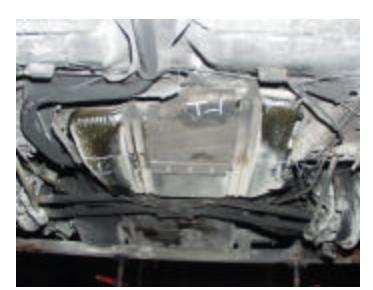
Figure 10. Test SNP2 After Exposure.

On February 19, 2003, Test SNP2 was conducted on the new 1998 Saturn Twin Cam 4Door fuel tank utilizing the Saturn test buck rebuilt with plastic quarter panels only. At 3 min 13 sec (or 1 min 13 sec into the extended fire exposure) the test was inadvertently terminated due to the false appearance of leakage and not actual fuel tank leakage. The test was categorized as a nonfailure. Subsequently, this test was rerun on April 28, 2003, as indicated below. Figure 10 provides a photograph of the fuel tank after the fire exposure. For additional photographs see Figures A-61 through A-68 in Appendix A.

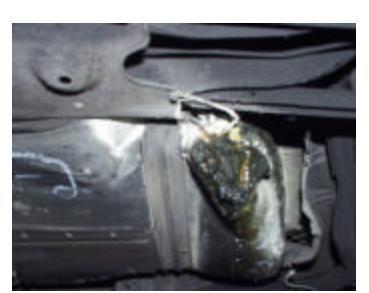
Figure 11. Test SNP3 After Exposure.

On February 19, 2003, Test SNP3 was conducted on the 1998 Saturn Twin Cam 4-Door plastic fuel

tank utilizing the Saturn test buck rebuilt with plastic quarter panels only. Test SNP3 demonstrated no leaks during the 2-min ECE R34.01 fire exposure period. Test results were slightly different due to extended failure termination when compared to the normal failure termination evident in initial Saturn Fuel Tank Tests, (Tests SCP1 and SNP1) in Section 2.4.1. Leakage did occur on the rear right side corner of the fuel tank at 4 min 36 sec from the start of the fuel tank fire exposure (or 2 min 36 sec into the extended fire exposure period). Figure 11 provides a photograph of the fuel tank after the fire exposure. For additional photographs see Figures A-69 through A-77 in Appendix A.

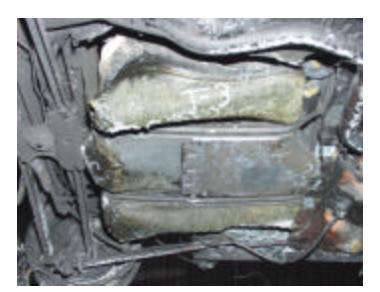
Figure 12. Test SNP4 After Exposure.

On April 28, 2003, Test SNP4 was conducted on the 1998 Saturn Twin Cam 4-Door plastic fuel tank utilizing the Saturn test buck rebuilt with plastic quarter panels, door fascias, deck-lid and a bumper fascia. Test SNP4 demonstrated no leaks during the 2-min ECE R34.01 fire exposure period. Results were

slightly different due to extended failure termination when compared to the normal failure termination evident in the initial Saturn Fuel Tank Tests (Tests SCP1 and SNP1) in Section 2.4.1. Leakage did occur on the front left bottom corner of the fuel tank at 4 min 19 sec from the start of the fuel tank fire exposure (or 2 min 19 sec into the extended fire exposure period) but was allowed to continue leaking until 4 min 25 sec (or 2 min 25 sec into the extended fire exposure period). Figure 12 provides a photograph of the fuel tank after the fire exposure. For additional photographs see Figures A-78 through A-88 in Appendix A.

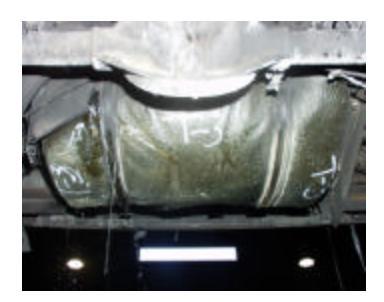
Figure 13. Test JCP1 After Exposure.

On December 18, 2002, Test JCP1 was conducted on the conditioned 1998 Jeep Grand Cherokee fuel tank utilizing the original Jeep Grand Cherokee test buck. Test JCP1 demonstrated no leaks during the 2-min ECE R34.01 fire exposure period. At 2 min 10 sec from the start of fuel tank fire exposure (or 10 sec into the extended fire exposure), the fuel tank leaked at the front right side bottom of the tank along the outboard side of the strap and the front right top corner of the fuel tank. Figure 13 provides a photograph of the fuel tank after the fire exposure. For additional photographs see Figures A-89 through A-100 in Appendix A.

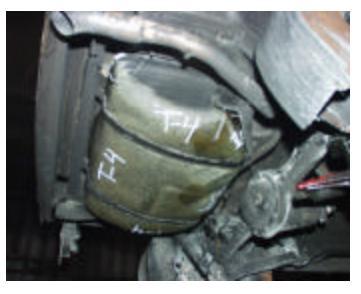
Figure 14. Test JNP1 After Exposure.

On December 18, 2002, Test JNP1 was conducted on the new 1998 Jeep Grand Cherokee fuel tank utilizing the same non-modified Jeep Grand Cherokee test buck. Test JNP1 demonstrated a leak at 1 min 50 sec into the 3-min ECE R34.01 test period. Leakage occurred on the front right side bottom of fuel tank, on the outboard side of the strap. The early failure mode demonstrated by this test may have been attributed to an increase in ventilation due to the loss of body material resulting from Test JCP1. Figure 14 provides a photograph of the fuel tank after the fire exposure. For additional photographs see Figures A-101 through A-110 in Appendix A.

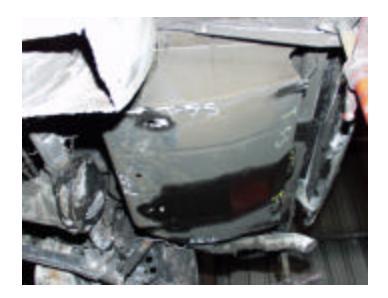
Figure 17. Test JNP2(S) After Exposure With Skid-Plate.

On April 30, 2003, Test JNP2(S) was conducted on the new 1998 Jeep Grand Cherokee fuel tank modified with a new OEM fuel tank skid-plate, utilizing the Jeep Grand Cherokee test buck rebuilt with plastic exhaust vents, bumper fascia and a license plate housing. Test JNP2(S) demonstrated no leaks during the 2min ECE R34.01 fire exposure period. At 2 min 52 sec from the start of fuel tank fire exposure (or 52 sec into the extended fire exposure), the fuel tank leaked at rear left corner, rear middle and along the rear right corner. Because the leaks were minimal and not growing due to the skid-plate, the fire exposure was allowed to continue. At 3 min 15 sec and at 3 min 35 sec the rear side windows shattered and broke away. At 3 min 49 sec and 3 min 51 sec, the lift-gate strut-supports, on both sides of the rear window opening, ruptured loudly. At 3 min 58 sec the test was terminated and the fuel pan was immediately pulled out from underneath the vehicle due to safety concerns stemming from the loud abrupt rupture of the lift-gate strut supports. Figures 15, 16, 17, and 18 provide photographs of the fuel tank installed without skid-plate, with skid-plate, after fire exposure with skid-plate, and after fire exposure without skid-plate, respectively. For additional photographs see Figures A-111 through A-131 in Appendix A.

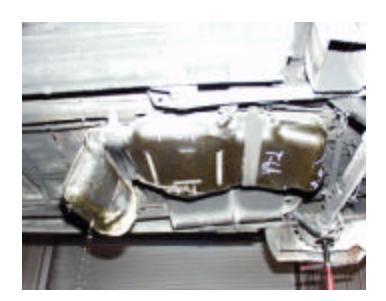
Figure 20. Test PNP1 After Exposure.

On January 2, 2003, Test PNP1 was conducted on the new 1998 Plymouth Voyager fuel tank utilizing the same non-modified Plymouth Grand Voyager test buck. Test PNP1 demonstrated no leaks during the 2-min ECE R34.01 fire exposure period. At 2 min 32 sec from the start of the fuel tank fire exposure (or 32 sec into the extended fire exposure), leakage occurred along the front strap and topside of the fuel tank. Figure 20 provides a photograph of the fuel tank after the fire exposure. For additional photographs see Figures A-142 through A-154 in Appendix A. Figure 19 Test PCP1

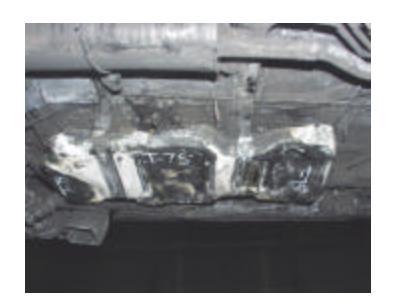
Figure 23. Test PNP2(S) After Exposure With Tank Shield.

On May 20, 2003, Test PNP2(S) was conducted on the new 1998 Plymouth Voyager fuel tank consisting of the fabricated fuel tank shield utilizing the same non-modified Plymouth Grand Voyager test buck. Test PNP2(S) demonstrated no leaks during the 2-min ECE R34.01 fire exposure period. At 2 min 21 sec from the start of the fuel tank fire exposure (or 21 sec into the extended fire exposure), leakage occurred through the drain hole of the 14-gauge thick heat shield and along the left perimeter side of the fuel tank and heat shield interface. The fire exposure continued until extended failure occurred at 6 min 5 sec. Figures 21, 22, 23, and 24 provide photographs of the fuel tank installed without shield, with shield, after fire exposure with shield and after fire exposure without shield, respectively. For additional photographs see Figures A-155 through A-183 in Appendix A.

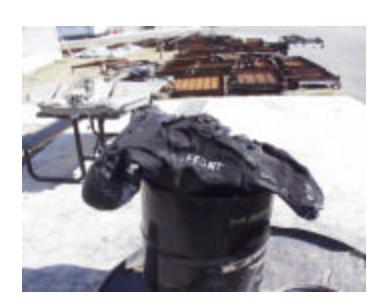
Figure 25. New Plastic Fuel Tank After Exposure.

On January 21, 2003, Test CNP1 was conducted on the new 2000 Chevrolet Cavalier plastic fuel tank utilizing the original Chevrolet Cavalier test buck. Test CNP1 demonstrated no leaks during the 2-min ECE R34.01 fire exposure period. At 5 min 45 sec from the start of the fuel tank fire exposure (or 3 min 45 sec into the extended fire exposure period), leakage occurred on the front right side corner and on the rear top inboard side of each strap of the fuel tank. Figure 25 provides a photograph of the plastic fuel tank after the fire exposure. For additional photographs see Figures A-184 through A-194 in Appendix A.

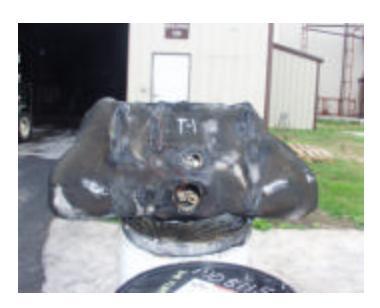
Figure 26. Conditioned Metal Fuel Tank After Exposure.

On February 18, 2003, Test CCM1 was conducted on the conditioned 1999 Chevrolet Cavalier metal fuel tank utilizing the same non-modified Chevrolet Cavalier test buck. Test CCM1 demonstrated no leaks during the 2-min ECE R34.01 fire exposure period. At 1 min 32 sec from the start of fuel tank fire exposure, the vapor canister at the rear of the metal fuel tank melted and fell away allowing the carbon contents to spill out and burn. At 4 min 57 sec from the start of the fuel tank fire exposure (or 2 min 47 sec into the extended fire exposure period), venting noises were beginning to develop. At 5 min 15 sec from the start of the fuel tank fire exposure period), an increase of ignited gaseous vapors developed at the back end of the vehicle.

At 6 min 22 sec from the start of the fuel tank fire exposure (or 4 min 12 sec into the extended fire

exposure period), the metal fuel tank vented at an approximate pressure of 20 psig and the test concluded. The metal fuel tank post-test analysis indicated that this occurrence resulted from additional melting of the rollover valve and rupturing of the fill neck hose, causing a rapid release of fuel vapors and ignition of these vapors. The fuel tank contained a small amount of gasoline at the conclusion of testing. Figure 26 provides a photograph of the metal fuel tank after exposure. For additional photographs see Figures A-195 through A-201 in Appendix A.

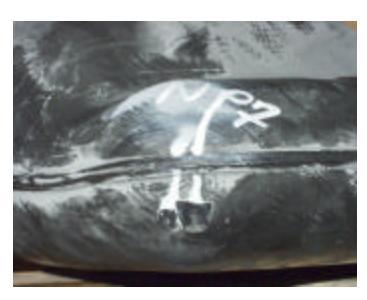
Figure 28. New Plymouth Plastic Fuel Tank After Impact.

There were no leaks after five impacts were delivered on the front right side corner of each tank. The impact energy levels consisted of 30.1 Nm, 33.3 Nm, 36.6 Nm, 40.1 Nm, and 48.6 Nm. Also, there were no leaks after two additional impacts were delivered on the front left side corner of each tank. These impact energy levels consisted of 43.6 Nm and 147.2 Nm. Figure 28 provides a photograph of the new 1998 Plymouth Voyager fuel tank after impact.

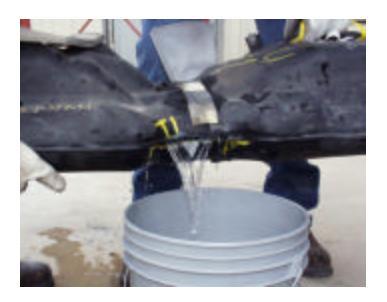
Figure 30. Leakage of Conditioned Plymouth Plastic Fuel Tank After Sever Drop.

The conditioned 2000 Model Plymouth Grand Voyager fuel tank leaked approximately 150 oz by weight of water per minute due to pinch-off separations⁴ at the front strap location (Figure 30). The conditioned 1998 Model Jeep Grand Cherokee fuel tank leaked approximately 900 oz by weight of water per minute due to pinch-off separation along the front right side of the tank (Figure 31).

⁴ Failure at end-seams along edges of a plastic fuel tank resulting from a blow molding process.

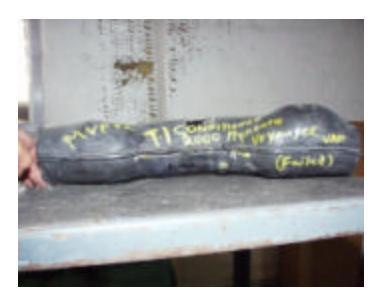
Figure 32. External View of Plymouth Tank Pinch-Off Section

Since drop testing indicated there could possibly be an issue of bond strength weakness at the pinch-off locations, tensile tests were considered. By conducting these tests in general accordance to the ASTM D 638-00, "Standard Test Method for Tensile Properties of Plastics" one could determine if the bond strength pinch-off location as demonstrated by the failed drop tanks is a weak aspect of the tank design.

Figures 32 and 33 below depict the external and internal view of the pinch-off sections of the conditioned 2000 Plymouth Grand Voyager fuel tank that failed during the drop test.

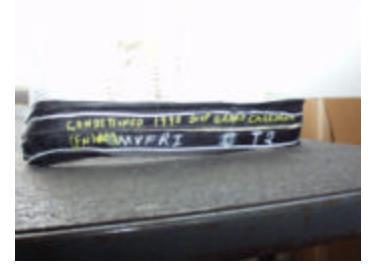
Figure 34. External View of Jeep Tank Pinch-Off Section.

Figures 34 and 35 below depict the external and internal view of the pinch-off sections of the 1998 Model Jeep Grand Cherokee fuel tank that failed during the drop test.

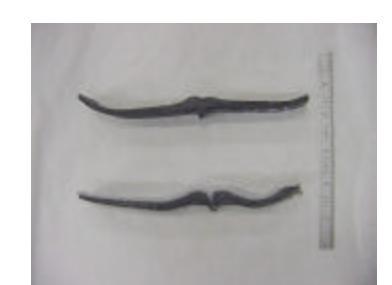
Figure 38. Thickest Region at Pinch-Off Location.

As these coupons were extracted from the fuel tanks, the pinch-off location in each was perpendicular to the long-axis of the specimen parent material. The overall length of the specimen coupons depended on the location of extraction and ranged from 6 in. to 9 in. in length. The thickness of the specimen coupons varied as well, ranging from 0.2 in. to 0.5 in. For all specimen coupons, the thickest region was at the pinch-off location. Figures 37 and 38 depict the typical specimen coupons.

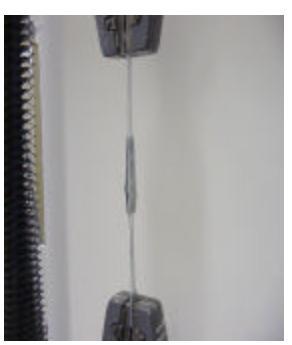
Figure 40. Elongation of Parent Material.

Tensile testing was conducted on June 12, and 13, 2003. Results of the tests indicated that failure for all specimen coupons was attributed to elongation in the long-axis of the specimen's parent material and not at the pinch-off location. The bond pinch-off location was maintained despite the uniaxial stresses imposed during the test. Figure 40, provides a photograph of elongation in the long-axis of the specimen parent material during testing.

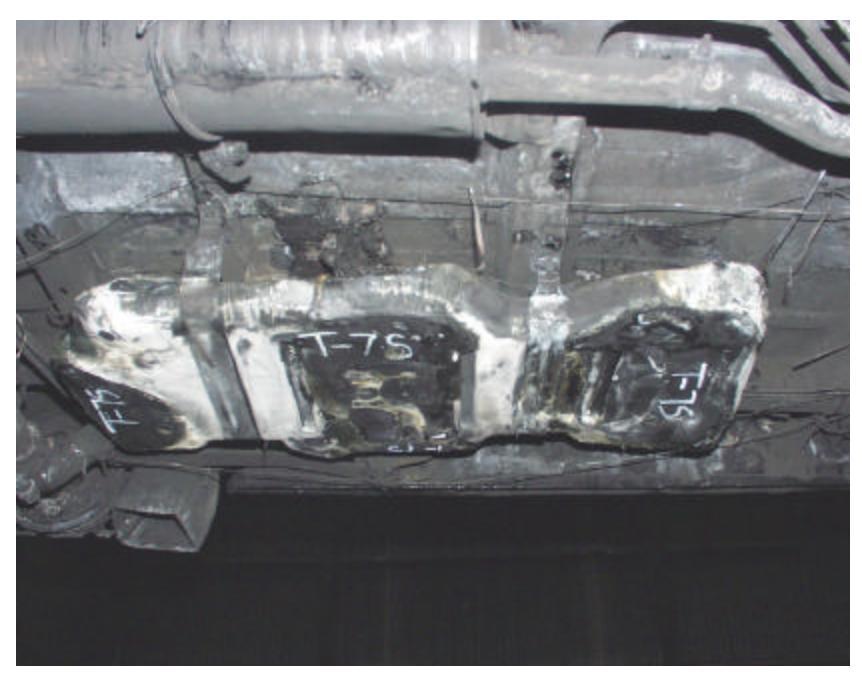
Figure A-23. Test PNP2(S) After Exposure With Tank Shield.

$^{^{5}}$ At 2 min 21 sec from the start of the fuel tank fire exposure (or 21 sec into the extended fire exposure), leakage occurred through the drain hole of the 14-gauge thick heat shield and along the left perimeter side of the fuel tank and heat shield interface. The fire exposure continued until extended failure occurred at 6 min 5 sec.

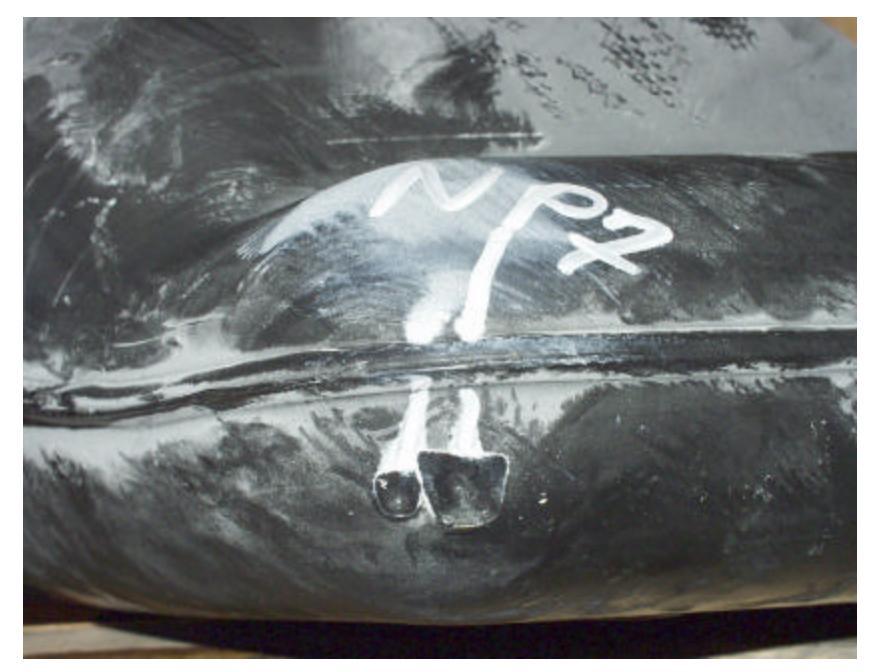
Figure A-28. New Plymouth Plastic Fuel Tank After Impact.

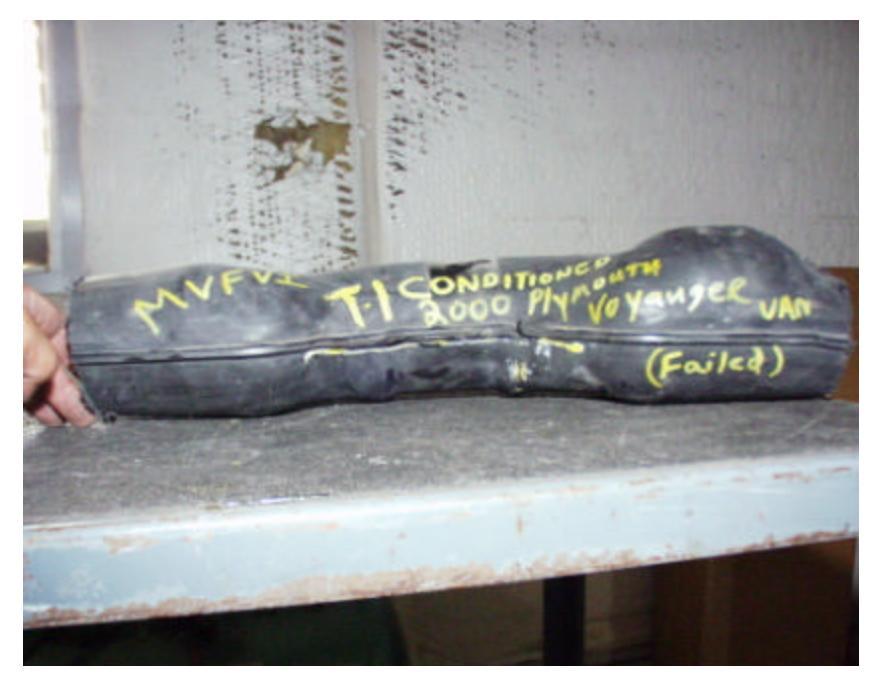
Since the drop tests indicated there could possibly be an issue of bond strength weakness at the pinch-off locations of the conditioned 2000 Plymouth Grand Voyager fuel tank and the conditioned 1998 Jeep Grand Cherokee fuel tank, tensile tests were conducted in general accordance with ASTM D 638-00, "Standard Test Method for Tensile Properties of Plastics." Results of this evaluation indicated that failure for all specimen coupons was attributed to elongation in the long-axis of the specimen's parent material and not from the bond at the pinch-off location. Alternative test methods should be considered or developed to evaluate the bond strength at the pinch-off location under conditions more representative of the dynamics of the drop test, for example to evaluate the effect of shear stresses.

Figure A-32. External View of Plymouth Tank Pinch-Off Section.

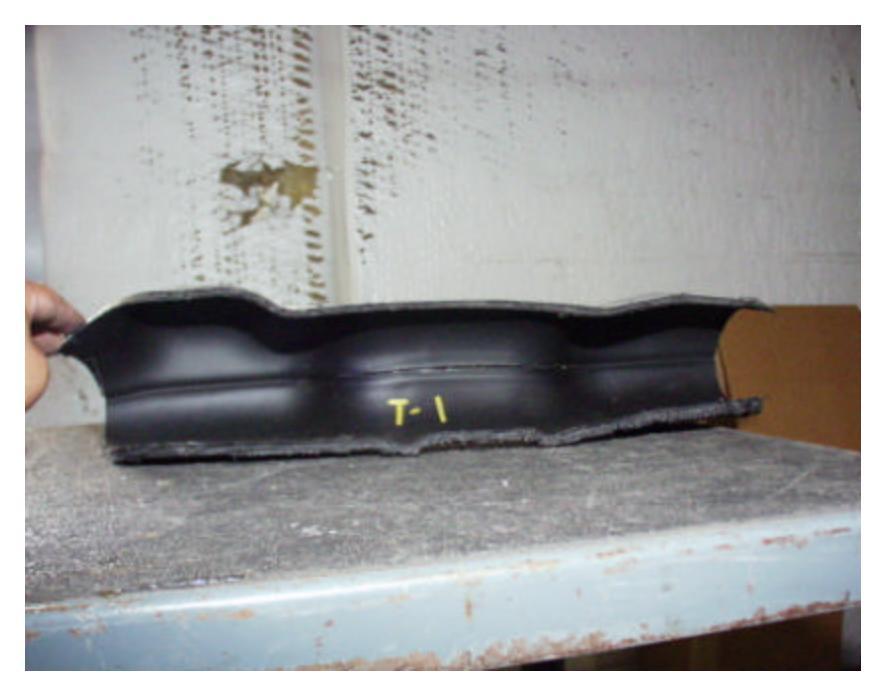
Figure A-33. Internal View of Plymouth Tank Pinch-Off Section.

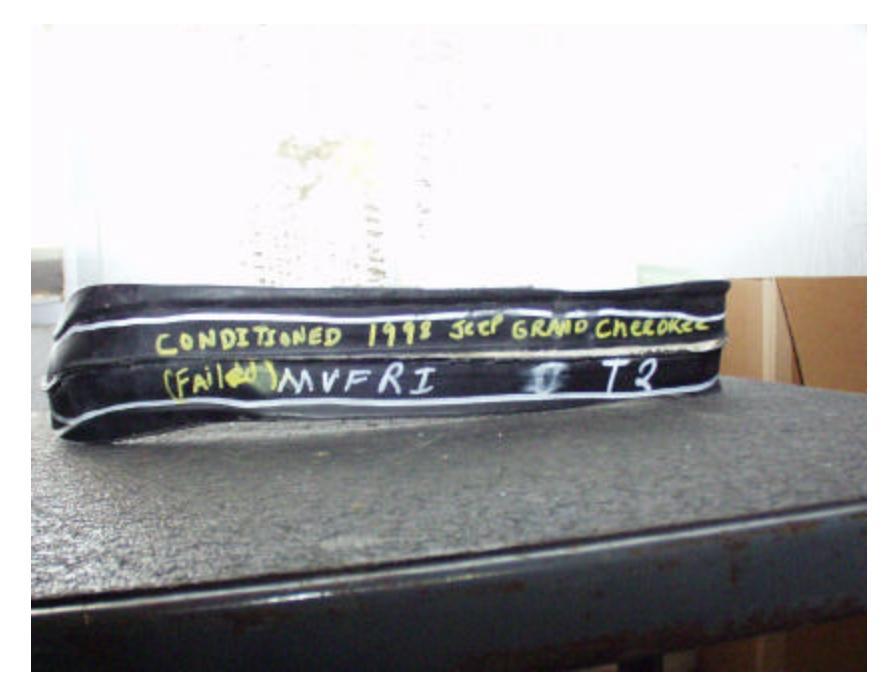
Figure A-34. External View of Jeep Tank Pinch-Off Section.

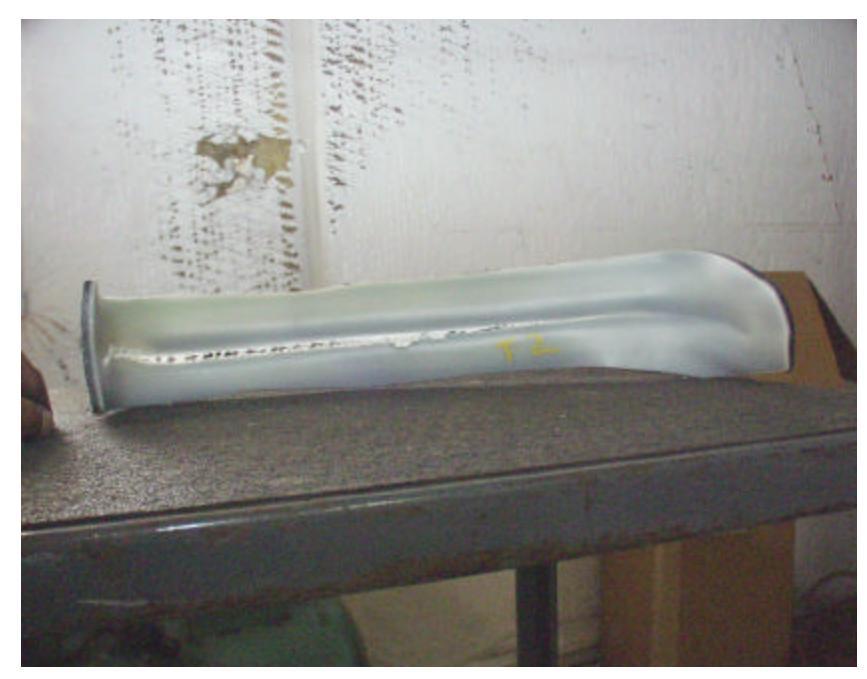
Figure A-35. Internal View of Jeep Tank Pinch-Off Section.

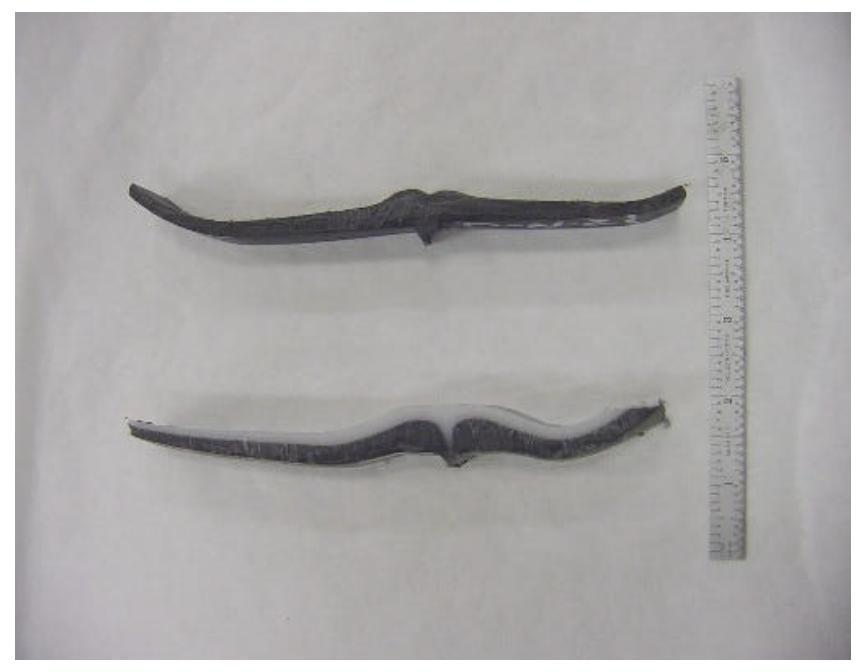
Figure A-38. Thickest Region at Pinch-Off Location.

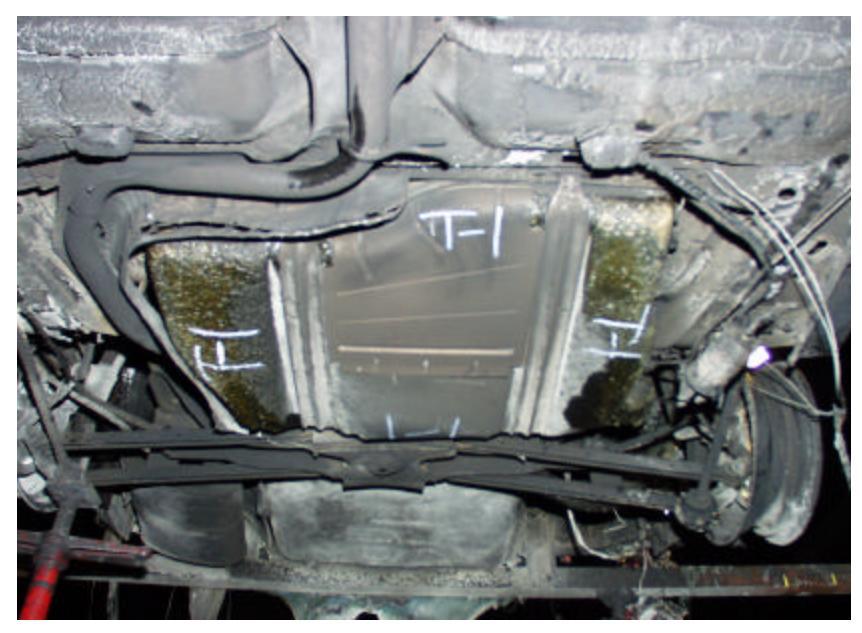
Figure A-48. Test No. 1, Conditioned 1998 Saturn Twin Cam 4-Door Fuel Tank Immediately After Fire Exposure.

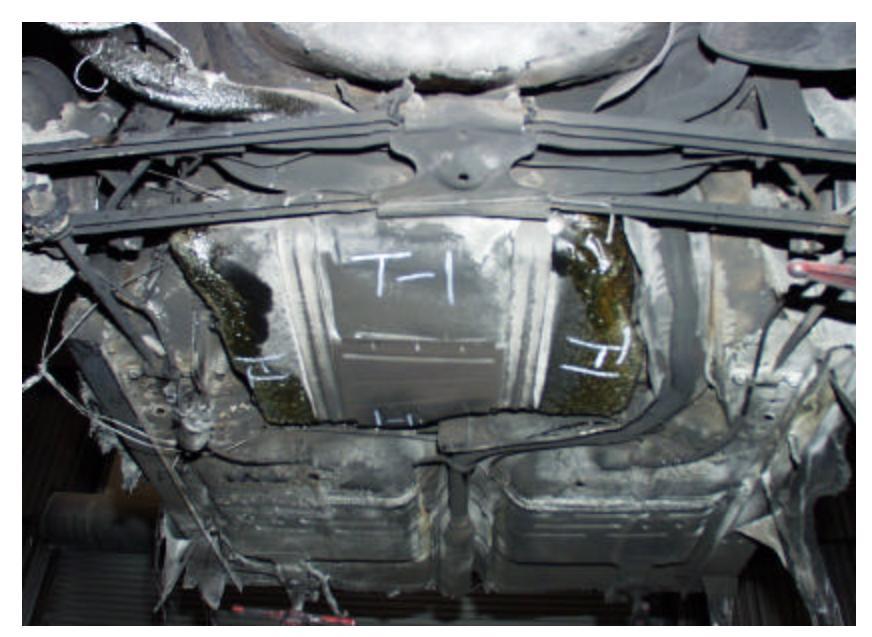
Figure A-49. Test No. 1, Top View of Conditioned 1998 Saturn Twin Cam 4-Door Fuel Tank After Fire Exposure.

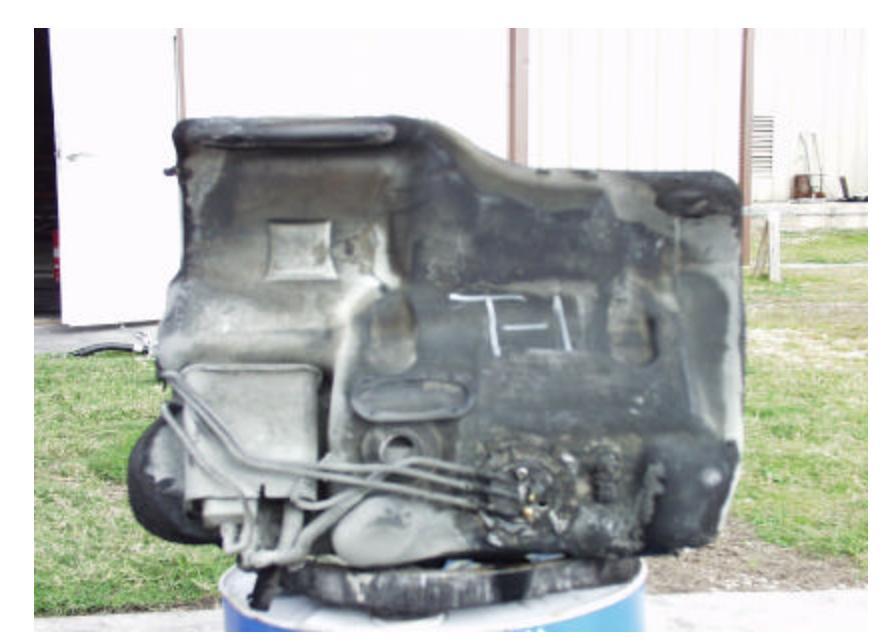
Figure A-50. Test No. 1, Bottom View of Conditioned 1998 Saturn Twin Cam 4-Door Fuel Tank After Fire Exposure.

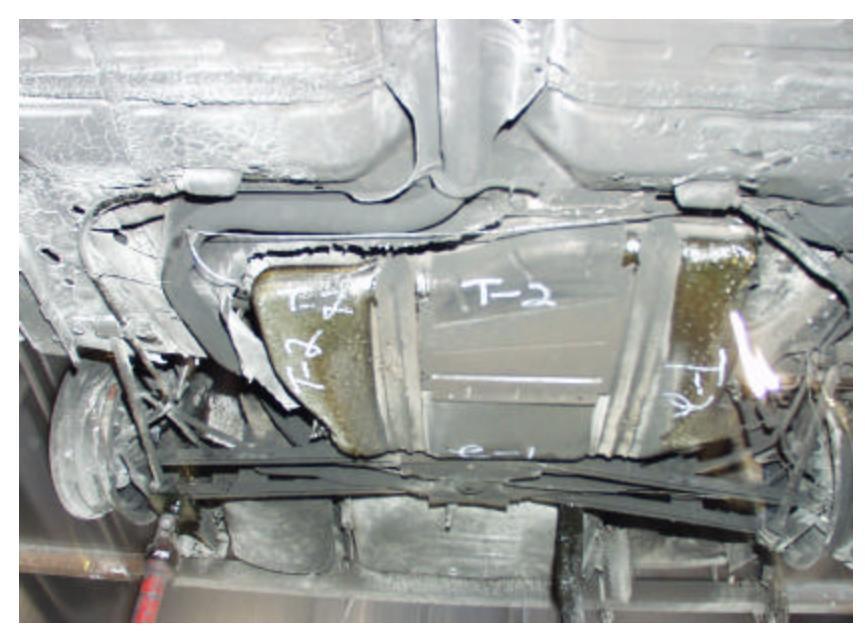
Figure A-57. Test No. 2, New 1998 Saturn Twin Cam 4-Door Fuel Tank Immediately After Fire Exposure.

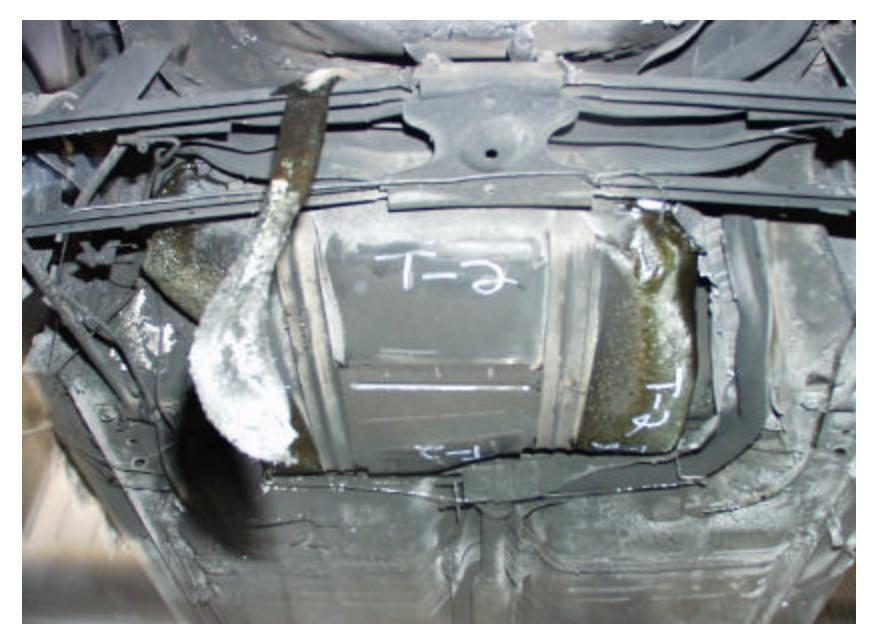
Figure A-58. Test No. 2, Top View of New 1998 Saturn Twin Cam 4-Door Fuel Tank After Fire Exposure.

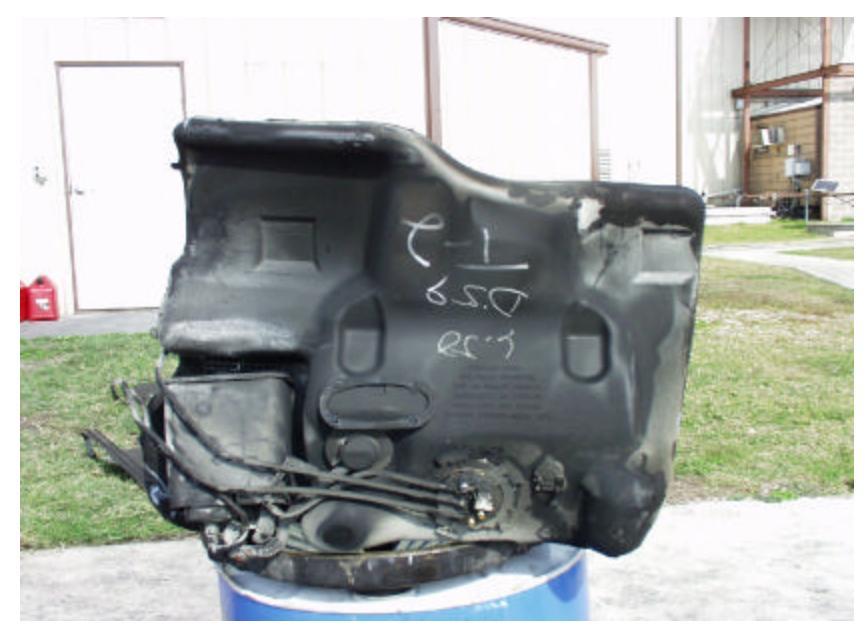
Figure A-59. Test No. 2, Bottom View of New 1998 Saturn Twin Cam 4-Door Fuel Tank After Fire Exposure.

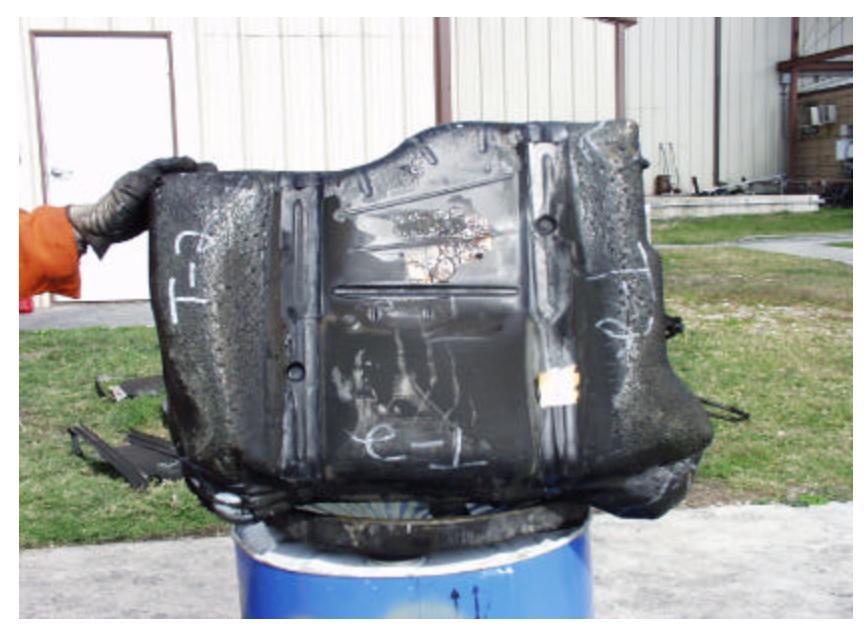
Figure A-60. Test No. 2, Fire Exposure Hole at Front Left Side Bottom Corner of New 1998 Saturn Twin Cam 4-Door Fuel Tank.

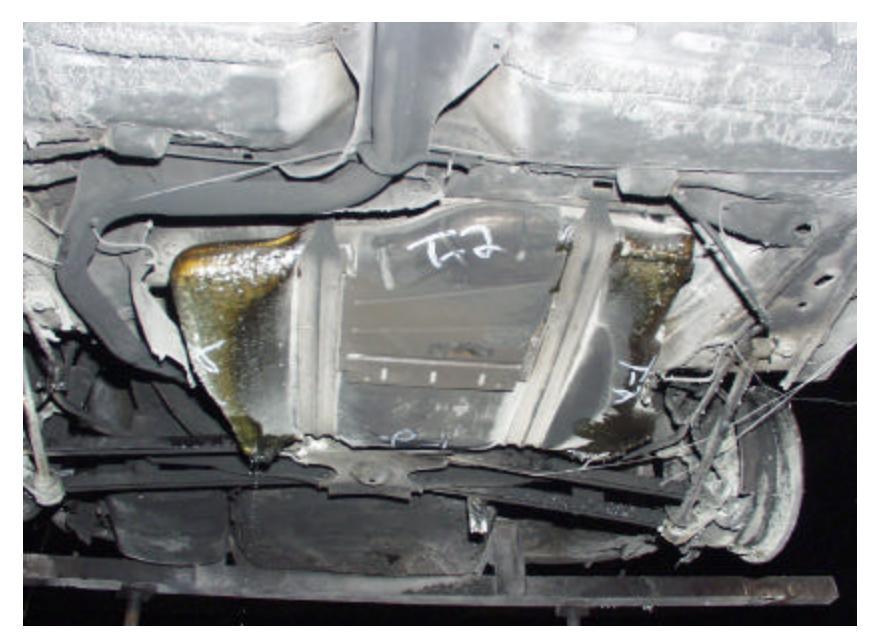
Figure A-71. Test No. 2, Repeatability Evaluation on a New 1998 Saturn Twin Cam 4-Door Fuel Tank Immediately After Fire Exposure with a Leak on Rear Passenger Side Corner of Fuel Tank.

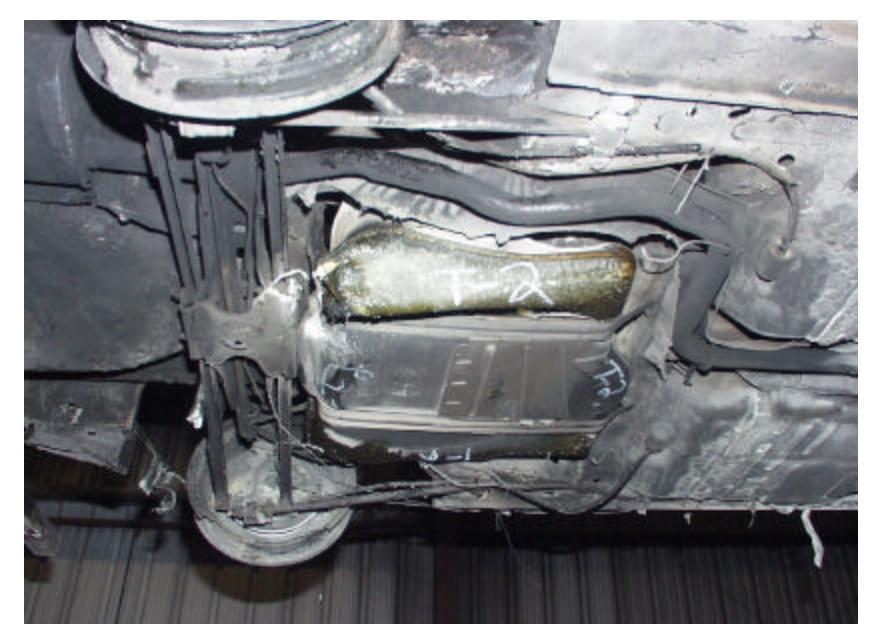
Figure A-73. Test No. 2, Repeatability Evaluation on a New 1998 Saturn Twin Cam 4-Door Fuel Tank Immediately After Fire Exposure with a Leak on Rear Passenger Side Corner of Fuel Tank.

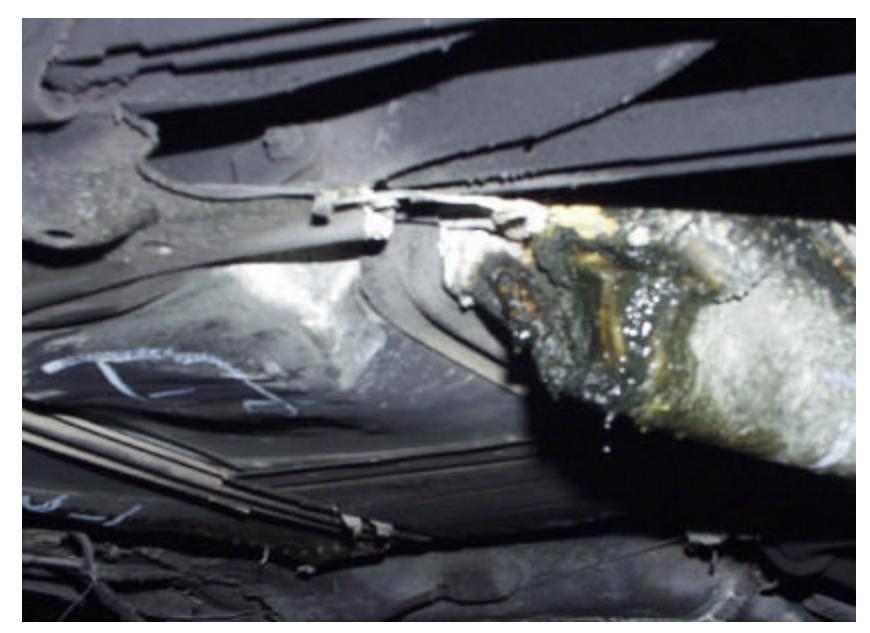
Figure A-75. Test No. 2, Repeatability Evaluation on a New 1998 Saturn Twin Cam 4-Door Fuel Tank Immediately After Fire Exposure with Leak on Rear Passenger Side Corner of Fuel Tank.

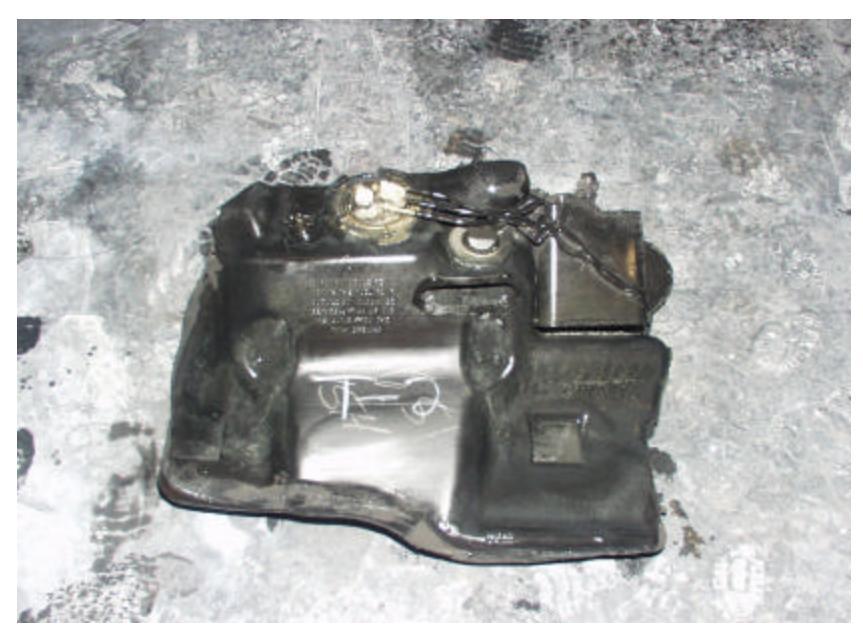
Figure A-76. Test No. 2, Repeatability Evaluation on a New 1998 Saturn Twin Cam 4-Door Fuel Tank After Fire Exposure, Top View.

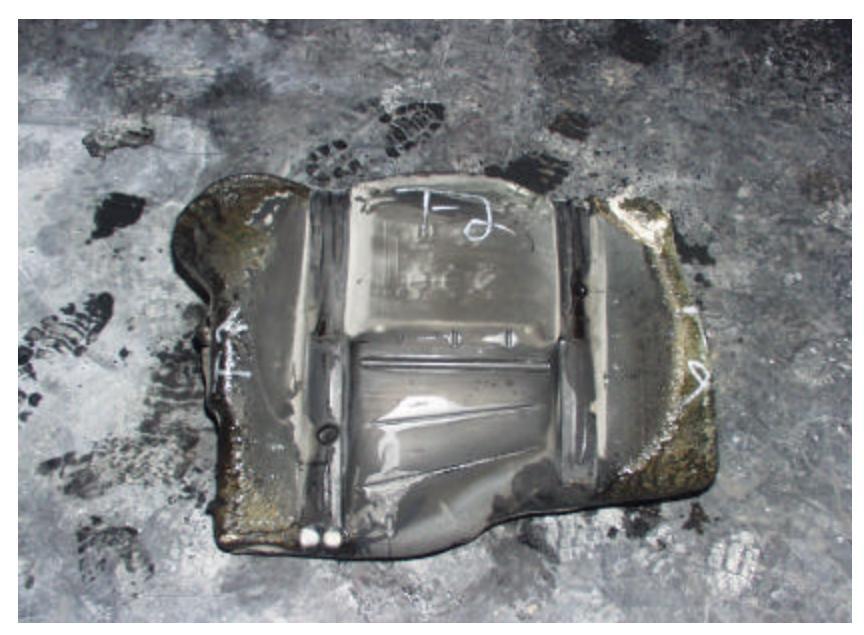
Figure A-77. Test No. 2, Repeatability Evaluation on a New 1998 Saturn Twin Cam 4-Door Fuel Tank After Fire Exposure, Bottom View.

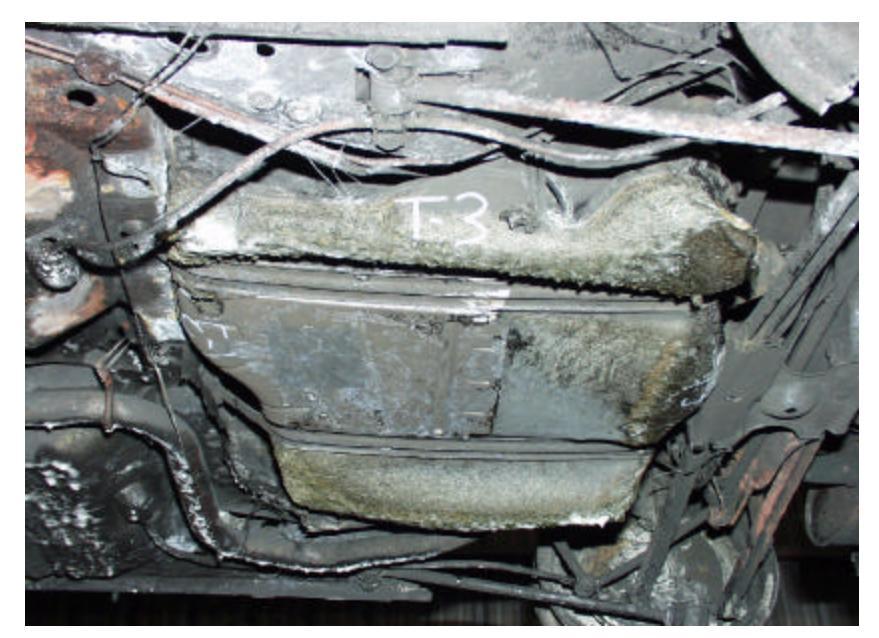
Figure A-82. Test No. 3, Repeatability Evaluation on a New 1998 Saturn Twin Cam 4-Door Fuel Tank Immediately After Fire Exposure with a Leak at Front Left Passenger Side Bottom Corner.

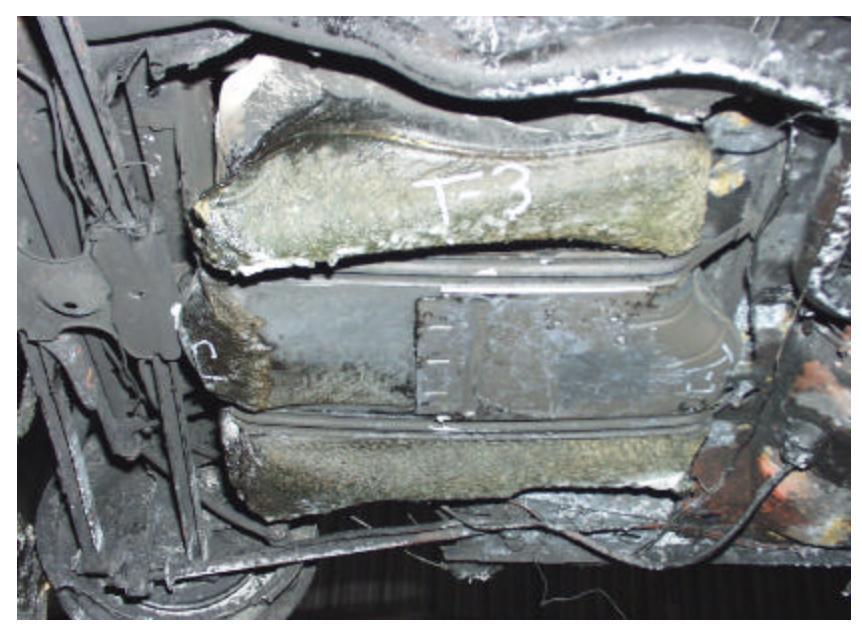
Figure A-83. Test No. 3, Repeatability Evaluation on a New 1998 Saturn Twin Cam 4-Door Fuel Tank Immediately After Fire Exposure with a Leak at Front Left Passenger Side Bottom Corner and Rear Left Passenger Side of Fuel Tank.

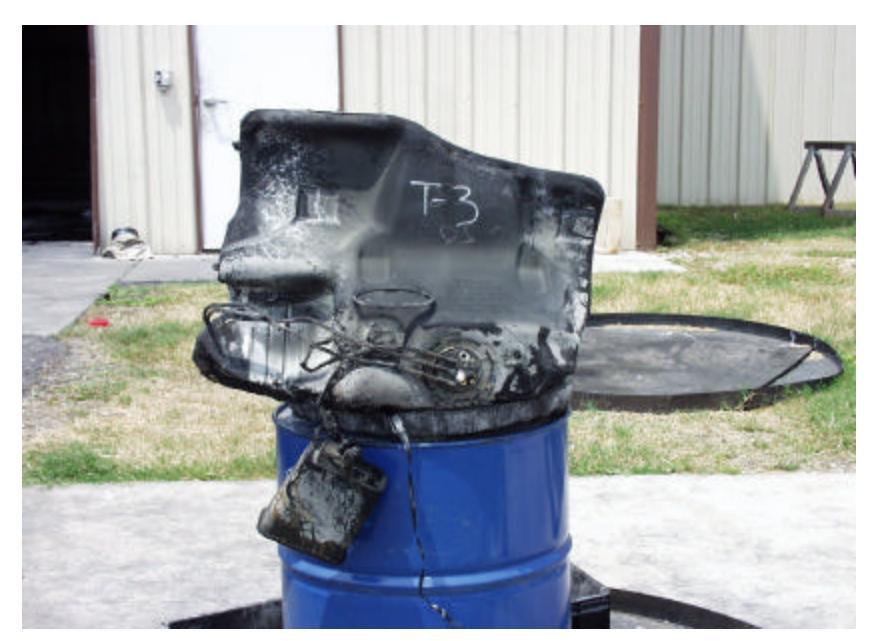
Figure A-84. Test No. 3, Repeatability Evaluation on a New 1998 Saturn Twin Cam 4-Door Fuel Tank After Fire Exposure, Top View.

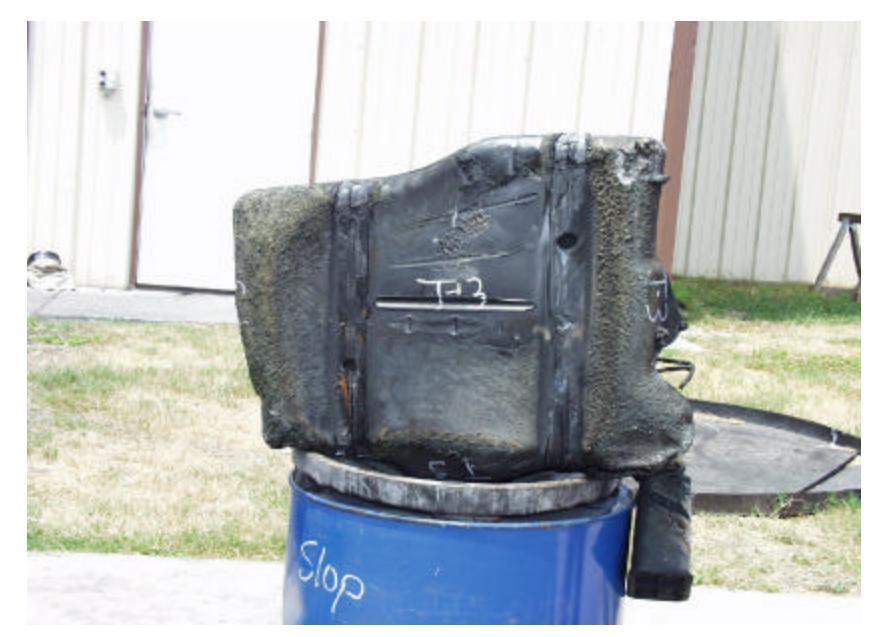
Figure A-85. Test No. 3, Repeatability Evaluation on a New 1998 Saturn Twin Cam 4-Door Fuel Tank After Fire Exposure, Bottom View.

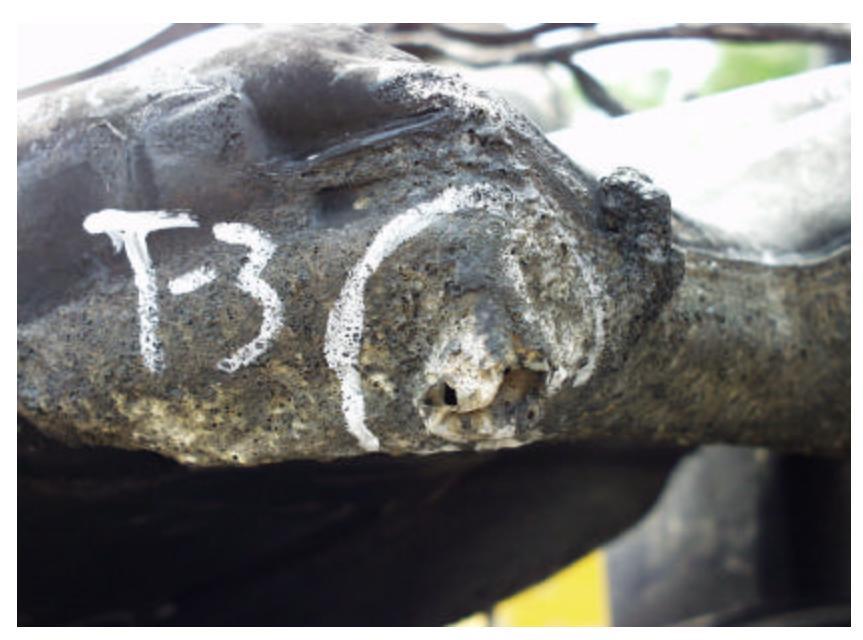
Figure A-86. Test No. 3, New 1998 Saturn Twin Cam 4-Door Fuel Tank Post-Test Observation at Front Left Passenger Side Bottom Corner of Fuel Tank.

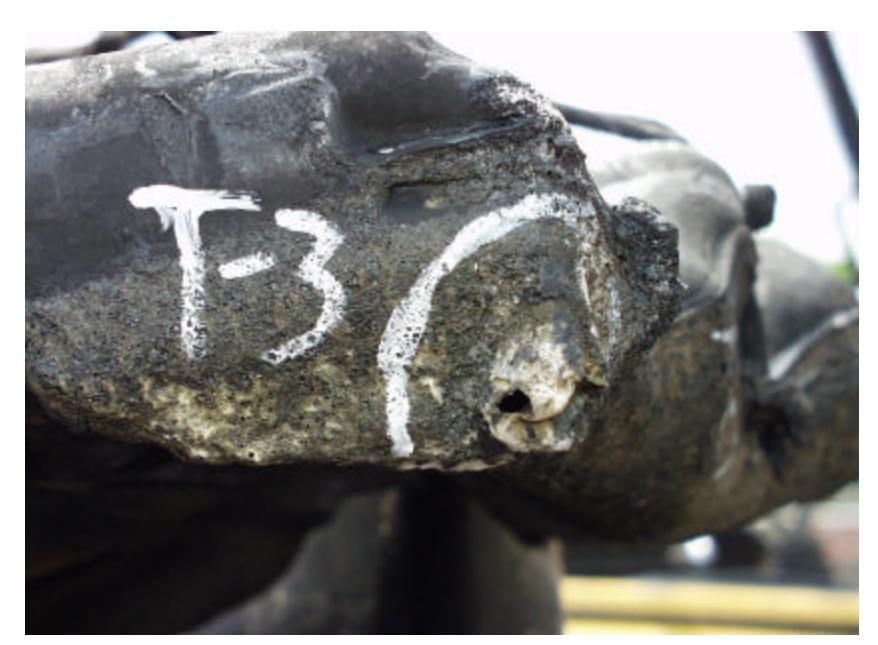
Figure A-87. Test No. 3, New 1998 Saturn Twin Cam 4-Door Fuel Tank Post-Test Observation at Front Left Passenger Side Bottom Corner of Fuel Tank.

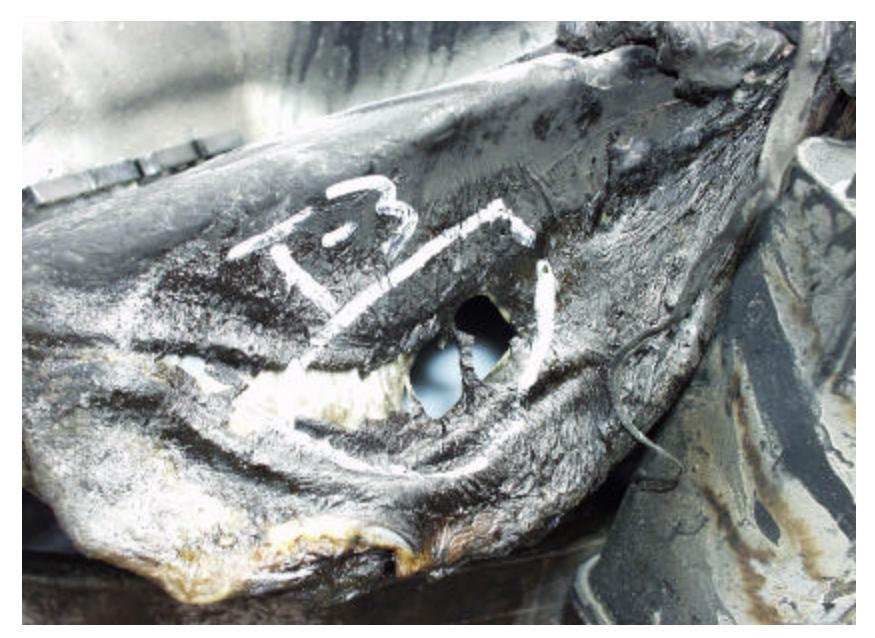
Figure A-88. Test No. 3, Saturn Twin Cam 4-Door Fuel Tank Post-Test Observation at Rear Left Passenger Side of Fuel Tank.

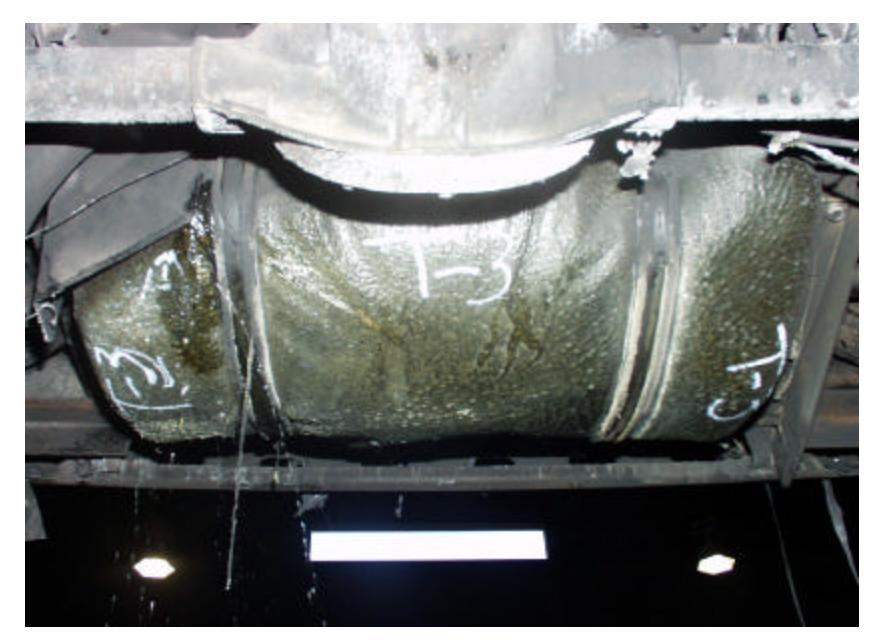
Figure A-94. Test No. 3, Conditioned 1998 Jeep Grand Cherokee Fuel Tank Immediately After Fire Exposure with Leak at Front Right Side Along Outboard Side of Strap.

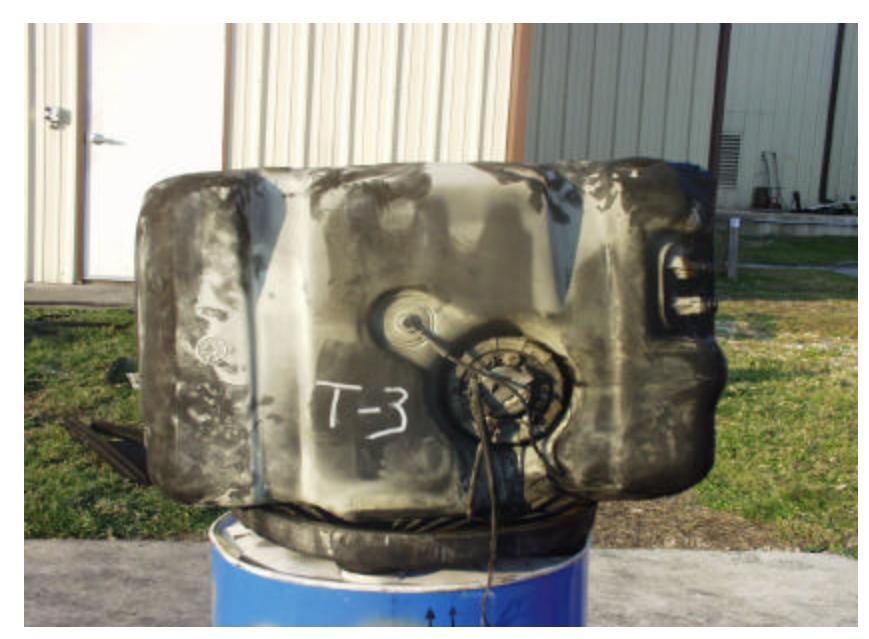
Figure A-97. Test No. 3, Top View of Conditioned 1998 Jeep Grand Cherokee Fuel Tank After Fire Exposure.
