AUTOMOTIVE FUEL TANK EVALUATION

COMPARATIVE EVALUATION OF AUTOMOTIVE FUEL TANKS IN GENERAL ACCORDANCE WITH THE ECE R34.01, ANNEX 5 SECTION 5.0 "RESISTANCE TO FIRE;" AND SECTION 1.0 "IMPACT RESISTANCE;" THE US DEPARTMENT OF TRANSPORTATION 49 CFR 393.67, SECTION E "DROP TEST;" AND ASTM D 638-00, "STANDARD TEST METHOD FOR TENSILE PROPERTIES OF PLASTICS"

FINAL REPORT Consisting of 228 Pages SwRI® Project No. 01.06081.01.001 August 2003

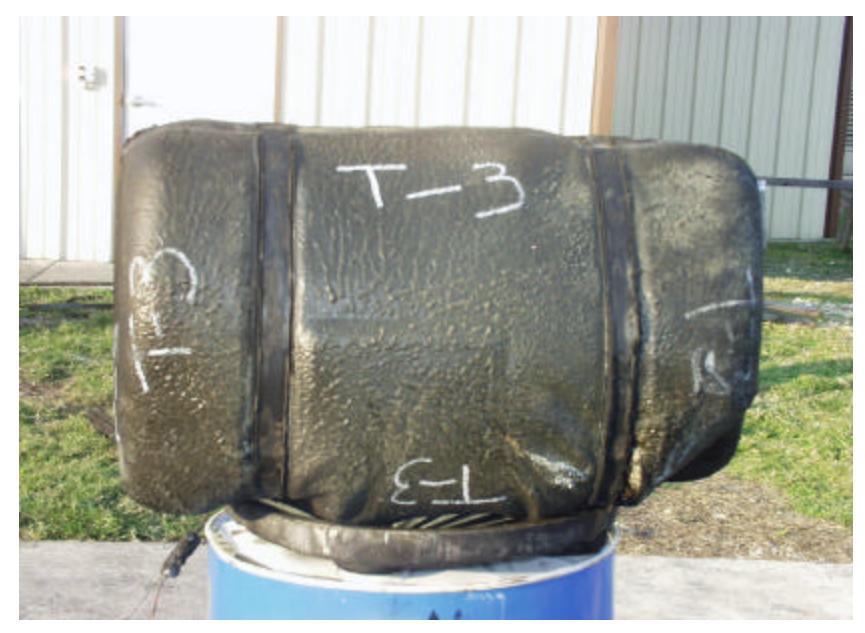
Figure A-98. Test No. 3, Bottom View of Conditioned 1998 Jeep Grand Cherokee Fuel Tank After Fire Exposure.

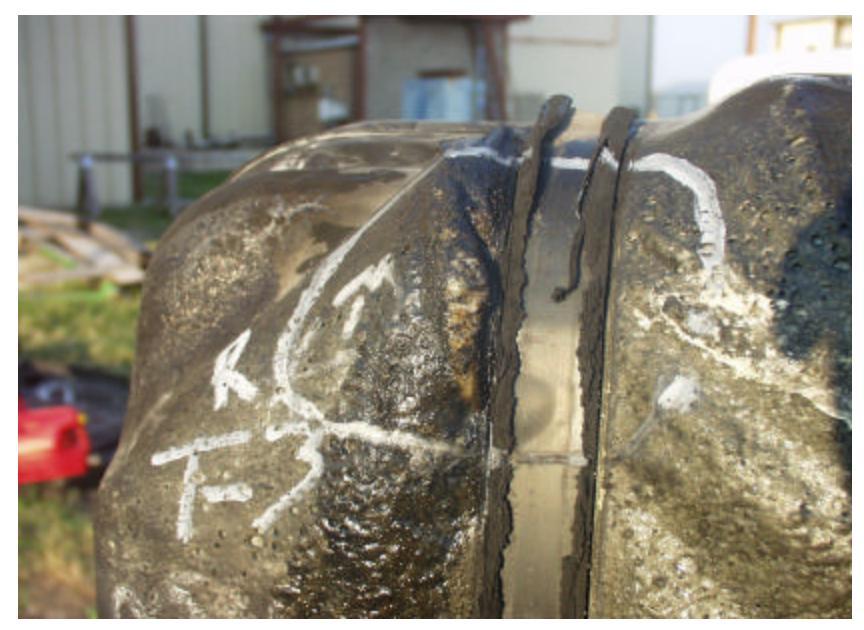
Figure A-99. Test No. 3, Fire Exposure Hole at Front Right Side Along Outside of Strap of Conditioned 1998 Jeep Grand Cherokee Fuel Tank.

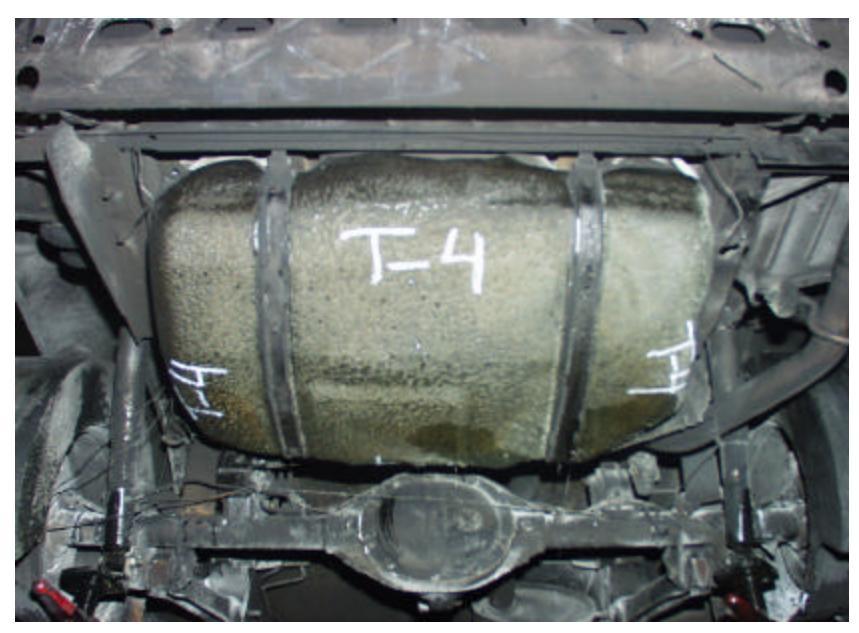
Figure A-105. Test No. 4, New 1998 Jeep Grand Cherokee Fuel Tank Immediately After Fire Exposure with Leak at Front Right Side Bottom of Fuel Tank.

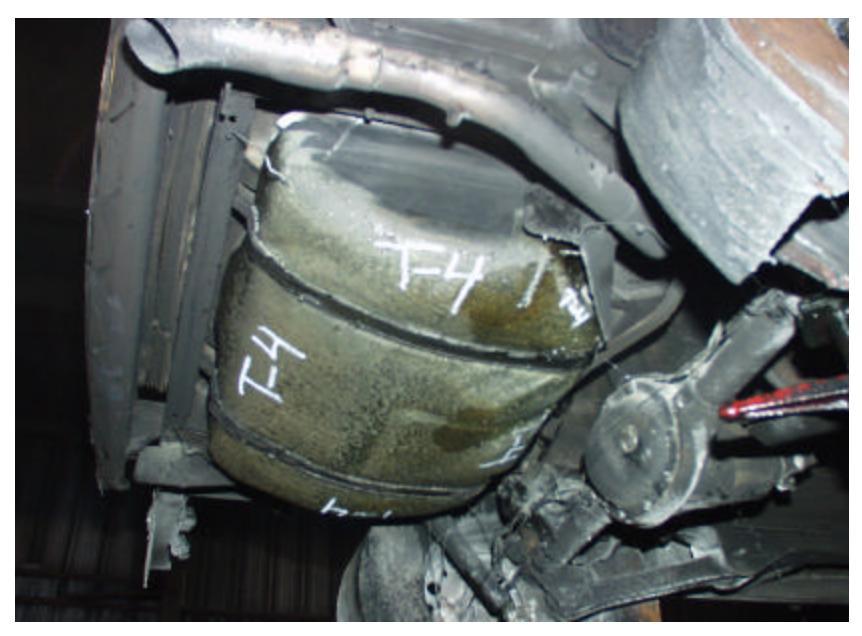
Figure A-106. Test No. 4, New 1998 Jeep Grand Cherokee Fuel Tank Immediately After Fire Exposure with Leak at Front Right Side Bottom of Fuel Tank.

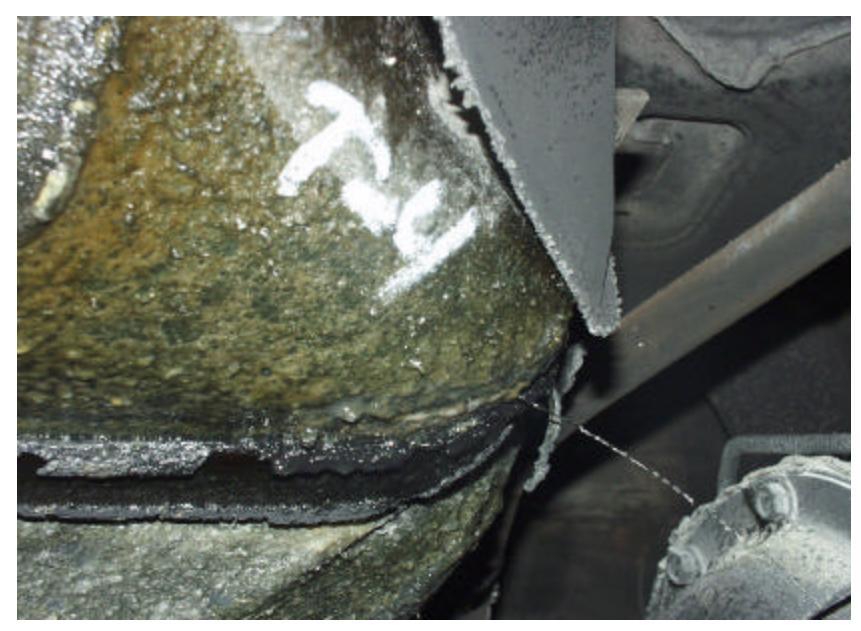
Figure A-107. Test No. 4, New 1998 Jeep Grand Cherokee Fuel Tank Immediately After Fire Exposure with Leak at Front Right Side Bottom of Fuel Tank.

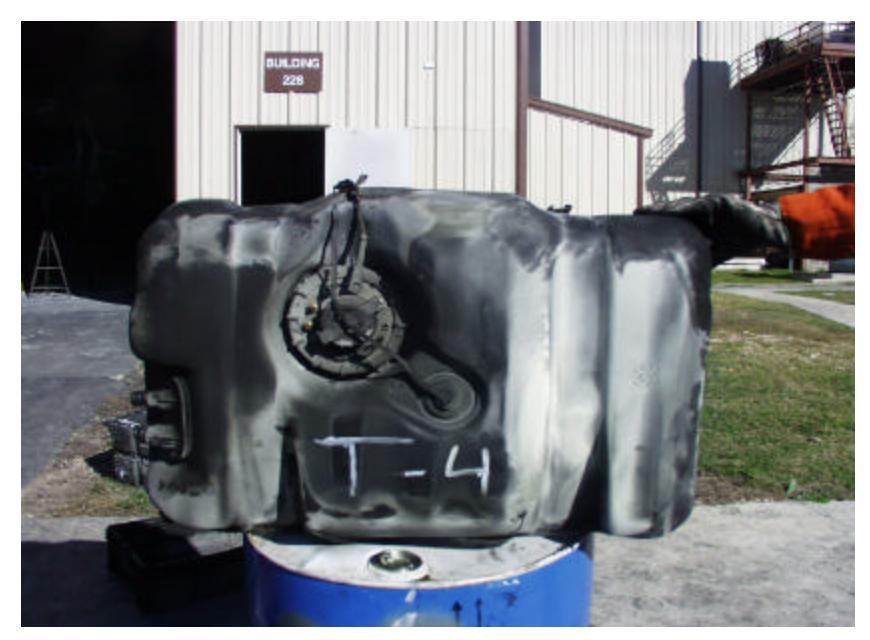
Figure A-108. Test No. 4, Top View of New 1998 Jeep Grand Cherokee Fuel Tank After Fire Exposure.

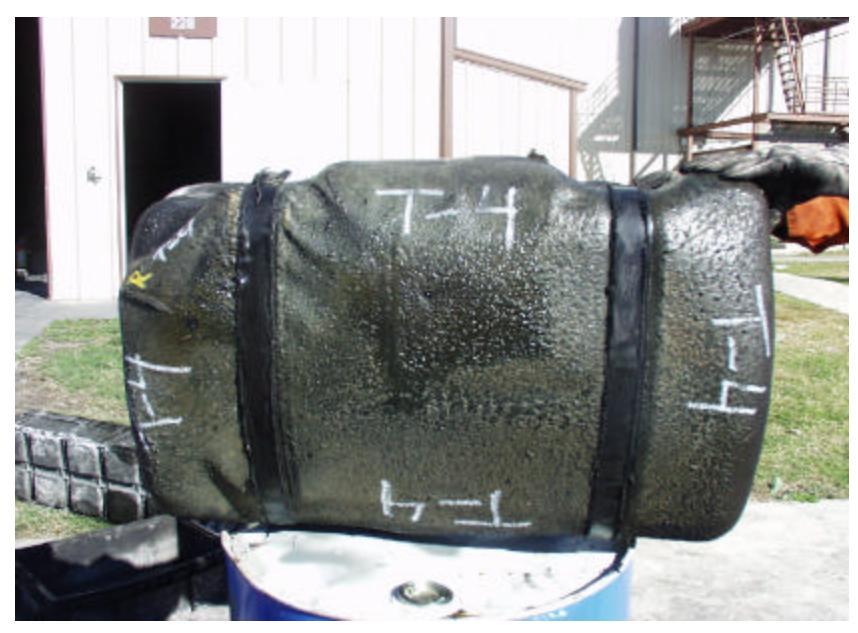
Figure A-109. Test No. 4, Bottom View of New 1998 Jeep Grand Cherokee Fuel Tank After Fire Exposure.

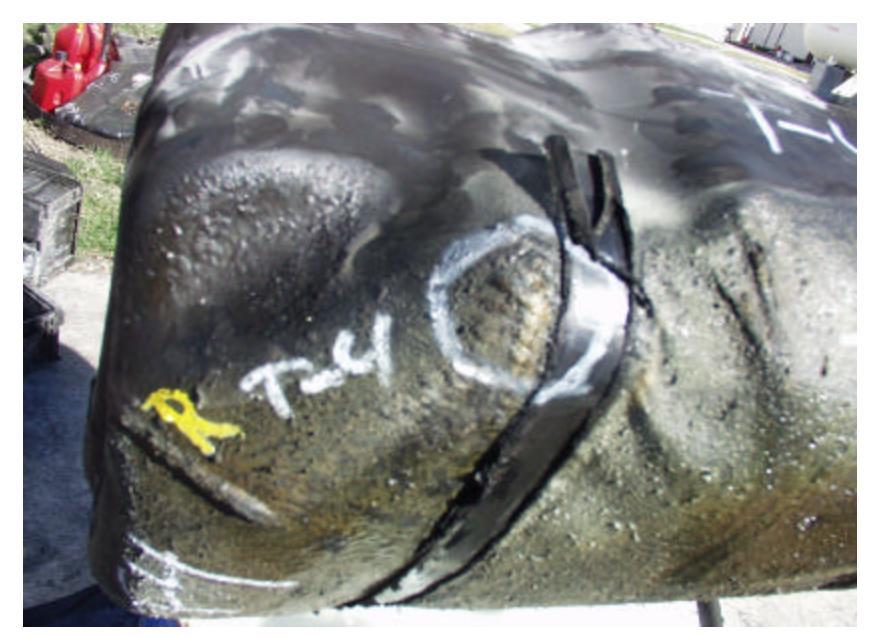
Figure A-110. Test No. 4, Fire Exposure Hole at Front Right Side Bottom Outboard Side of Strap of New 1998 Jeep Grand Cherokee Fuel Tank.

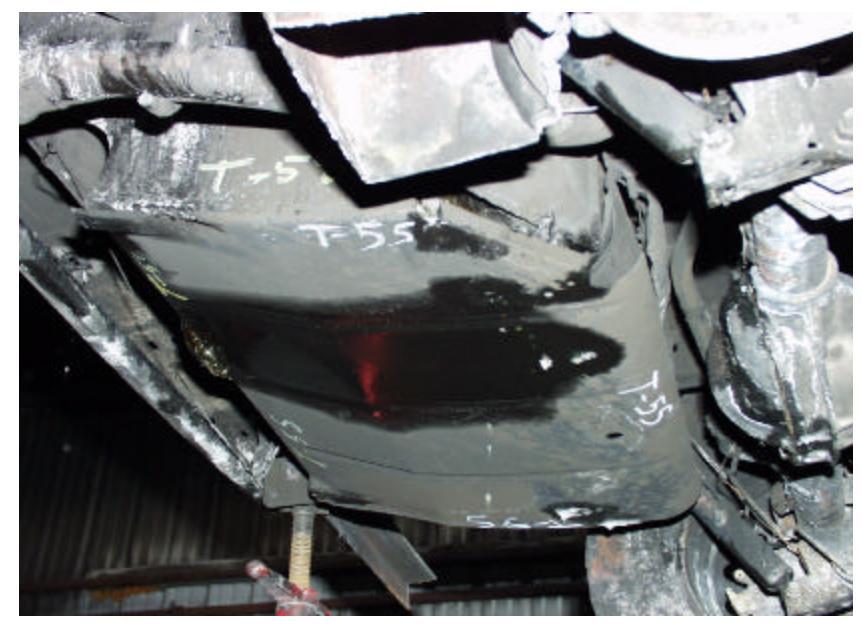
Figure A-119. Test No. 5S, New 1998 Jeep Grand Cherokee Fuel Tank Immediately After Fire Exposure with Heat Shield and Leak Location at Rear of Tank.

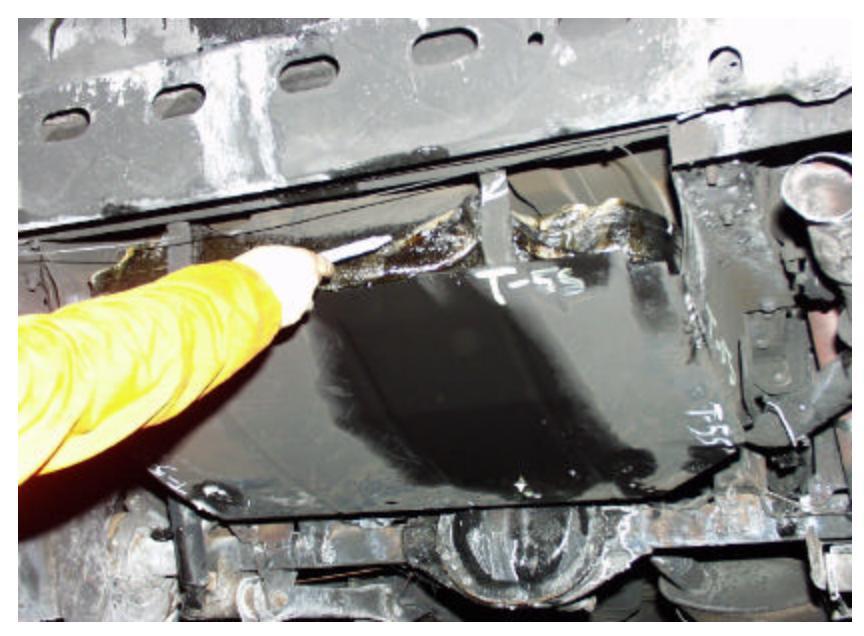
Figure A-120. Test No. 5S, New 1998 Jeep Grand Cherokee Fuel Tank Immediately After Fire Exposure with Heat Shield and Leak Location at Rear Middle of Tank.

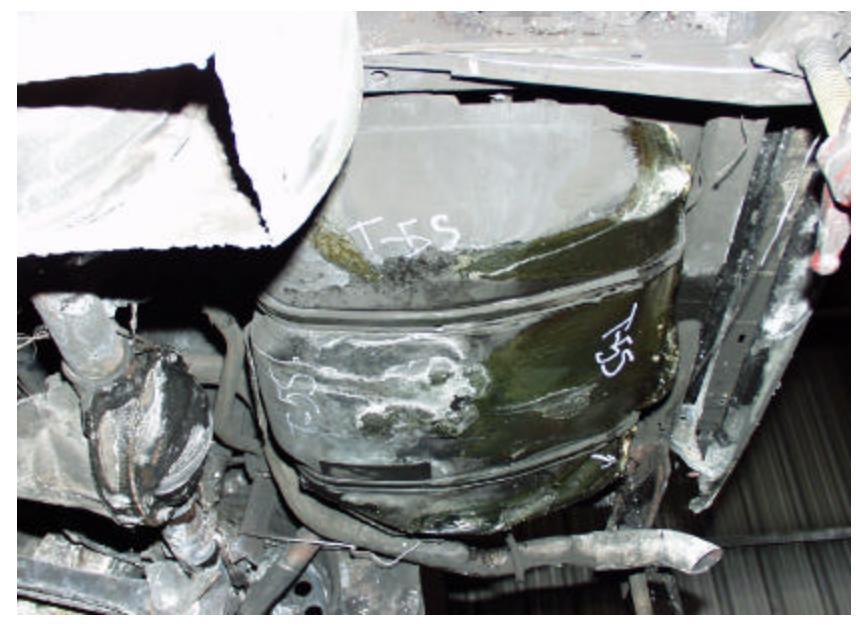
Figure A-121. Test No. 5S, New 1998 Jeep Grand Cherokee Fuel Tank Immediately After Fire Exposure with Heat Shield Removed and Leak Location at Rear Left Corner and Rear Middle of Tank.

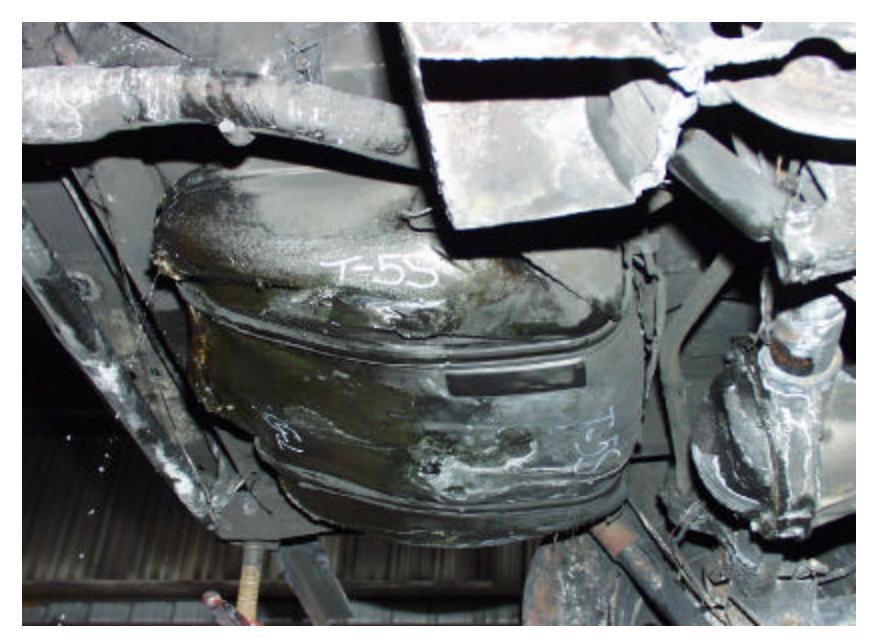
Figure A-122. Test No. 5S, New 1998 Jeep Grand Cherokee Fuel Tank Immediately After Fire Exposure with Heat Shield Removed and Leak Location at Rear Left Corner and Rear Middle of Tank.

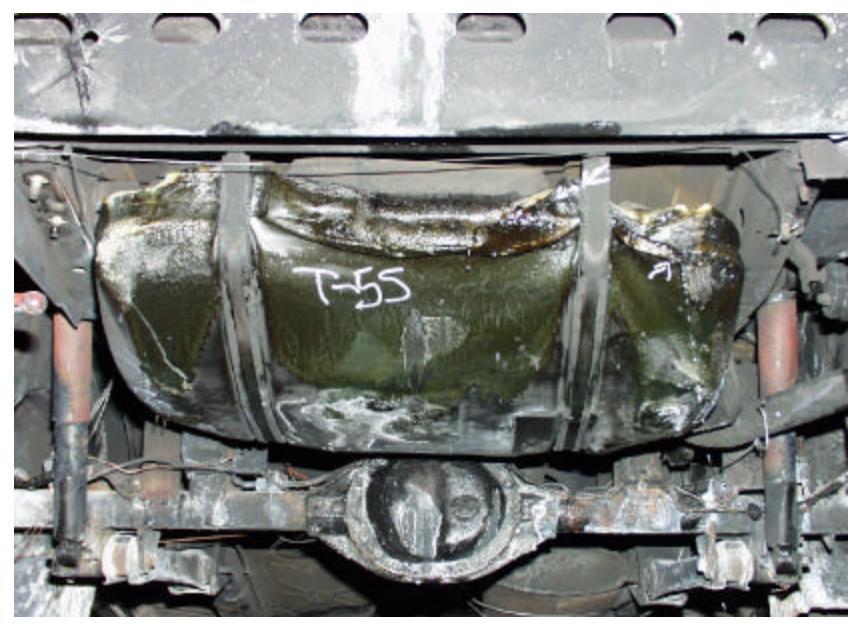
Figure A-123. Test No. 5S, New 1998 Jeep Grand Cherokee Fuel Tank Immediately After Fire Exposure with Heat Shield Removed and Leak Location at Rear Left Corner and Rear Middle of Tank.

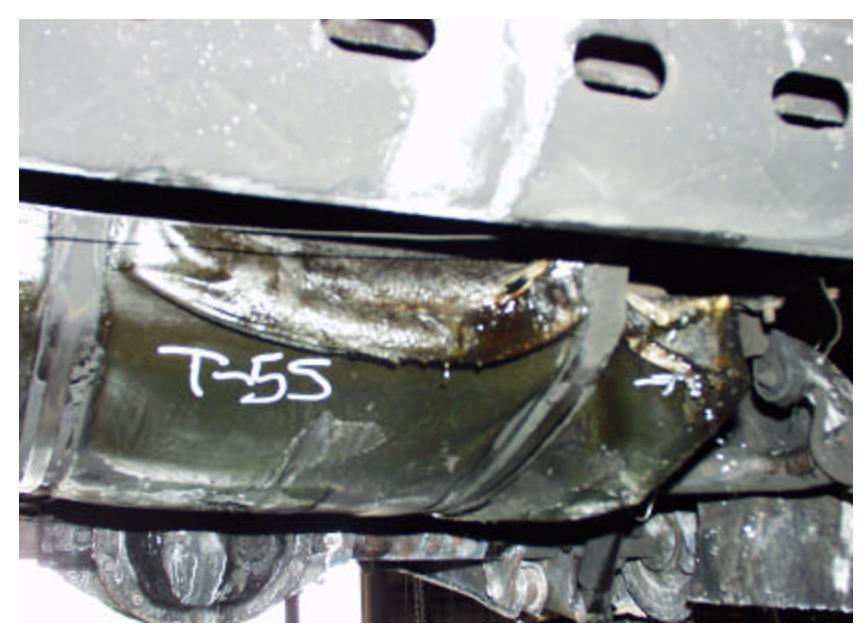
Figure A-124. Test No. 5S, New 1998 Jeep Grand Cherokee Fuel Tank Immediately After Fire Exposure with Heat Shield Removed and Leak Location at Rear of Tank.

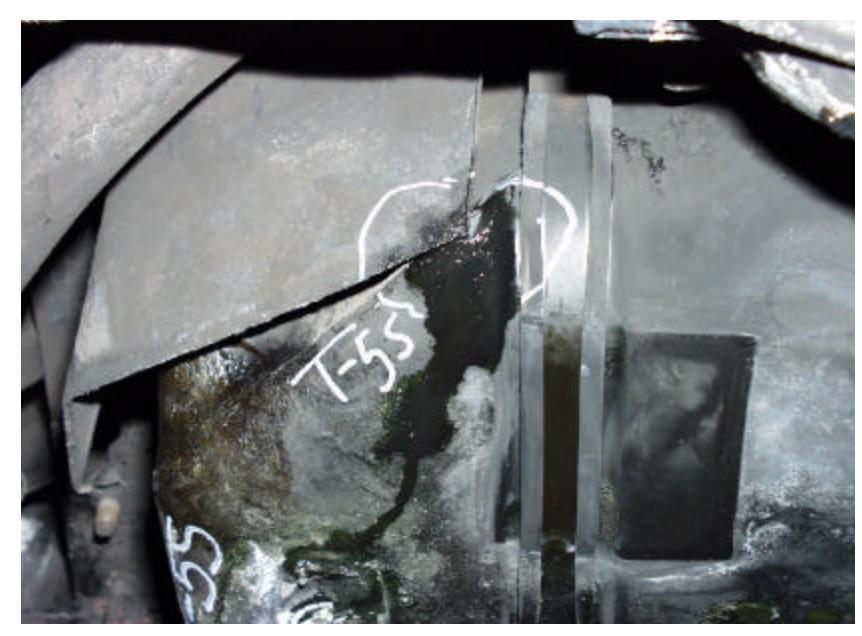
Figure A-125. Test No. 5S, New 1998 Jeep Grand Cherokee Fuel Tank Immediately After Fire Exposure with Leak Location at Front Right Corner of Tank due to Exhaust Shield.

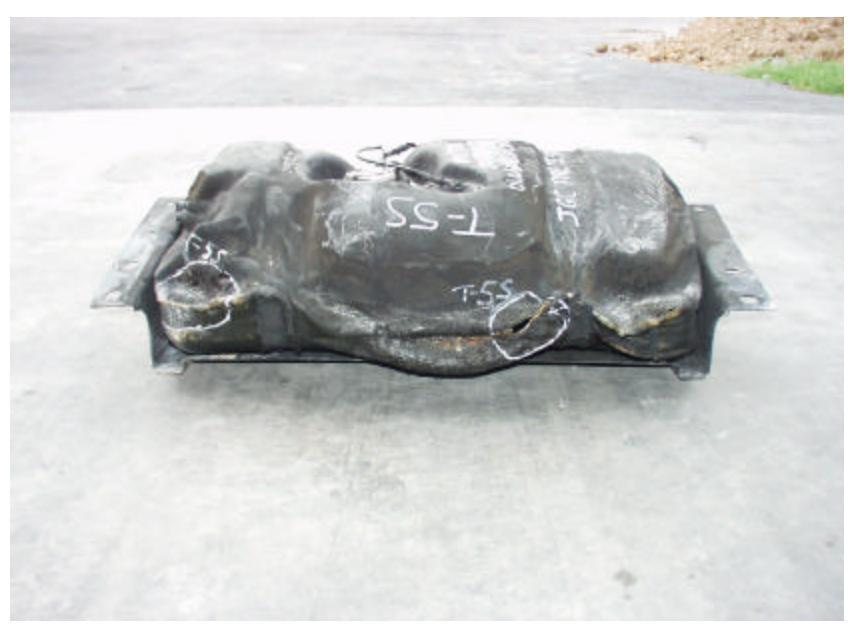
Figure A-128. Test No. 5S, Post-Test Observation of New 1998 Jeep Grand Cherokee Fuel Tank Leak Locations at Rear of Tank.

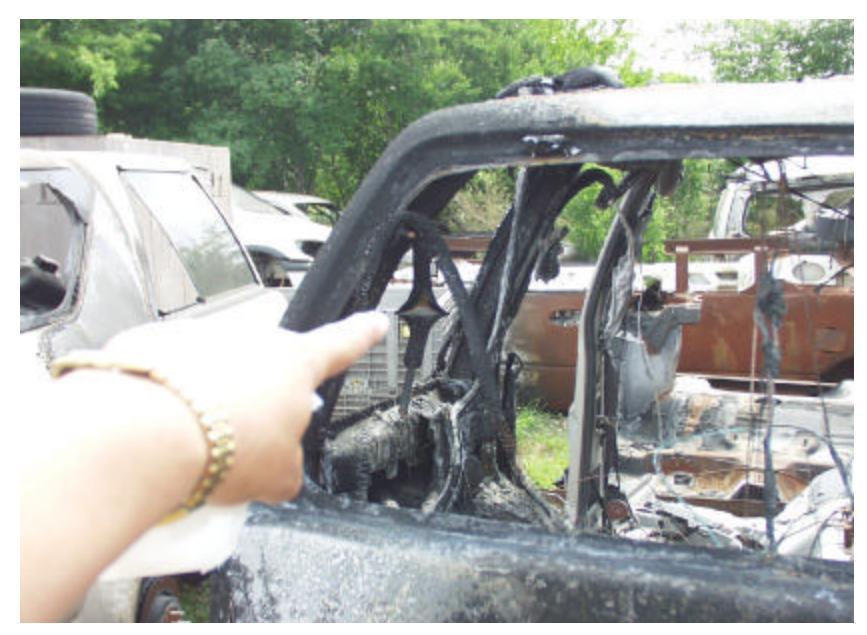
Figure A-130. Test No. 5S, Post-Test Observation of 1998 Jeep Grand Cherokee Lift Gate Strut Support That Vented Loudly During the Test.

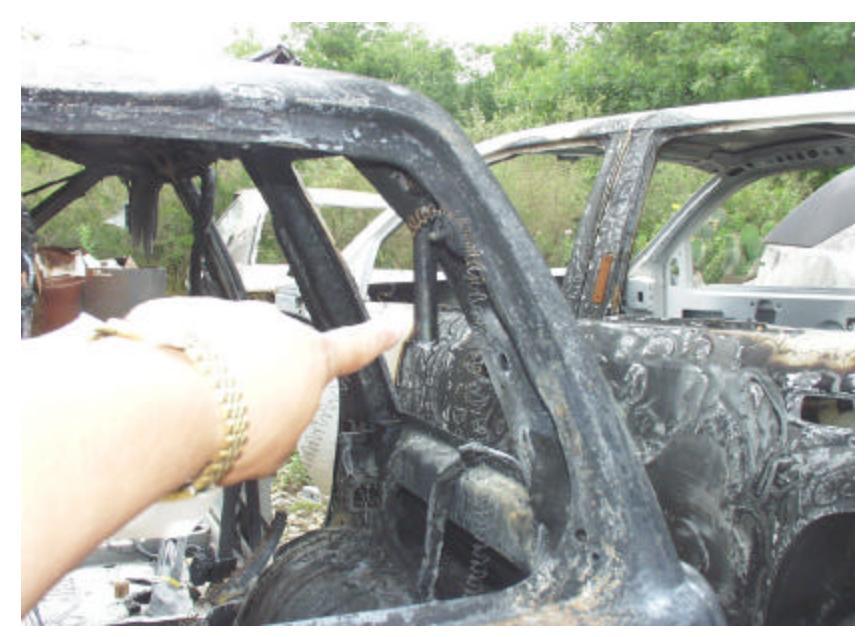
Figure A-131. Test No. 5S, Post-Test Observation of 1998 Jeep Grand Cherokee Lift Gate Strut Support That Vented Loudly During the Test.

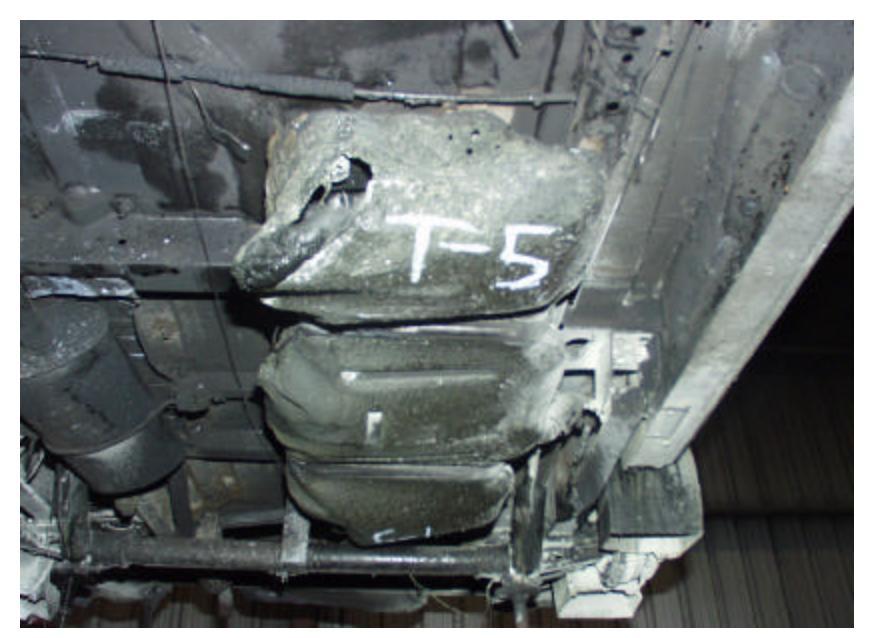
Figure A-138. Test No. 5, Conditioned 1998 Plymouth Grand Voyager Fuel Tank Immediately After Fire Exposure with Leak at Front Right Bottom Corner of Fuel Tank.

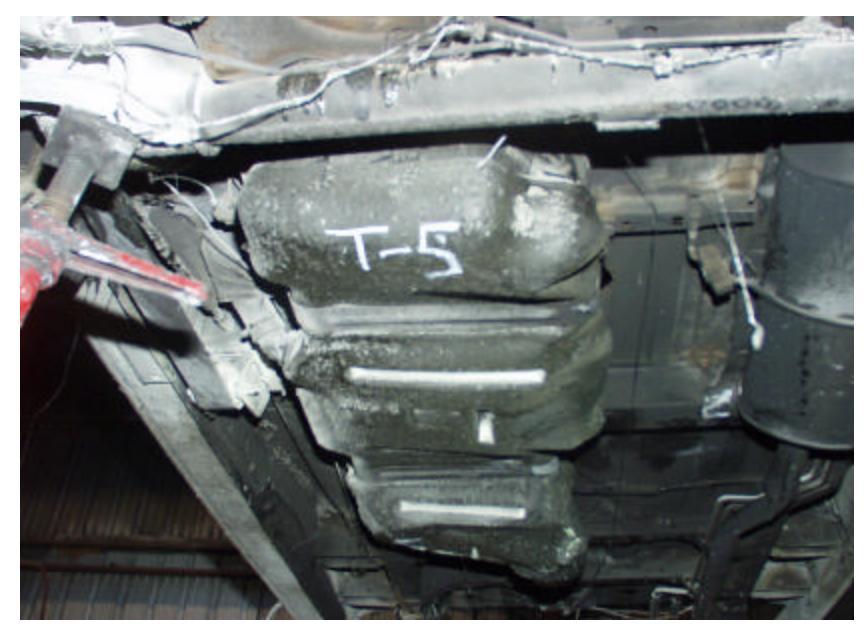
Figure A-139. Test No. 5 Conditioned 1998 Plymouth Grand Voyager Fuel Tank Immediately After Fire Exposure with Leak at Front Right Bottom Corner of Fuel Tank.

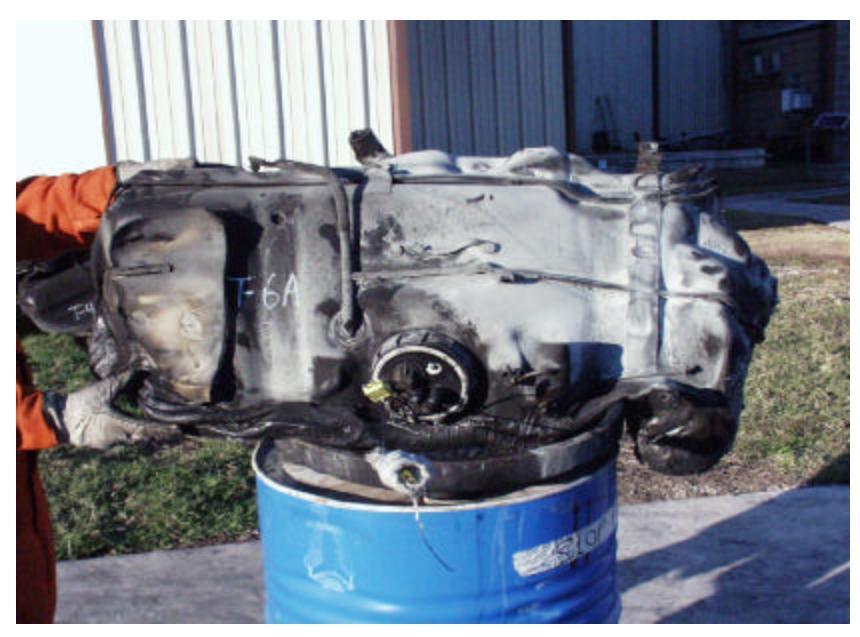
Figure A-149. Test No. 6A, Top View of New 1998 Plymouth Grand Voyager Fuel Tank After Fire Exposure.

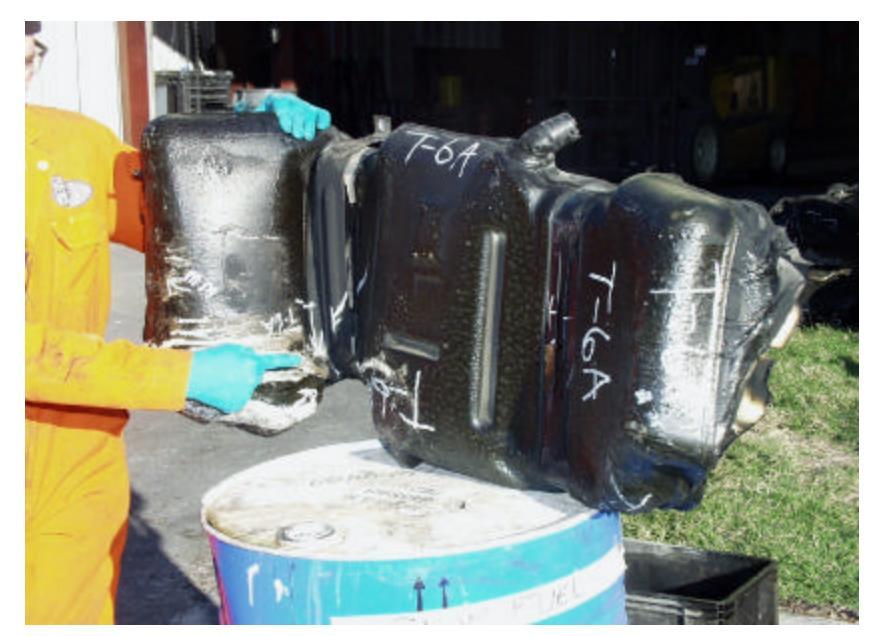
Figure A-151. Test No. 6A, Bottom View of New 1998 Plymouth Grand Voyager Fuel Tank After Fire Exposure at Front Strap Leak Location.

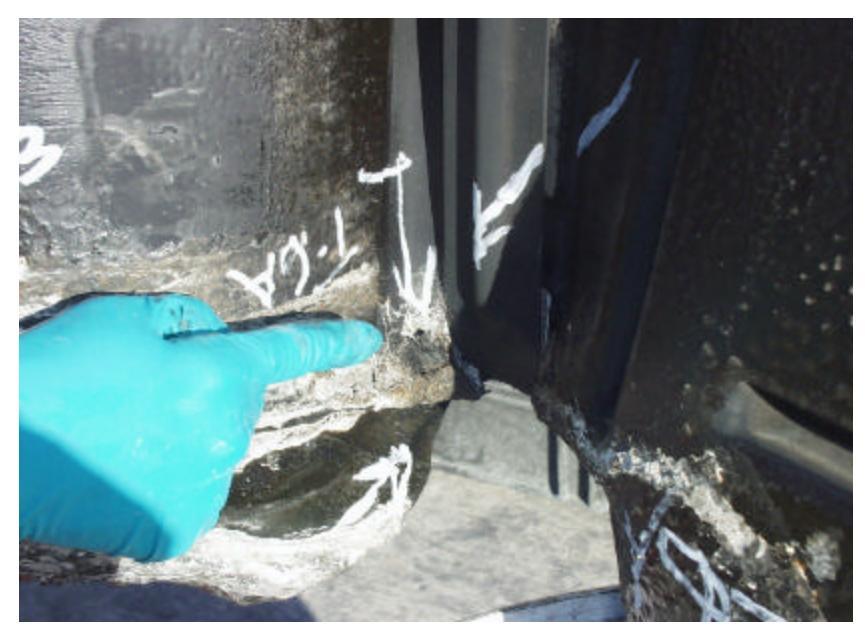
Figure A-152. Test No. 6A, Bottom View of New 1998 Plymouth Grand Voyager Fuel Tank After Fire Exposure at Front Strap Leak Location.

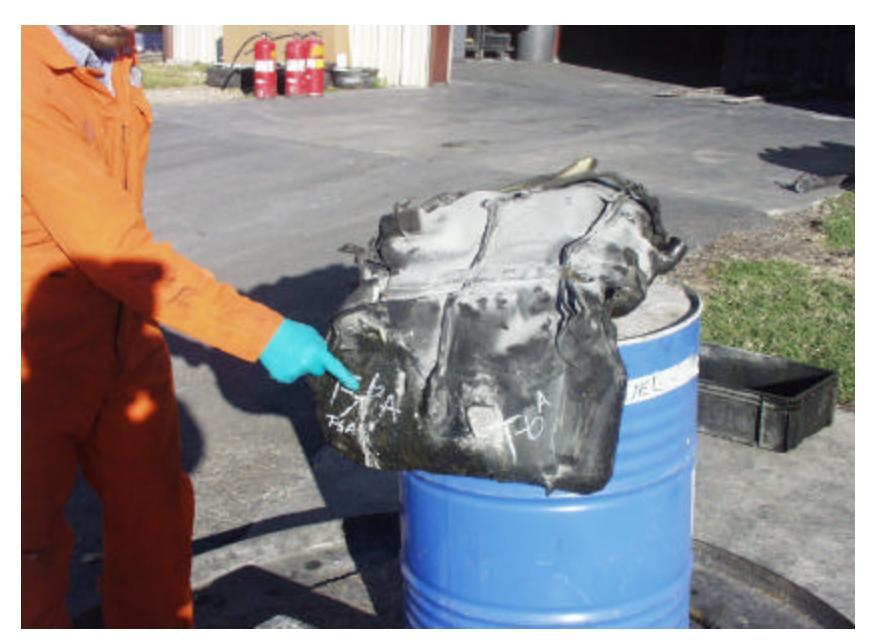
Figure A-153. Test No. 6A, Front Top View of New 1998 Plymouth Grand Voyager Fuel Tank After Fire Exposure at Leak Location.

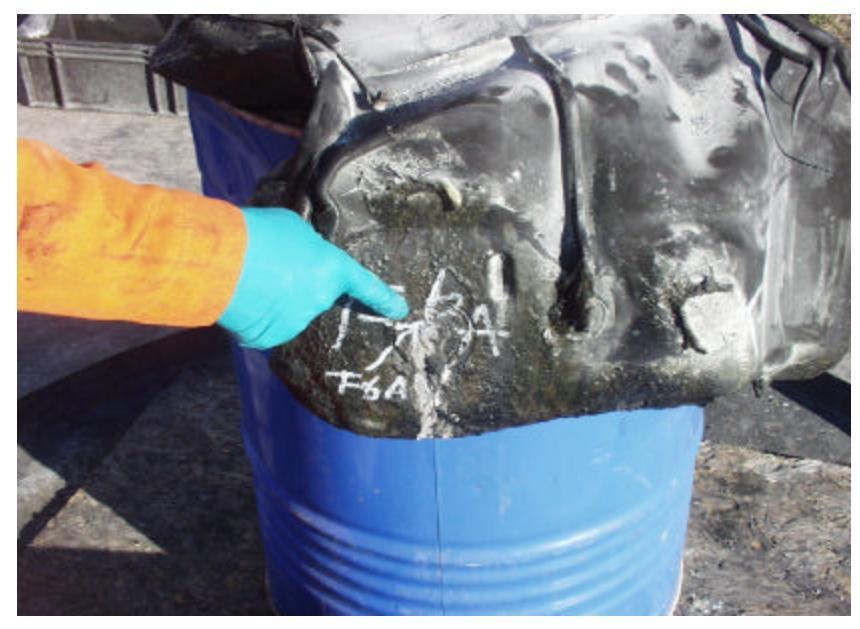
Figure A-154. Test No. 6A, Top Front View of New 1998 Plymouth Grand Voyager Fuel Tank After Fire Exposure at Leak Location.

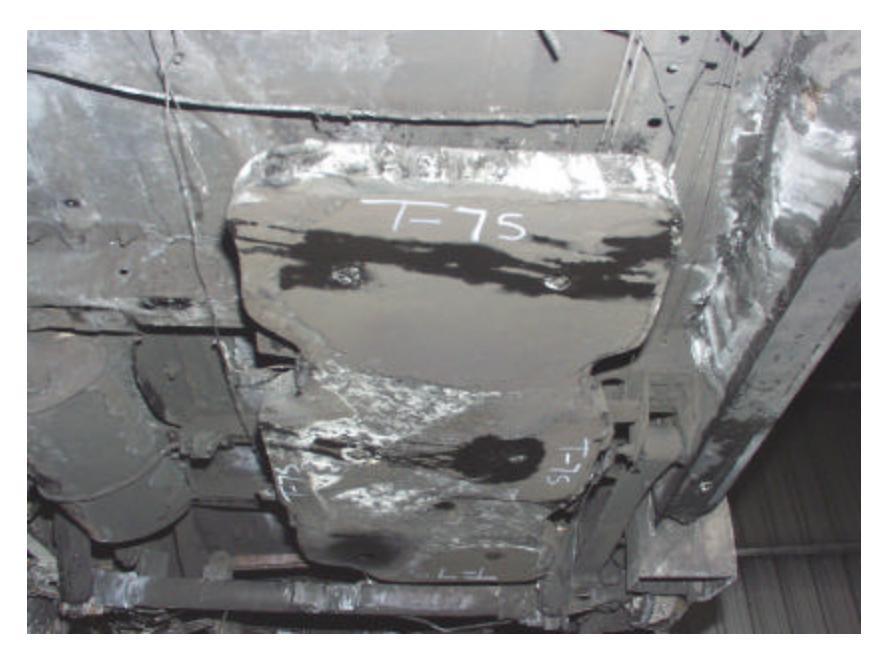
Figure A-164. Test No. 7S, Bottom View of New 1998 Plymouth Grand Voyager Fuel Tank With Heat Shield After Fire Exposure With Leak Location at Front Side and Middle Drain Holes.

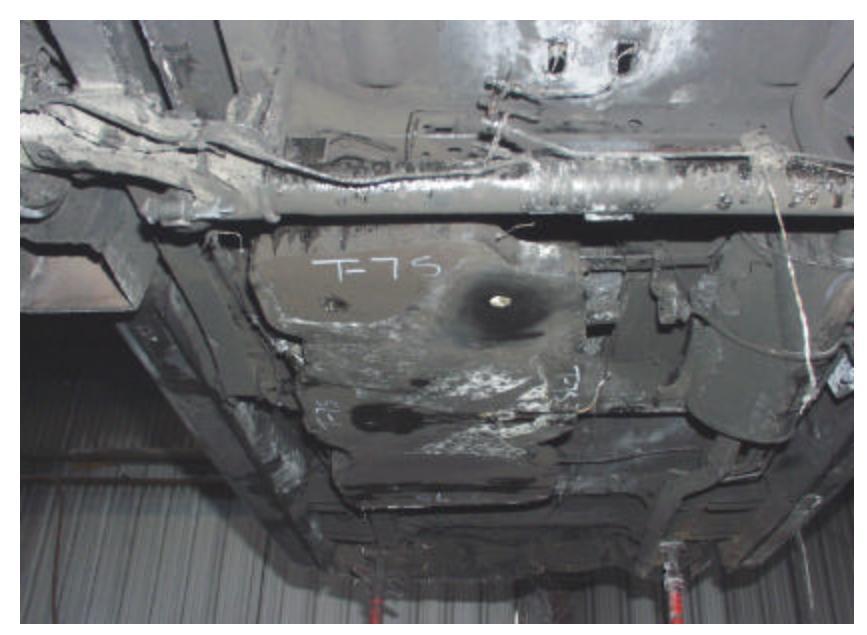
Figure A-165. Test No. 7S, Bottom View of New 1998 Plymouth Grand Voyager Fuel Tank With Heat Shield After Fire Exposure With Leak Location at Front Side and Middle Drain Holes.

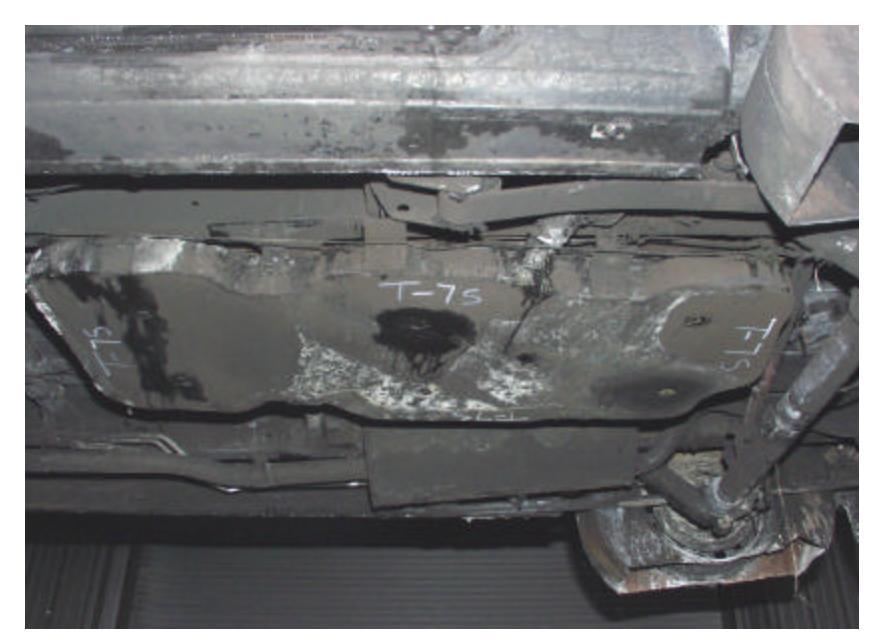
Figure A-166. Test No. 7S, Bottom View of New 1998 Plymouth Grand Voyager Fuel Tank With Heat Shield After Fire Exposure With Leak Location at Front Side and Middle Drain Holes.

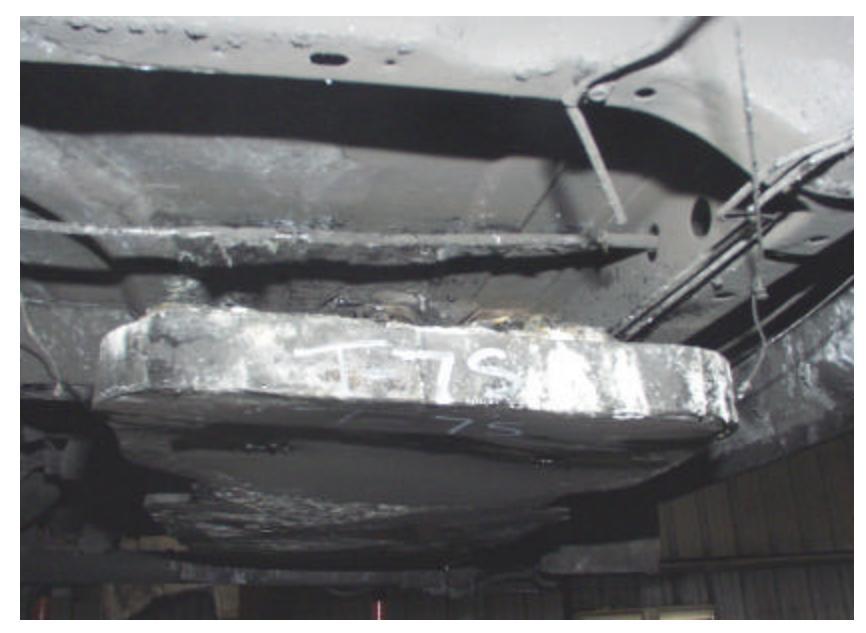
Figure A-168. Test No. 7S, Bottom View Indicating How New 1998 Plymouth Grand Voyager Plastic Fuel Tank Melted Down Into the Heat Shield After Fire Exposure.

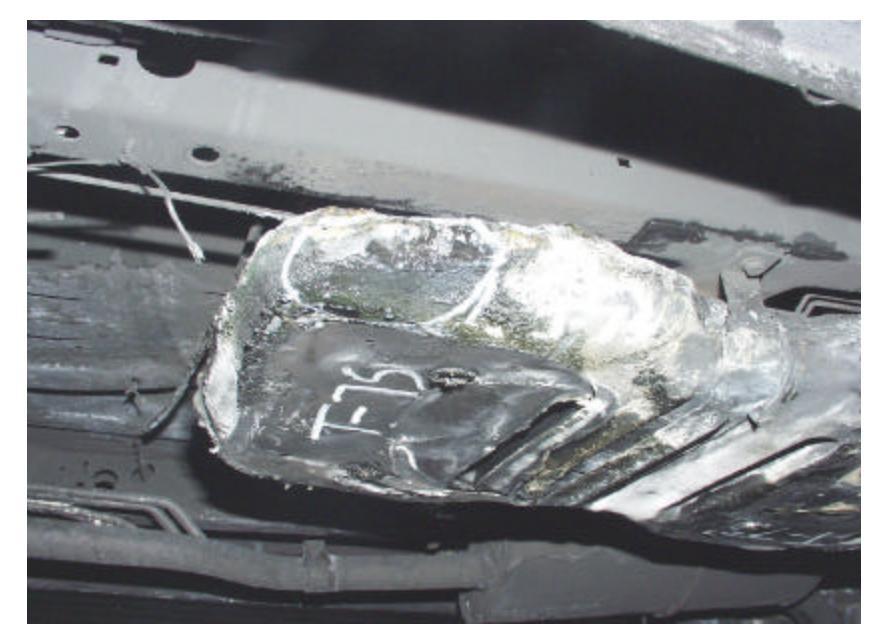
Figure A-172. Test No. 7S, Bottom View of New 1998 Plymouth Grand Voyager Fuel Tank With Heat Shield Removed After Fire Exposure With Leak Location at Front Driver Side Corner of Fuel Tank.

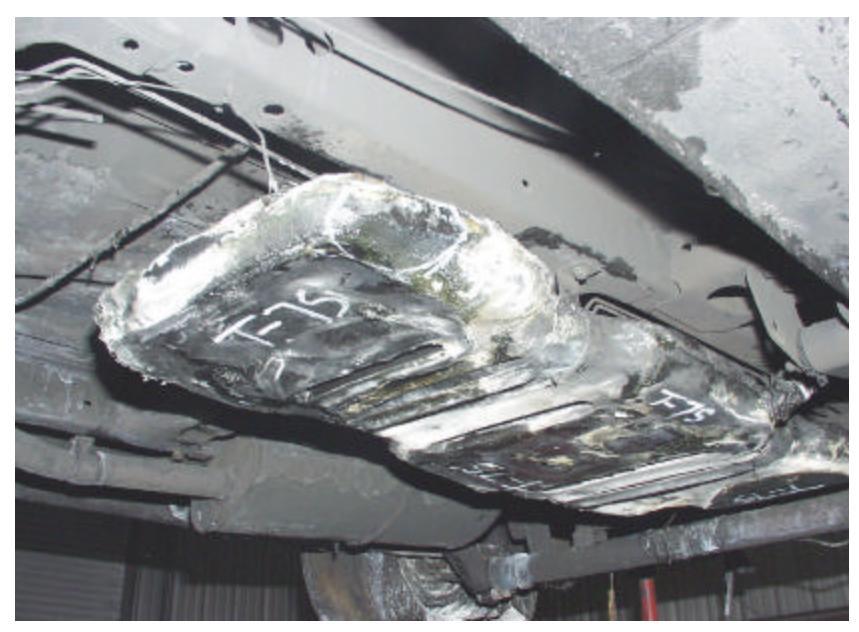
Figure A-173. Test No. 7S, Bottom View of New 1998 Plymouth Grand Voyager Fuel Tank With Heat Shield Removed After Fire Exposure With Leak Location at Front Driver Side Corner of Fuel Tank.

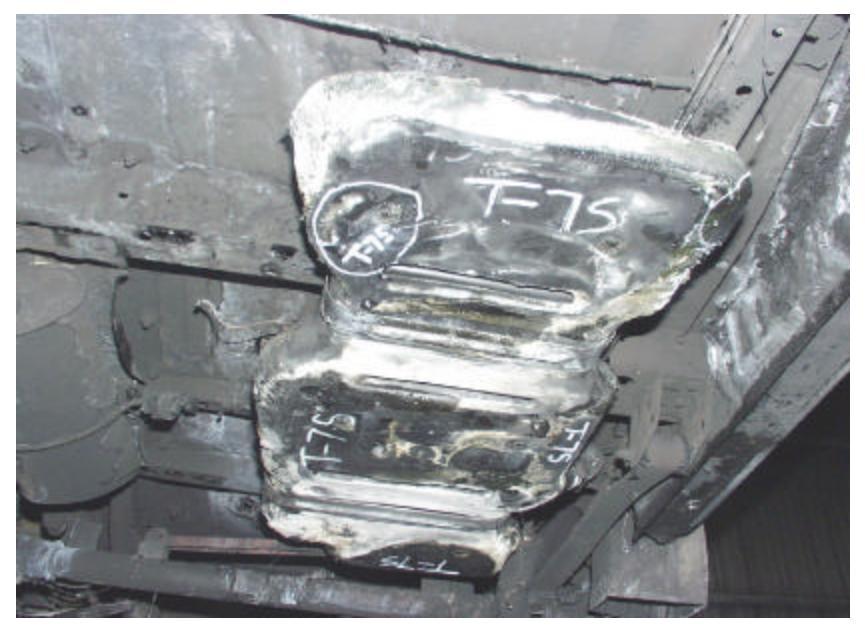
Figure A-174. Test No. 7S, Bottom View of New 1998 Plymouth Grand Voyager Fuel Tank With Heat Shield Removed After Fire Exposure With Leak Location at Front Bottom Passenger Side of Fuel Tank.

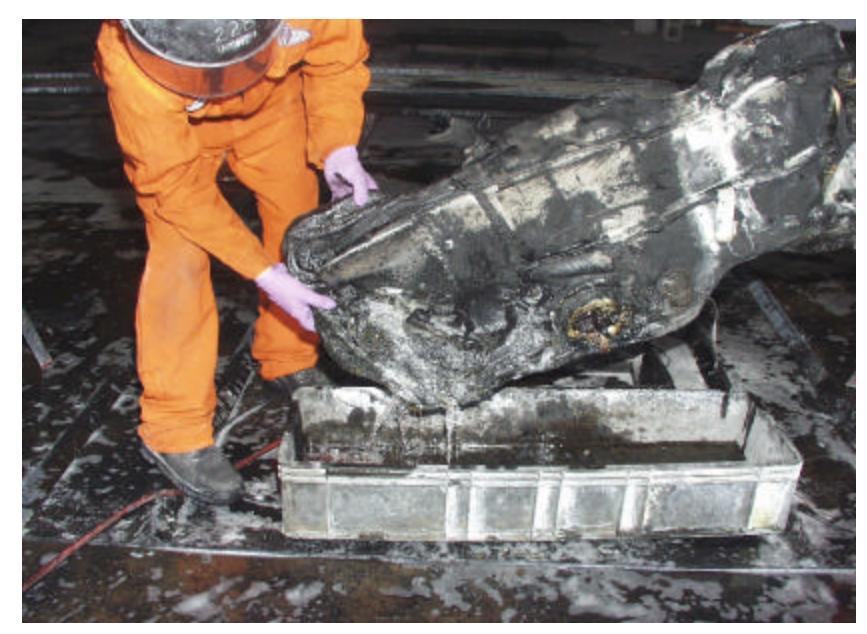
Figure A-175. Test No. 7S, Top View of New 1998 Plymouth Grand Voyager Fuel Tank After Fire Exposure With Leak Location at Rear Corner and Rear Top Driver Side of Fuel Tank.

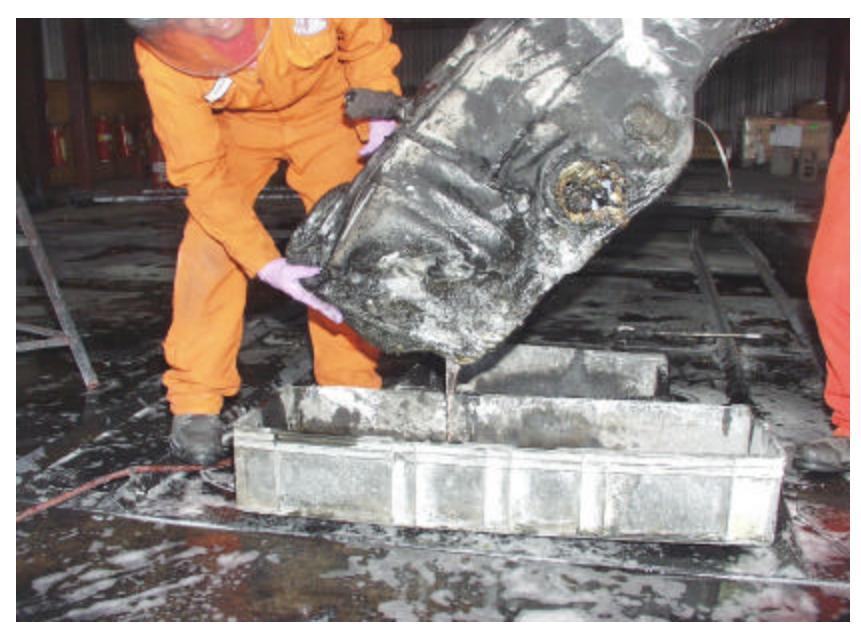
Figure A-176. Test No. 7S, Top View of New 1998 Plymouth Grand Voyager Fuel Tank After Fire Exposure With Leak Location at Rear Corner Driver Side of Fuel Tank.

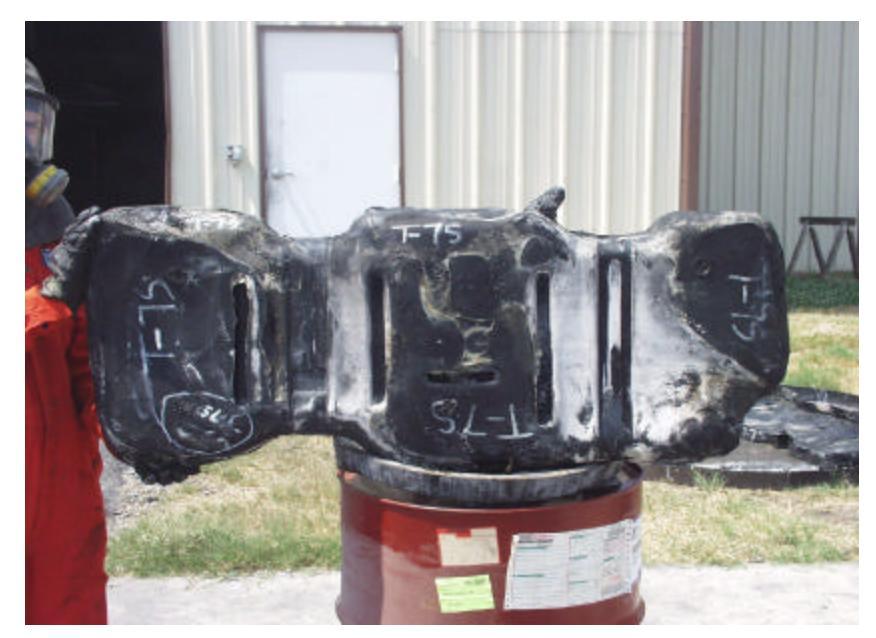
Figure A-178. Test No. 7S, Bottom View of New 1998 Plymouth Grand Voyager Fuel Tank After Fire Exposure With Leak Location at Front Bottom Passenger Side of Fuel Tank.

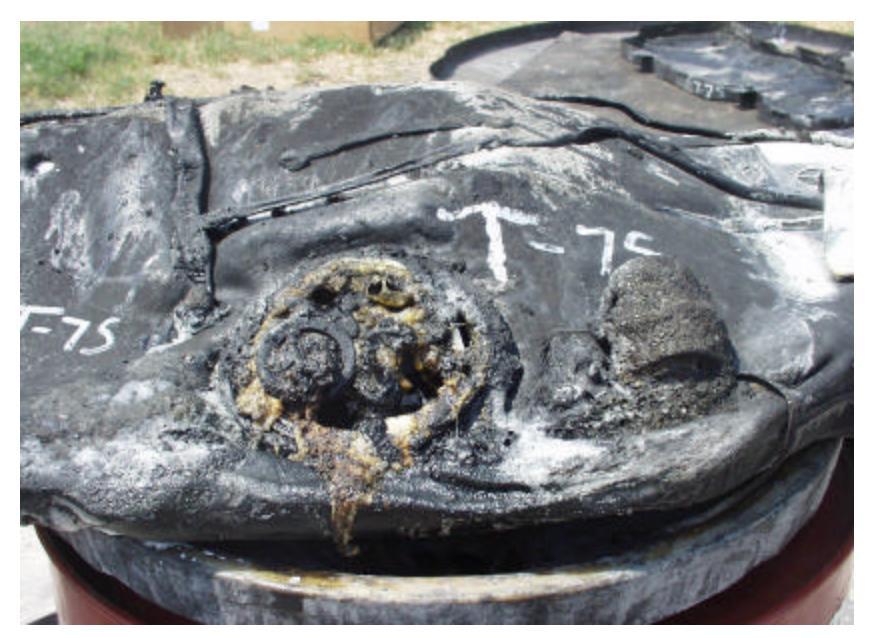
Figure A-180. Test No. 7S, Top View of New 1998 Plymouth Grand Voyager Fuel Tank After Fire Exposure With Leak Location at Sending Unit of Fuel Tank.

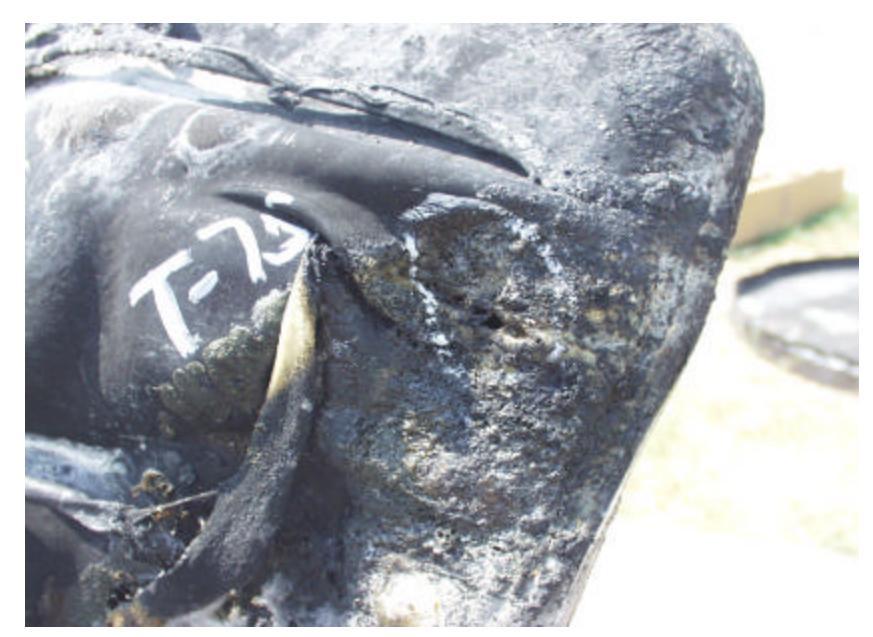
Figure A-181. Test No. 7S, Top View of New 1998 Plymouth Grand Voyager Fuel Tank After Fire Exposure With Leak Location at Top Driver Side of Fuel Tank.

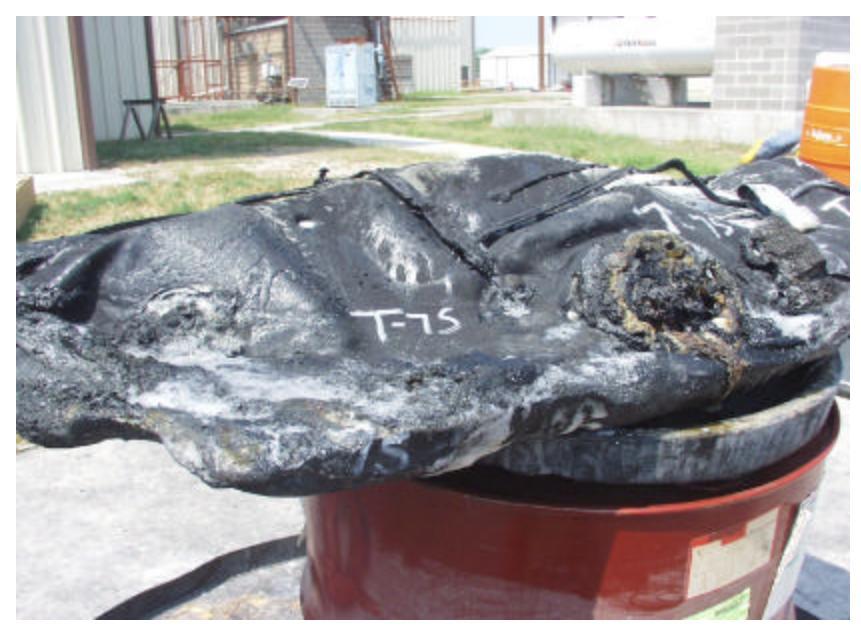
Figure A-182. Test No. 7S, Top View of New 1998 Plymouth Grand Voyager Fuel Tank After Fire Exposure With Leak Location at Rear Corner Passenger Side of Fuel Tank.

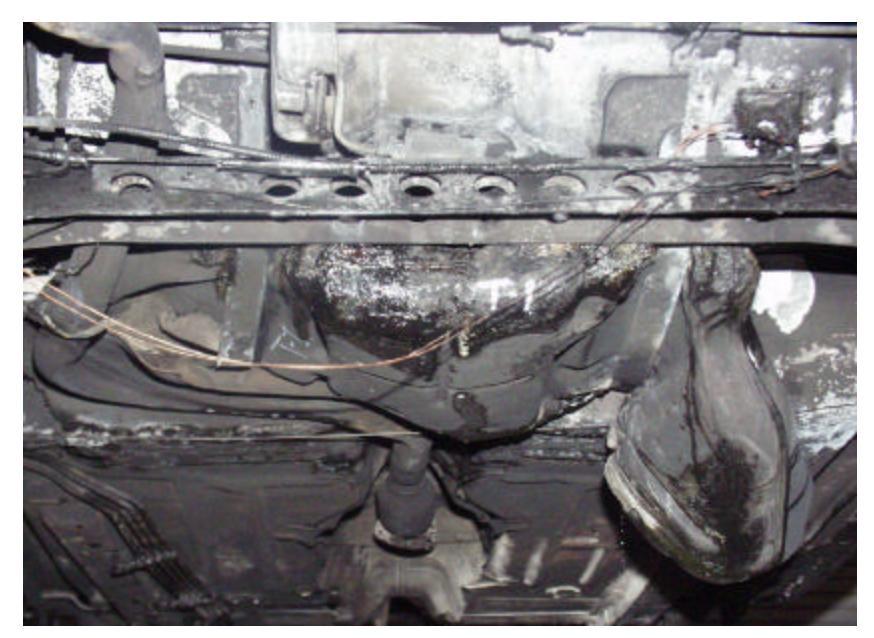
Figure A-188. Test No. 1 (January 21, 2003), New 2000 Chevrolet Cavalier Plastic Fuel Tank Immediately After Fire Exposure with Passenger Side of Fuel Tank Sagging.
