AUTOMOTIVE FUEL TANK EVALUATION

COMPARATIVE EVALUATION OF AUTOMOTIVE FUEL TANKS IN GENERAL ACCORDANCE WITH THE ECE R34.01, ANNEX 5 SECTION 5.0 "RESISTANCE TO FIRE;" AND SECTION 1.0 "IMPACT RESISTANCE;" THE US DEPARTMENT OF TRANSPORTATION 49 CFR 393.67, SECTION E "DROP TEST;" AND ASTM D 638-00, "STANDARD TEST METHOD FOR TENSILE PROPERTIES OF PLASTICS"

FINAL REPORT Consisting of 228 Pages SwRI® Project No. 01.06081.01.001 August 2003

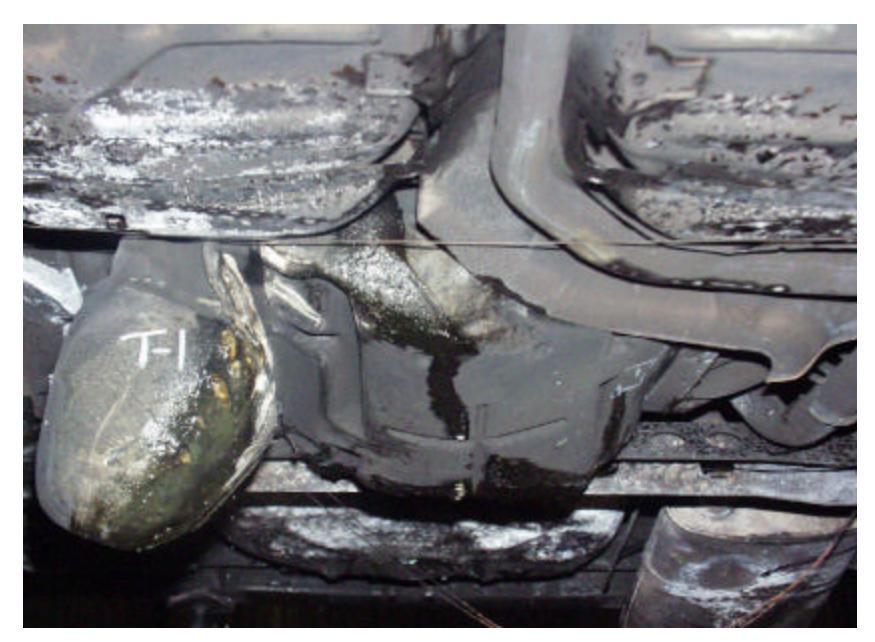
Figure A-189. Test No. 1 (January 21, 2003), New 2000 Chevrolet Cavalier Plastic Fuel Tank Immediately After Fire Exposure with Passenger Side Fuel Tank Sagging.

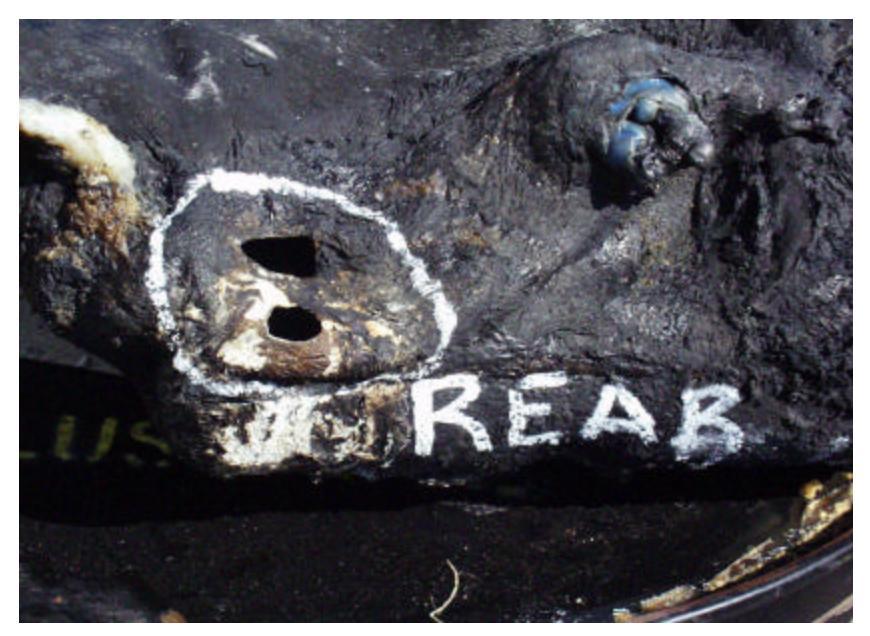
Figure A-193. Test No. 1 (January 21, 2003), Driver Side Fire Exposure Hole, Rear Topside of New 2000 Chevrolet Cavalier Plastic Fuel Tank.

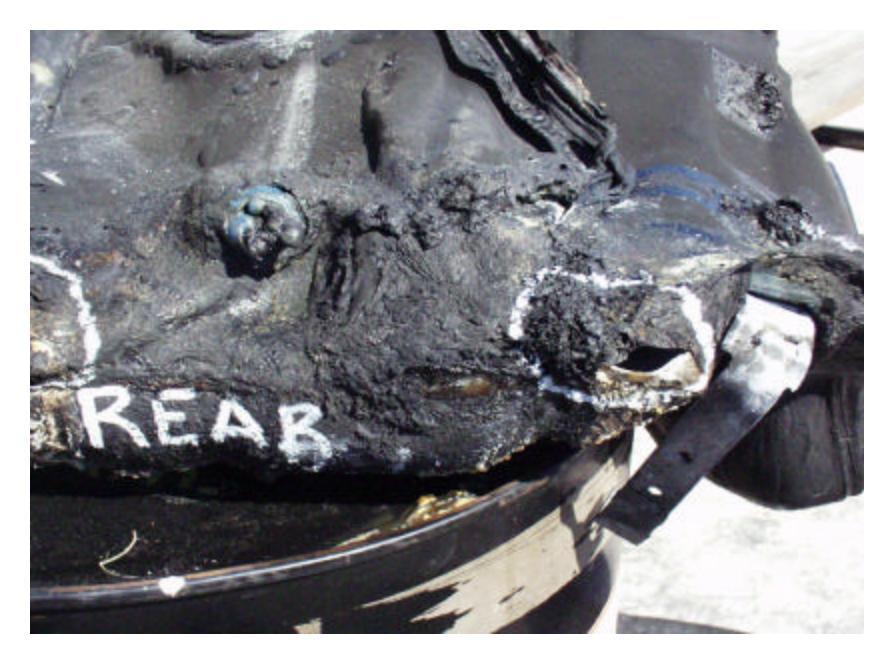
Figure A-194. Test No. 1 (January 21, 2003), Passenger Side Fire Exposure Hole, Rear Topside of New 2000 Chevrolet Cavalier Plastic Fuel Tank.

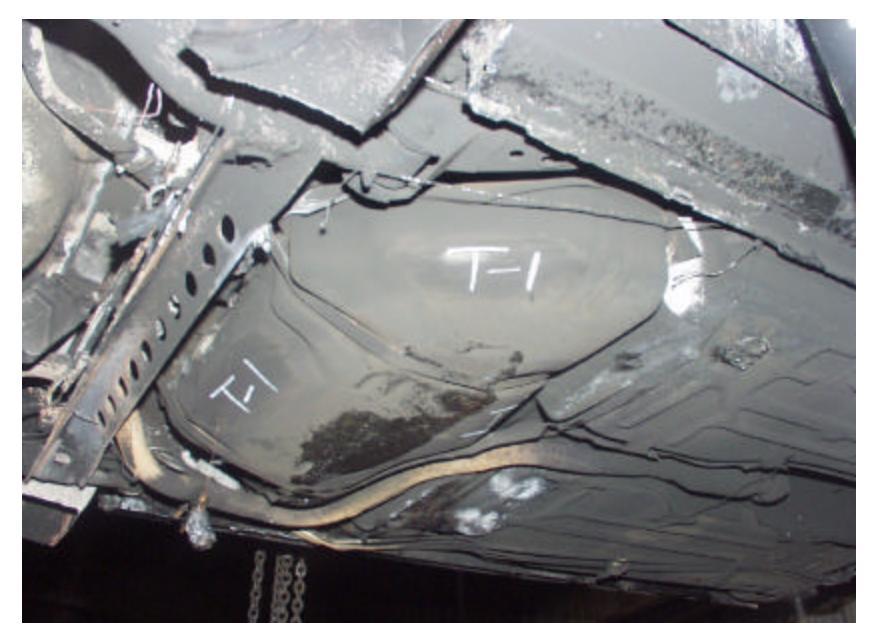
Figure A-199. Test No. 1 (February 18, 2003), Conditioned 1999 Chevrolet Cavalier Metal Fuel Tank Immediately After Fire Exposure.

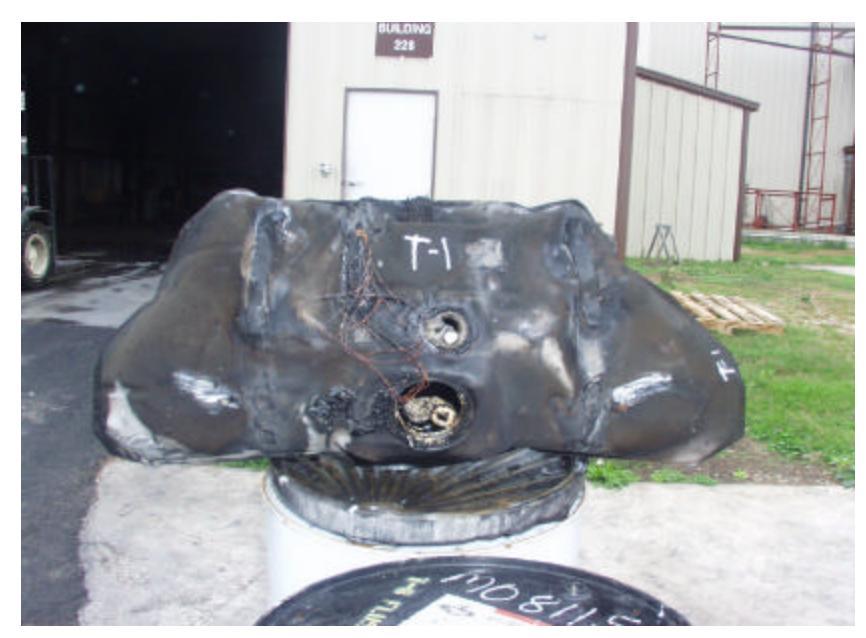
Figure A-200. Test No 1, (February 18, 2003), Top View of Conditioned 1999 Chevrolet Cavalier Metal Fuel Tank After Fire Exposure.

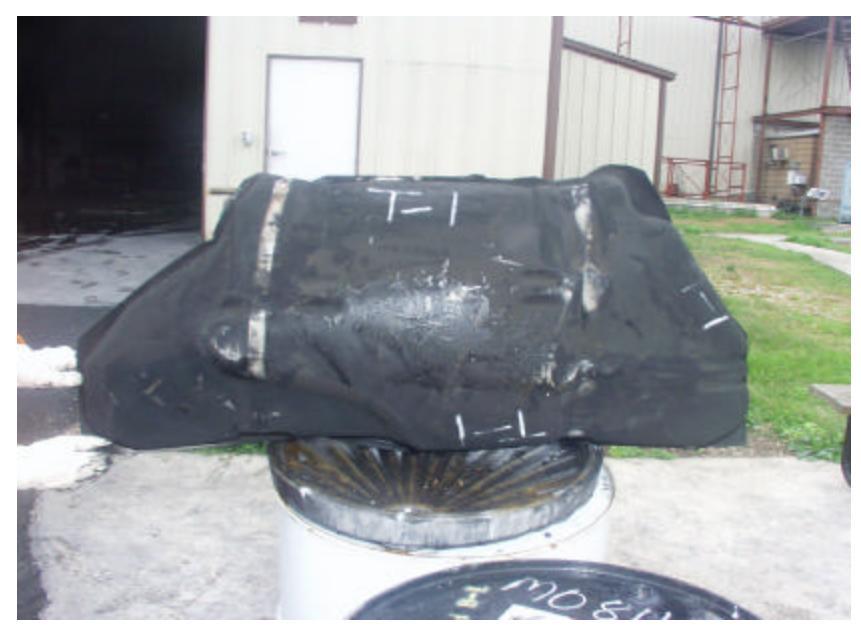
Figure A-201. Test No. 1 ((February 18, 2003), Bottom View of Conditioned 1999 Chevrolet Cavalier Metal Fuel Tank After Fire Exposure.

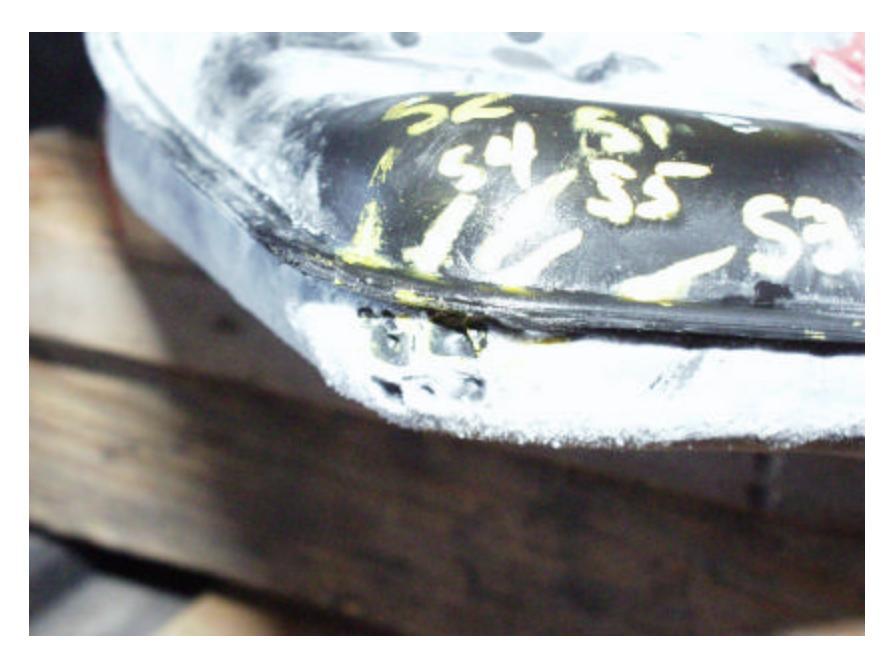
Figure A-205. No Leaks to the Front Passenger Side of the Conditioned 1999 Saturn Twin Cam 4-Door Fuel Tank After Five Impacts Ranging Between 30.1 Nm to 43.6 Nm.

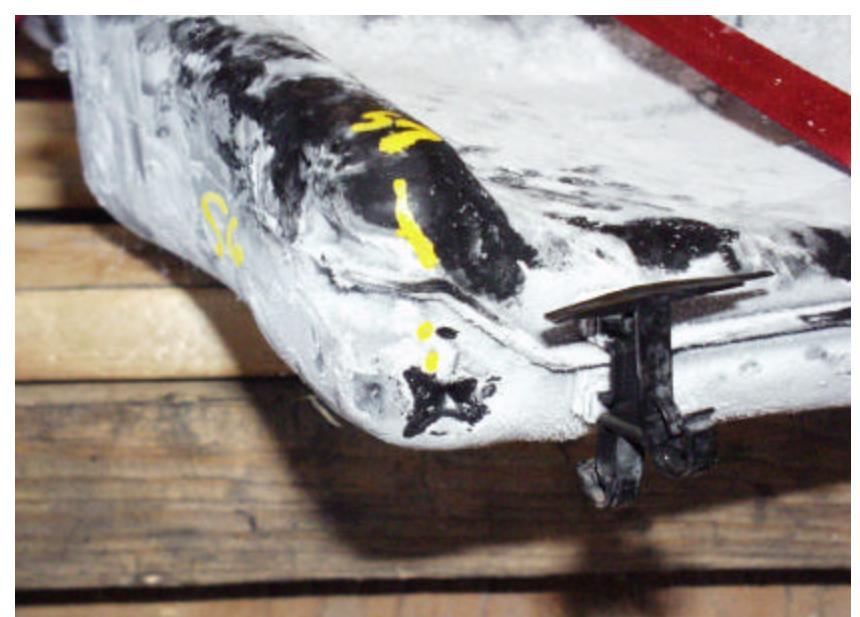
Figure A-206. No Leaks to the Front Driver Side of the Conditioned 1999 Saturn Twin Cam 4-Door Fuel Tank After Two Impacts Ranging Between 43.6 Nm and 147.2 Nm.

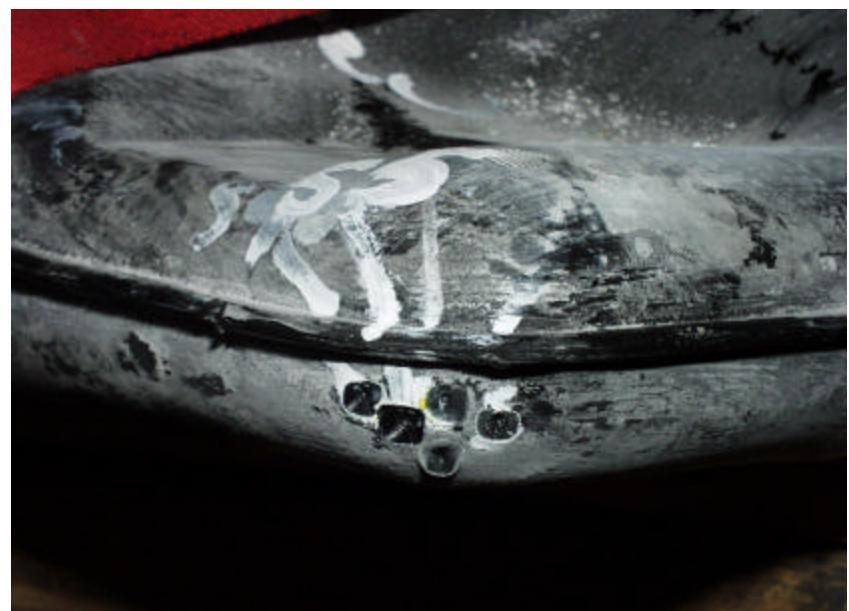
Figure A-208. No Leaks to the Front Passenger Side of the New 1998 Saturn Twin Cam 4-Door Fuel Tank After Five Impacts Ranging Between 30.1 Nm to 43.6 Nm.

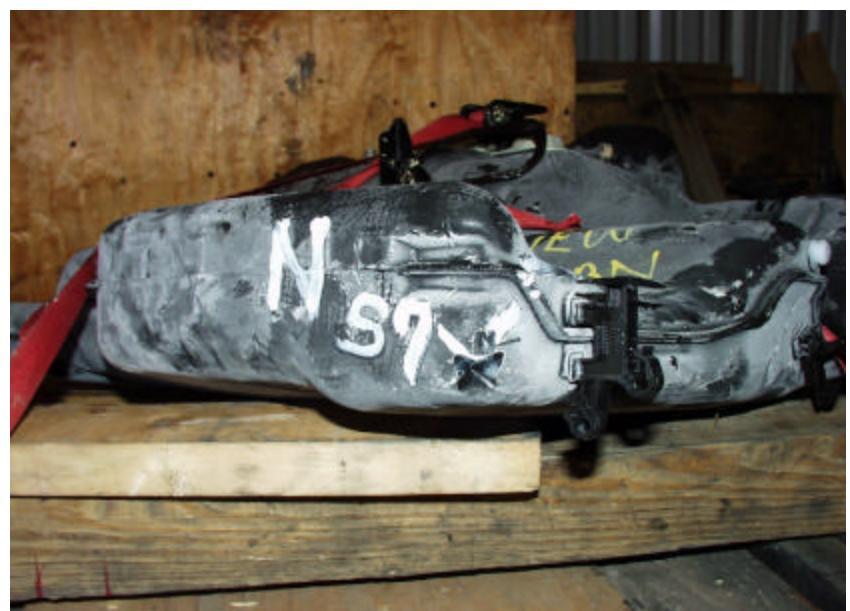
Figure A-210. No Leaks to the Front Driver Side of the New 1998 Saturn Twin Cam 4-Door Fuel Tank After Two Impacts Ranging Between 43.6 Nm and 147.2 Nm.

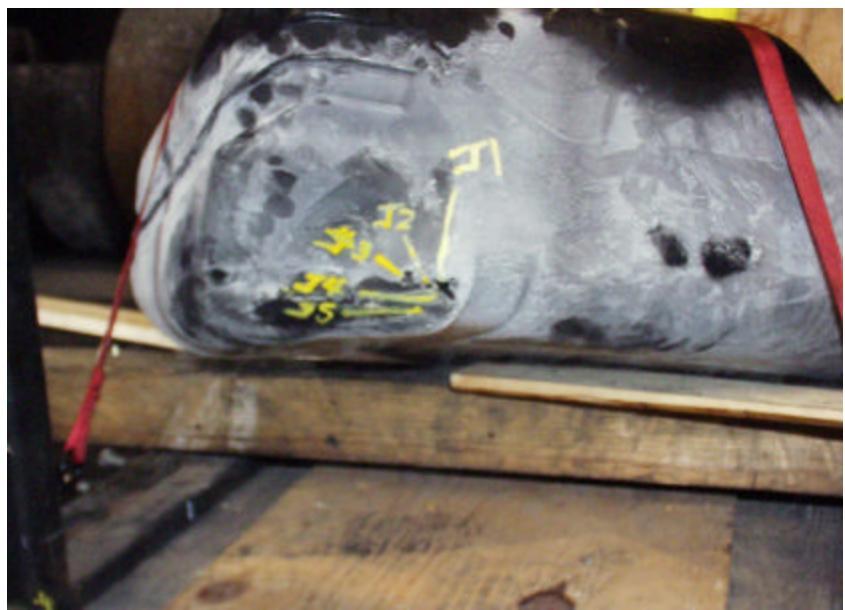
Figure A-212. No Leaks to the Front Passenger Side of the Conditioned 1998 Jeep Grand Cherokee Fuel Tank After Five Impacts Ranging Between 30.1 Nm to 43.6 Nm.

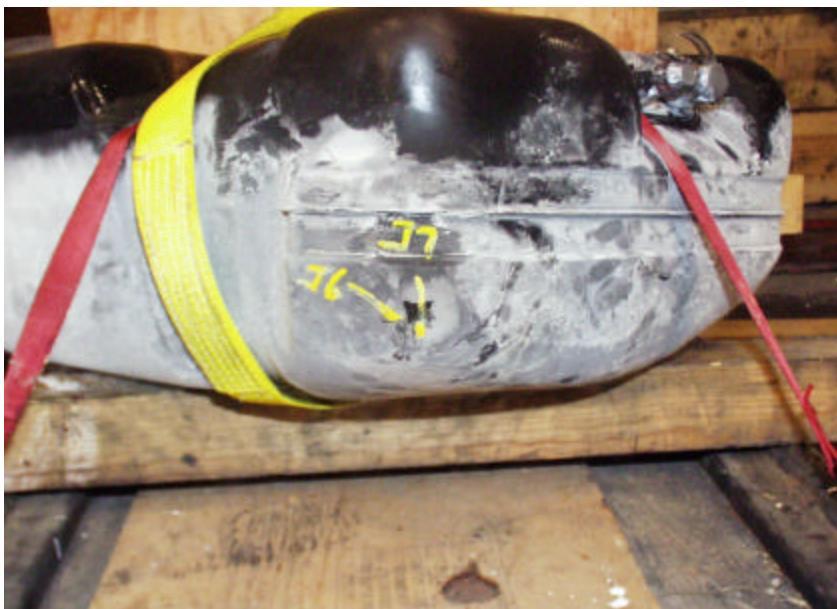
Figure A-214. No Leaks to the Front Driver Side of the Conditioned 1998 Jeep Grand Cherokee Fuel Tank After Two Impacts Ranging Between 43.6 Nm and 147.2 Nm.

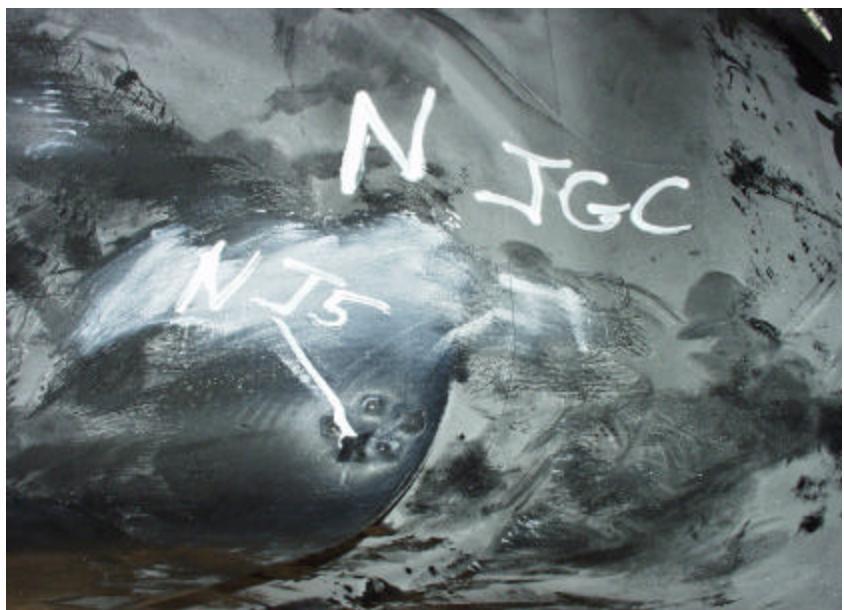
Figure A-216. No Leaks to the Front Passenger Side of the New 1998 Jeep Grand Cherokee Fuel Tank After Five Impacts Ranging Between 30.1 Nm to 43.6 Nm.

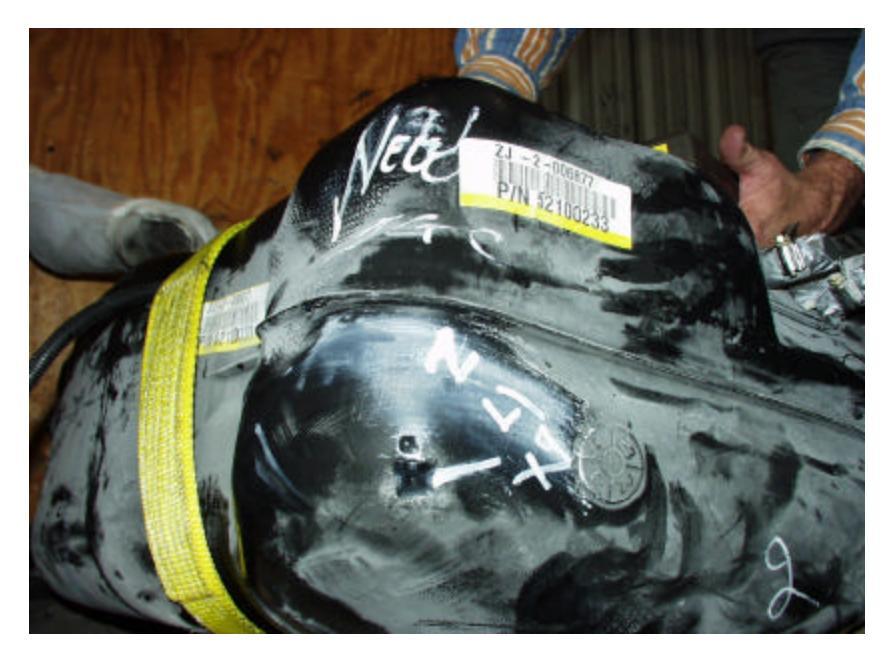
Figure A-217. No Leaks to the Front Driver Side of the New 1998 Jeep Grand Cherokee Fuel Tank After Two Impacts Ranging Between 43.6 Nm and 147.2 Nm.

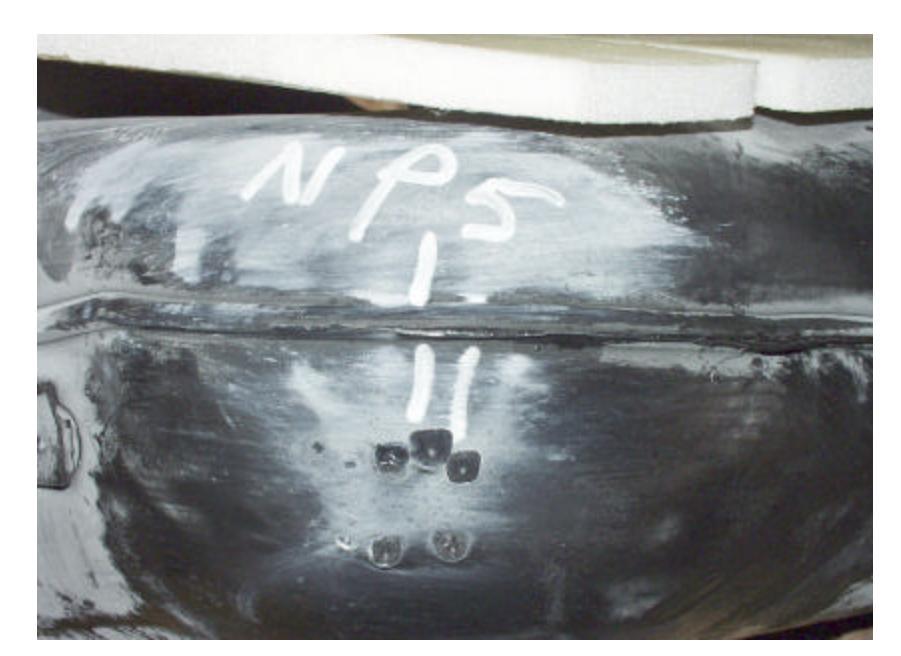
Figure A-219. No Leaks to the Front Passenger Side of the New 1998 Plymouth Grand Voyager Fuel Tank After Five Impacts Ranging Between 30.1 Nm to 43.6 Nm.

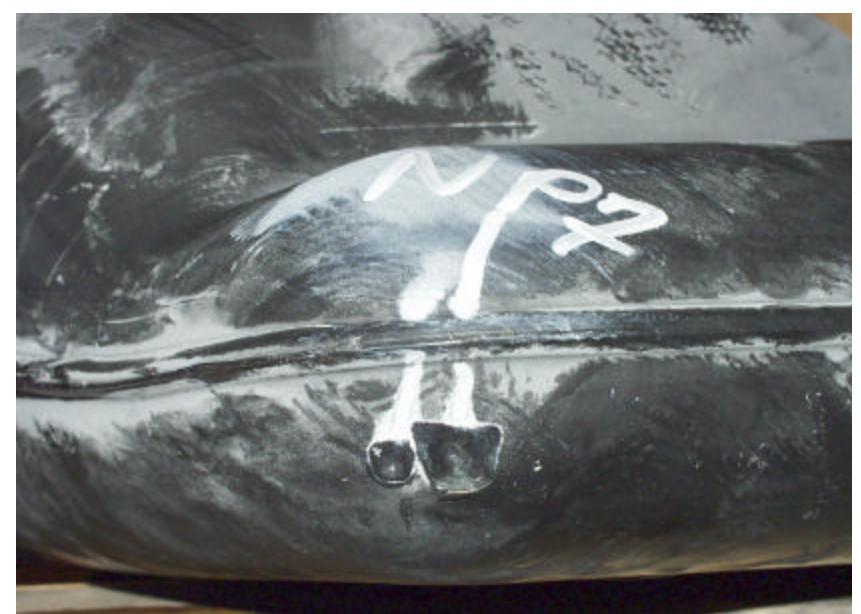
Figure A-220. No Leaks to the Front Driver Side of the New 1998 Plymouth Grand Voyager Fuel Tank After Two Impacts Ranging Between 43.6 Nm and 147.2 Nm.

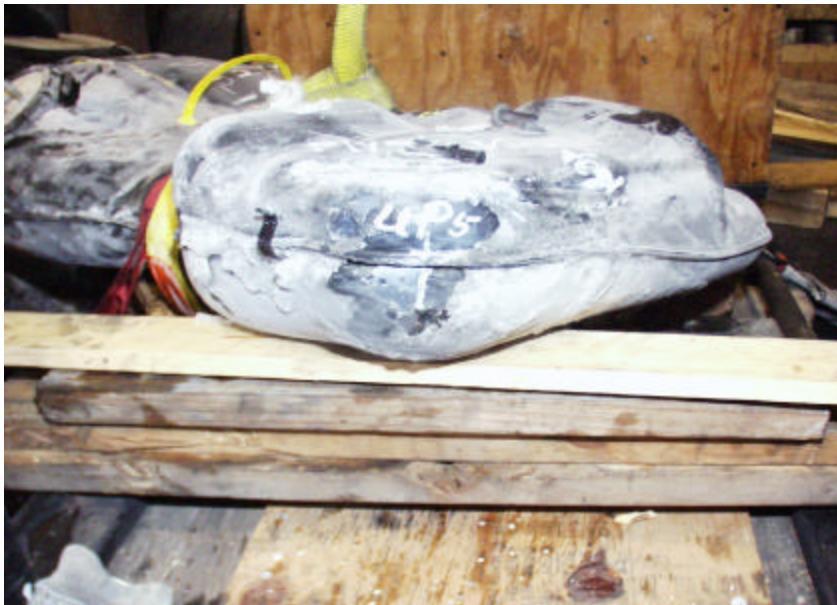
Figure A-222. No Leaks to the Front Passenger Side of the Conditioned 1998 Plymouth Grand Voyager Fuel Tank After Five Impacts Ranging Between 30.1 Nm to 43.6 Nm.

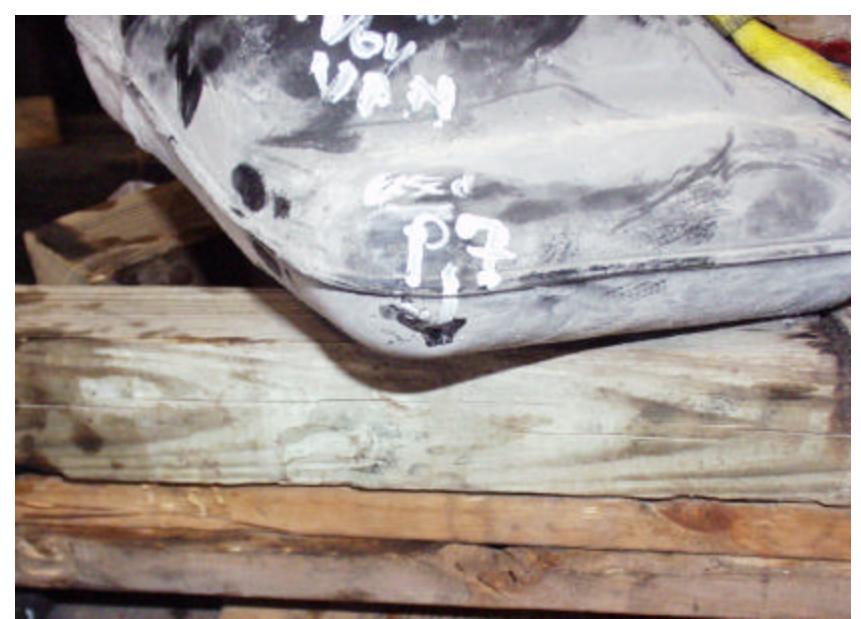
Figure A-224. No Leaks to the Front Driver Side of the Conditioned 1998 Plymouth Grand Voyager Fuel Tank After Two Impacts Ranging Between 43.6 Nm and 147.2 Nm.

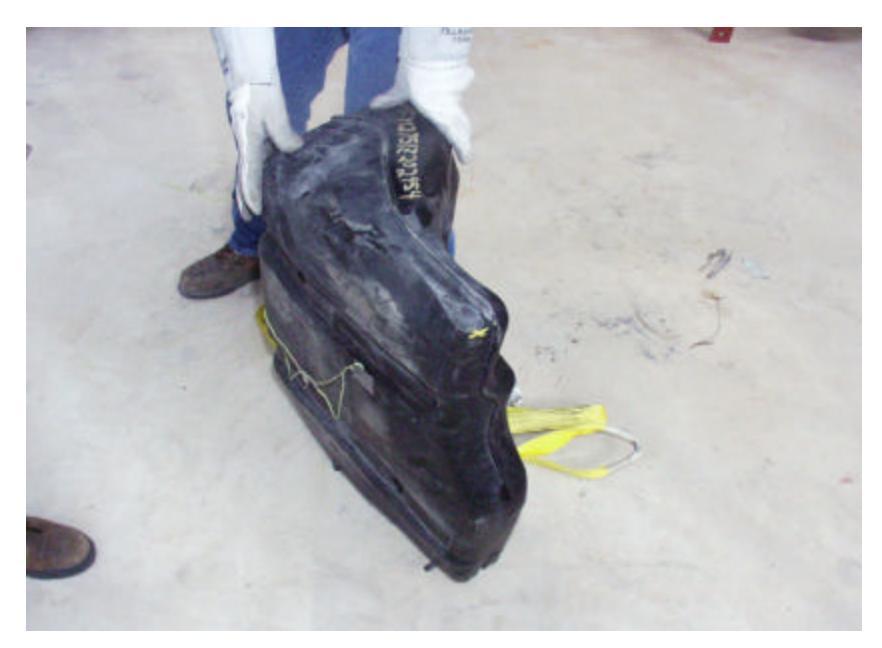
Figure A-227. No Leaks on the Front Passenger Side of the Conditioned 2001 Saturn Fuel Tank After the 30-ft Drop Test.

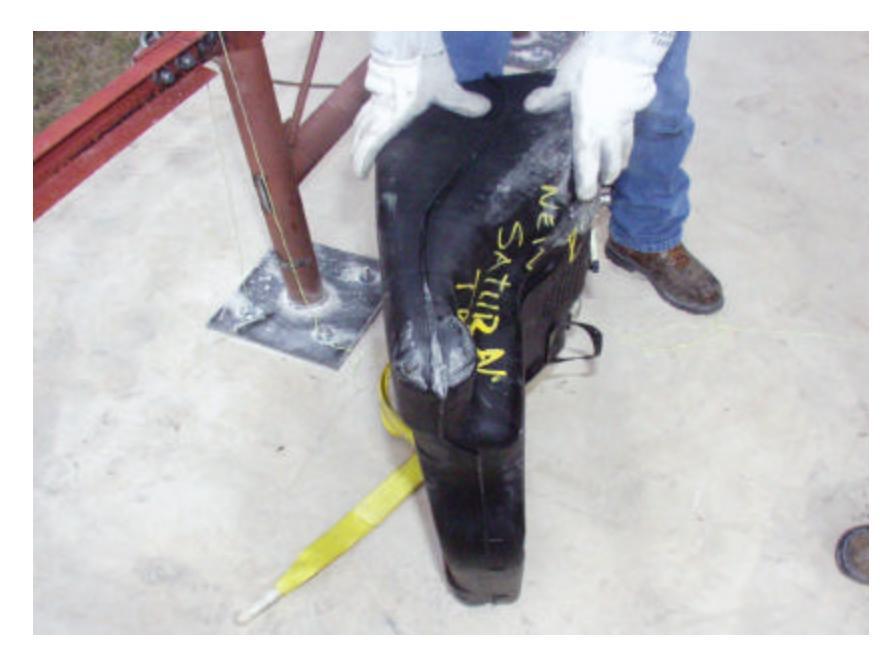
Figure A-230. No Leaks on the Front Passenger Side Corner of the New 1998 Saturn Fuel Tank After the 30-ft Drop Test.

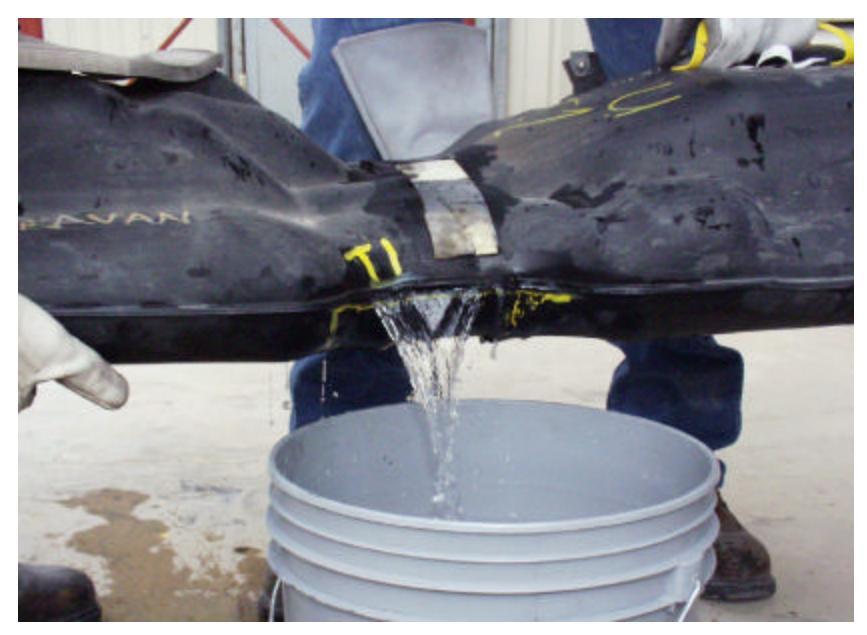
Figure A-233. Leak Rate of 149.98 oz/min of Ethylene -Glycol Water Mixture Due to Pinch-Off Separation at Front Strap Location of the 2000 Plymouth Grand Voyager Fuel Tank After the 30-ft Drop Test.

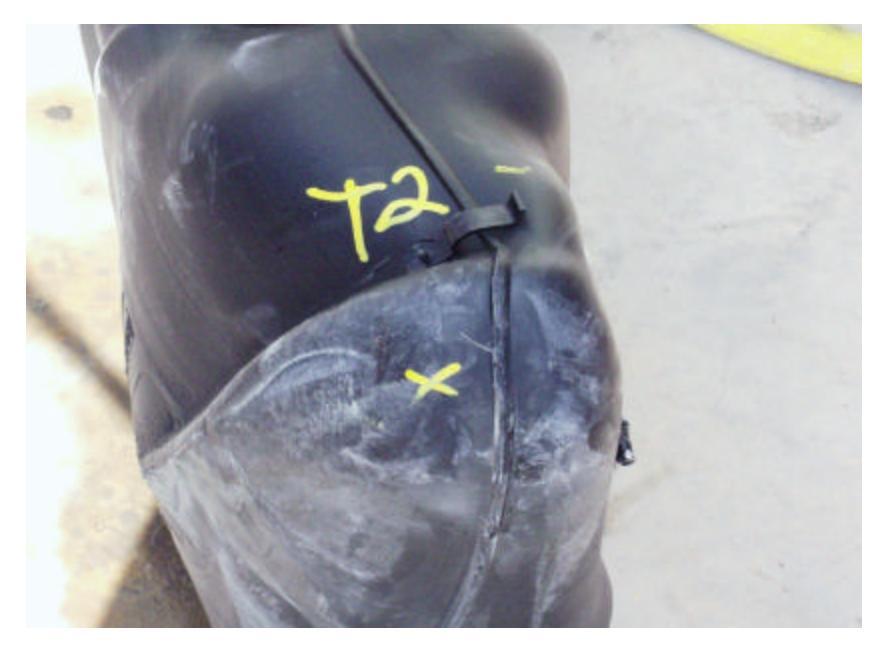
Figure A-236. No Leaks on Front Passenger Side Corner of the New 1998 Plymouth Grand Voyager Fuel Tank After the 30-ft Drop Test.

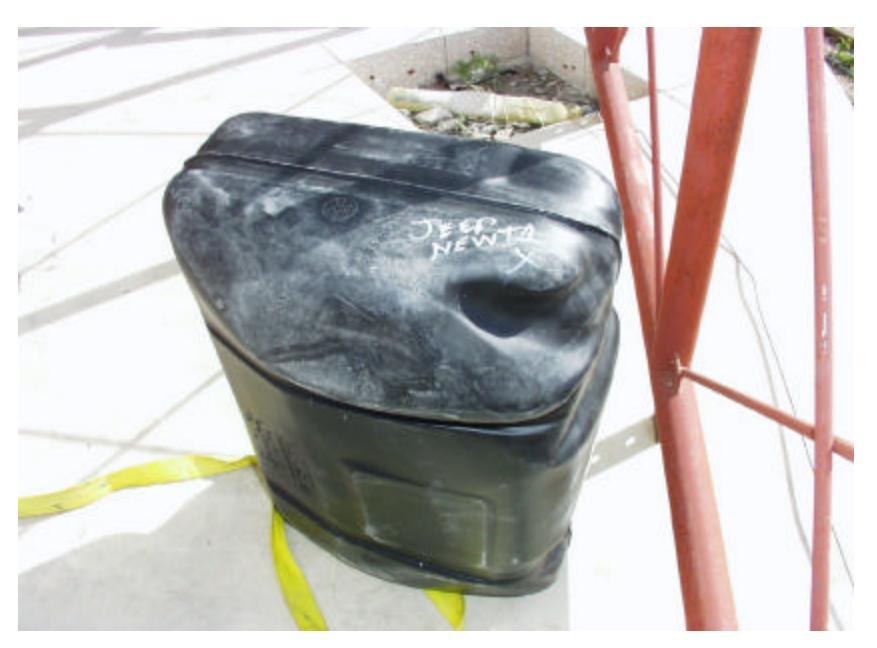
Figure A-239. No Leaks on Front Passenger Side Corner of the New 1998 Jeep Grand Cherokee Fuel Tank After the 30-ft Drop Test.

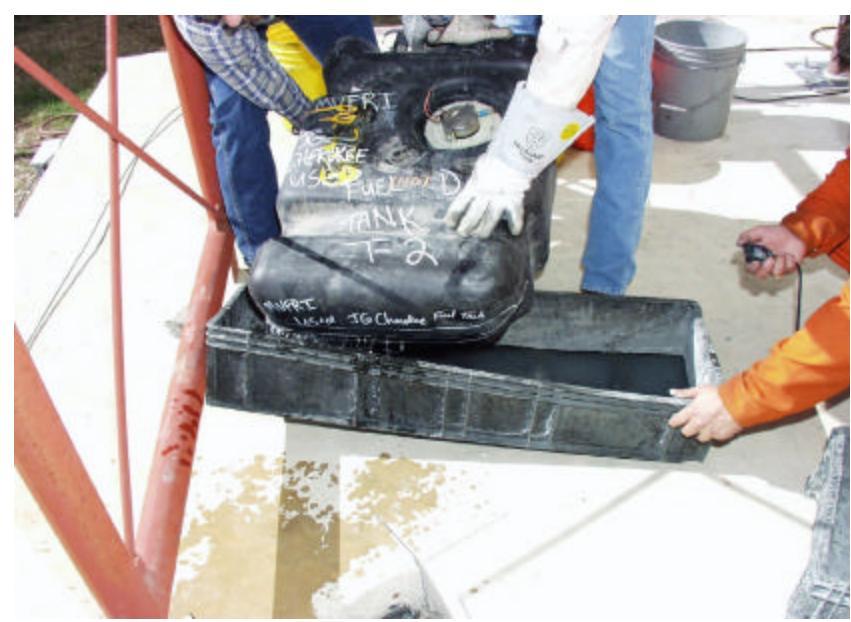
Figure A-243. Leak Rate of 899.49 oz/min of Ethylene-Glycol Water Mixture Due to Pinch-Off Separation at the Front of the Conditioned 1998 Jeep Grand Cherokee Fuel Tank After the 30-ft Drop Test.
