NISTIR 6316

Burning Behavior of Selected Automotive Parts from a Sports Coupe

Thomas J. Ohlemiller
John R. Shields
Building and Fire Research Laboratory
Gaithersburg, MD 20899

Selected functional parts from a sports coupe were subjected to a gas flame ignition source and burned in a manner that allowed measurement of the resulting total heat release rate and heat fluxes to the surroundings. This is the second part of a study undertaken to: (1) assess possible means for determining the flammability characteristics of automotive components, (2) obtain data on the range of flammability behavior exhibited by such components and the physical processes underlying that behavior, and (3) obtain insights into the fire behavior seen in related full-scale vehicle fire tests. Most of the vehicle components examined in this study were mounted in isolation on a vehicle buck (a stripped, partial section of the original sports coupe). This led, in some cases, such as with a rear interior trim panel, to a strong influence of the vehicle structure on the behavior seen; it also led to other interactions such as the penetration of the windshield by a front fender fire. Other parts exhibited a wide

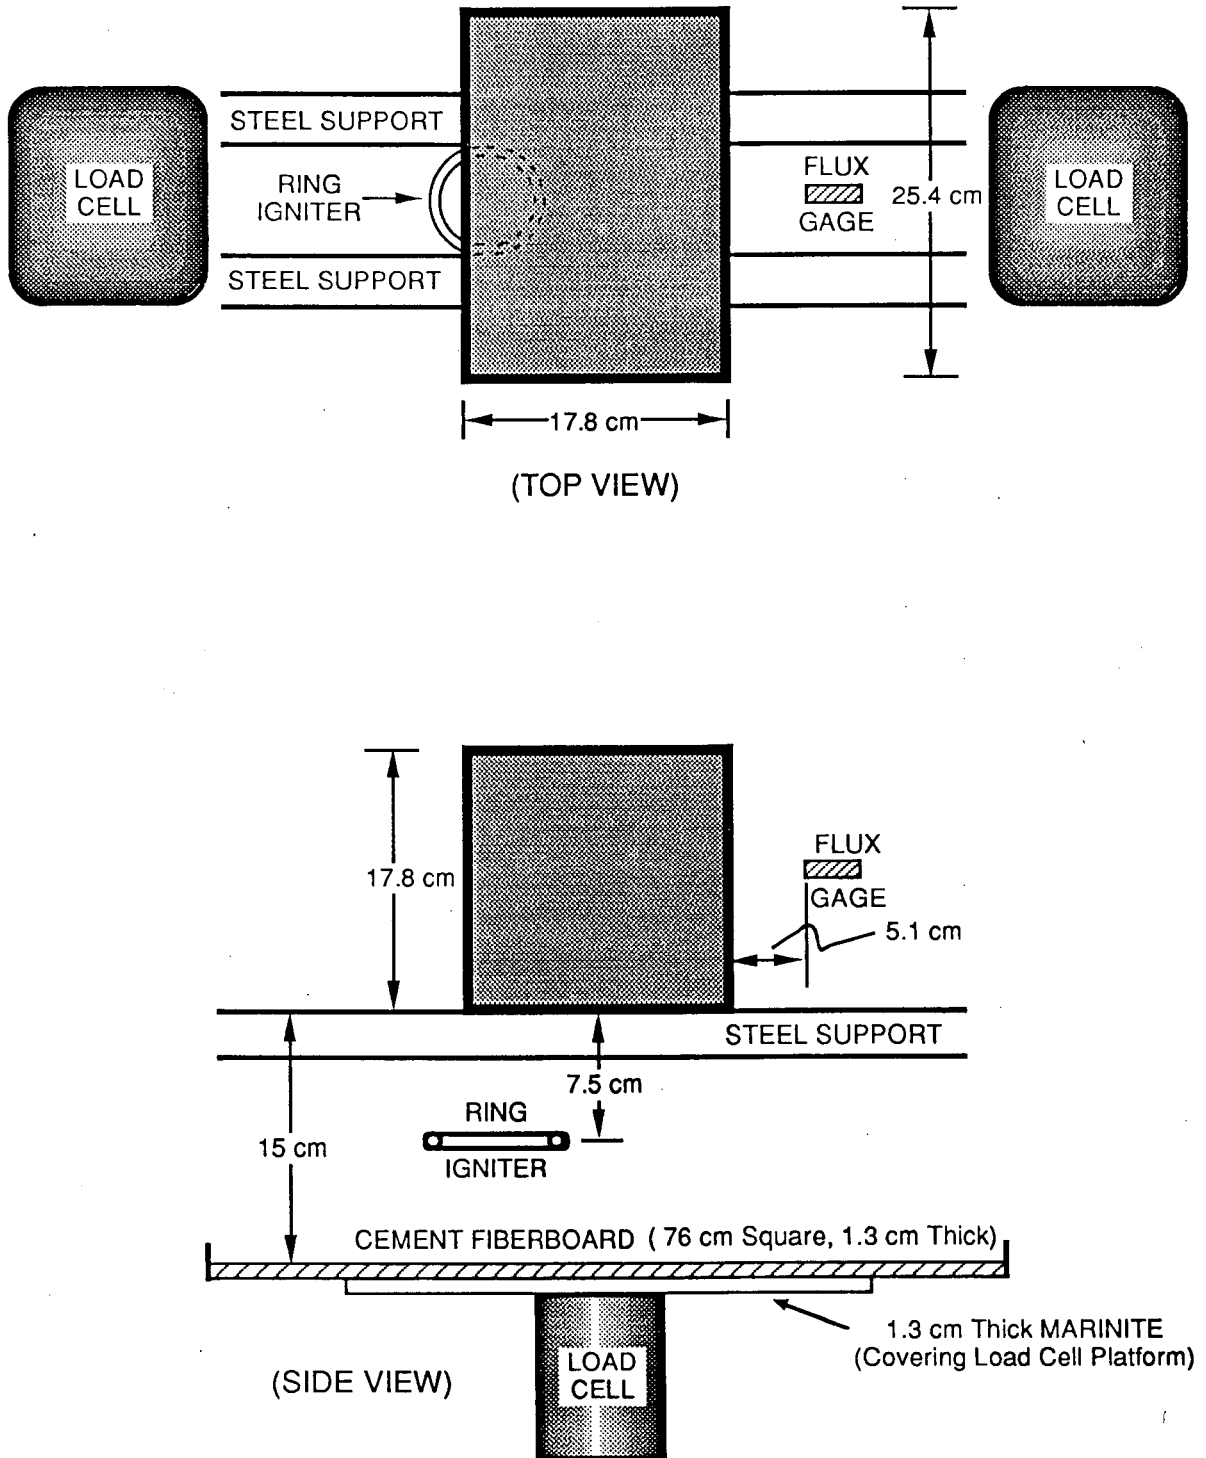
Figure 15. Test configuration for isolated parts, as applied to a generic part.

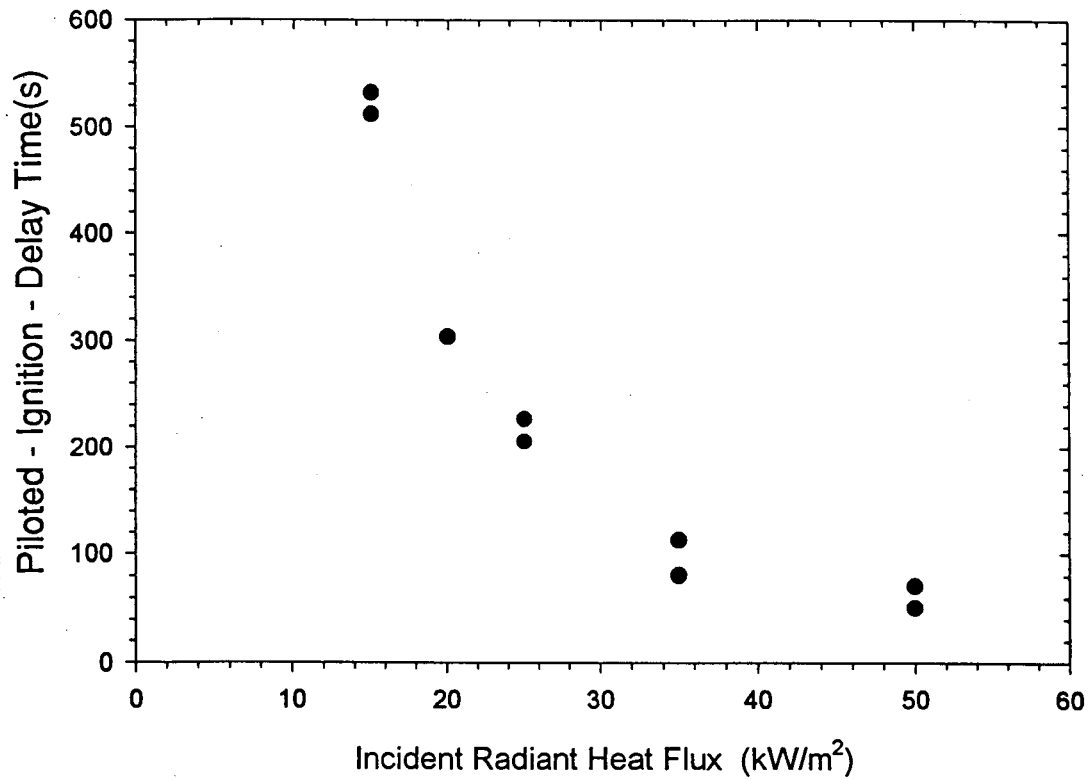
Ignition Behavior of Windshield Sections
(Fractured with < 10% of outer glass layer removed)

Figure 16. Cone Calorimeter data for windshield sections. Piloted ignition delay time versus incident radiant flux.

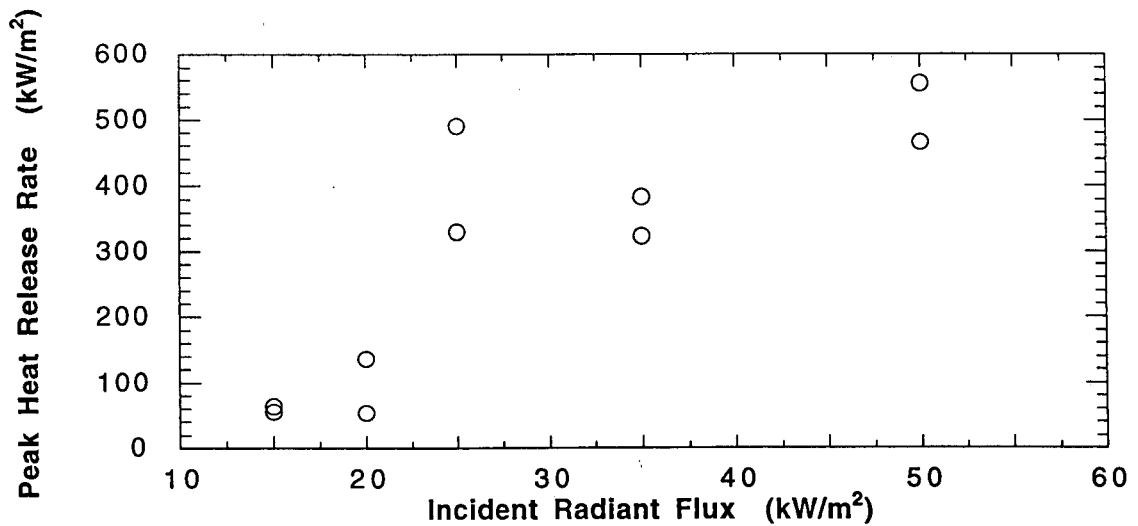
Figure 18. Cone calorimeter test results for windshield sections. Peak heat release rate at five incident heat flux levels.

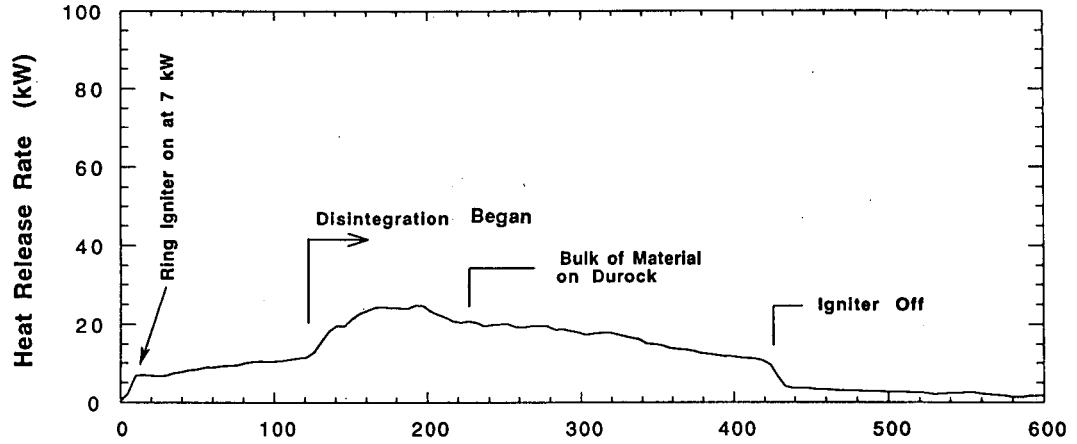
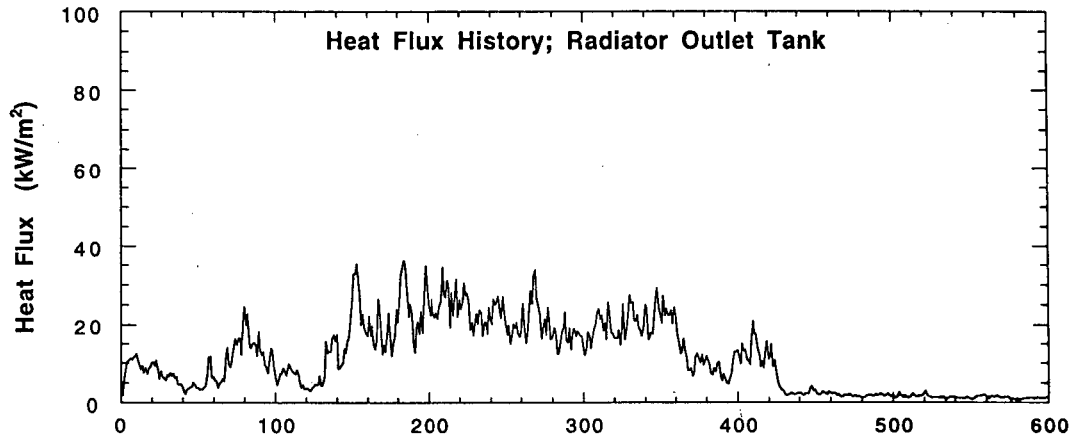
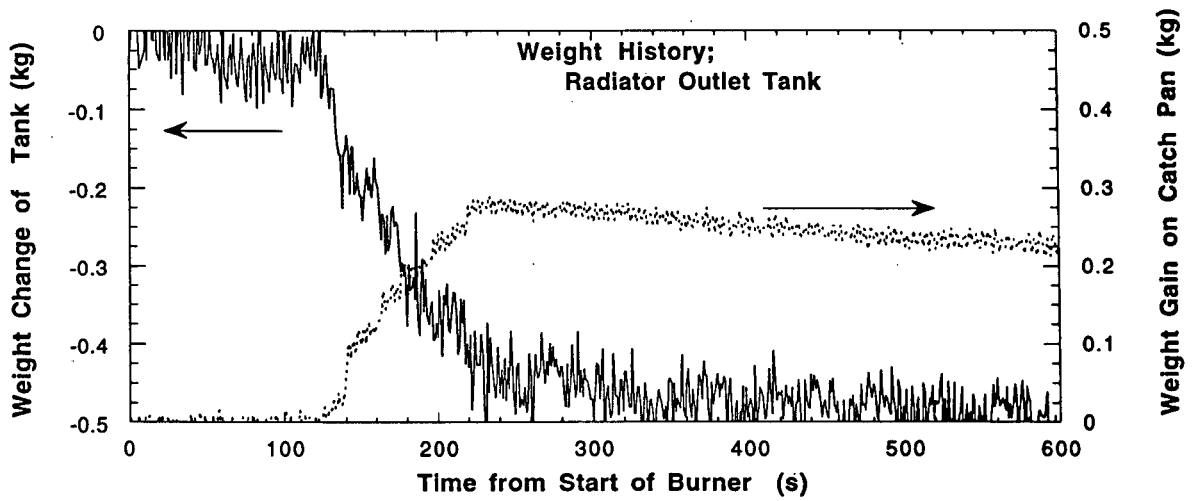
**Radiator Outlet Tank
(Mounted on Radiator; ATF Cooler Removed)**

Figure 19. Results from fire test of radiator outlet tank (mounted on end of vertical radiator).

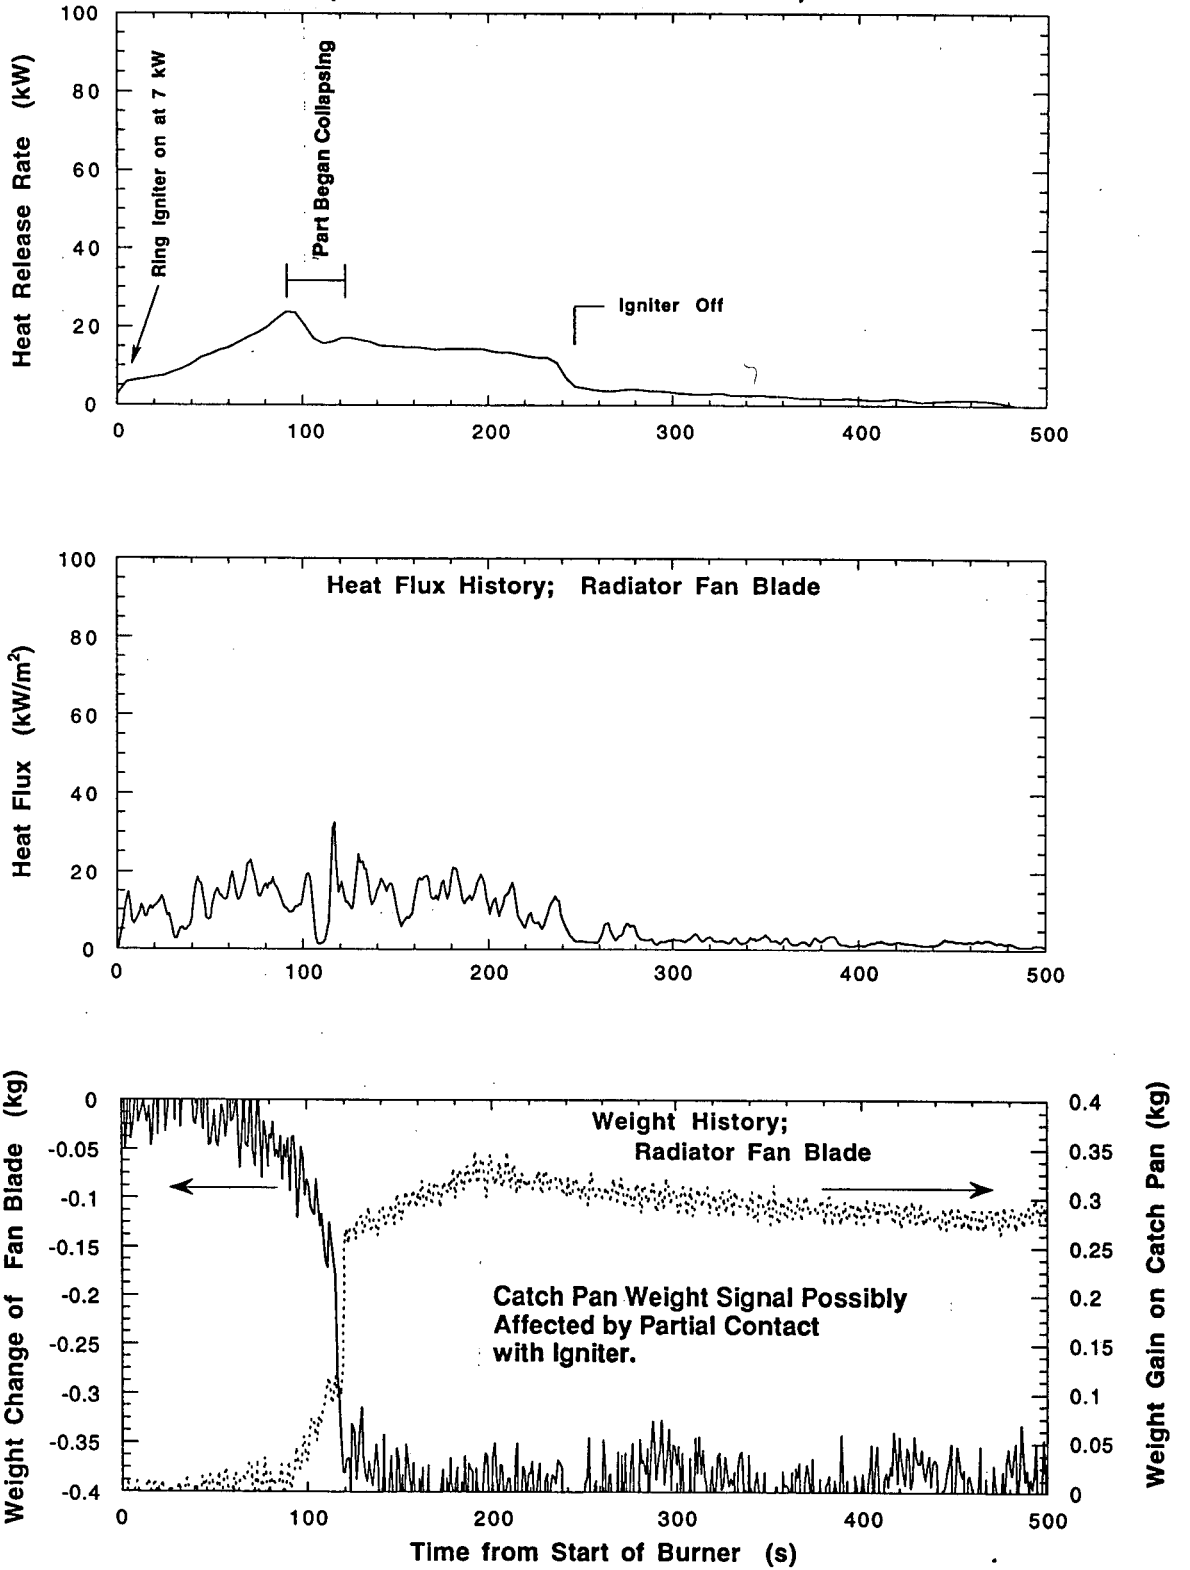
**Radiator Fan Blade
(Mounted from Central Shaft)**

Figure 20. Results from fire test of radiator fan blade (suspended vertically from central shaft).

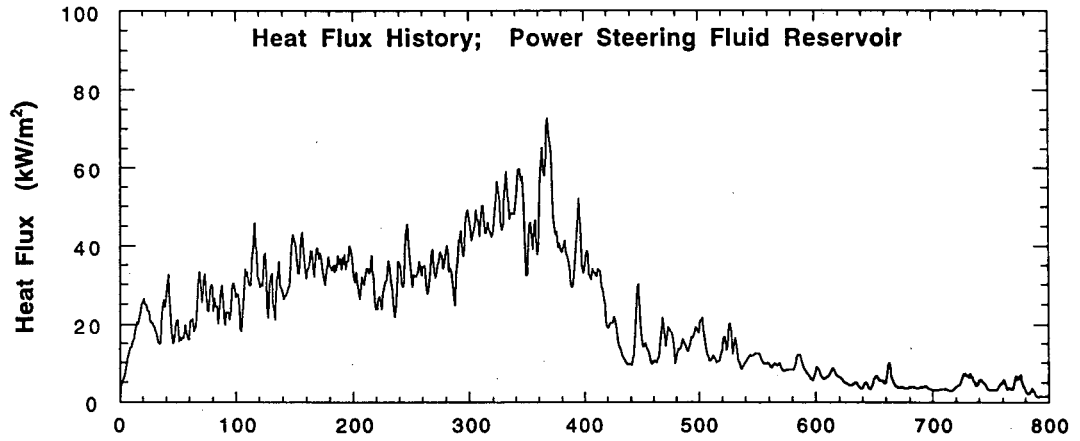
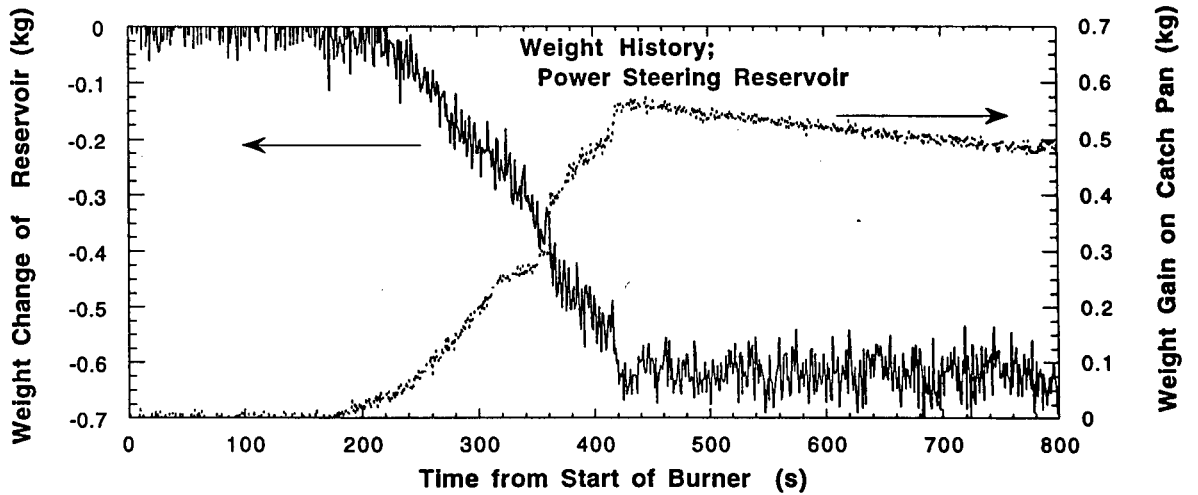
Power Steering Fluid Reservoir (Half-Filled with Fluid)

Figure 21. Results from fire test of power steering fluid reservoir (half filled with power steering fluid).

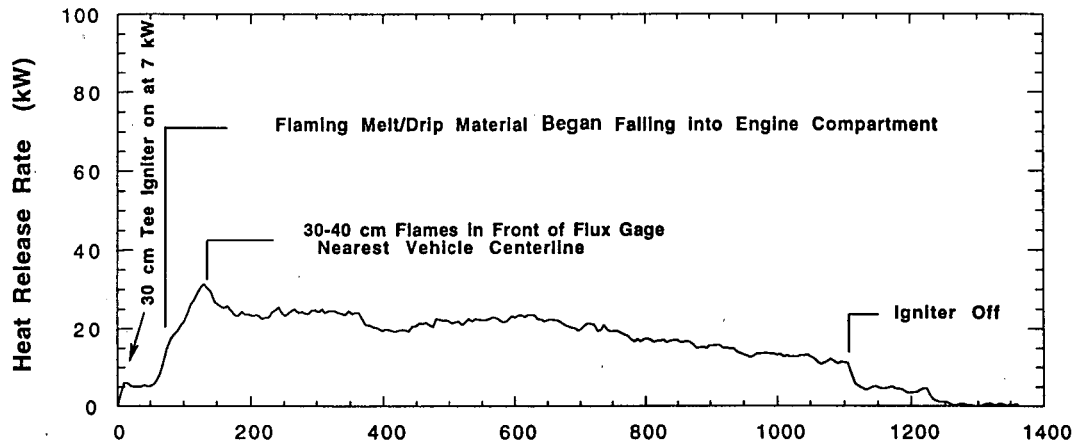
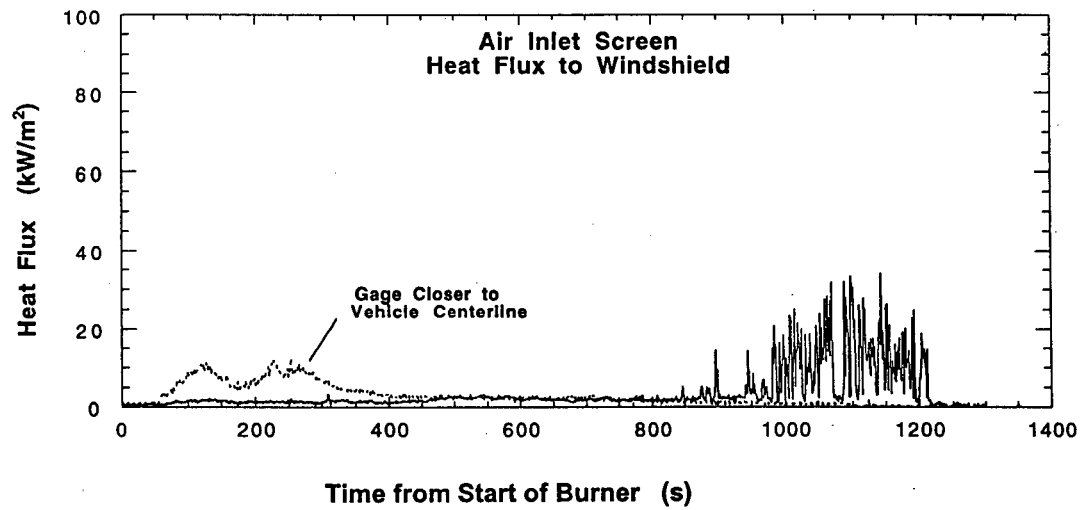
**Driver's Side Air Inlet Screen
(Mounted on Front Buck)**

Figure 22. Results from fire test of left half of air inlet screen (mounted on front buck, at base of windshield).

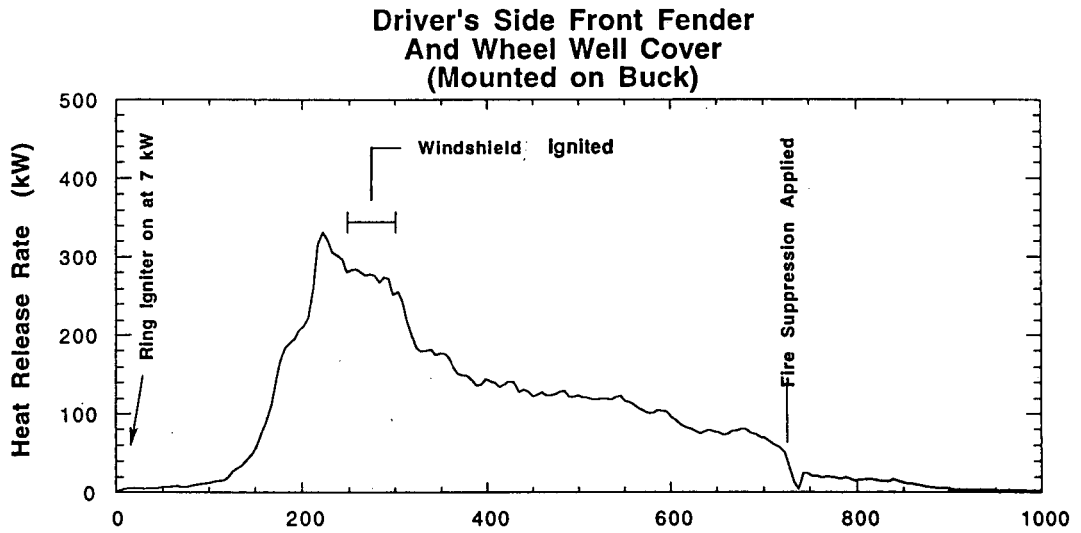
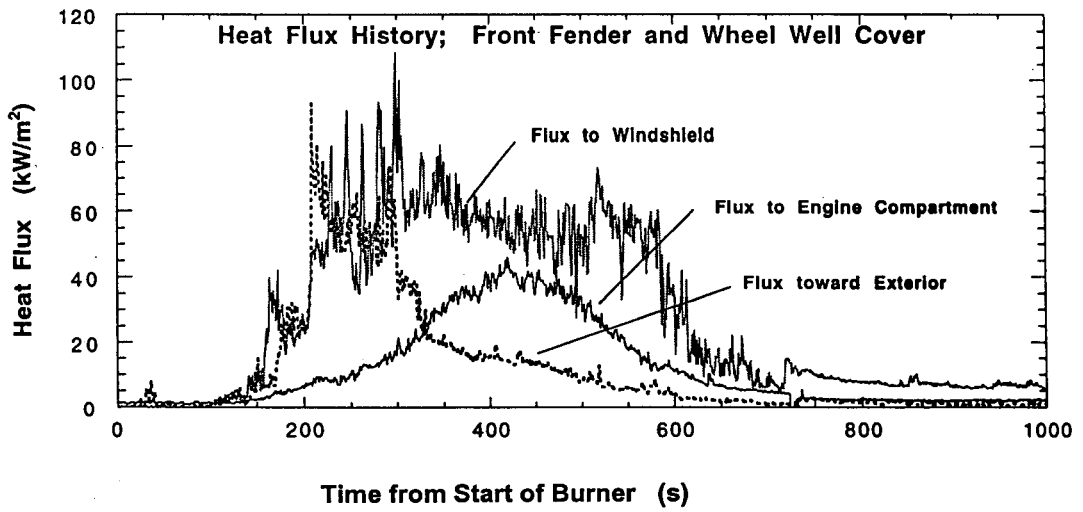
Figure 23. Results from fire test of left front fender and wheel well liner (mounted on buck).

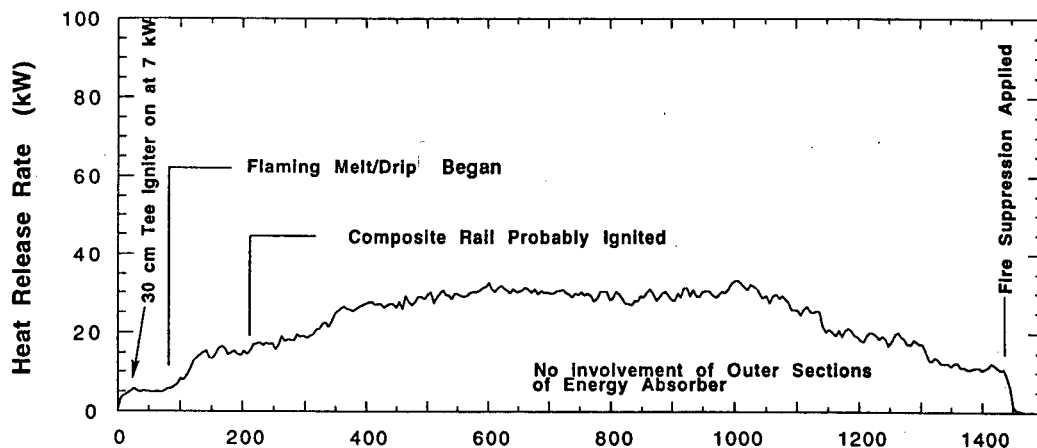
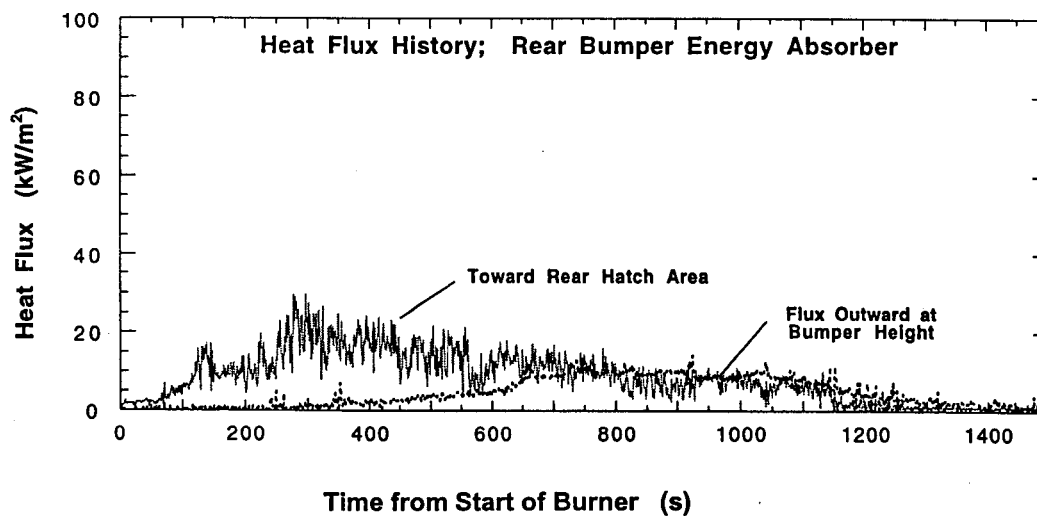
Rear Bumper Energy Absorber (Mounted to Composite Rail on Rear Buck)

Figure 24. Results from fire test of rear bumper energy absorber (mounted on rear buck; attached to impact bar).

Fig. 24 shows the test results. The energy absorber comprises a 4.4 kg mass of a polyethylene-based formulation. The heat release rate that developed here was 30 kW or less due to the large separation between the test assembly and the ground surface, coupled with the horizontal orientation of the components. These factors caused the amount of mass burning at any given time to be a small fraction of the total available. The fire progressed up the rear surfaces of the honeycomb above the igniter, melting much of the material which then dripped to the Durock surface. This melt/drip material burned (partially) on the Durock surface but this pool fire had flames which reached less than a quarter of the way up toward the bottom of the energy absorber. Thus the pool fire did not accelerate flame spread on the absorber or the burning of it. When the center of the absorber had melted out of the way, the igniter flame played directly on the impact bar, igniting its resin. It was this portion of the fire which produced the maximum in heat flux toward the rear compartment. The lateral spreading flame fronts on the energy absorber propagated slowly outward in opposite directions from the centerline of the vehicle¹⁹, continuing to send much of the resin onto what eventually became two separate pool fires on the ground. The flame front spreading toward the driver's side caused the lower peak (radiative) flux seen by the second heat flux gage. Eventually the flame front on the impact bar split and spread laterally in the same two-front manner. When the last few lower centimeters of the central honeycomb section remained on each side (ca. 15 minutes into the test), each melted off of its support screws and hung by the straps attached to the two outermost honeycomb sections. One side burned out in this configuration; the other side was extinguished. A substantial amount of unburned resin was left on the Durock.

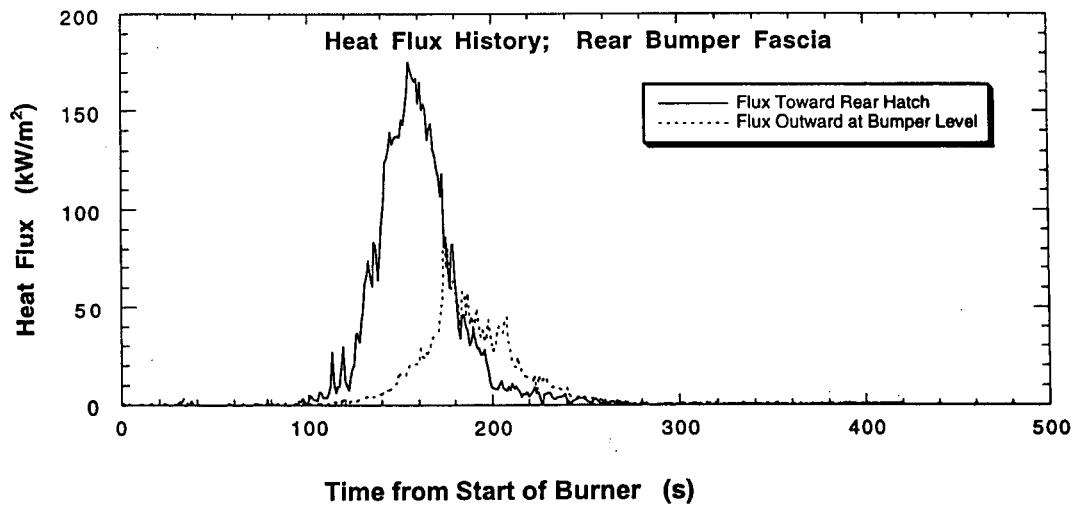
Figure 25. Results from fire test of rear bumper fascia (mounted on rear buck).

Fig. 25 shows the test results; note that the ordinate scales differ from those in most of the previous figures. By 1-1/2 minutes into the test the videos showed little change except that the exterior surface of the license plate indent area was ignited. By two minutes this area was beginning to open up and drop flaming chunks of material onto the Durock; smoke was issuing from nearly the entire top edge of the bumper at its juncture with the vehicle body. The smoke pattern appeared consistent with flames spreading on the interior surface of the fascia. However, flames spread in such an enclosed space would be inhibited by a poor air supply. It is more probable that most of the smoke arose from pyrolysis of this interior surface as the flames in the license indent area neared penetration.

Both heat flux gages gave flux peaks normally only seen with immersion in large, sooty fire plumes [8]. The gage in the rear compartment was driven past its 150 kW/m² limit and was discarded after this test; its peak value in Fig. 25 is thus in doubt. The results in Ref. 2 show that a flux of 75 kW/m² can ignite various polymeric automotive components (from a different vehicle) in times ranging from 8 to 60 seconds, depending on the particular component. The flux toward the rear compartment exceeded this for 40 seconds.

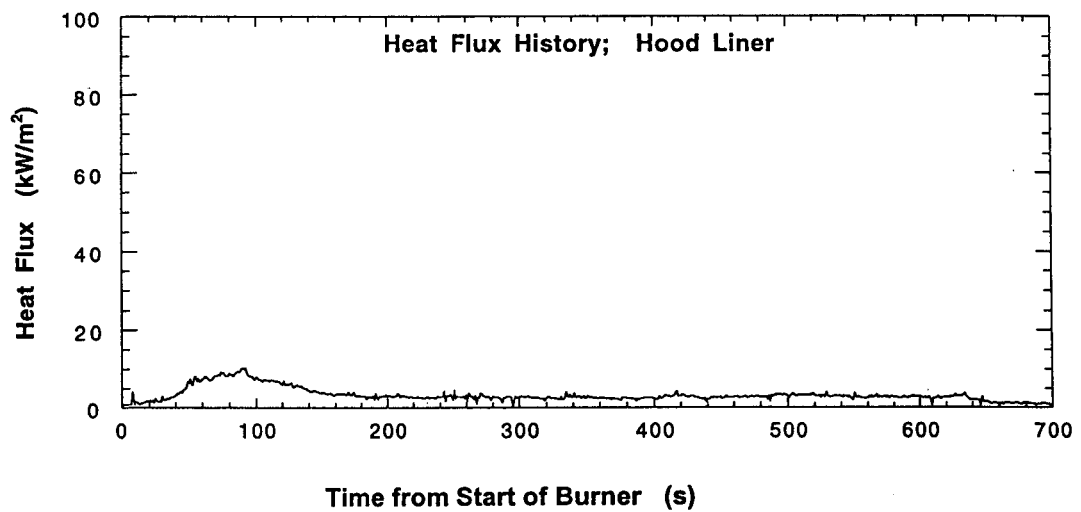
Figure 26. Results from fire test of hood liner (mounted on hood). One half sprayed with 50/50 coolant /water mixture.

Fig. 26 shows the test results. Virtually the only flame spread seen here was on the side that was sprayed with coolant; there was no indication of ignition or spread on the dry side of the hood liner. On the wetted side, flames spread from the igniter area to the forward (top) end of the hood liner in about 20 seconds after an initial delay of about 20 seconds. No lateral flame spread on either the dry or the sprayed portions of the liner was seen. The flames that resulted from upward spread persisted for about one minute. They were rather weakly luminous, consistent with the oxygenated nature of ethylene glycol. The peak heat release rate was modest (ca. 15 kW/m^2); so also was the peak radiative flux downward from the burning liner (10 kW/m^2). The radiative flux was probably too low and too short-lived to have ignited any solid object in an engine compartment (though it would enhance the burning rate of any already burning object there). The flames themselves probably did not persist for sufficient time to have ignited solid polymeric materials immersed in them, since the expected flux level to them would be $20\text{-}30 \text{ kW/m}^2$ [8]. However, it appears likely that had more coolant been sprayed on the liner, the flame would have lasted longer²⁰ and ignition of other polymeric components, especially those with thin cross-sections, would then be more probable [8]. Coolant is normally at an elevated temperature within the engine; this too would enhance the burning in this type of situation.

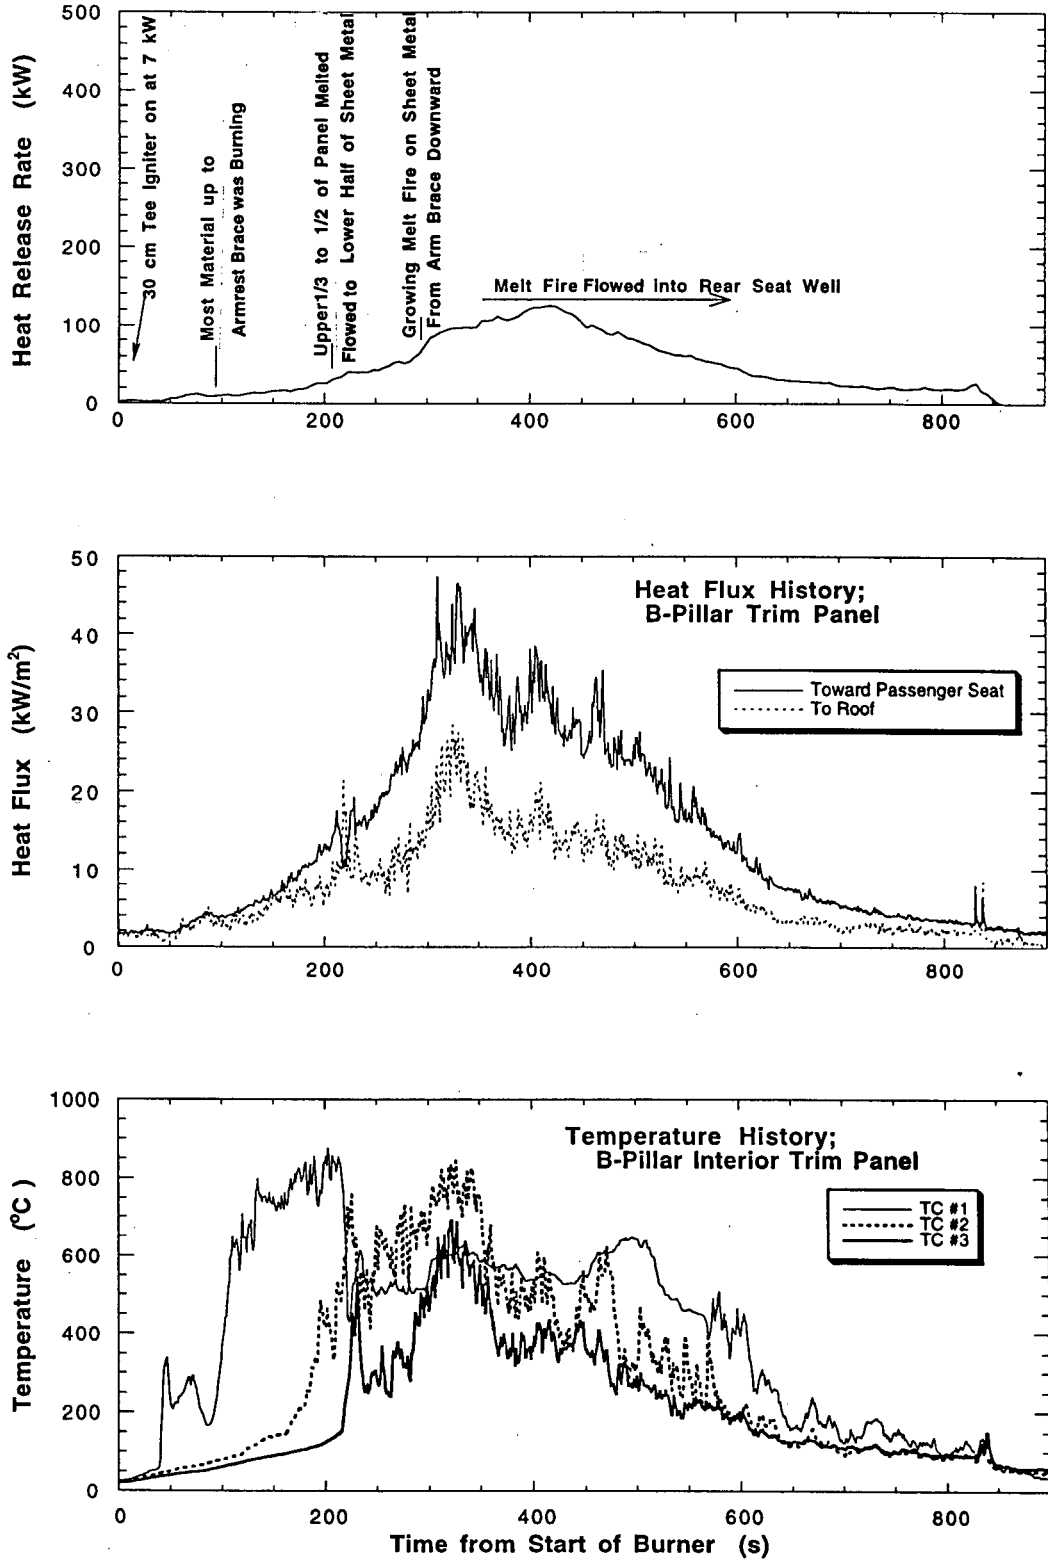
**B-Pillar Interior Trim Panel
(Mounted in Rear Buck)**

Figure 27. Results from fire test of B-pillar interior trim panel (mounted in rear buck).

Fig. 27 shows the test results; note the ordinate for the heat release rate plot. The observed behavior was, in large measure, dominated by the thermoplastic behavior of the panel and its interaction with the metal body panels. In the first two minutes, the armrest brace (and the shape of the panel at the armrest height) tended to serve as a temporary inhibitor²¹ of what was a mixed process of upward flame spread accompanied by substantial flaming melt/drip/flow downward toward the floor pan. The armrest brace then tended to become a pooling area for flaming melt material. Flames from this pool and from upward moving flames on the melting panel then began to reach upward behind and in front of the upper half of the panel. Both the thermocouples and the video images indicated that the flames moved upward behind the panel more rapidly and extensively than they did in front of it (i.e., on its outer surface), possibly because of a chimney-like

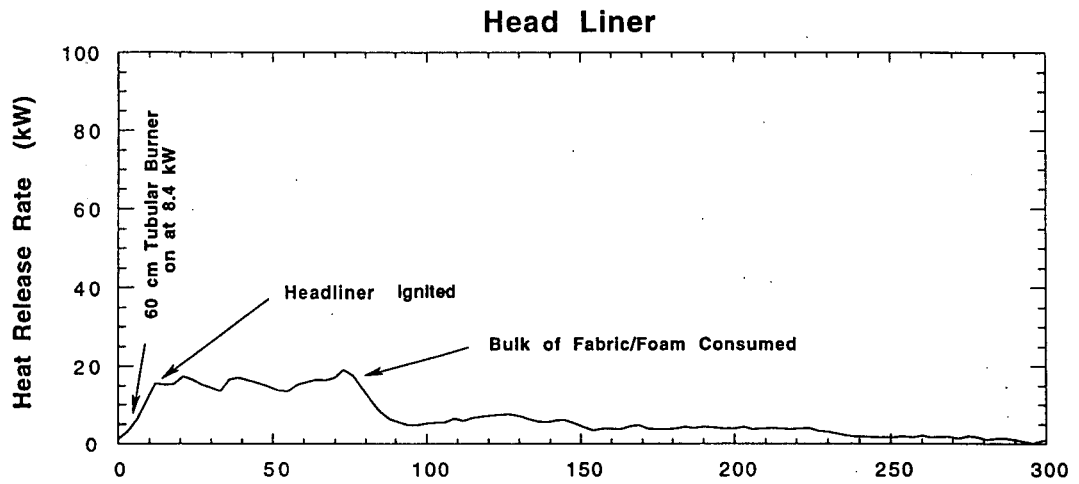
Figure 28. Results from fire test of head liner (mounted in inverted sheet metal pan).

Fig. 28 shows the test results. The fire lasted about 90 s and fully consumed the fabric-covered foam layer. Within 8 seconds a front representing a visible physical change to the liner fabric (possibly melting) had moved to the location of the third pair of thermocouples, 50 cm from the front of the liner, within the domed (highest) region of the liner on both sides. The thermocouples themselves gave ambiguous indications of

The peak heat release rate, shown in Fig. 28, was less than 20 kW. However, it is occurring in a space where buoyancy naturally causes heat to accumulate. Heat from any other burning objects in the passenger compartment accumulates just below the headliner, as well. Radiation from this hot gas layer may ignite the tops of the seats, etc., leading to generalized ignition, known as flashover of the compartment. This was the endpoint of some of the vehicle fire tests in Project B.3; these involved multiple burning objects in the passenger compartment.
