**NISTIR 6748**

# **Influence of Flame-Retarded Resins on the Burning Behavior of a Heating, Ventilating and Air Conditioning Unit from a Sports Coupe**

T.J. Ohlemiller  
Building and Fire Research Laboratory  
Gaithersburg, MD 20899

June 2002

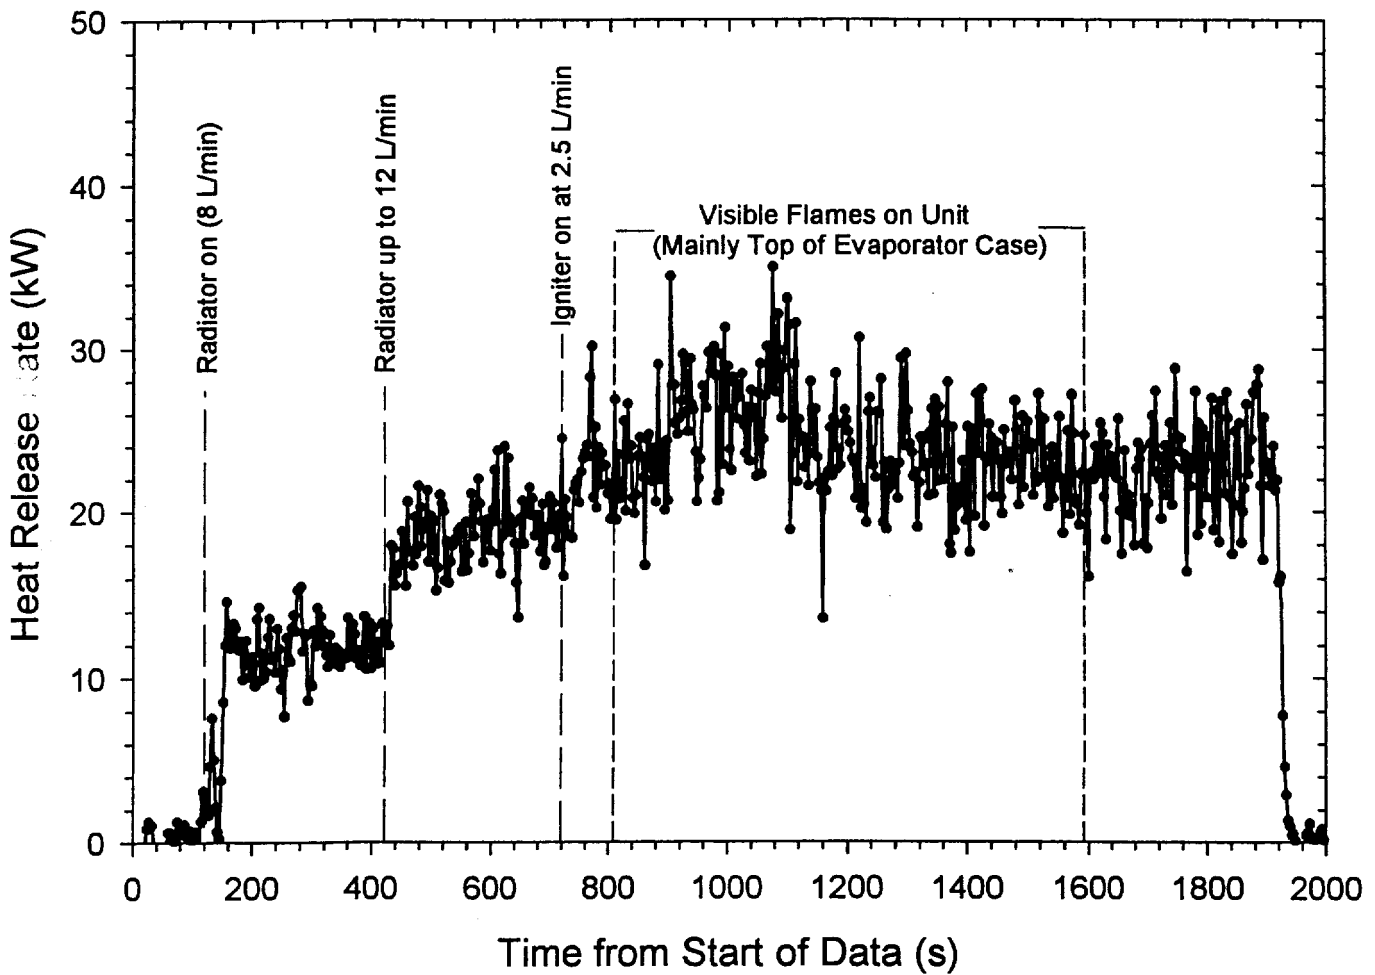
Figure 2 Heat Release Rate versus Time during test of HVAC unit A; heat release is total from burners plus burning of test assembly.

The top of the evaporator case was the only object which burned unambiguously. The peak heat release rate from this was about 5 kW, as Fig. 2 indicates. There was no indication of flame spread into any portion of the HVAC unit rearward of the forward

Figures 4 and 5 bear a strong resemblance to Figs. 2 and 3; in fact, much of the fire test behavior was the same for the two units<sup>15</sup>. However, unit B did start out with a notable difference. There were flames visibly attached to the lower, fiber-filled portion of the evaporator case within about 30 s of the start of the igniter flame adjacent to this area of

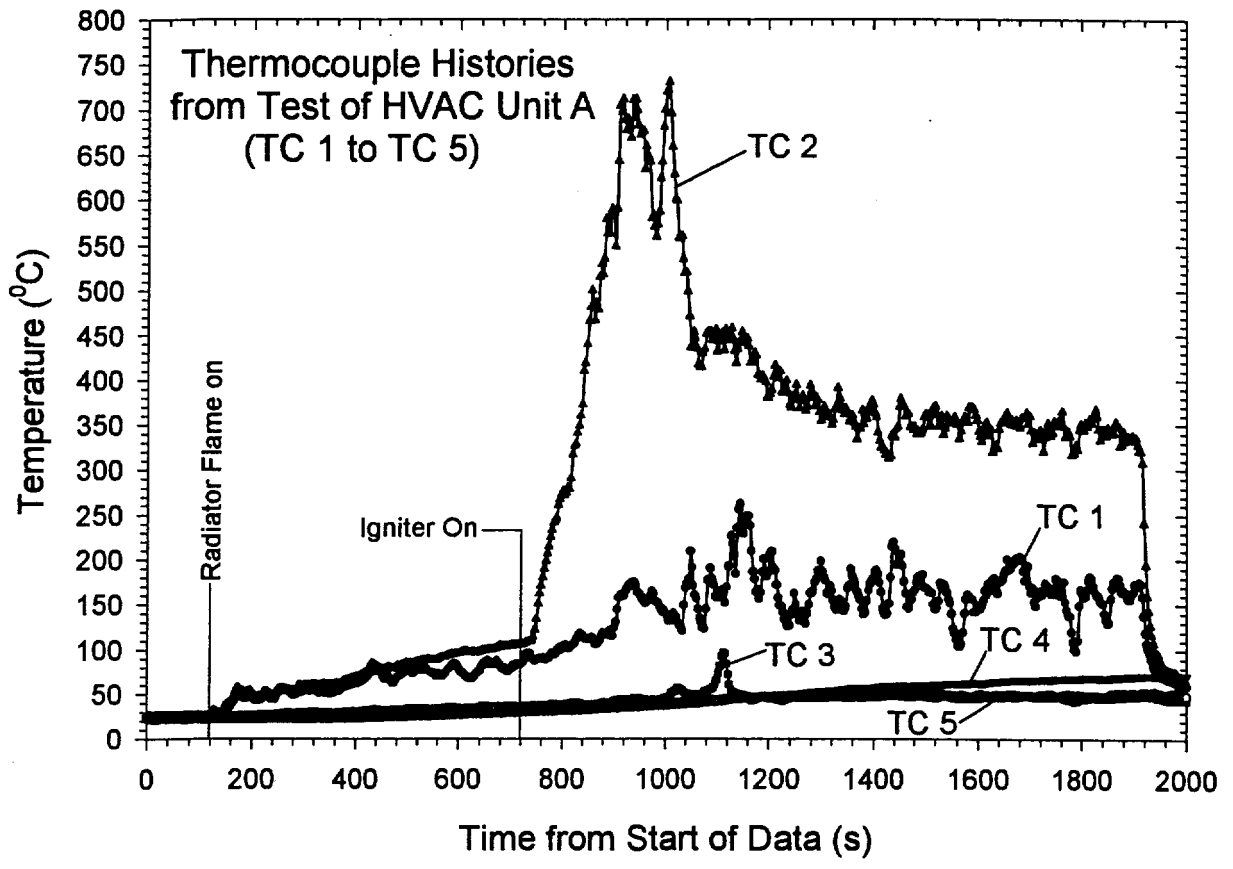
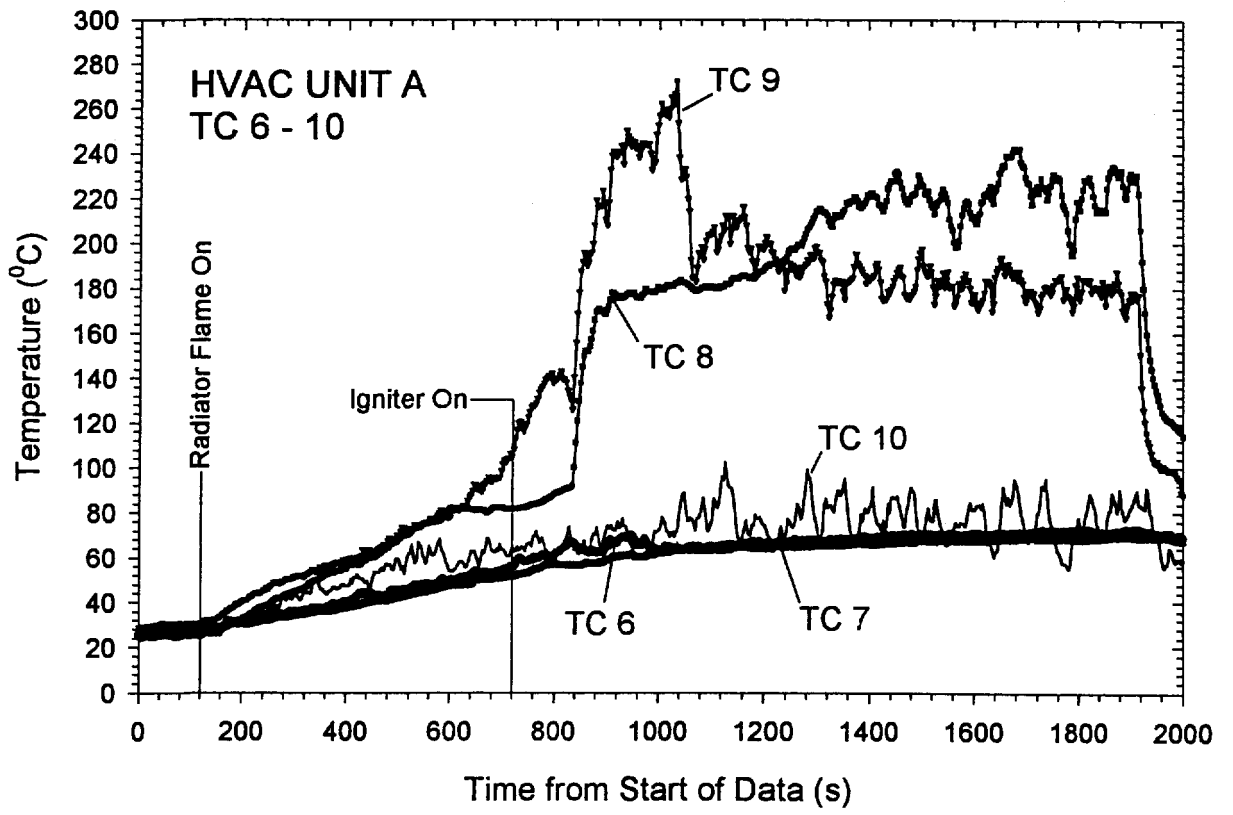
Figure 3 Temperature -Time results from 10 thermocouples in and around HVAC unit A.

The polypropylene upper section of the evaporator case began to ignite at about 800 s, in the area near TC 2. Figure 3 shows that this was the only thermocouple to reach temperatures of more than 300 °C during this test. Over approximately the next 800 s the flames spread over the inboard and top portions of this upper evaporator case. Flames did not spread onto the outboard side of the top cover which had not received any radiative pre-heating. There was no clear indication of flames attached to the fiber-filled lower portion of the AC evaporator case, though such flames are not always easy to discern in the presence of an adjacent igniter flame. In any event, at the end of the test, the igniter-exposed part of this lower case was white, indicating that all of the resin had been driven out, probably by burning. The glass fibers retained the original part shape and showed no holes.

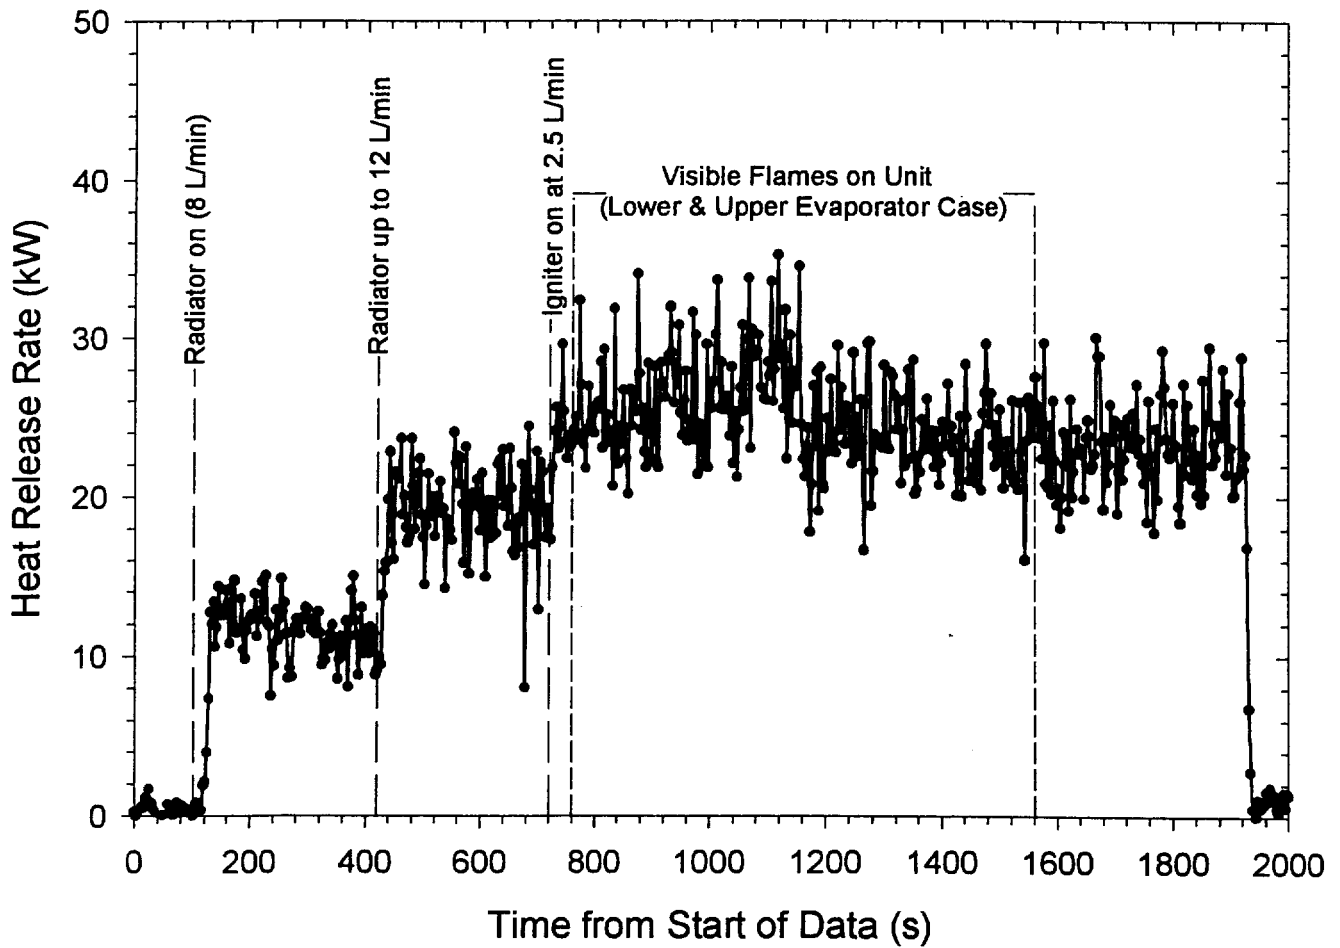
Figure 4 Heat Release rate versus Time during test of HVAC unit B:  
heat release is total from burners plus burning of test assembly

**HVAC Unit B.** Figures 4 and 5 show the heat release rate and thermocouple results, respectively, from the test of unit B. Note again that the temperature scales in the upper and lower portions of Fig. 4 differ.

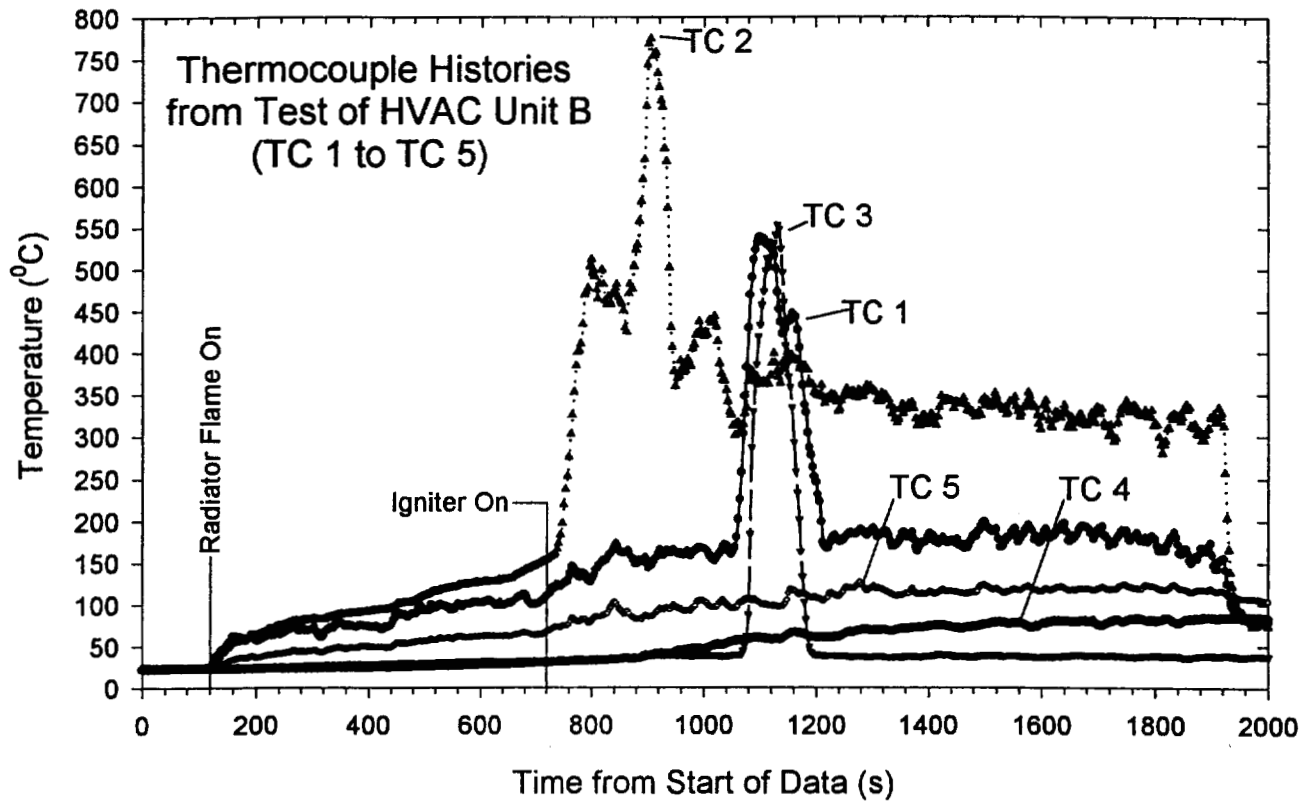
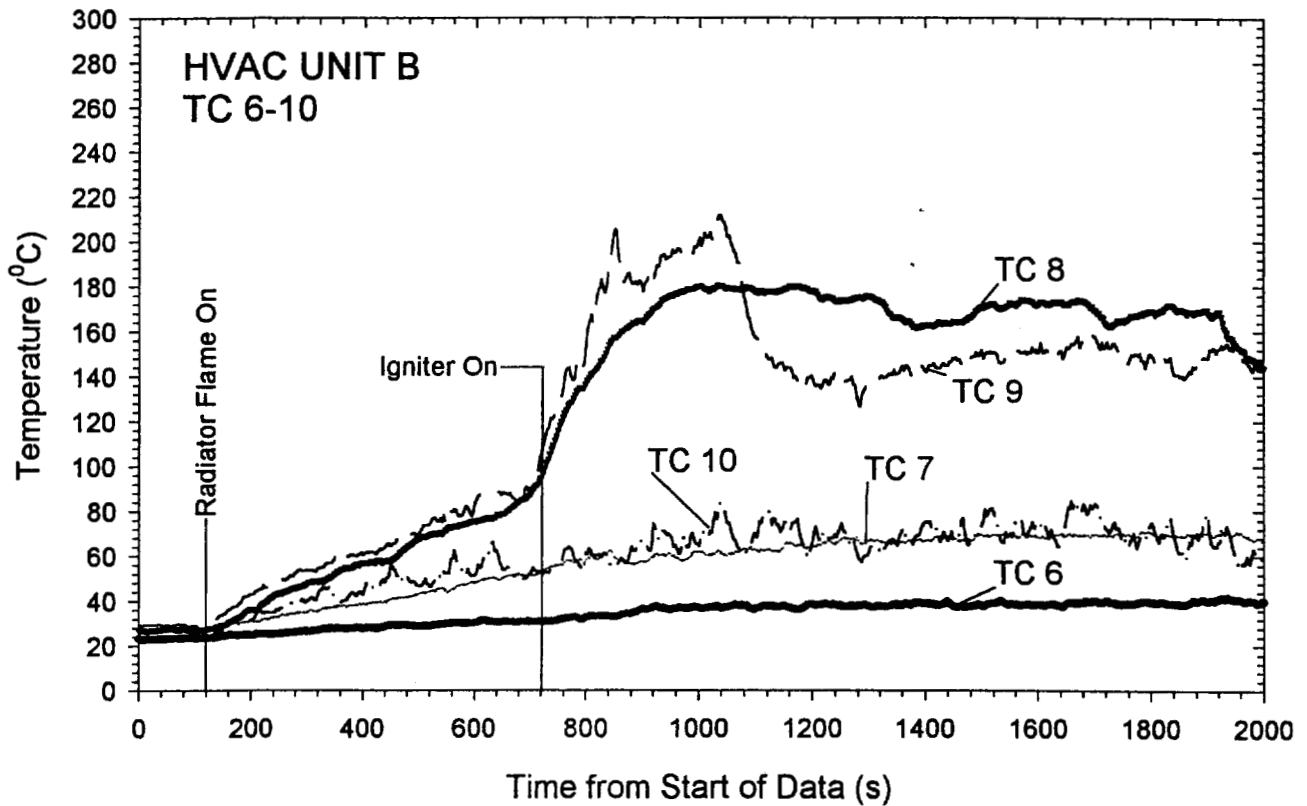
Figure 5 Temperature - Time results from 10 thermocouples in and around HVAC unit B.

In Figure 5 one sees that again only TC 2, placed in the upper forward area of the evaporator case, exceeded the 600 °C criterion for the presence of flames. TCs 1 and 3, high and low in the rear of the evaporator case, respectively, showed spikes to about 550 °C. This indicates nearby flames, possibly from a mass of flaming material from the top of the evaporator case which fell partially to the bottom; this material had a clear tendency to sag into the lower part of the evaporator case.
