ESCAPE WORTHINESS OF VEHICLES FOR OCCUPANCY SURVIVALS AND CRASHES. SECOND PART: APPENDICES

OKLAHOMA UNIV. RESEARCH INST., NORMAN

DOT HS-800 737

Second Part: Appendices

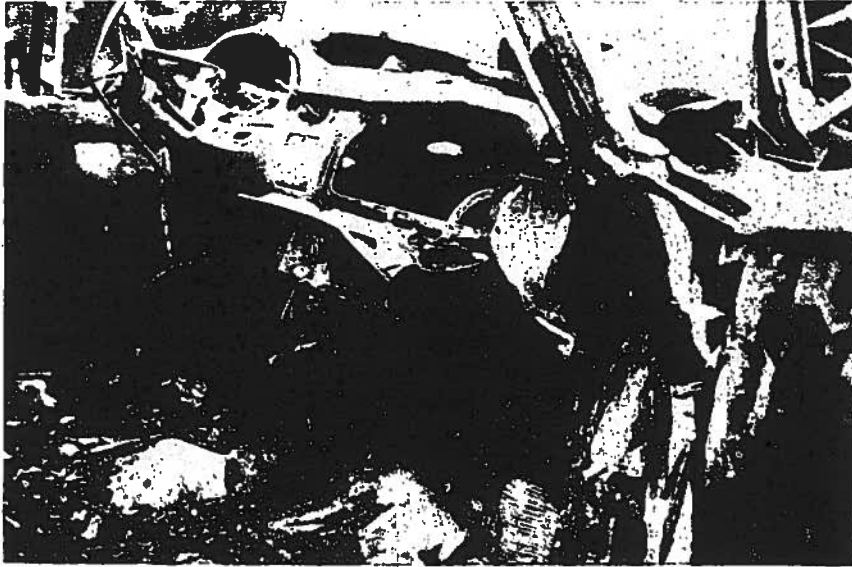
Figure 12. Interior of vehicle #2, 1960 Ford.

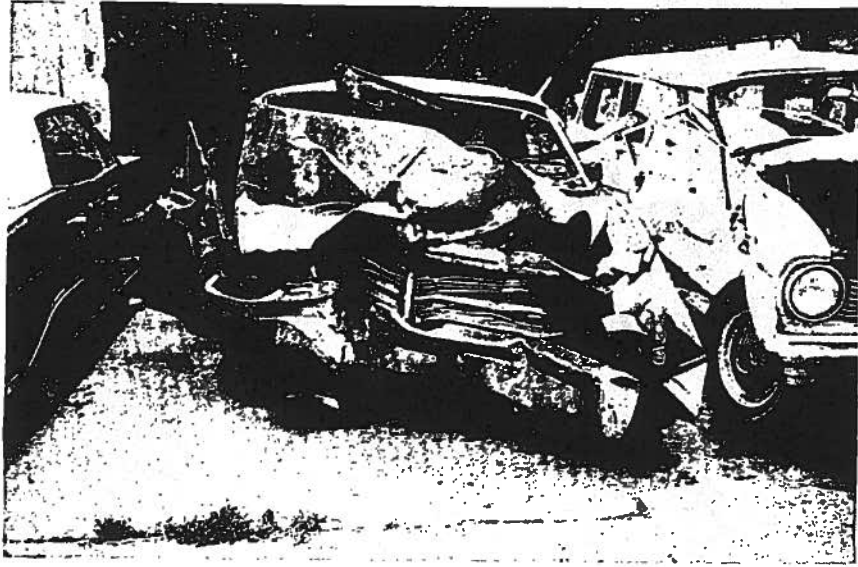
Figure 14. Vehicle #1, 1966 Mercury, front view.

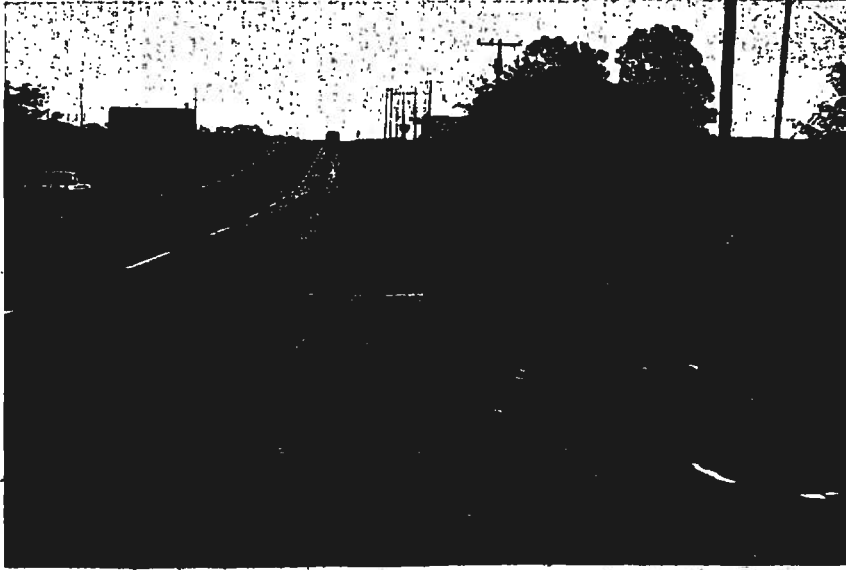
Figure 1. Scene of accident.

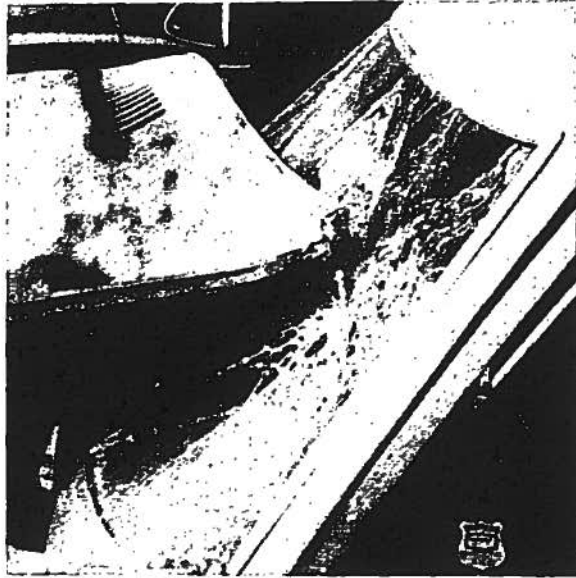
Figure 11. Front end damage, vehicle #2. Note slight scorching of paint, no other fire damage.

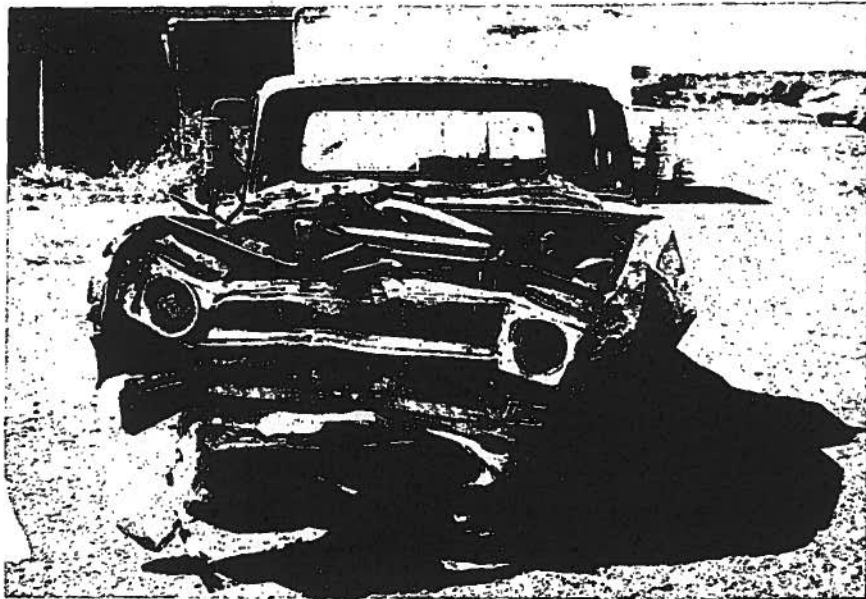
Vehicle #2 suffered damage to the front fenders at impact and the propane regulator was broken. The front of the vehicle burst into flames at impact. The occupants were forced to escape on the left side since the right door was jammed at impact. The flames engulfed the interior in 1-2 minutes post-crash.

Figure 4. Front of vehicle #2, 1971 International Harvester half-ton pickup.

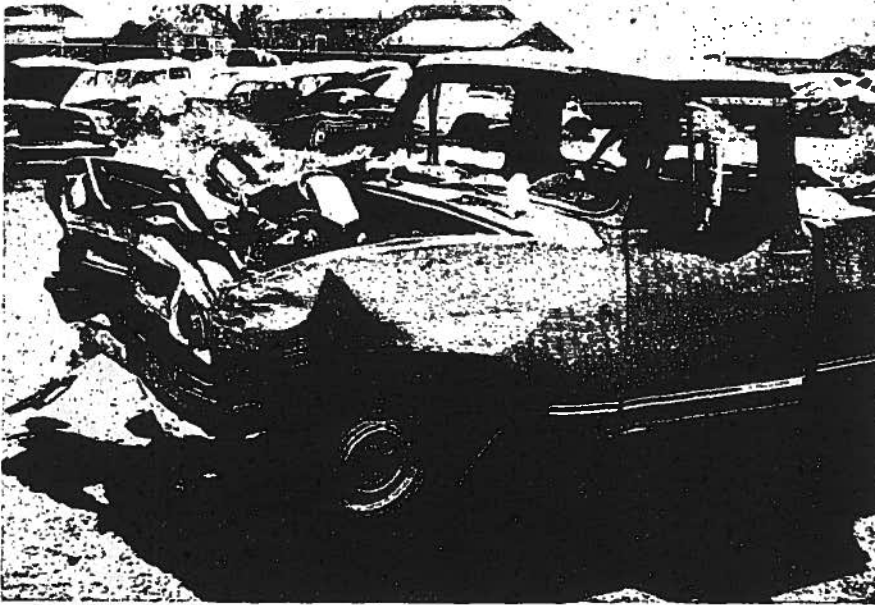
Figure 6. Left side of vehicle #2.

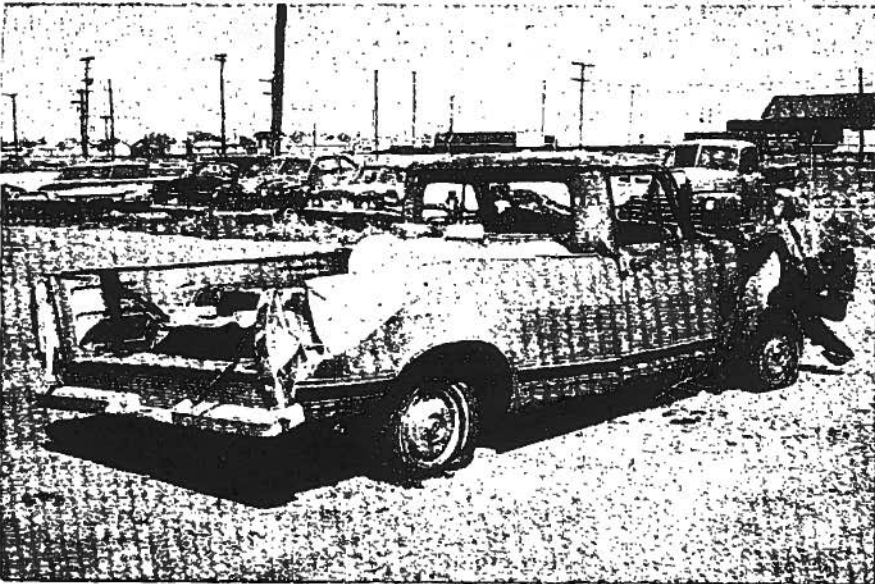
Figure 7. Right side of vehicle #2.

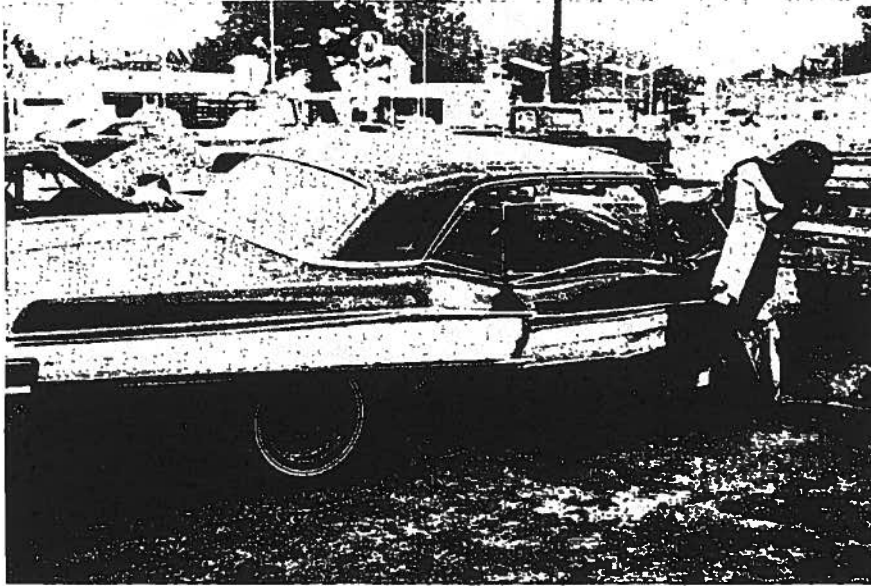
Figure 3. Right side of vehicle #1.

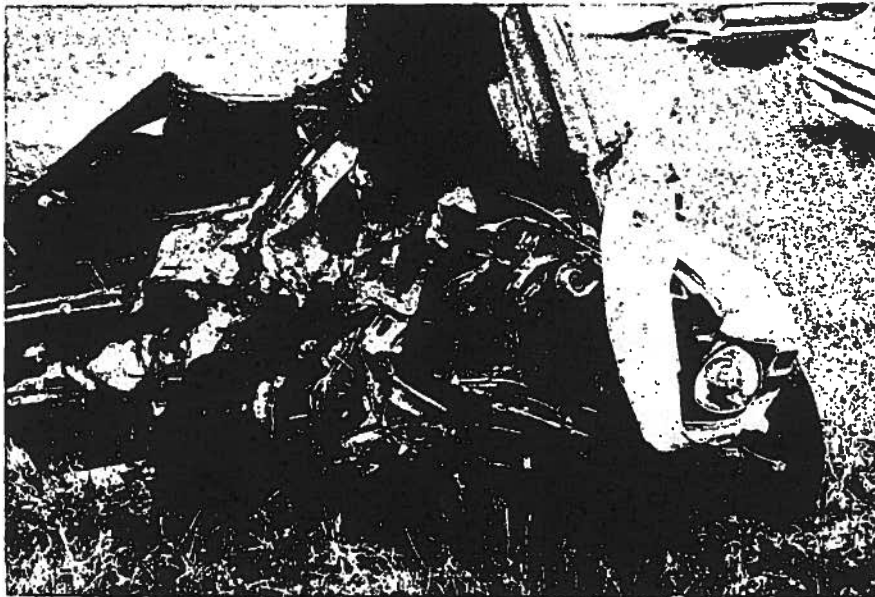
Figure 5. Front of vehicle #2.

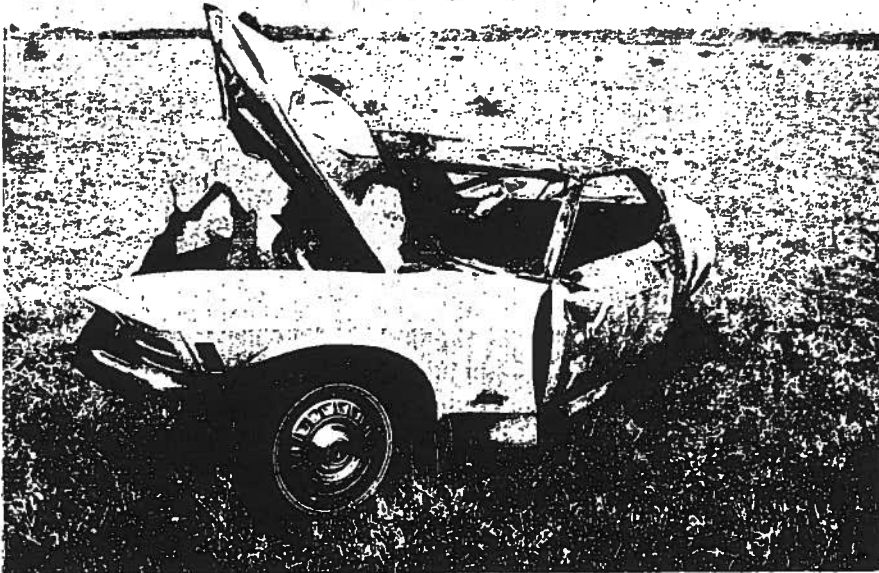
Figure 7. Left side of vehicle #2, 1969 Ford Mustang.

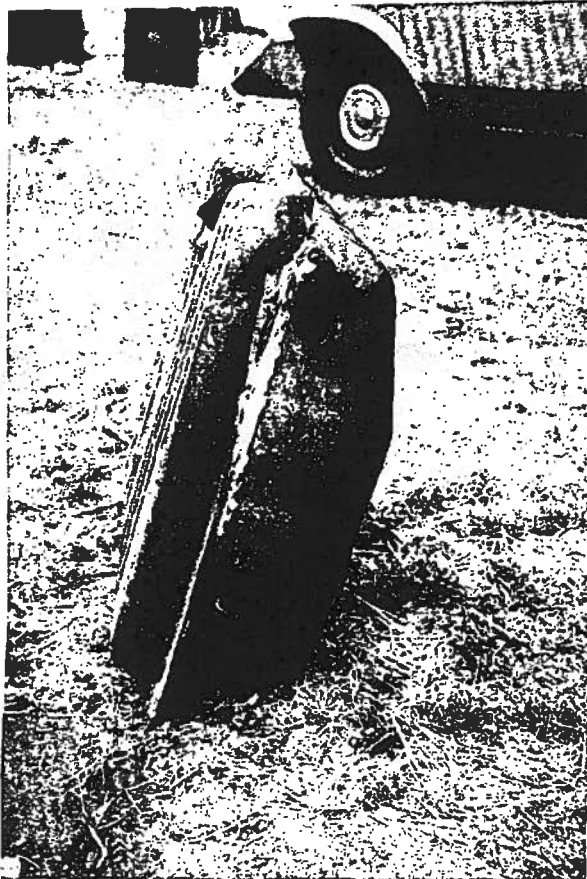
Figure 9. Fuel tank, vehicle #2.

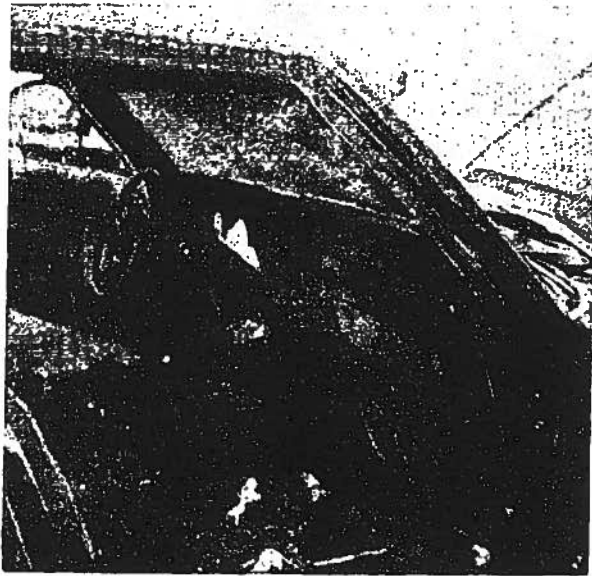
Figure 6 presents close-up views of the front seat area fire damage from both sides of the vehicle. The seat padding material was removed by the firemen to insure that the fire was not smoldering in the cotton backing. However, note that the seat springs still retain their full tension. This indicates that the fire did not start at nor spread to the underside of the seats, that the heat build-up was not excessive, and that the fire did not penetrate through the seat cushion assembly. Although not too clearly shown in these photographs, the left side of the instrument panel sustained considerably more damage than the right side. This fact will be a significant point in the subsequent discussions. The floor area on both the driver and passenger sides did not sustain any fire damage at all. This again indicates the base of the fire was higher up in the vehicle.

Figure 6. Close-up of front seat area and padded dashboard. NOTE: 1. Seat padding removed by firemen.
2. Observe that seat springs retained full tension.

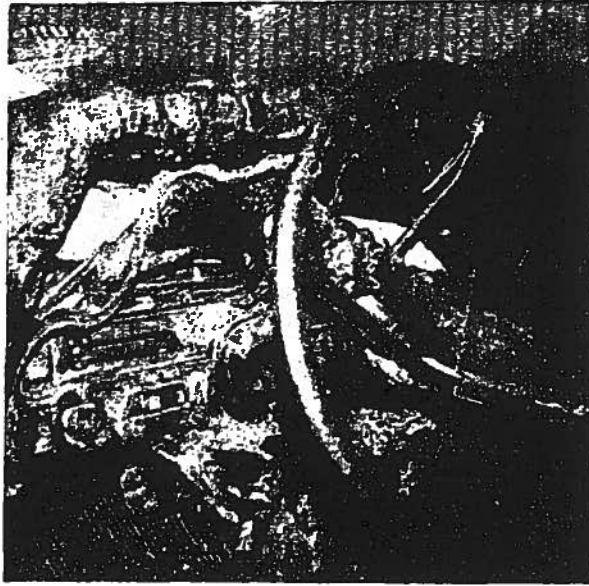
Figure 9 presents close-up views of the instrument panel on the driver's side. Note the almost complete destruction of the crash pad covering. Considerably more damage, melting and deformation, in the polymer coverings occurred on the right than on the left of the steering column (see Figures 10 and 11). This localization of damage coupled with the total absence of fire damage to the floor area at the front seat and lack of fire damage to the engine compartment fire-wall area indicates that the fire base was behind the instrument panel on the right side of the steering column.

Figure 9. View of the fire damage to the instrument panel,
driver's side.

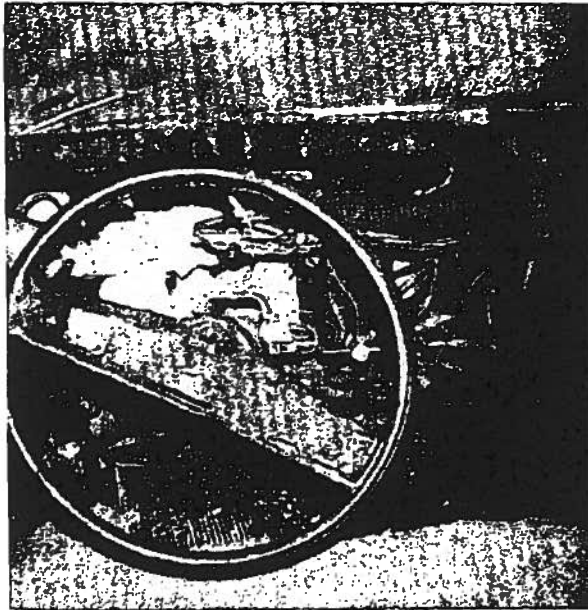
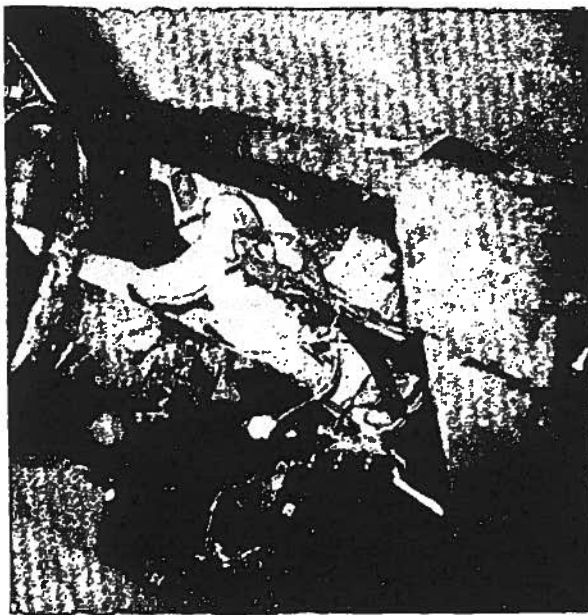
After the instrument panel face had been stripped away, it was found that the instrument cluster wiring harness had sustained only localized fire damage. The "CHECK DOOR" light lead-in-wire insulation was completely destroyed from the socket base to about 3 inches down the wire. The plastic tape used to constrain the wiring bundle was destroyed for about 4 inches on each side of this point. Small pieces of fused plexiglass were also found in this area of the harness. Figure 10 presents close-up views of this area.

Figure 10. Views of wiring harness just behind instrument panel cluster. Note localized fire damage, especially to light socket for "CHECK DOOR."
